Printed Circuit Board Reliability and Integrity Characterization Using MAJIC

M. Simard-Normandin
MuAnalysis Inc.
Ottawa, ON, Canada

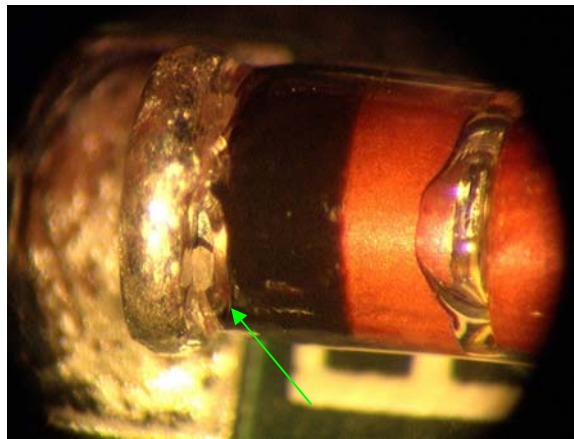
The IPC-A-610D is very precise regarding how visual inspection should be performed. In lead-free soldering we have often found that some components cannot handle the extra heat. An example of a cracked diode is shown in Figure 1.

Figure 1 - A cracked diode.

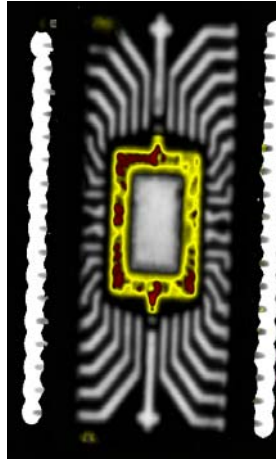
Figure 2 – An IC showing delamination of the lead- frame, revealed by Acoustic microscopy. This IC tested good electrically.

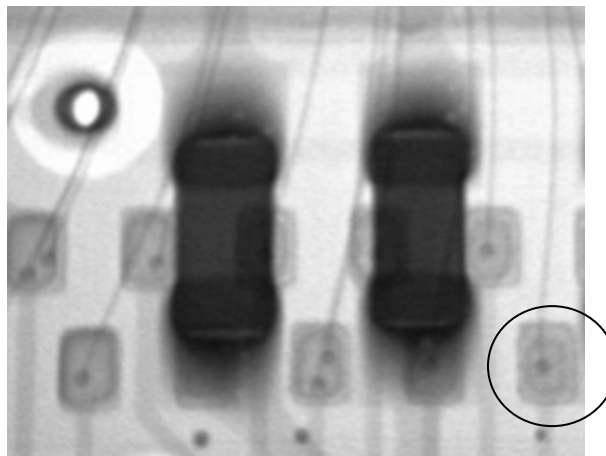
Figure 3 – Poor wetting and incomplete coverage of most of the solder pads in a QFN device. Only a small section of the device is shown. The worst pad is circled. The two discrete components in the field of view are on the other side of the board.

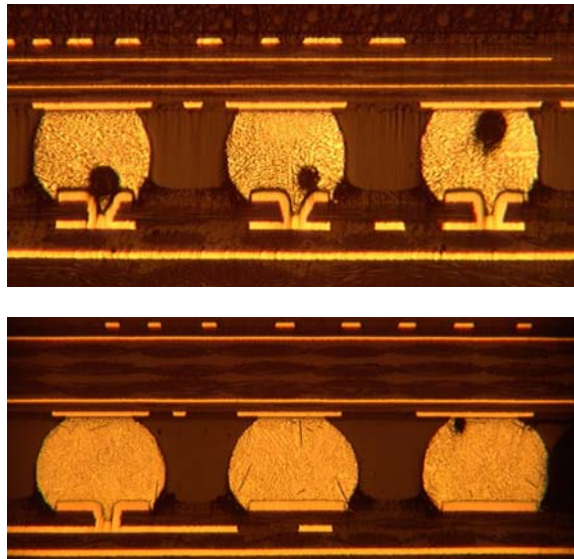
Figure 4 – BGA balls from two different components on the same product, showing significantly different voiding behavior.

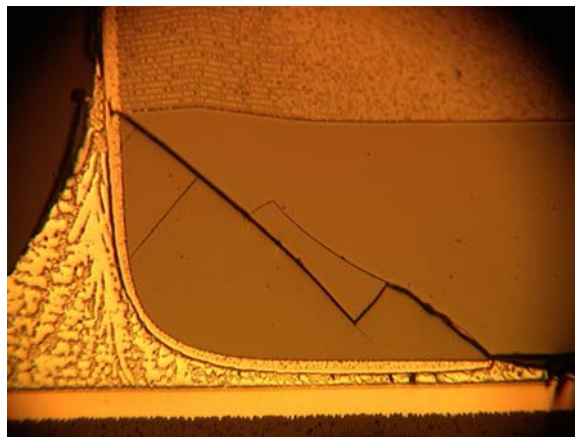
Cracked capacitors are very difficult to detect at the board level. Although we have found that the capacitor of Figure 5 had cracked we could not detect the crack with acoustic microscopy. The geometry of the plates caused attenuation that hid the acoustic signal. Electrically this capacitor was still good since the crack had not reached the plates. Optically the crack could not be detected since it is within the solder fillet and hidden from view. This capacitor would eventually fail electrically, damaging the product. It is not clear whether this capacitor failed because of heat or because of the mechanical stresses, but understanding that there is a reliability risk associated with this component, it is easy to devise experiments to figure out the root cause and address the issue.

Figure 5 – Capacitor with crack that is invisible to optical inspection and acoustic microscopy.

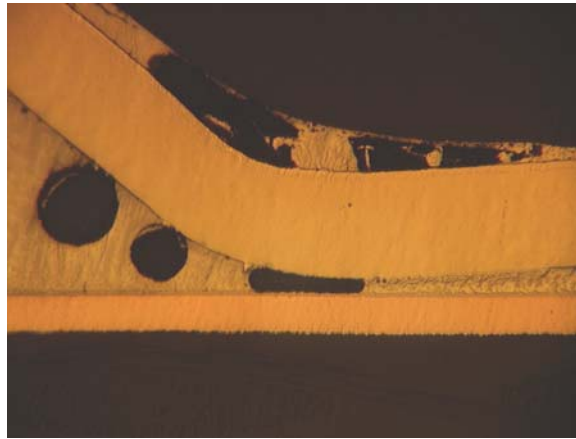
Wetting problems should be detectable at visual inspection, but there are situations that elude detection. An example is shown in Figure 6: a gull wing component that looked good at visual inspection proved to be of poor quality after cross-section. It is likely that this solder joint will fail prematurely in the life of the product.

Figure 6 – Solder joint on gull wing component showing poor wetting, undetectable at visual inspection.

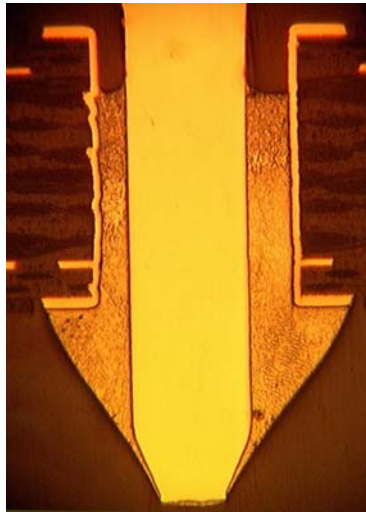
Plated through holes are very difficult to inspect. IPC-A-610D determines that the holes should be at least 75% filled. The pin of Figure 7 is very close to this figure of merit but, because of its location, the void could not be seen optically. In Figure 8, the pin passed visual inspection, but is it filled? Both these devices are likely to fail prematurely.

Figure 7- Pin in plated through via showing border line fill, not detectable by visual inspection because of location.

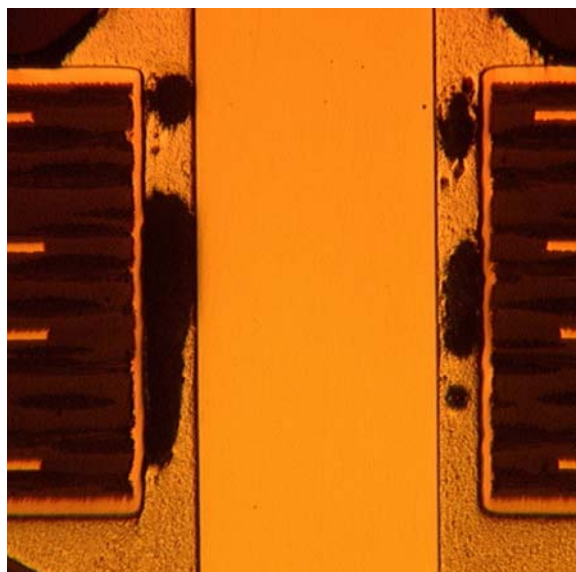
Figure 8 – Does this pin pass? It passed visual inspection.

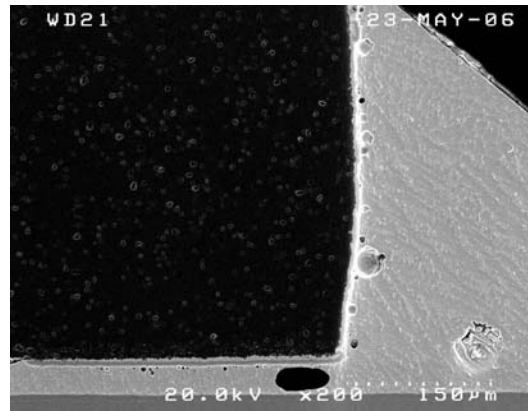
Figure 9 – Voids and bubbles on the component side of the solder joint of a resistor. It is possible that the component was contaminated.

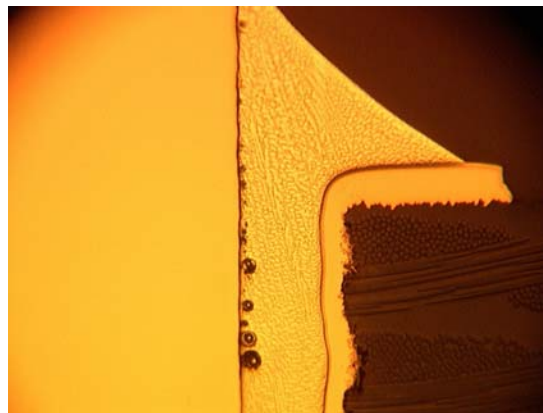
Figure 10 – Voids and bubbles in the solder joint along the pin of a connector. It is possible that the component was contaminated.

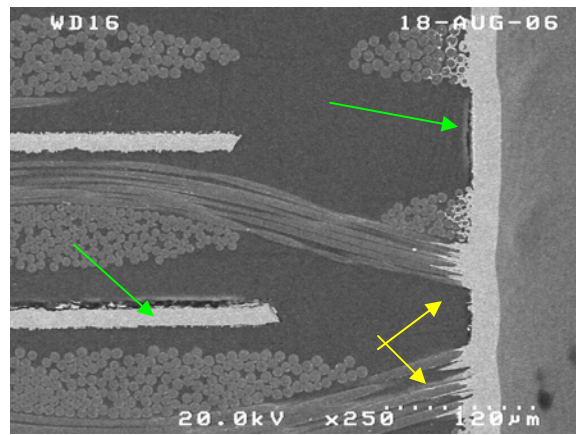
A significant area of concern and a frequently observed cause of failures in electronic products is the integrity of the printed circuit board itself. The best assembly process cannot compensate for board defects causing shorts, intermittents or opens. Electrical problems related to poor board construction do not occur immediately and are not necessarily detected at electrical testing. The latent defects will eventually become evident and cause failures for which the assembly manufacturer is likely to be blamed. The MAJIC stresses imposed on the product are not severe and should not cause cracking or delamination of a good board. However, if the board is improperly constructed, the stresses are likely to expose the flaws, particularly at cross-section where tiny defects can be seen by electron microscopy. Separation of the via barrel from the laminate, such as shown in Figure 11, is unfortunately very common and often leads to more severe damage including open circuits.

Figure 11- Cross-section of board showing separation between the laminate and the copper traces and the laminate and the copper barrel (green arrows). This board also exhibits significant copper wicking along the barrel of the via (yellow arrows).

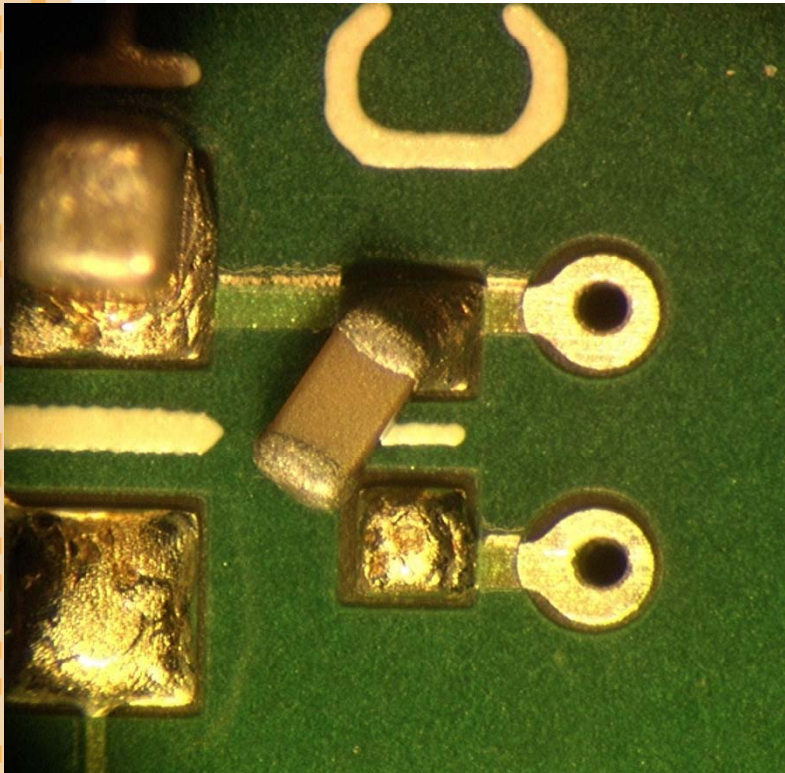
Misplaced resistor

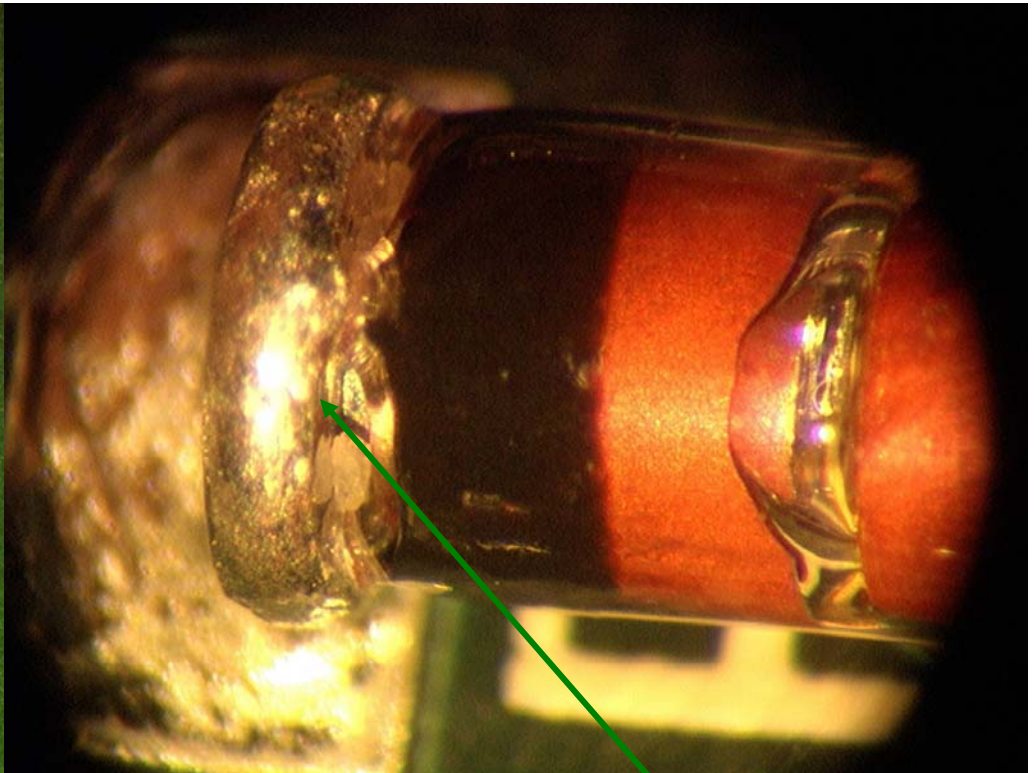
Cracked diode

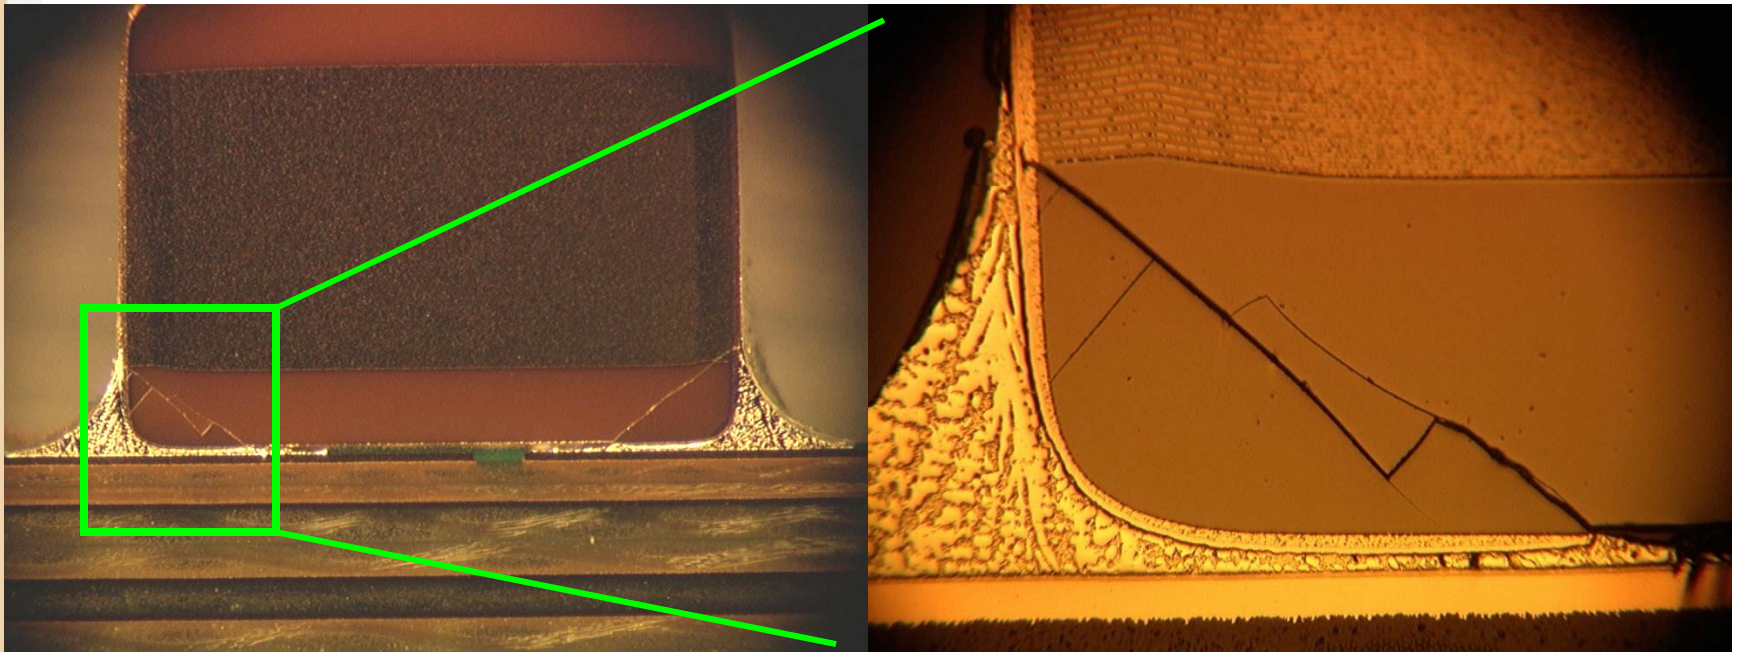
Cracked capacitor, cannot take the heat!

- Crack is not detectable by acoustic microscopy
- Inside the solder fillet, invisible to inspection

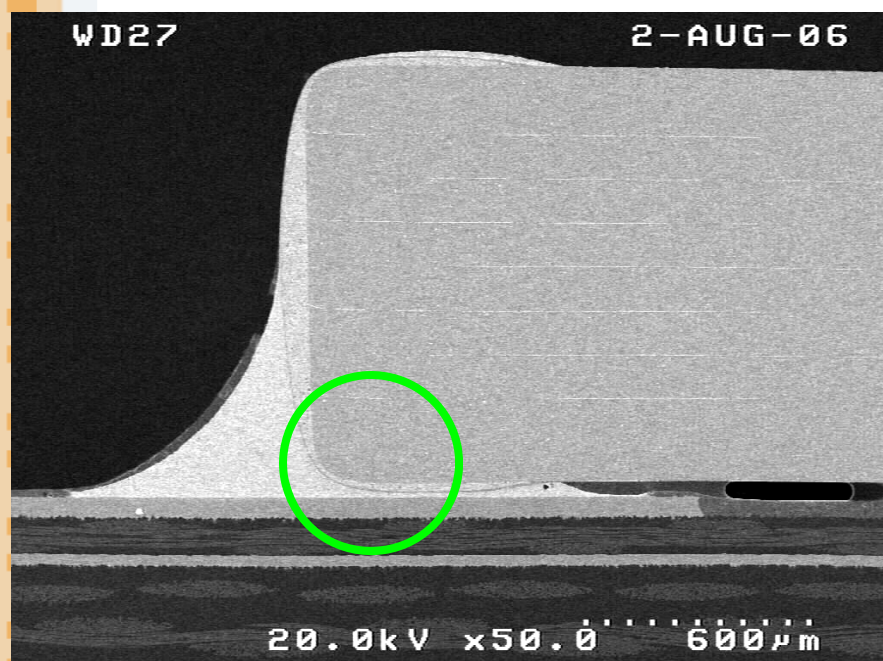
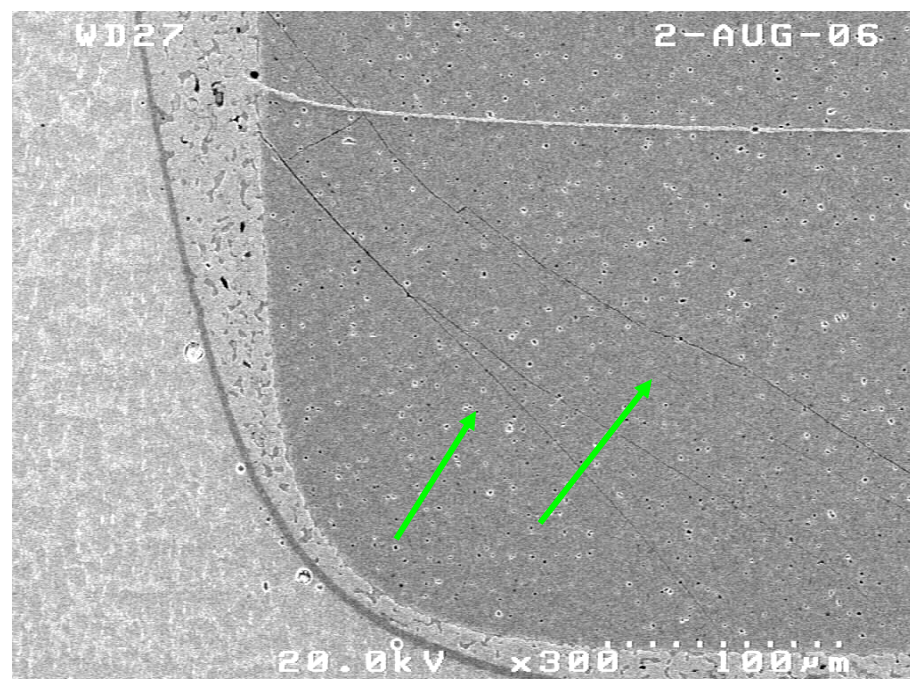
Another cracked capacitor

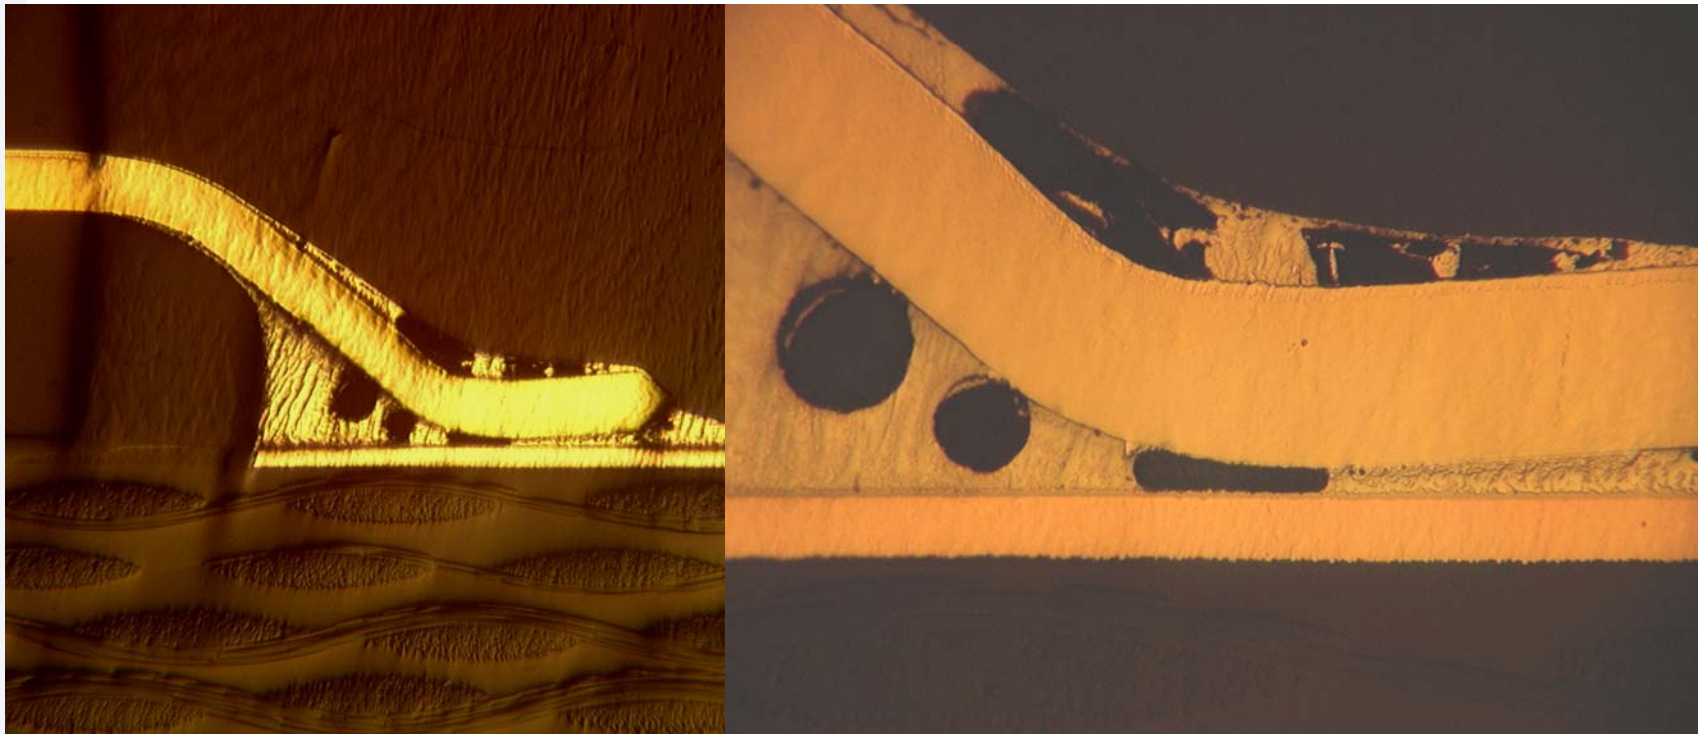
Gull wing lead

- Wetting looked fine at optical inspection
- High probability of premature failure

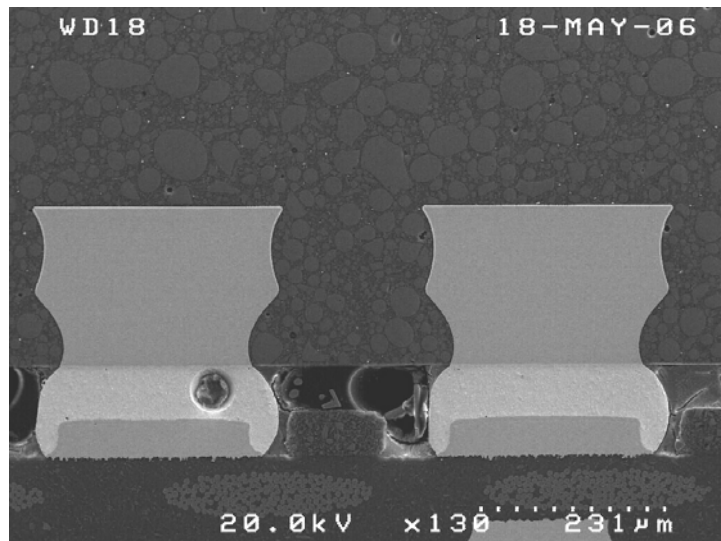
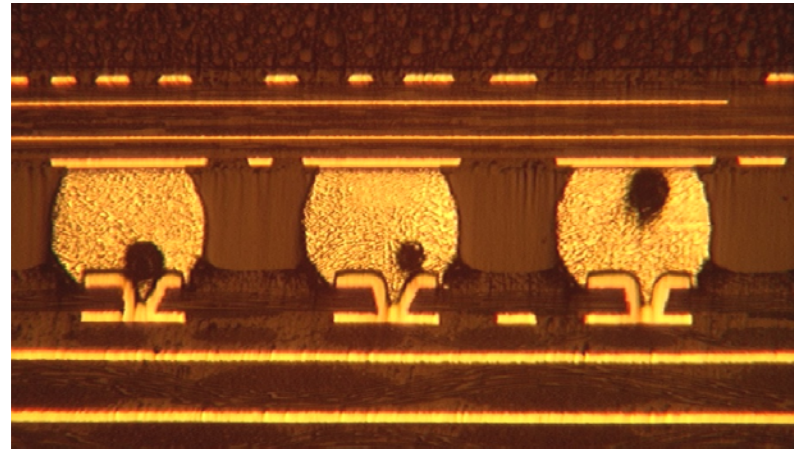
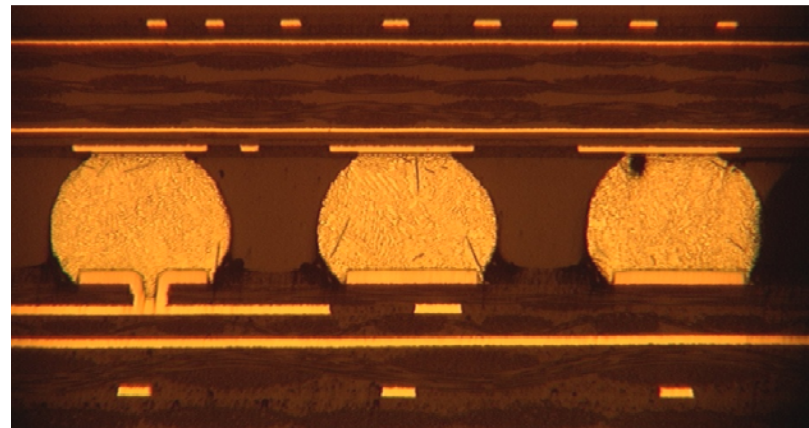
BGA and QFN

- Different components on the same product can exhibit significantly different behaviors

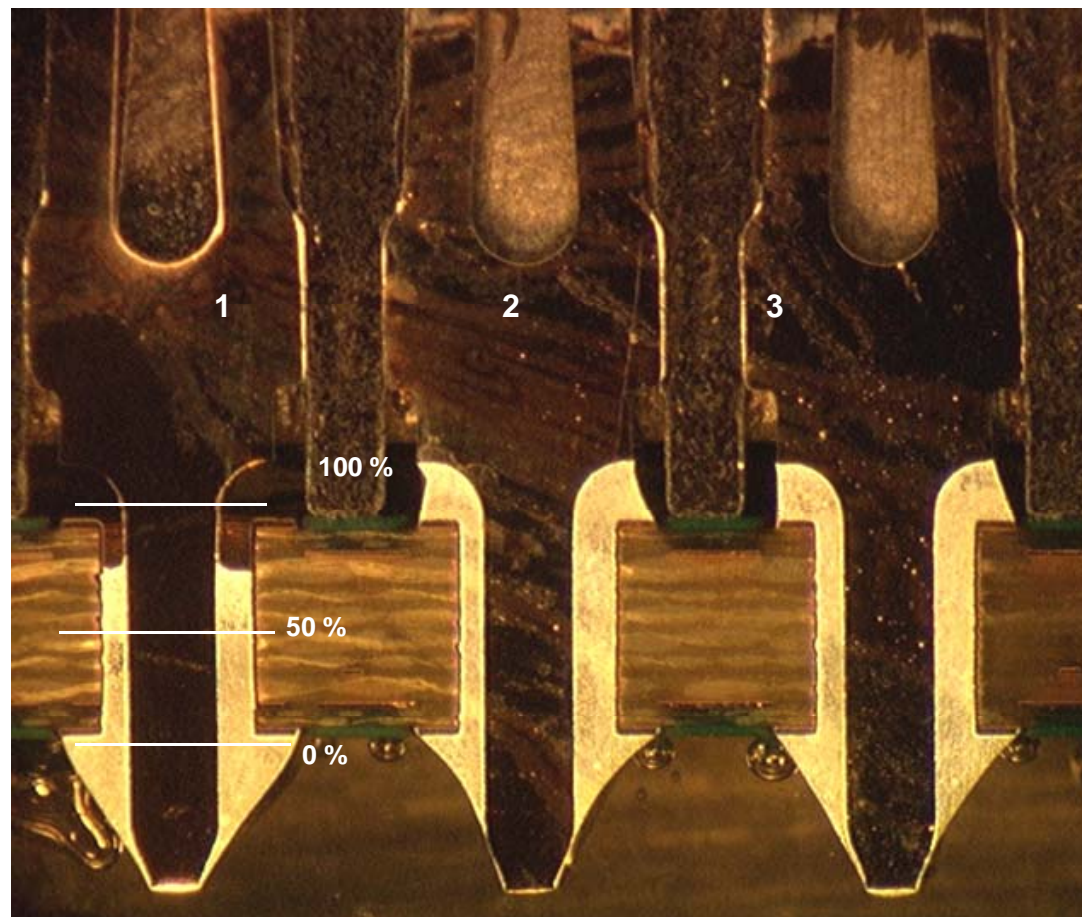
Pin 1 shows less than the 75 % fill criterion

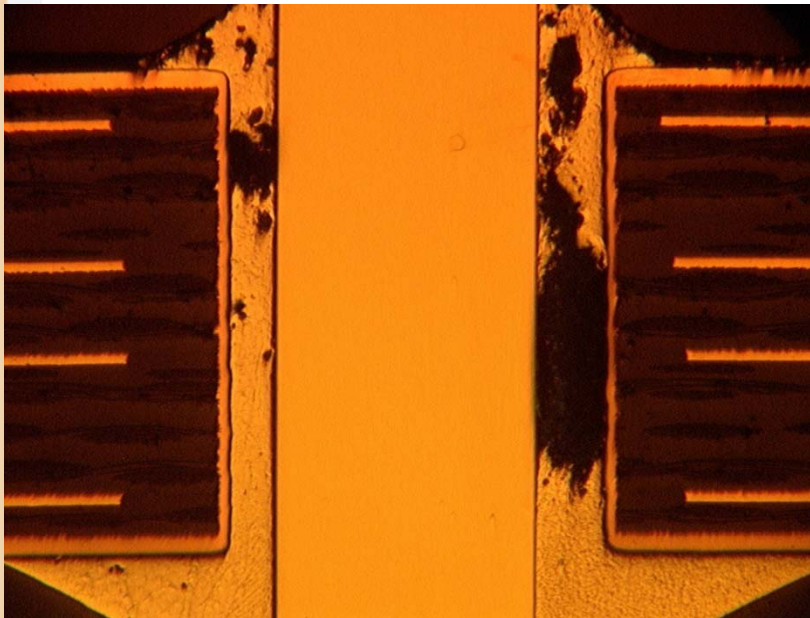
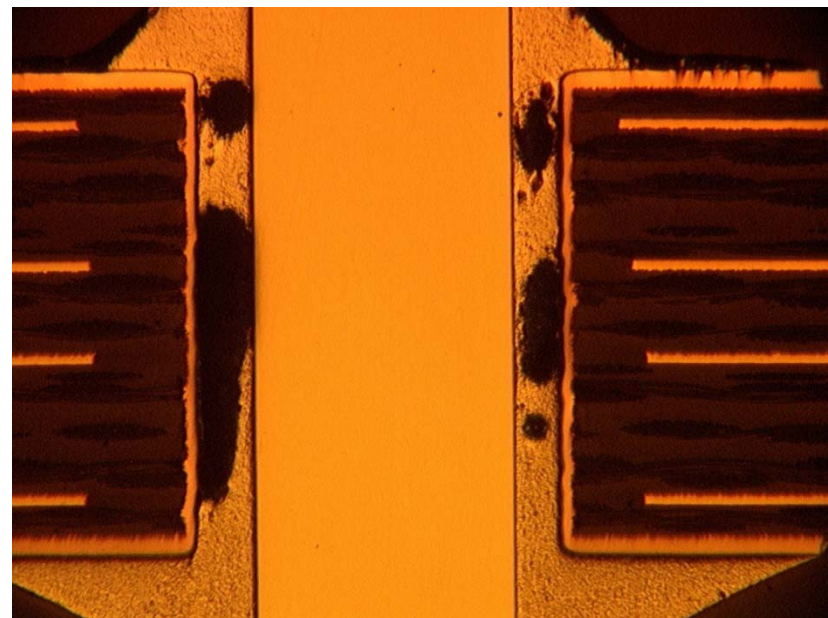
Missing solder in PTH against pin

- Cannot be detected at visual inspection

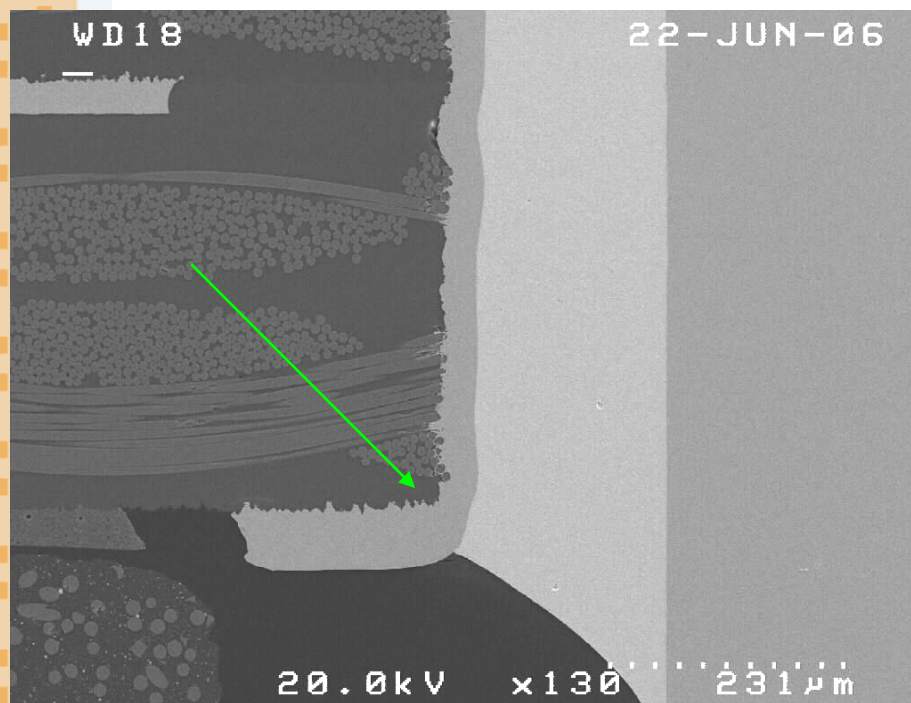
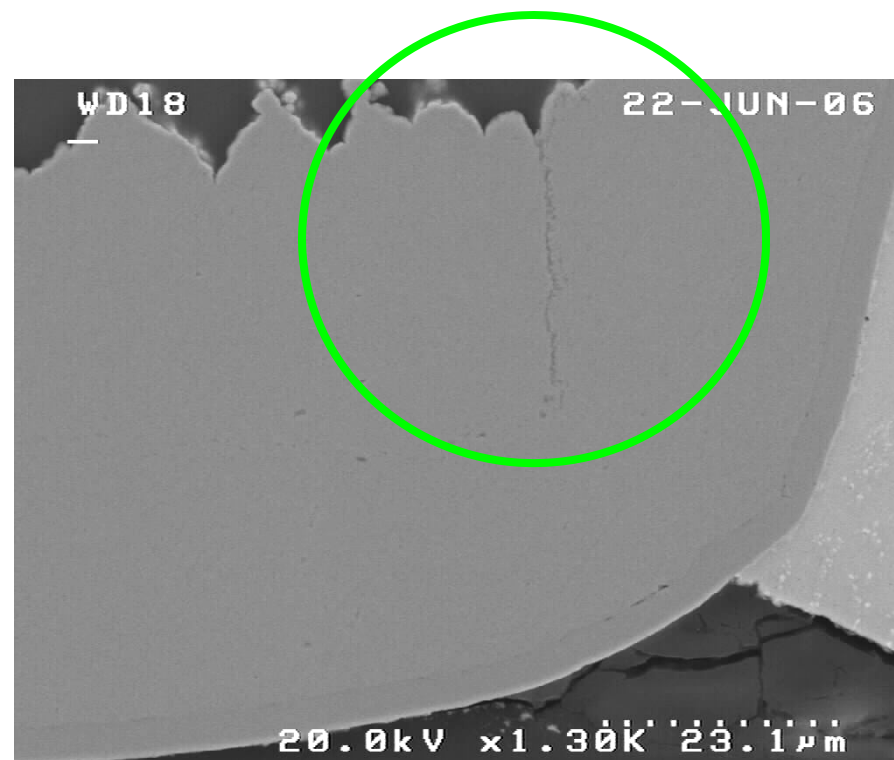
Crack at corner of PTH

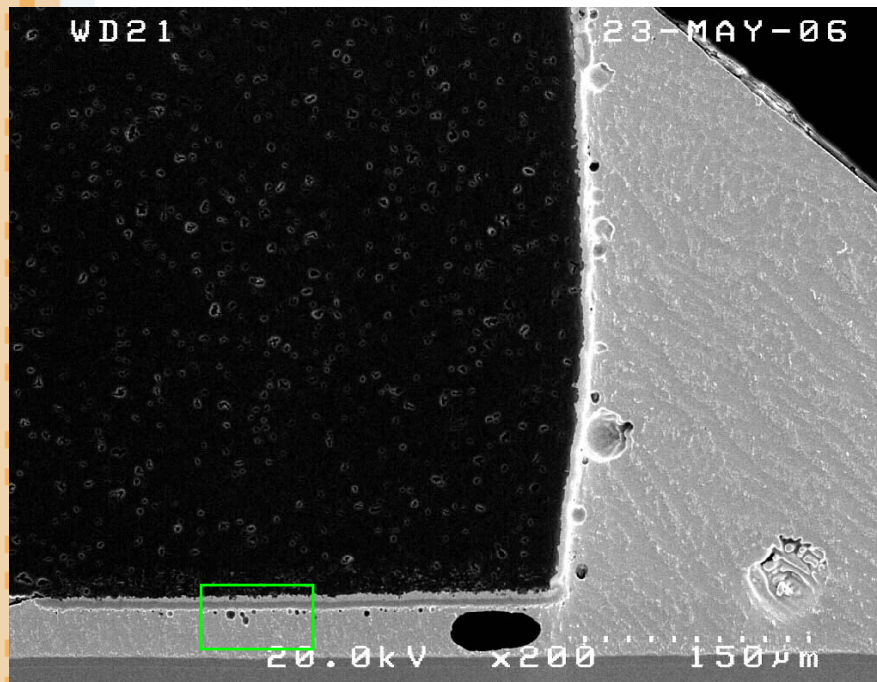
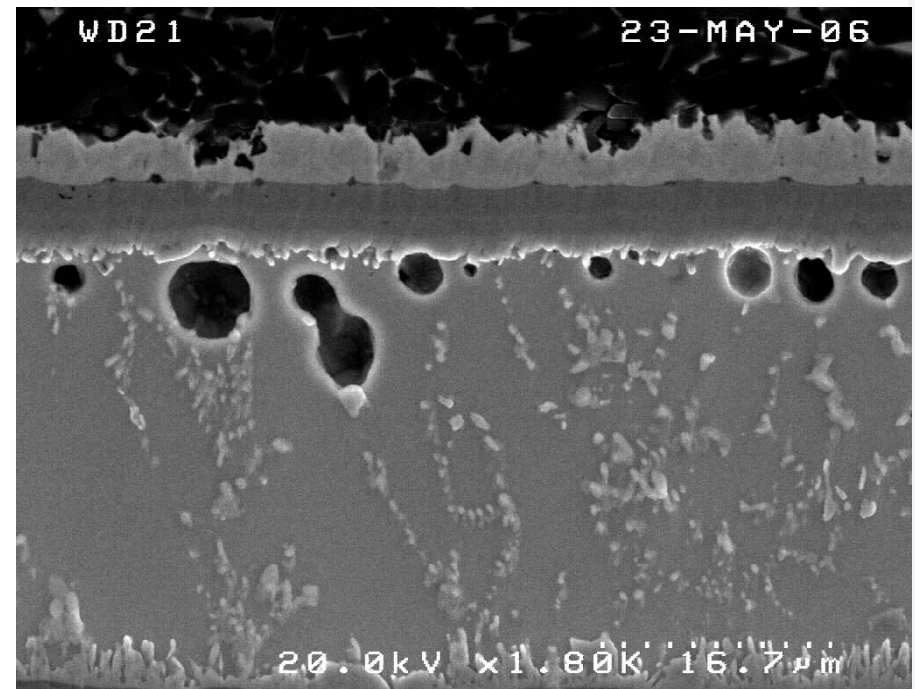
Voids are against the component,
not against the joint to the board pad

Component is likely contaminated

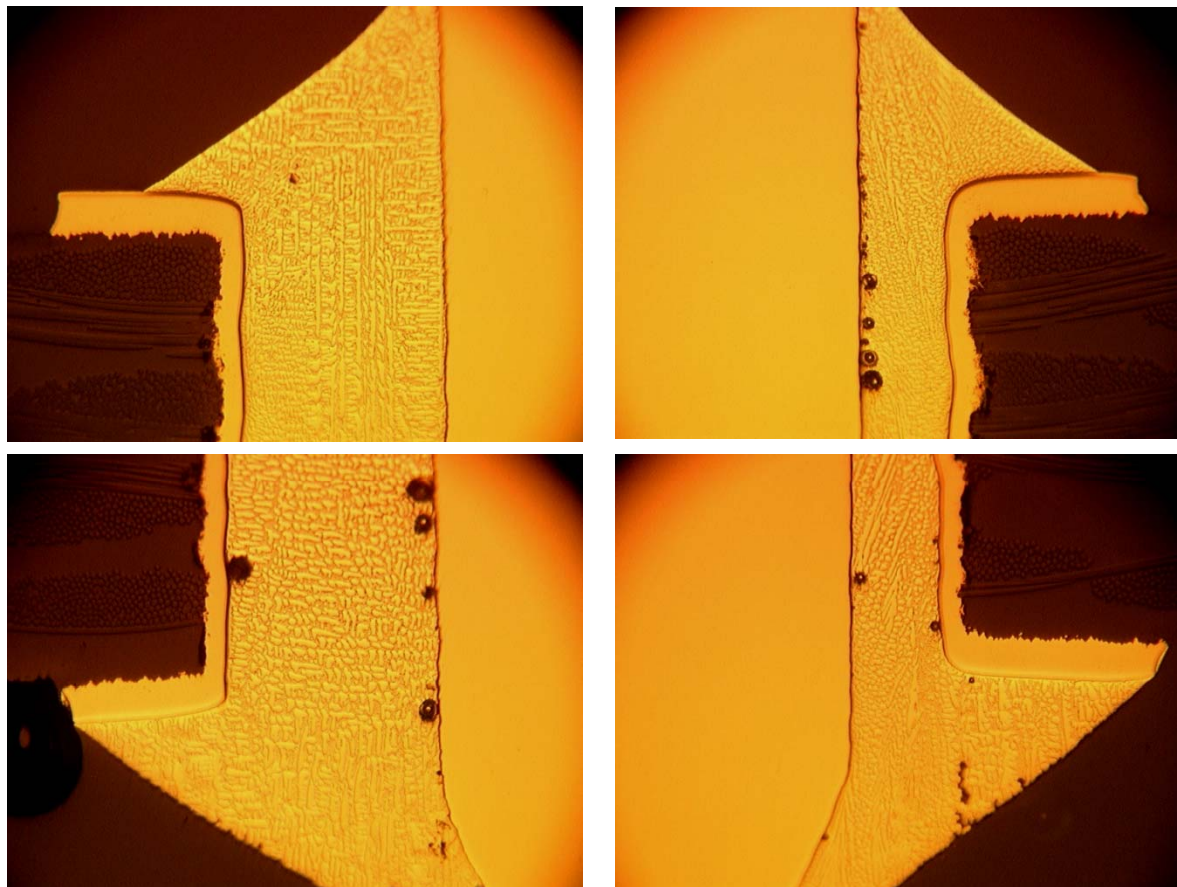
Voids against a contaminated pin

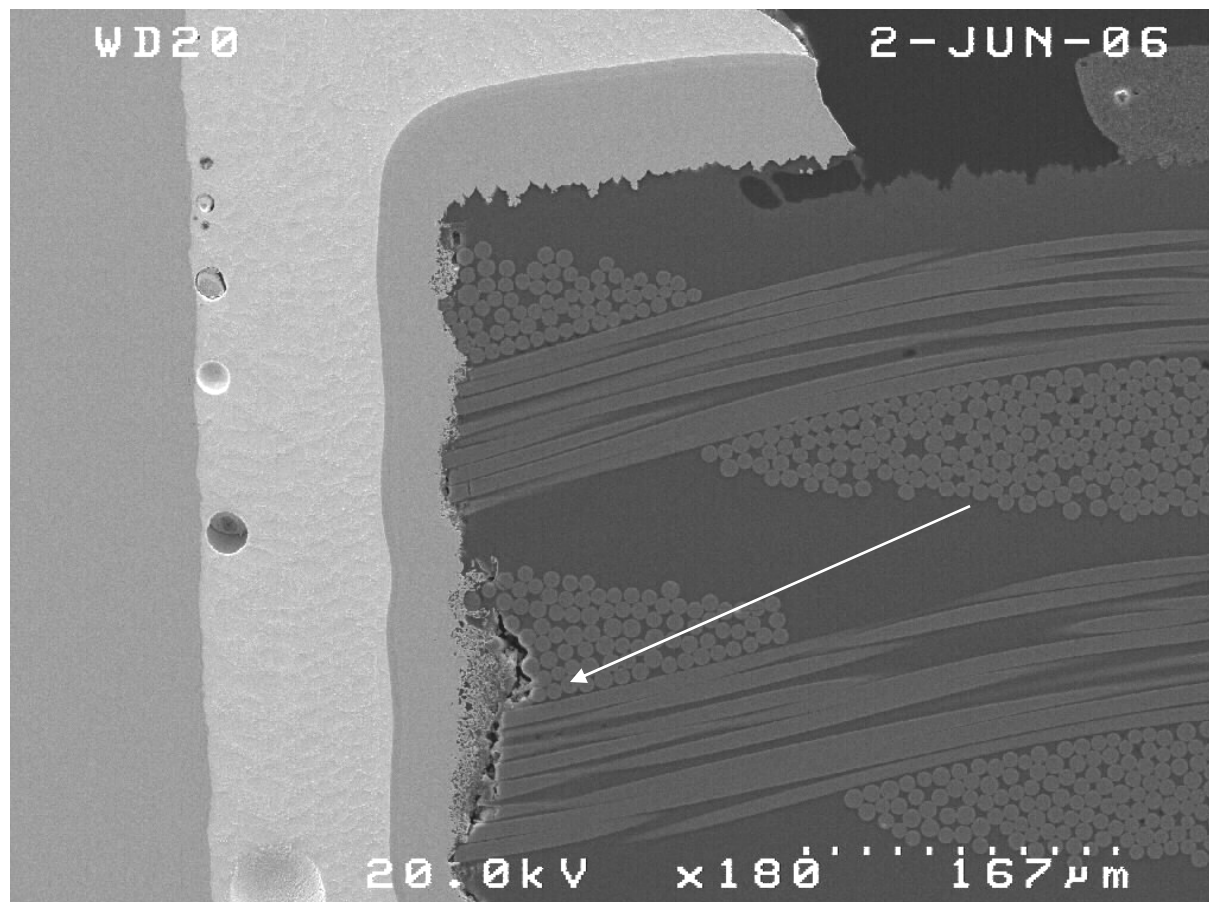
Hole plating separating from board

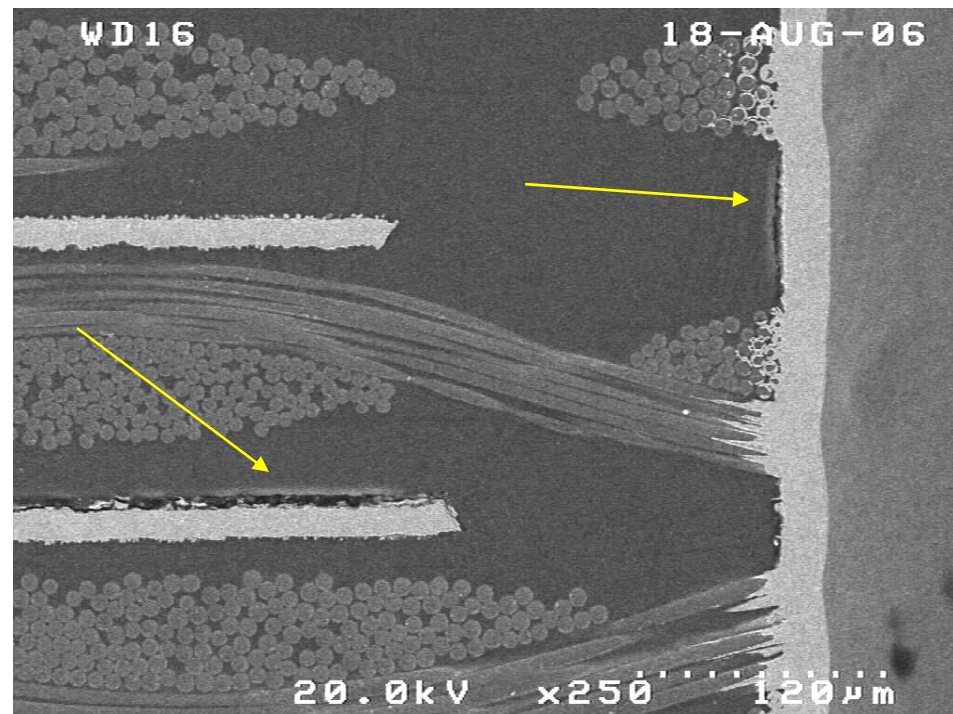
Poor board quality

- Copper is separating from laminate. Product will fail.
