Effects of Dielectric Material, Aspect Ratio and Copper Plating on Microvia Reliability

Thomas Lesniewski

Northrop Grumman Corp, San Diego, CA

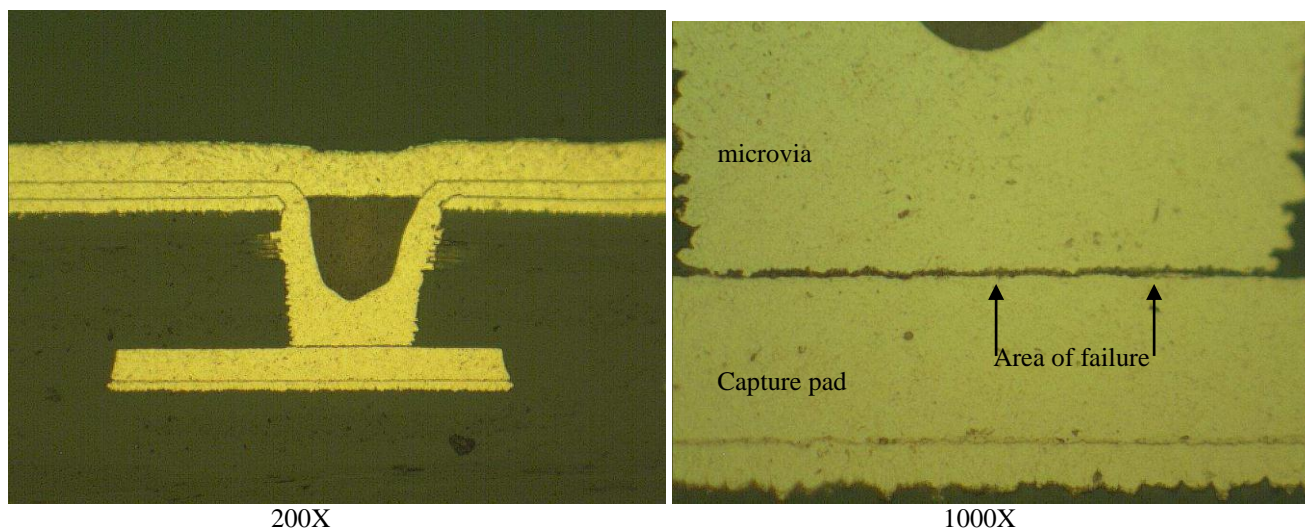
Board and coupon failures were isolated to discontinuities across microvias. Failed microvias were analyzed by cross section, FIB and SEM to determine the failure mechanism. In this study, all failures occurred at the interface between the microvia and the capture pad, as illustrated in Figure 3. In some cases, it was easy to see separation under a microscope, for example in Figure 3. However, in other cases, such as Figure 4, there was a line of demarcation at the base of the microvia but it was hard to tell at 1000X magnification whether or not there was separation between the microvia and capture pad. In those cases, cracks became visible 10,000X magnification, after the interface had been smoothed by Focused Ion Beam (FIB).

Figure 3. Cross section images of failed microvia.

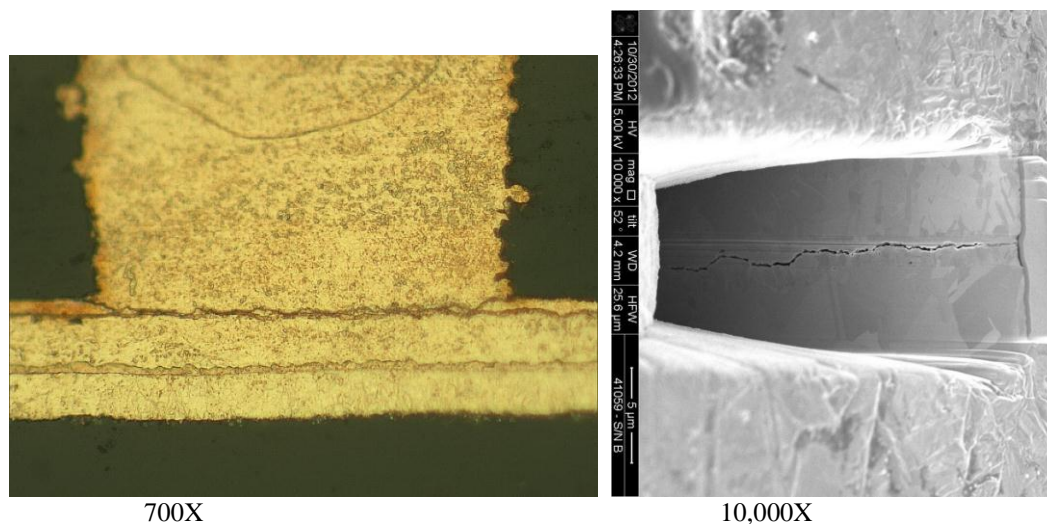
Figure 4. Cross section and SEM images of failed microvia

The FIB/SEM images showed separation within the electroless copper layer at the base of the microvia. The images led to these conclusions:

- Failure mechanism was brittle fracture of electroless copper. The most likely cause was fatigue stress brought about by the differential expansion and contraction between the dielectric and copper.
- Failures were cohesive rather than adhesive.
- Failures were not the result of residues or incomplete cleaning of the capture pad.
- Besides the microvia failures, there was evidence of thermal stress in the PWBs, but no evidence of thermal overstress.
- Any variation in the quality of electroless plating, such as voids or low density, weakened the copper and contributed to fractures.
- In some cases (discussed below), there was minimal electrolytic copper cap on the target pad at the base of failed microvias.

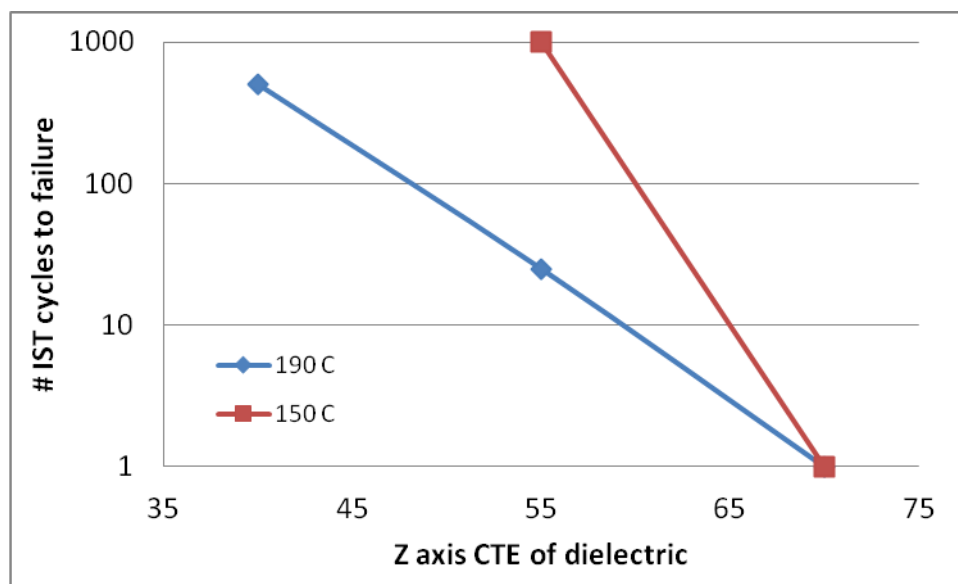
Most of the microvias that failed in test showed acceptable plating quality, and would not have been flagged during final PWB fabrication inspection. Detachment of the microvias from the capture pad suggests a strong z-axis effect which explained the trends with different materials. Material A, with the highest z-axis CTE, showed the most defects in thermal stress testing, while Material C had the lowest CTE and failure rates. Figure 5 illustrates the strong effect of the dielectric material on microvia reliability in IST.

Figure 5. Effect of Z axis CTE on microvia IST reliability, for aspect ratio 1:1. The two lines represent IST peak temperatures, either 190°C or 150°C.

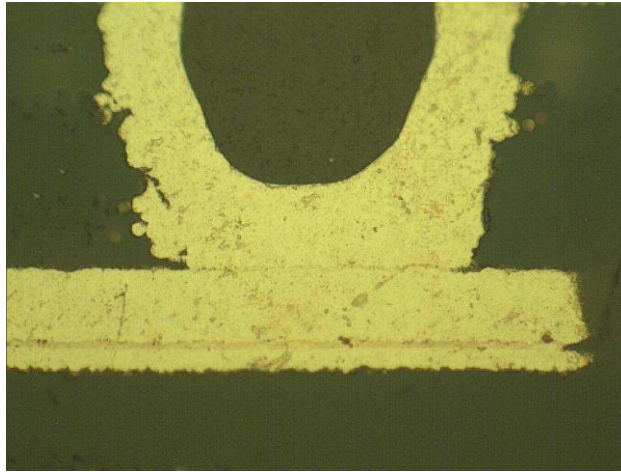
Figure 6. Microvia deposited on capture pad with 1 mil of electrolytic copper.

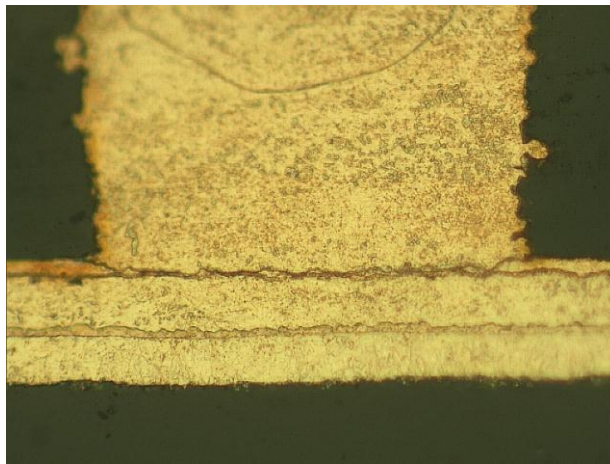
Figures 6 and 7 contrast a microvia deposited on a thick layer of electrolytic copper, and a microvia deposited on thin electrolytic copper. If the amount of electrolytic copper on the capture pad is thin to begin with, the resulting microvia will be susceptible to reliability issues. Laser drill and/or cleaning processes may further deplete the electrolytic copper, leaving behind an underlying layer of electroless copper, on which the microvia “seed” layer is deposited. The results of this study clearly showed that microvias with electroless-to-electroless connections failed at a higher rate than microvias on which the electroless copper was deposited onto a thick cap layer of electrolytic copper—see Figure 8.

Figure 7. Microvia deposited on capture pad with minimal electrolytic copper cap.

- Capture pad copper composition. Processes that result in an electroless-on-electroless base layer for microvias is prone to premature brittle failure. 0.0003" minimum of electrolytic copper is recommended at the microvia capture pad.

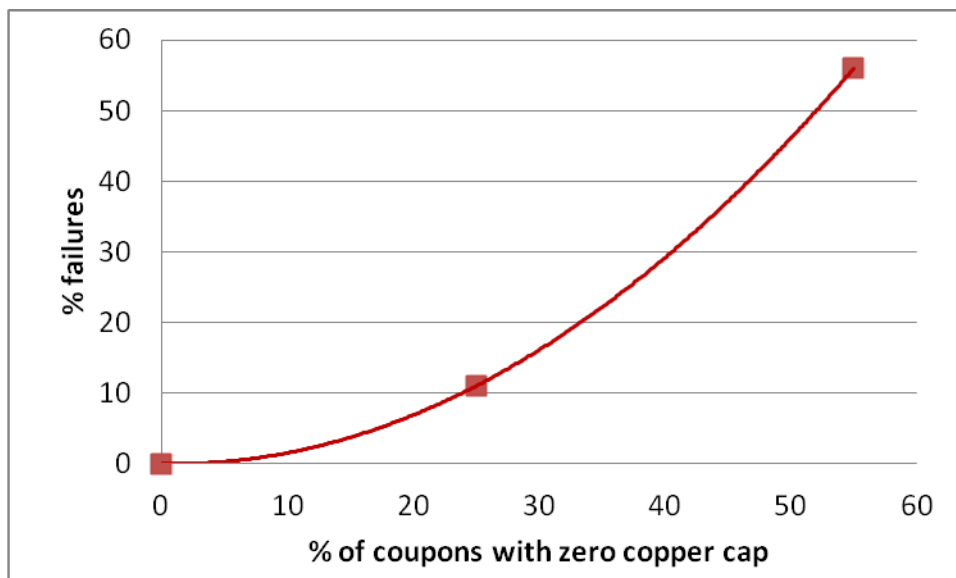
Figure 8. Microvia failure rate trend with copper cap thickness. As the number of samples with no electrolytic copper cap at the capture pad increased within a lot, the failure rate increased steeply. The trend illustrates that an electroless-to-electroless copper interface is less reliable than electroless-to-electrolytic.

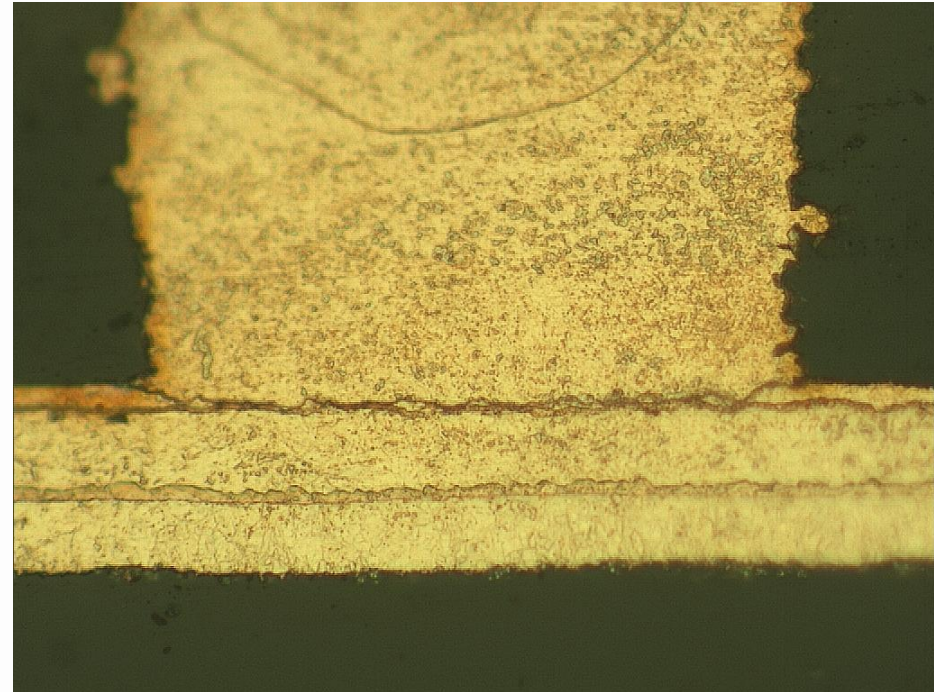
↑ Thin Electrolytic copper -
seed layer falls on
electroless copper

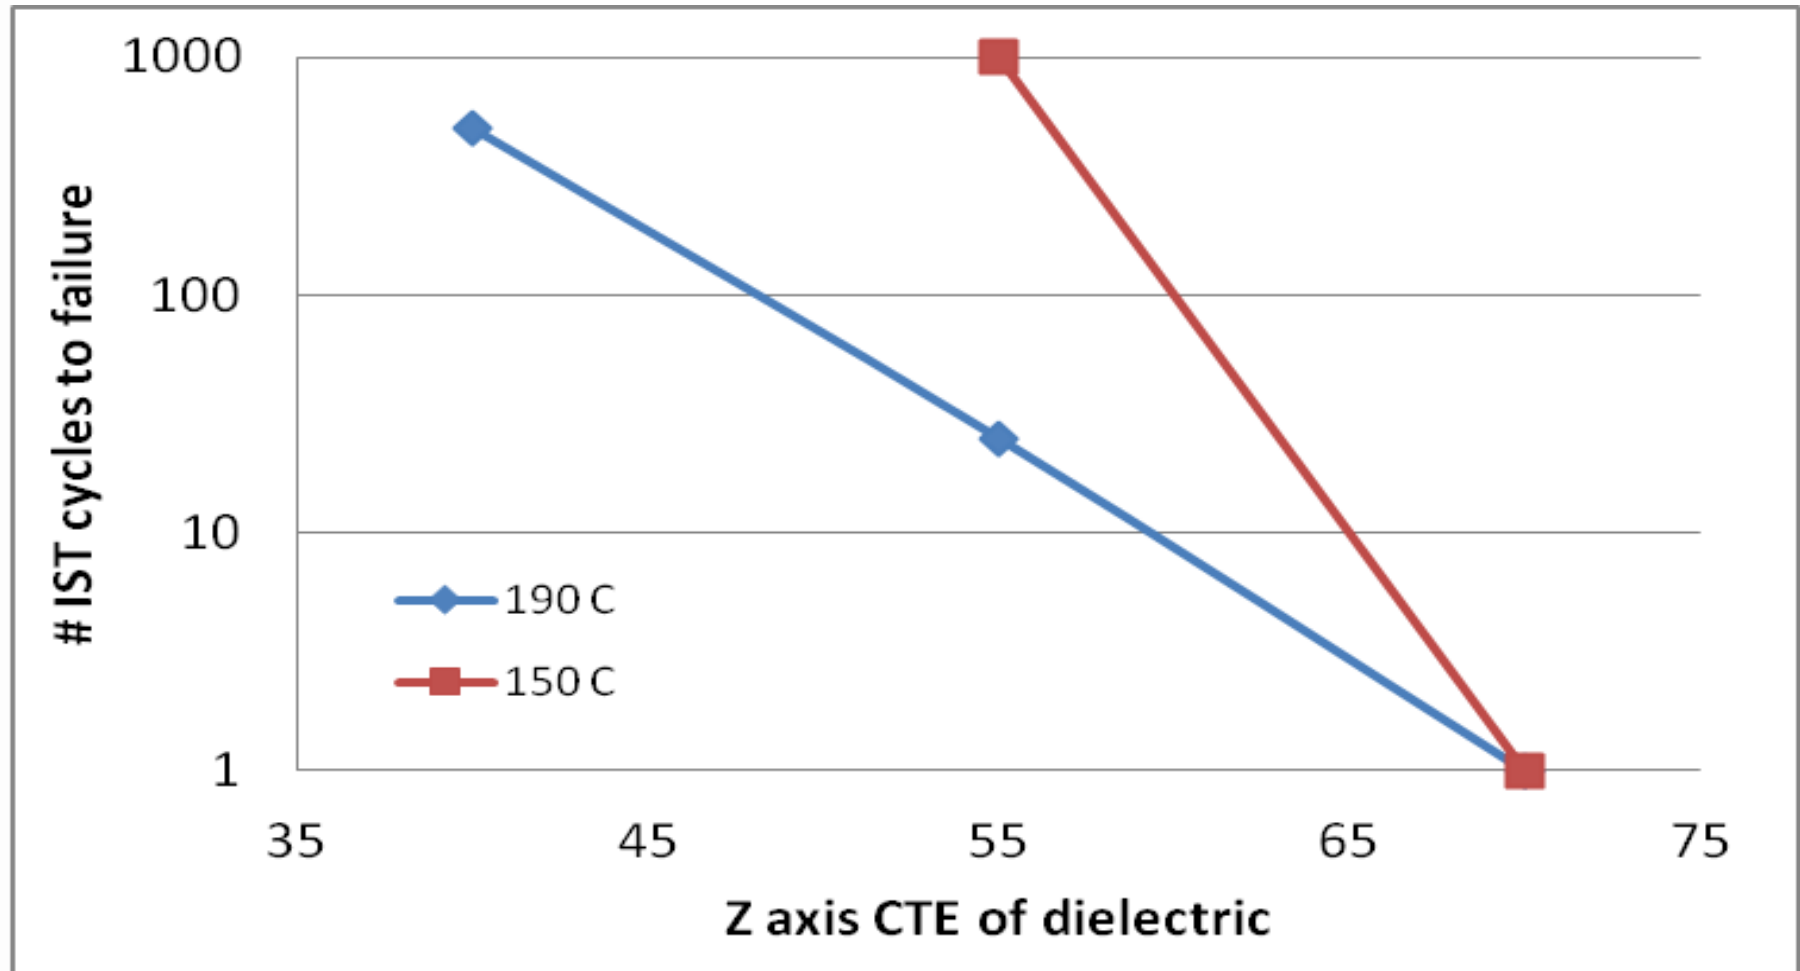
Effects of Z Axis CTE

For 1:1 aspect ratio, strong effect of Z CTE on reliability

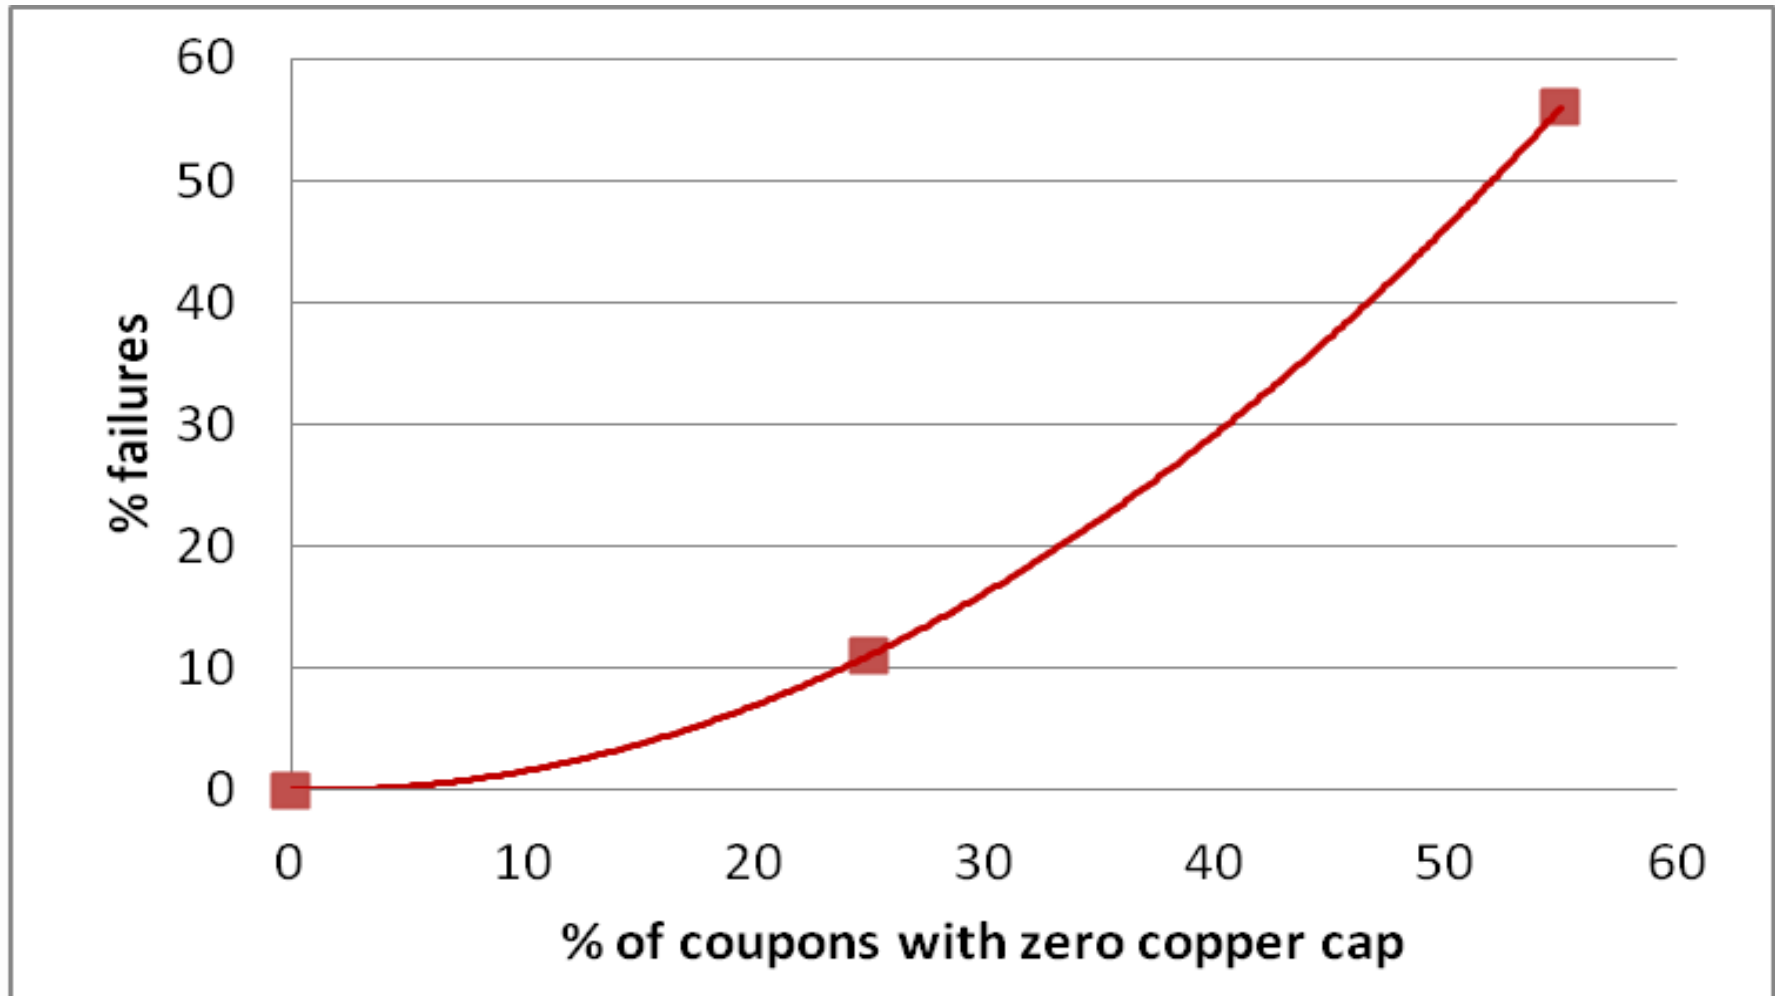
Effects of Copper at Capture Pad

Need electrolytic copper capture pad for reliable connection

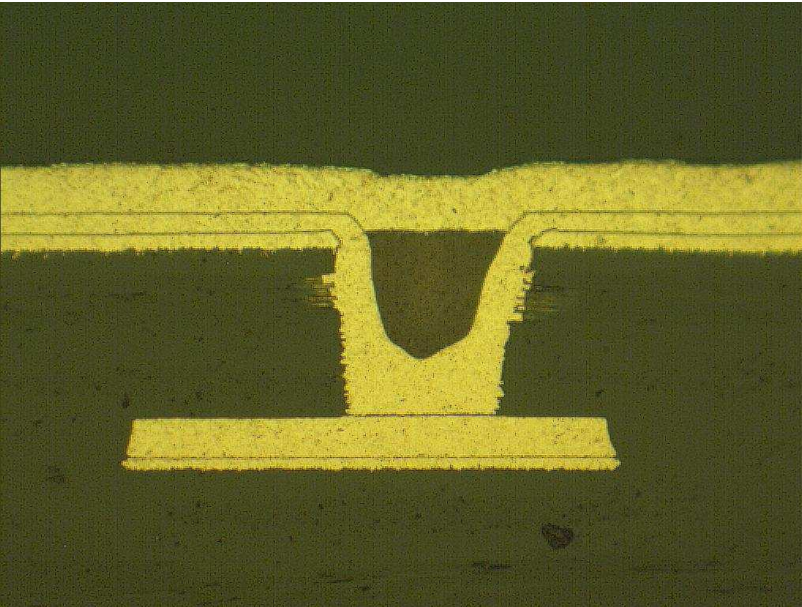
200X

Images of failed microvias

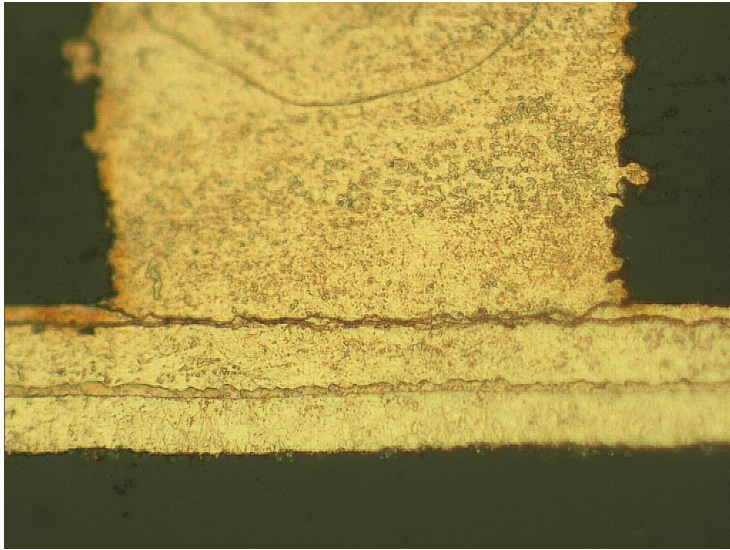
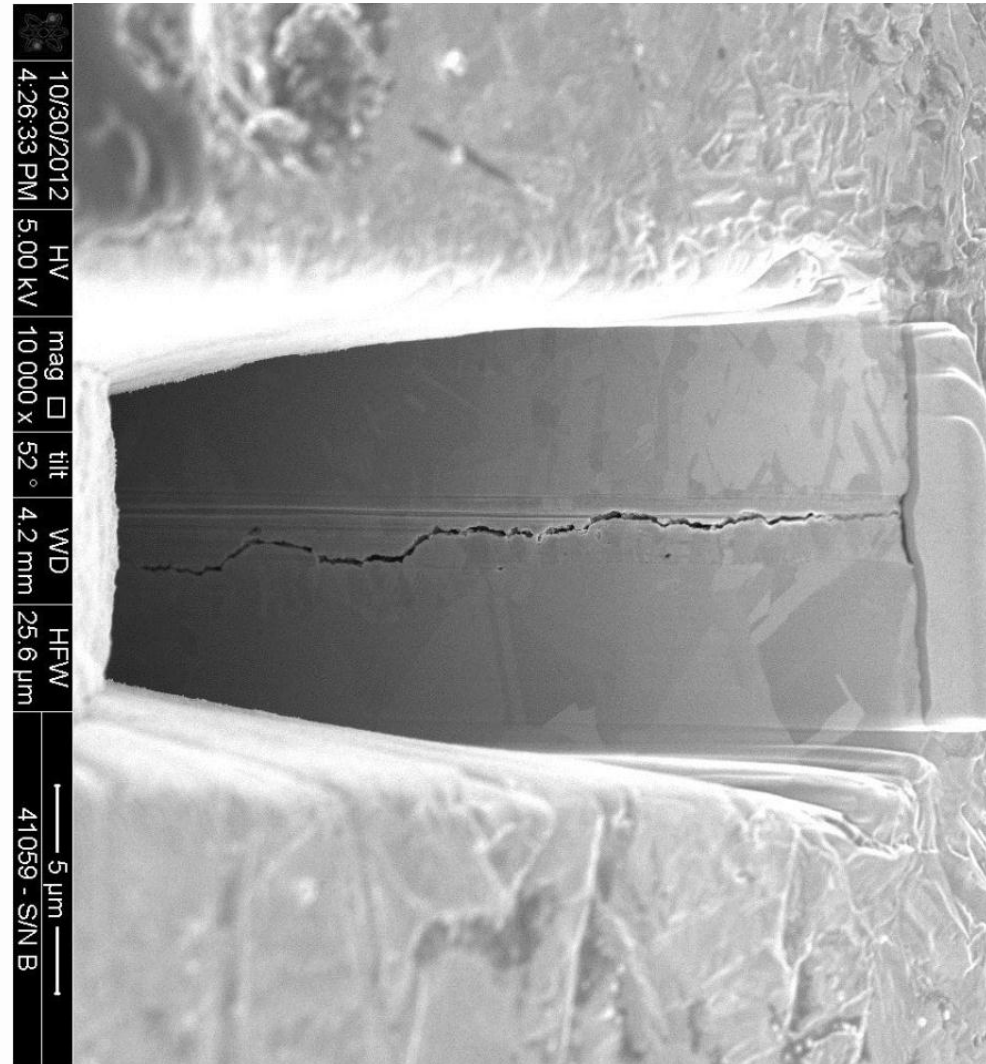
10,000X FIB / SEM image

Images of failed microvias

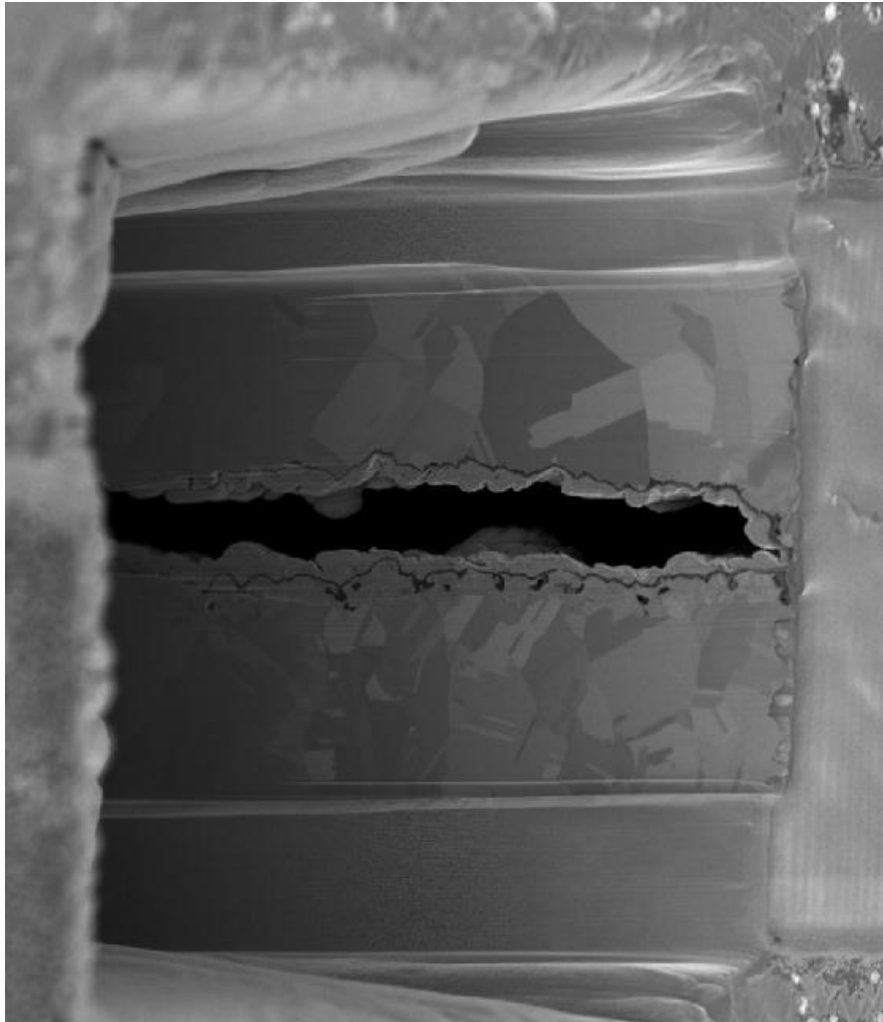
12,000X

Images of failed microvias
