Via (Plated Through Hole) Integrity with Lead Free Soldering

Joe Smetana, Alcatel
Ken Ogle, Sanmina-SCI
Bob Sullivan, HDPUG

Abstract

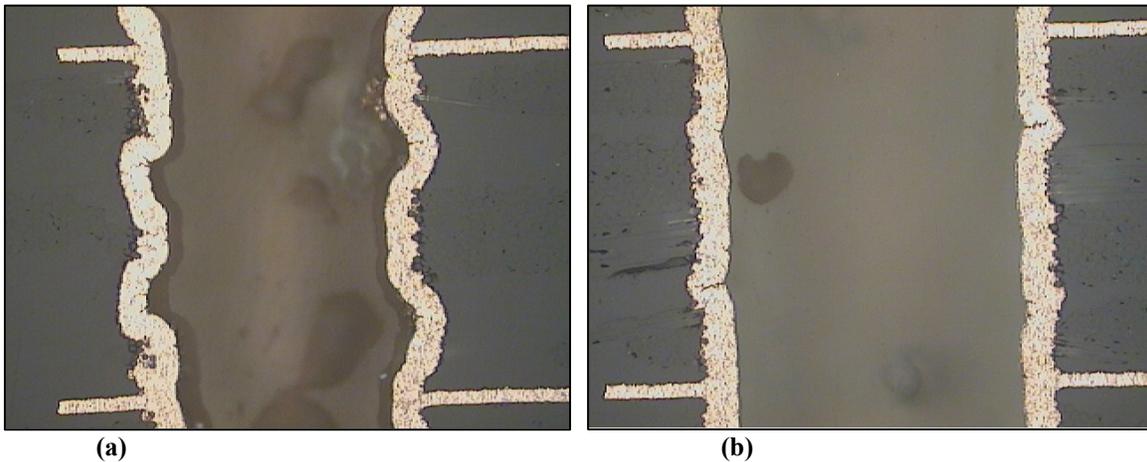
Hole size and the related aspect ratio are well known to have a significant effect on via reliability [1,4,5]. This is due to both the greater difficulties in plating smaller holes, when the aspect ratio gets larger, and the larger stresses on the plated through hole wall during thermal cycling or thermal excursions such as reflow. Similar trends are shown in this data. However, there are some rather unusual results for the smaller hole sizes. As shown in Figure 9 a and b, for both Nelco 4000-6 and Polyclad Turbo 370, the 10 mil hole size had a slightly better reliability than the 13.5 mil hole size. When statistically analyzed, these distributions are not greatly different, but even the same performance would be a surprise considering the difference in aspect ratios (12.5:1 vs. 9.26:1). Microsection comparison was completed for each material type to evaluate differences. The 10 mil holes generally had more small to mid-sized cracks spread throughout barrel in addition to the large, circumferential cracks. The 10 mil holes also sometimes had laminate voids or resin starvation that the 13.5 mil holes did not. These might have allowed the expansion of the material to relieve stress in the material or across a wider area of copper, so as not to focus the stress in one or two locations, which seems to be the case on the 13.5 mil vias. As can be seen from Figure 10, the hole walls are also smoother for the 13.5 mil vias. Smoother hole walls are expected to improve reliability[8,9], but this effect was not noted here. The overriding factor appears to be the small to mid-sized cracks spread throughout the plated through hole barrel.

Figure 10 - Comparison of Hole Wall Quality between 10 mil holes (a) and 13.5 mil holes (b)

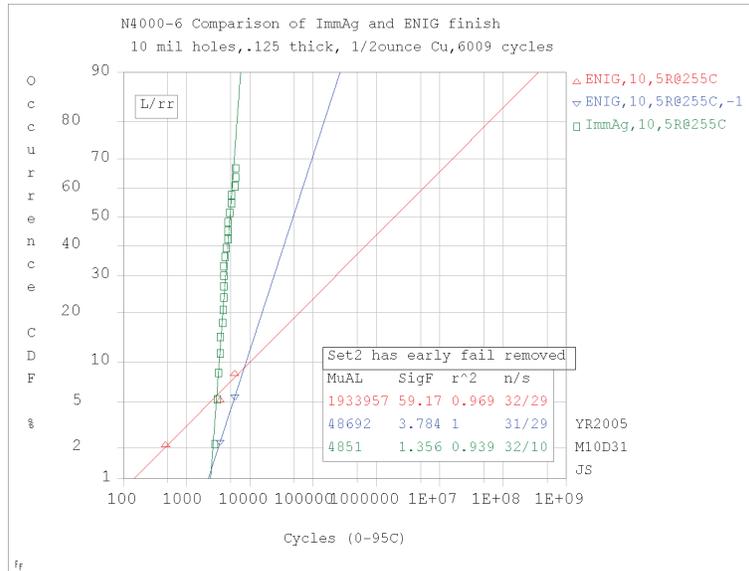
As mentioned above, two test cells were included to evaluate the effect of a nickel underplating (ENIG finish) on the plated through hole reliability and follow up on previous testing that had extremely poor performance from the ENIG finish when the boards were not subjected to reflow[4]. Figure 14 shows this comparison. The poor performance of ENIG with zero reflow did not repeat in this test. Zero reflow only had 2 failures, both at 5237 thermal cycles. The previous test identified nickel separation (not seen on the reflowed samples) that appeared to be the cause of the early failures in that test. In this case, the number of failures for ENIG finished plated through holes is very low. However, what becomes apparent from both the previous testing and this testing is that this finish may be susceptible to early via fatigue failures during thermal cycling.

If there is a defect in the nickel, or an area of thin nickel, the stress on the copper barrel will concentrate in a specific area of the plated through hole making it more susceptible to premature failure. Considering the sample size of the number of holes in this test compared to typical high complexity circuit boards, this becomes an area of concern. If, however, the nickel is sufficiently thick, uniform and defect free, it is expected to improve the plated through hole reliability. Nickel, as will be shown later in the failure analysis review, can stop the crack propagation in the copper plating. For an open to occur, the crack must reinitiate in the nickel and propagate through both the copper and the nickel. These results are consistent with previous studies on the effect of nickel [4, 10].

Figure 14 - Comparison of ENIG vs. Immersion Silver Finished on Nelco 4000-6

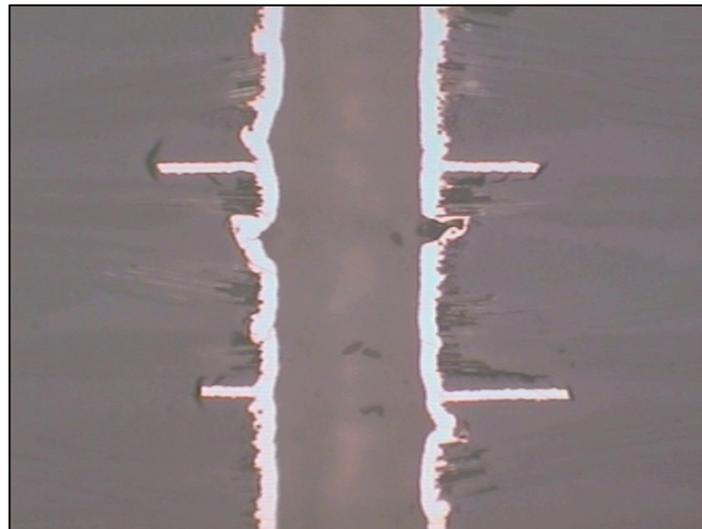
Drilling and plating processes have always been a significant factor in plated through hole reliability [8,9]. In general, the hole wall quality related to the drill and plating processes of the various board materials evaluated in this study were very similar. However, the hole wall roughness on the Polyclad Turbo 370 material was notably greater than the other materials. A number of plating folds, and resulting low copper thickness, in isolated areas were noted in the holes of this material. (See Figure 15.) Due to the way the test was designed it is impossible to verify, but this is the likely cause of the one early failure that occurred on this material.

Figure 15 - Example of Plating Fold and Resulting Low Copper Thickness on Polyclad Turbo 370 Materials

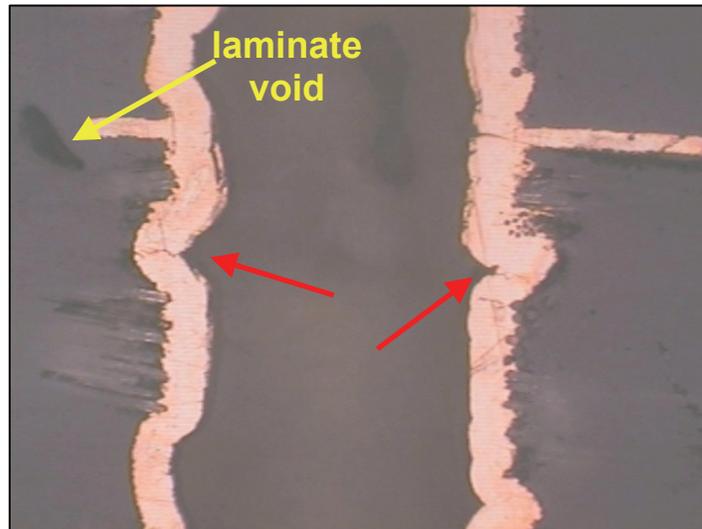
Twenty eight of 28 microsection samples identified barrel cracks that extended through the width of copper plating. Two of the samples also identified some small zone A laminate voids. Figure 18 shows an example microsection showing a small zone A laminate void and typical large size barrel cracks.

**Figure 18 - Example N4000-6 Cross section Showing Zone A Laminate Voids and Large Size Barrel Cracks
Sample #12HS5H-3 (5 LF Reflow Cycles, 200X)**

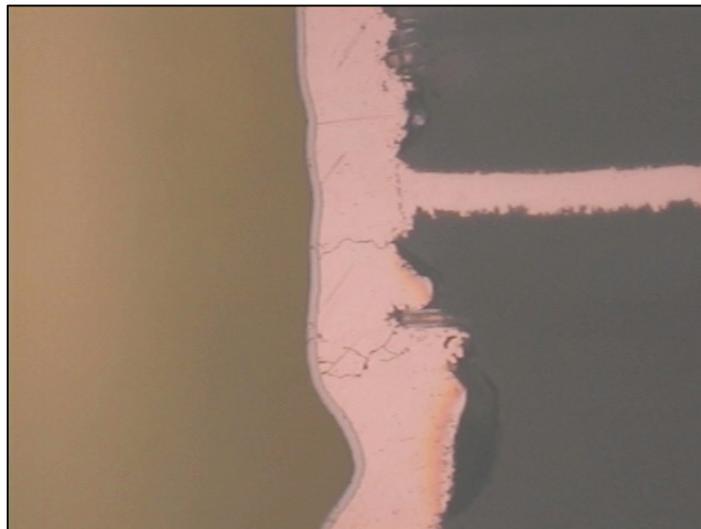
The failure analysis for these boards yielded results virtually identical to the Nelco 4000-6 boards with Immersion silver finish, with one notable exception. As can be seen in Figure 19, the cracks that go through the copper barrel stop at the nickel layer. There are cracks in the nickel also, but these are generally in different locations from the fatigue cracks in the copper barrels. Thus the cracks don't result in opens until they propagated through both plating materials.

**Figure 19 - Nelco 4000-6 with ENIG Finish Showing Cracks in Both The Copper and Nickel but
The Cracks are in Different Locations. Thus Opens don't Occur.
(5 LF reflow cycles, 400X).**

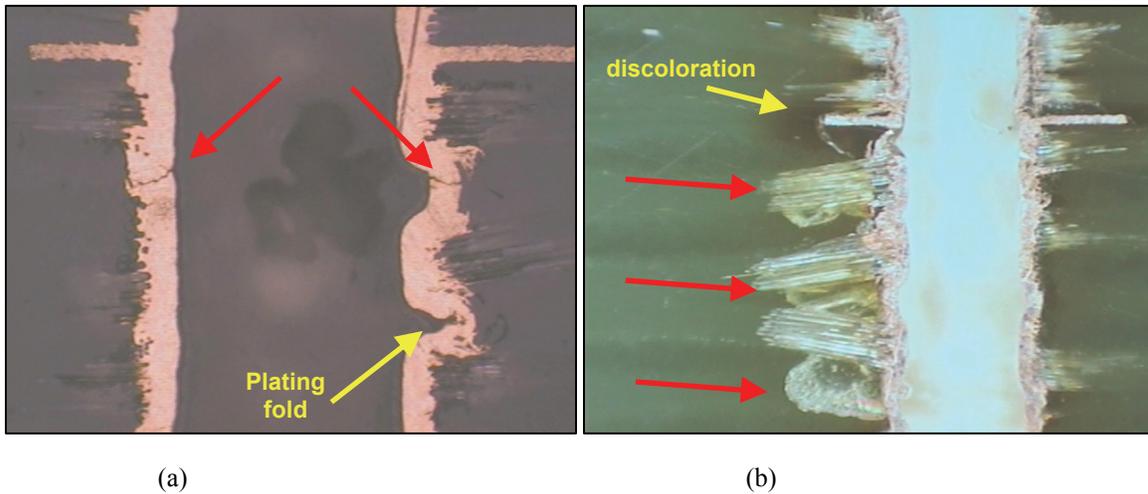
Microsection evaluation of the Polyclad Turbo 370 showed 12 of 12 samples with barrel fatigue cracks that extended through the width of copper plating, 11 of 12 samples with large zone A and/or zone B laminate cracks, and 6 of 12 samples with plating voids (due to rough hole wall where plating folds). Also some slight discoloration was noted near surfaces and interconnects. Figure 20a shows examples of a plating fold causing localized low copper thickness and typical large size barrel cracks. Figure 20b shows the large laminate cracks and the dark discoloration around the interconnect areas.

Figure 20 - Polyclad Turbo 370 (a) Examples of Plating Fold Causing Localized Low Copper Thickness and Large Barrel Fatigue Cracks (5 LF Reflow Cycles, 200X) and (b) Example of Large Laminate Cracks Observed Next to Hole Wall. Note also darker coloration around interconnects and small laminate crack (3 LF reflow cycles, 100X, Darkfield)

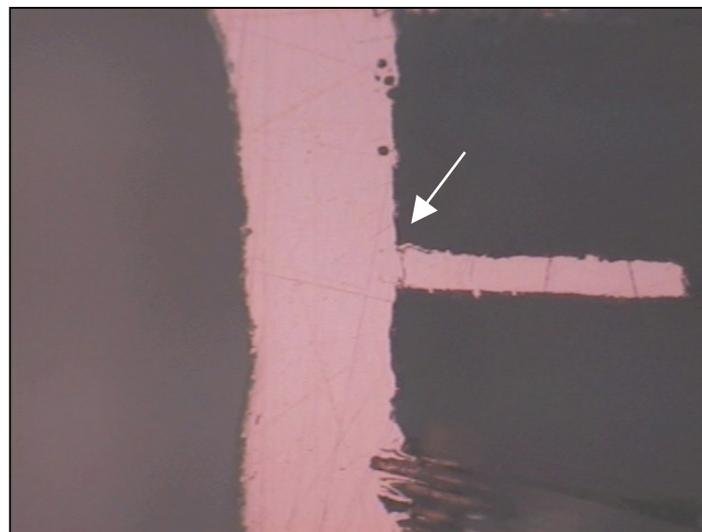
The IS410 failure analysis was completed after approximately 4000 thermal cycles. These microsections showed foil cracking of the inner layer copper, close to the hole wall. This was probably the initial failure location. This failure mode is consistent with the regression analysis on the data that indicated a best fit to the Weibull distribution. All of the samples (12 of 12) also exhibited large barrel cracks that extended through the width of the copper plating. Figure 21 shows an example of the inner layer foil cracks found in these microsections.

Figure 21 - Isola IS410 Example of Foil Crack Through Entire Width of Inner Layer (5 LF Reflow Cycles, 4,000 Thermal Cycles, 400X)

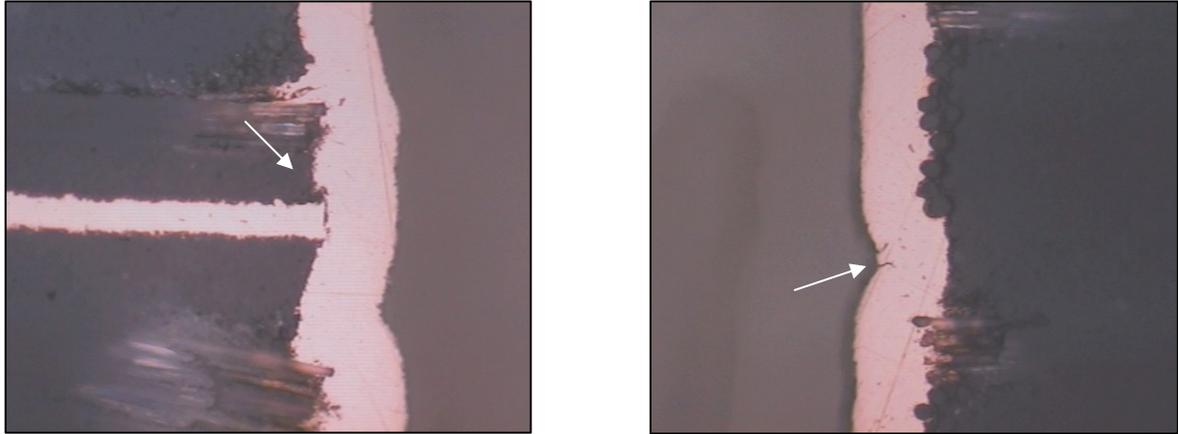
The Isola IS-420, which had zero failures during the test, also had the best hole ranking in the study of any material. There were no barrel cracks extending through the width of the copper plating and only a few small barrel cracks propagating partially through the copper plating were noted. The samples did have some large zone A laminate voids and also exhibited resin starvation. It is clear that these did not have a significant effect on the reliability of these holes through this testing. Figure 22a shows an example of some drill smear at the interconnect and Figure 22b shows examples of the small fatigue cracks.

Figure 22 - Isola IS420: (a) Some Drill Smear at The Inner Layer Connection. (b) Example of Small Barrel Crack Observed (5 LF Reflow Cycles, 400X)

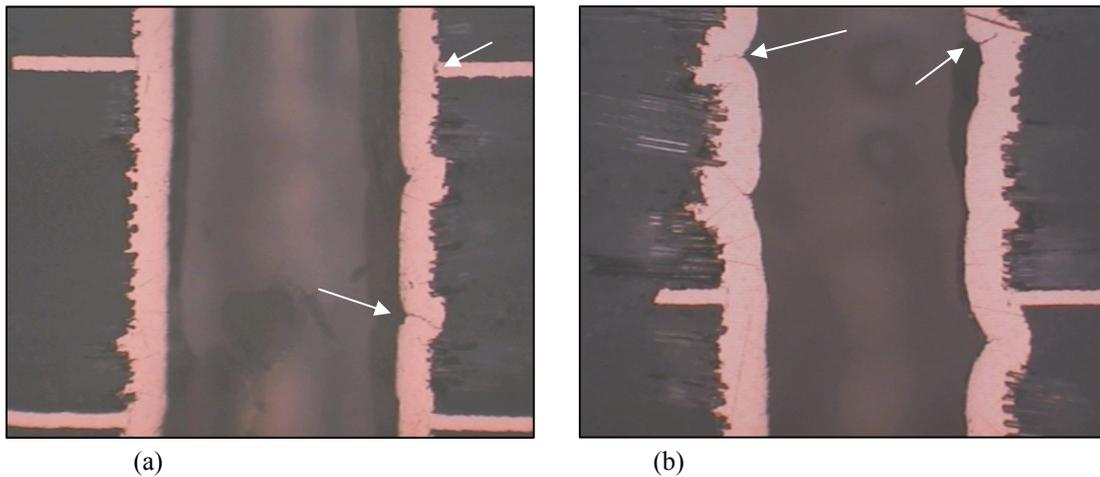
The failure analysis of the Nelco 4000-7 boards showed 20 of 20 samples with barrel cracks extended through the width of the copper plating. Seven of the samples also showed large zone A and/or B laminate cracks. Twelve of the samples were noted with slight smear/drill debris at the inner layer connections that did not cause any separation. Some slight discoloration of the laminate was noted near the surface and the internal layer connections. Figure 23 shows an example of this with Figure 23b showing that the cracks were more prevalent where the hole walls were rougher.

Figure 23 - Nelco 4000-7 (a) Example of Mid- to Large-Sized Barrel Cracks Observed. Also note some drill smear at interconnect (No reflow cycles, 200X), (b) Example of barrel cracks prevalent where drilled hole wall is rough (No reflow cycles, 100X)

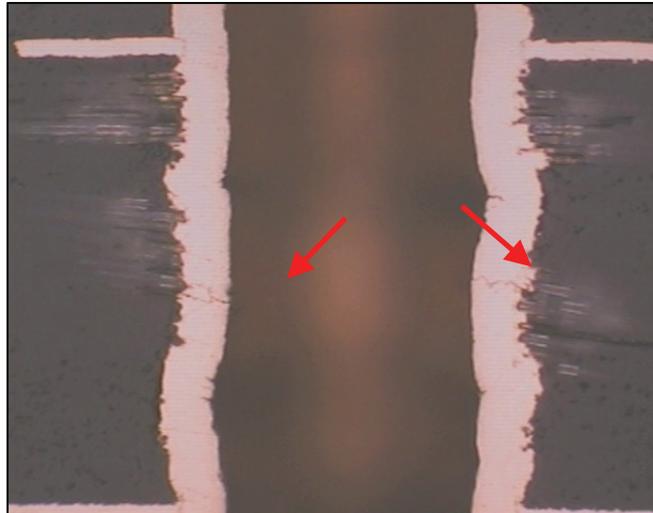
Microsection evaluation of the Nelco 4000-11 material showed 4 of 4 samples with barrel fatigue cracks that extended through the width of copper plating. (See Figure 24.) No other defects were observed.

Figure 24 - Nelco 4000-11 Example of Barrel Fatigue Cracks (5 LF Reflow Cycles, 200X)
