Salt Atmosphere, Temperature Humidity, Mechanical Shock Environmental Stress Testing Results, and FMA of the JG-PP / JCAA Lead Free Soldering Program

Rajan Deshmukh and Lee Whiteman
American Competitiveness Institute
Philadelphia, Pennsylvania

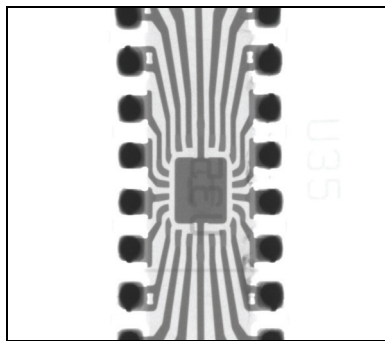
Board 104: Component U35:

Open circuits where the component leads were supposed to be in series (daisy chained) as shown in Figure 2.

Figure 2 - Component with No Internal Wire Bonds

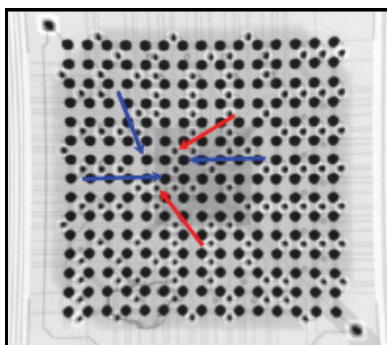
Board 104: Component U56:

Continuity testing prior to and after the salt atmosphere exposure showed that there was an open circuit within the component, as illustrated in Figure 3.

Figure 3 - BGA Package with Open Circuit (Red Arrows)

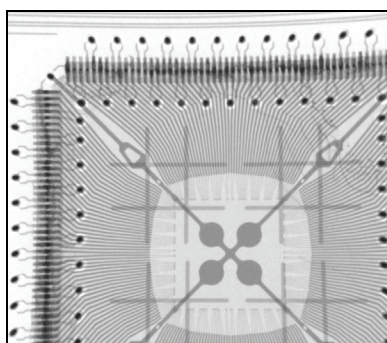
Board 105: Component U3:

There was a resistance reading of 70.6 Ω across the terminals of the component indicating an improperly wired component, as depicted in Figure 4.

Figure 4 - X-Ray Image of Quad Flat Pack

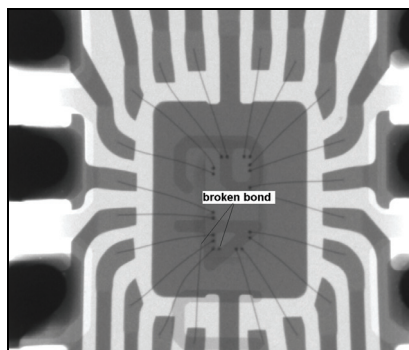
Board 38: Component U49:

The open circuit was caused by a broken bond within the chip, as illustrated in Figure 4.

Figure 4 - Broken Bond within package

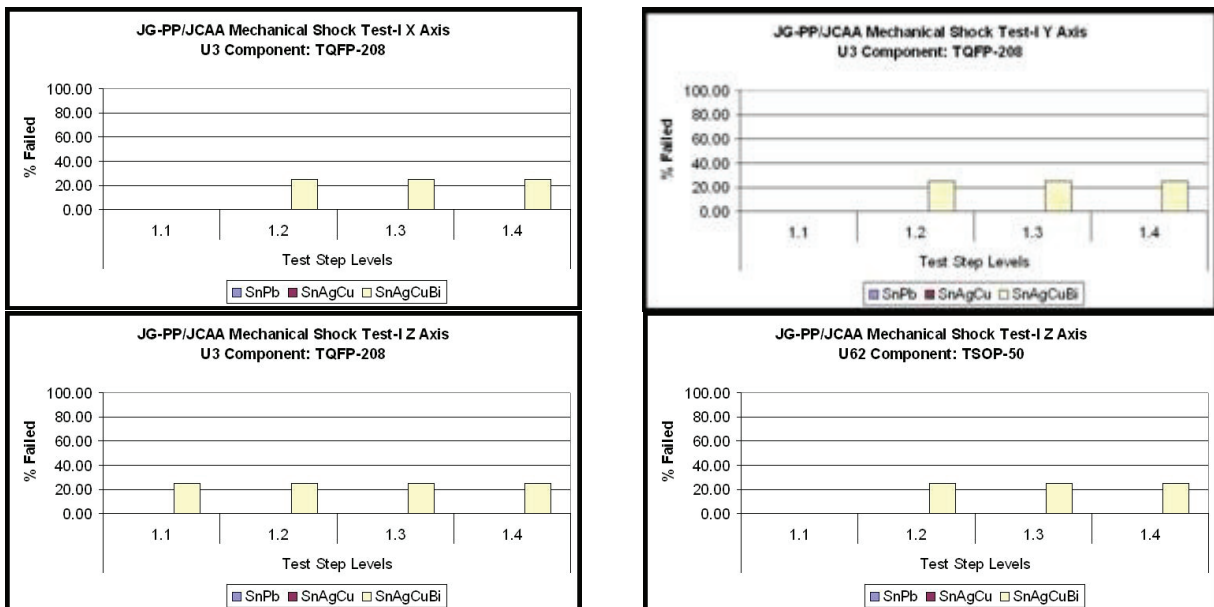
Figure 6 - Mechanical Shock Test 1 Test Results

ACI found no failures from the Tin Lead (SnPb) and SnAgCu soldered hardware. However, three (3) TQFP-208 components and one (1) TSOP-50 component soldered with SACB failed the Mechanical Shock Test 1. Failures occurred during test step levels 1.1 and 1.2, as per Figure 6 intermittent failures found with the TQFP-208 at Level 1.4 in the Y-axis. .

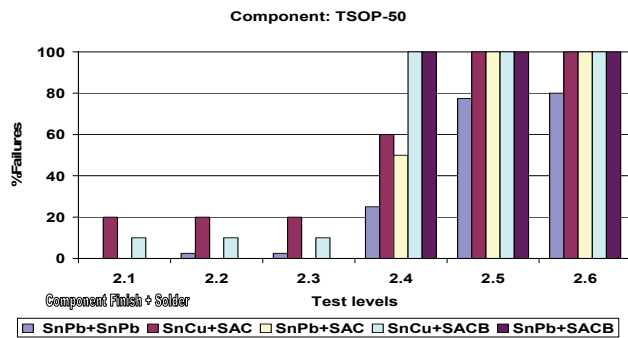
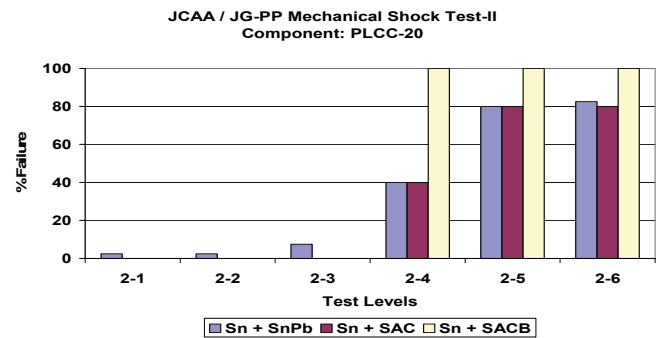
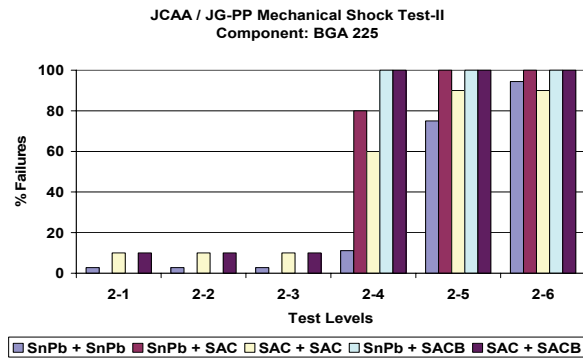
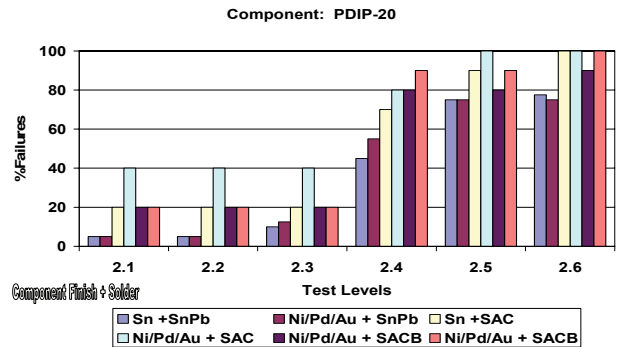
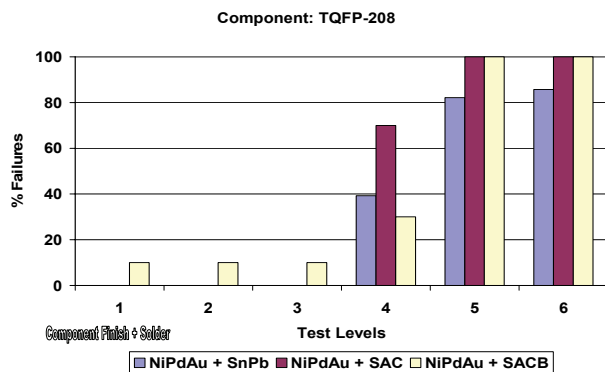
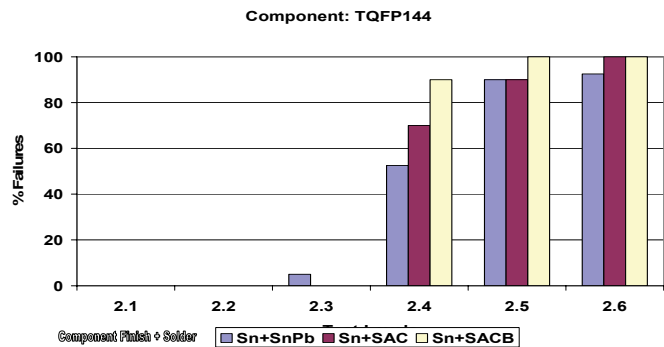
Figure 7 - Mechanical Shock Test 2 Test Results

Tin Lead (SnPb) soldered test vehicles performed better than the SAC and SACB soldered test vehicles. Lead Free Solder failures were most prominent after Level 2.3, as shown in Figure 7. The results are attributed to the higher mechanical shock levels experienced by the components, the quantity of shock pulses per test step level, and the tests being performed in the Z-axis only.

Tin Lead (SnPb) had high levels of intermittent failures. Approximately 50% of all Tin Lead (SnPb) soldered components tested had intermittent failures, at the Test Step Level 2.6. The SACB soldered test vehicles had intermittent failures at U17: CLCC-20 and at U57: TQFP-208. These failures were found at Test Step Level 2.3. SnAgCu had no intermittent failures.

At the higher shock levels, Level 2.4 (> 100 G Peak) and above, failure event data indicated simultaneous failures and intermittent failures of several devices. The intermittent failures confound the test data and do not allow clean interpretation of the test results. An intermittent contact/open may be result of several possibilities such as: shock failed solder/interconnect joints break and remake the contact or the failures are not at the device level but somewhere on the board interconnect chain at the board level or at the mechanical connector. For these reasons, we rigorously applied the IPC 9701 failure criteria. Failure was defined as an electrical interruption lasting greater than 0.2 μ sec and continuity interruption greater than 300 Ω up to 1000 Ω .

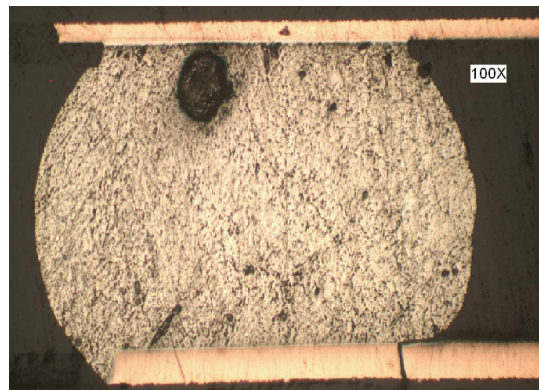
BGA devices we evaluated from the SnPb, SAC and SACB boards had similar failure mode. In each case, the Cu trace connecting the daisy chain on the board broke, at the land-trace interface area. Most of the failures were located at the corner areas of BGAs. The cross-sections also revealed that some of the BGA solder balls had partially propagated cracks, indicating another emerging mode of failure. However, none of the solder joint exhibited complete solder joint failure. This signifies board level copper interconnect traces were the weak links in the case of the BGA devices. Figures 8 through 12 illustrate examples of the failures found from the Failure Mode Analysis.

Figure 8 - Example of BGA Failure from Mechanical Shock Test 2

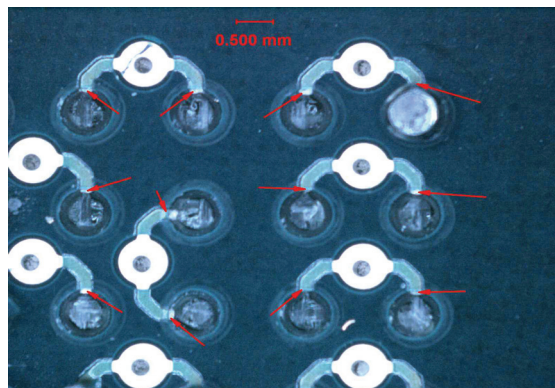
Figure 9 - Tin Silver Copper (SAC) Pry and Dye Failure Analysis, U6 PCB Trace Failures

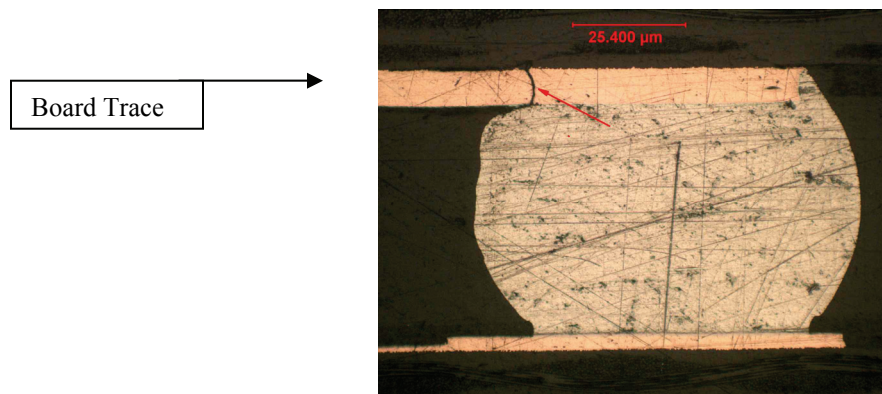
Figure 10 - Tin Lead (SnPb) U44 PCB Trace 1R Failure

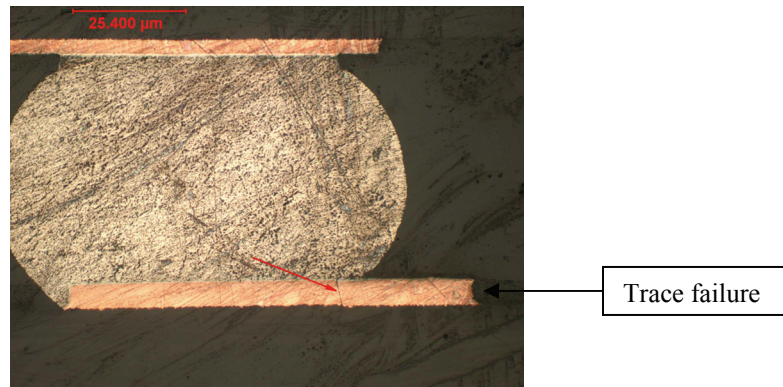
Figure 11 - Tin Silver Copper (SAC) U44 BGA Trace 2R Failure

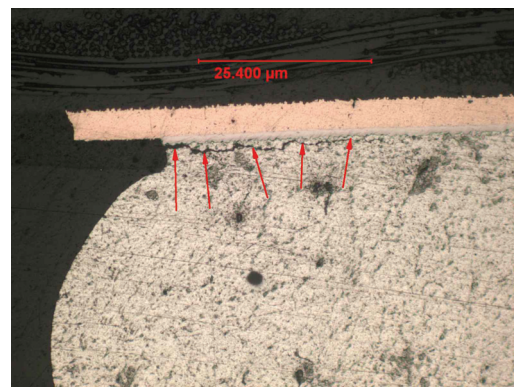
Figure 12 - Tin Lead (SnPb) U44 BGA Solder Crack
