QFN Flux Entrapment Case Study

By Terry Munson

Foresite Inc.

QFN Flux Entrapment Case Study #1

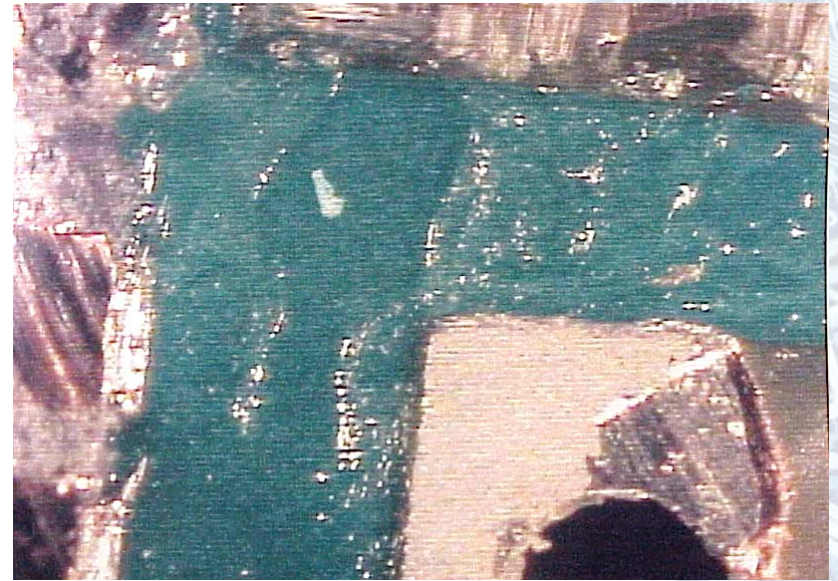
Residue under QFN in the gap still gooey

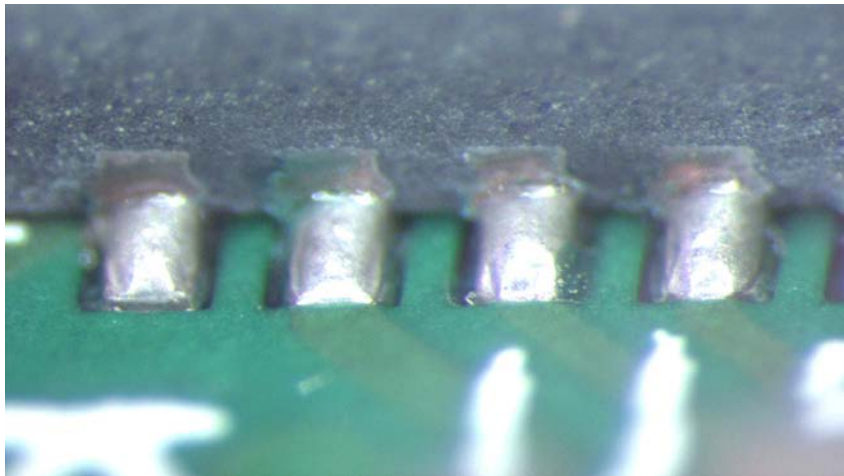
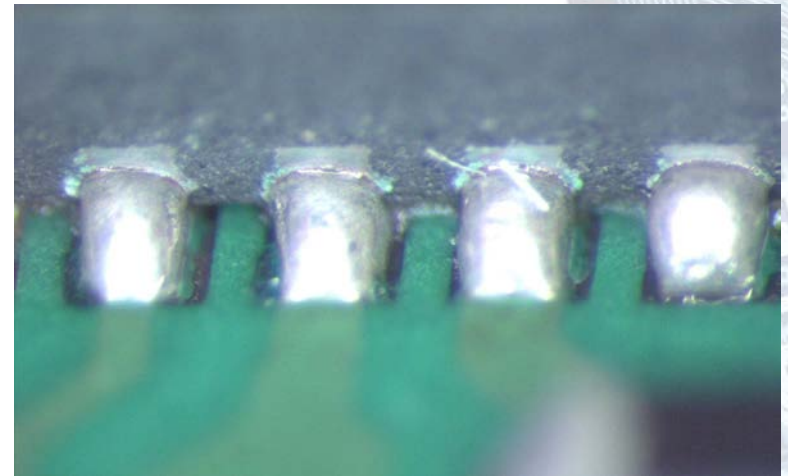
Solder at the edge of the QFN Perimeter pad showing no intermetallic or wetting to the edge lead-frame exposed / oxidized copper

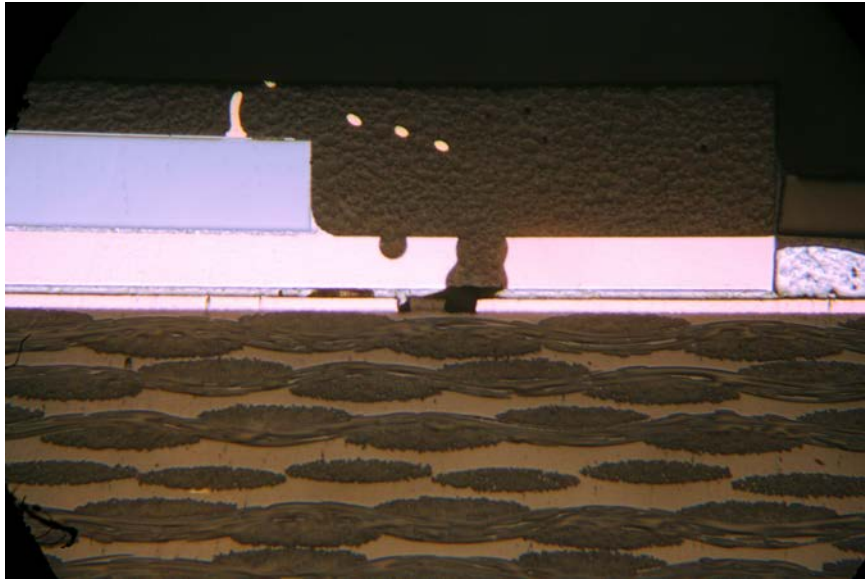
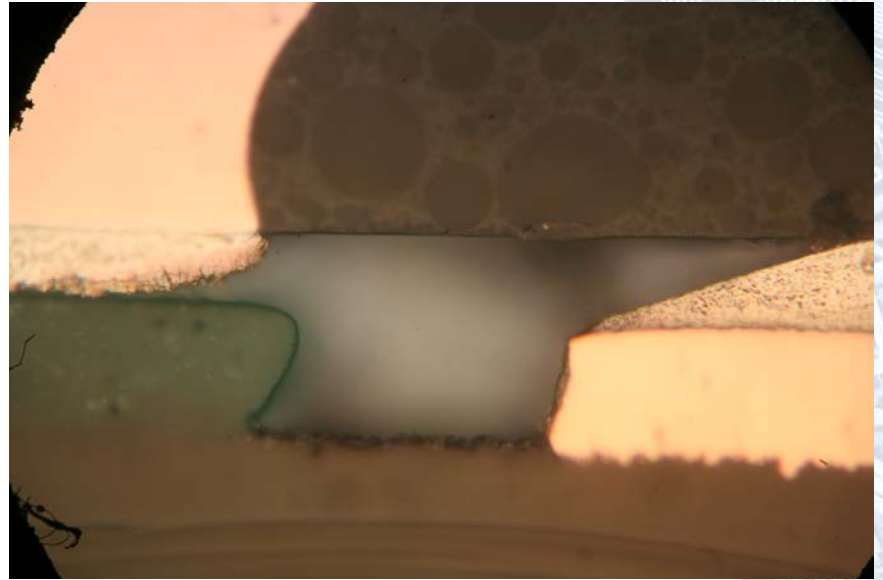
Cross section view of the QFN with a 0.5 mil standoff showing the part shift in the gap is now reduced from 10 mils to 7 mils

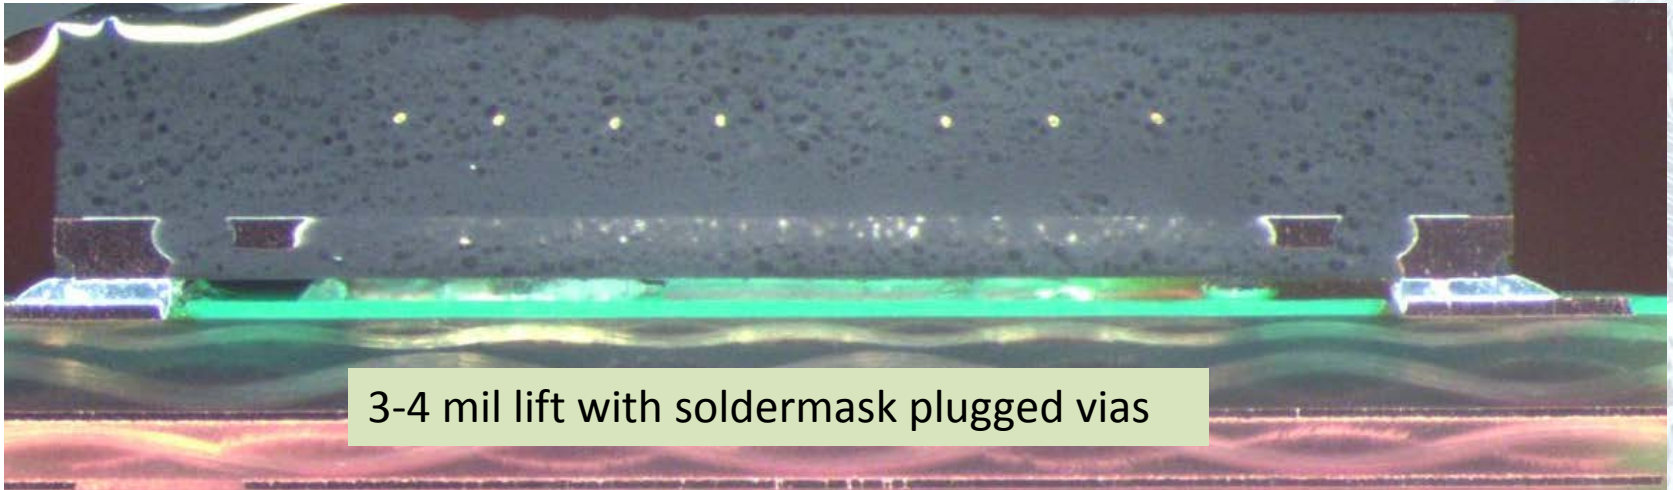
3-4 mil lift with soldermask plugged vias

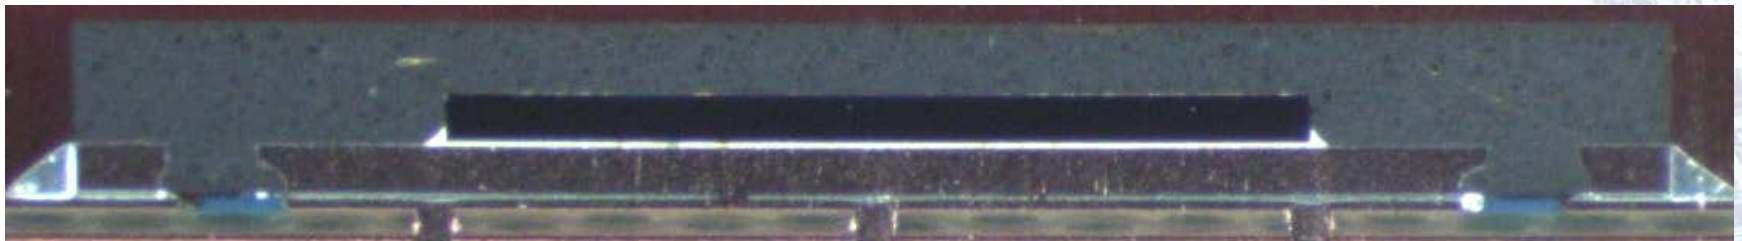
0.80 lift mil without soldermask plugged vias
