# **Microvia Reliability Concerns in the Lead Free Assembly Environment**

## **Abstract**

## **Background**

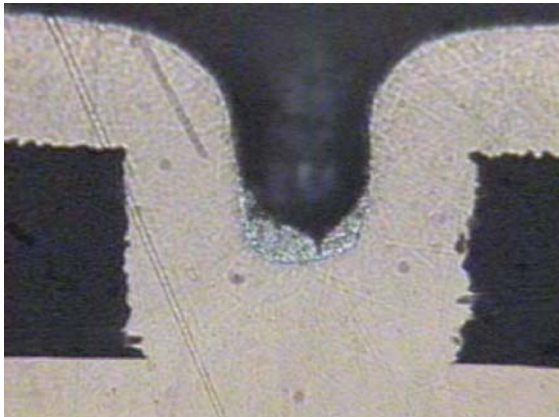
The established method for evaluating microvia by microsection requires the evaluation of the microvia to target pad interface to be examined without the use of a microetch. It was determined that this methodology was inadequate, due to poor definition between the various copper surfaces. Known failed microvias would have passed visual examination when a non-microetched microvia was assessed. In Figures 1 and 2 below a non-failed microvia was photographed before and after a mild micro-etch. The figure demonstrate that the layer one foil, electroless copper, interface between the bottom of the microvia and the capture pad and the plating on the top of the capture pad are not visible with a mild micro-etch. It was demonstrated that a well-controlled microetch using hydrogen peroxide and ammonium hydroxide greatly enhanced the physical details of the failing interconnect and improved the ability to objectively evaluate failures and causative mechanisms. The microvias evaluated in this study employed the use of a mild microetch.

**Figure 1 - Un-Etched Microvia**

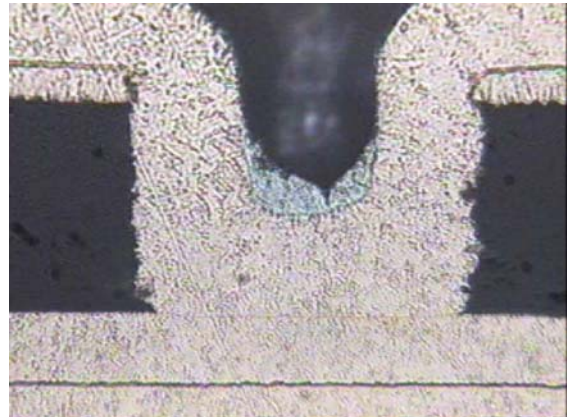
**Figure 2 - Etched Microvia**

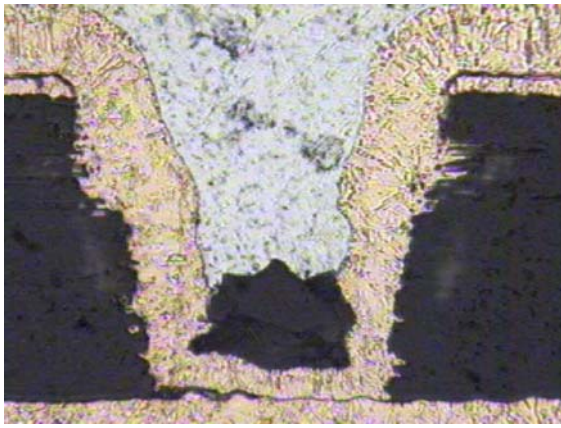
IST equipment has the inherent ability to stop testing an individual coupon automatically when it achieves a 10% increase in resistance, in any test circuit. This assures that the failing circuit is stopped before the coupon has achieved a catastrophic failure. Figure 3 is of an obviously failing microvia, while Figure 4 is one the subtle failures. Both coupons were stopped at a 10% increase in resistance and then identified, with thermal imaging techniques, as the microvias contributing the highest resistance to the failed circuit.

**Figure 3 - Microvias Contributing a 10% Increase in Resistance**

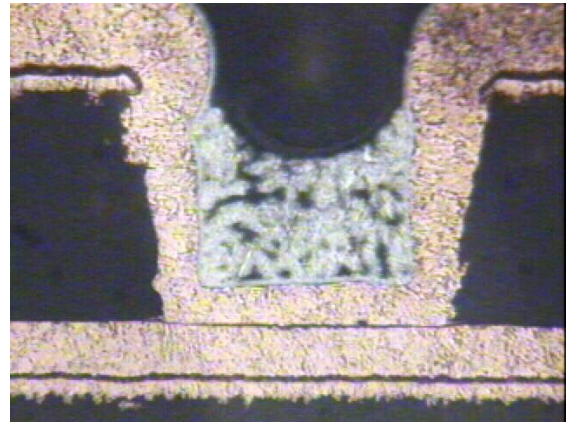
**Figure 4 - Microvias Contributing a 10% Increase in Resistance**

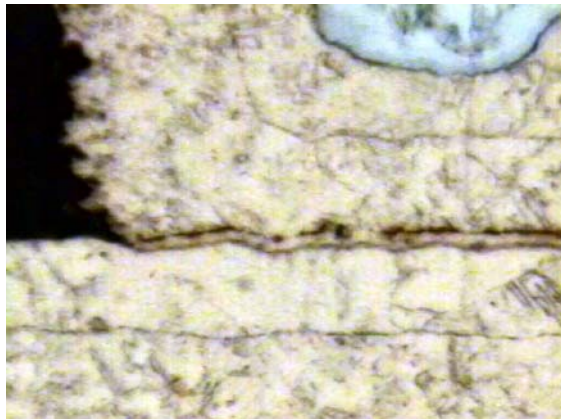
After analysis of a large number of failed microvia some common characteristics came. One of the characteristics of failing microvias due to a capture pad separation is that they usually exhibited inclusions between the electroless copper and the capture pad or the electroless copper and the electrolytic copper. Because we are viewing failing microvias that have not failed completely (fully separated), we have the opportunity to review the failure in progress. The microsection is acting to capture a moment in time of the failure. We were able to review the most electrically degraded microvia and the neighboring microvias that are in various stages of failing. Frequently failing microvias exhibited precursor black dots that tend to become small micro-cracks and the micro-cracks coalesced into large cracks. Commonly the cracks would appear in the center and at one edges of the microvia. Microvia that were advanced in the failing process had the appearance of a crack that started on one side of the base of the microvia and progressed completely across the interface. It is most probable that the crack started as small cracks that coalesced into a large crack rather than a wedge crack intruding from the edge of the microvia. Figures 5 and 6 exhibit the precursor black dot above and below the electroless copper. Figure 7 shows coalescing micro-cracks both above and below the electroless copper.

**Figure 5 - Precursor "Black Dots" and Coalescing Micro-cracks**

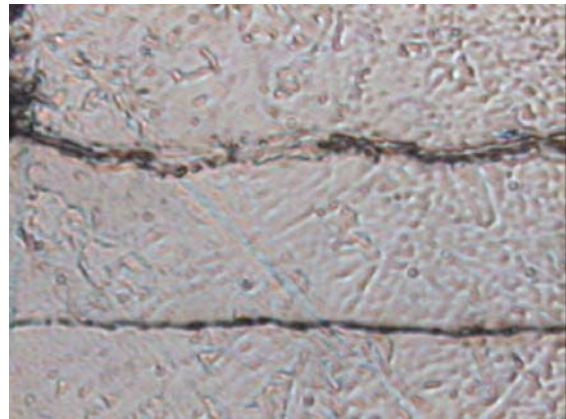
**Figure 6 - Precursor "Black Dots" and Coalescing Micro-cracks**

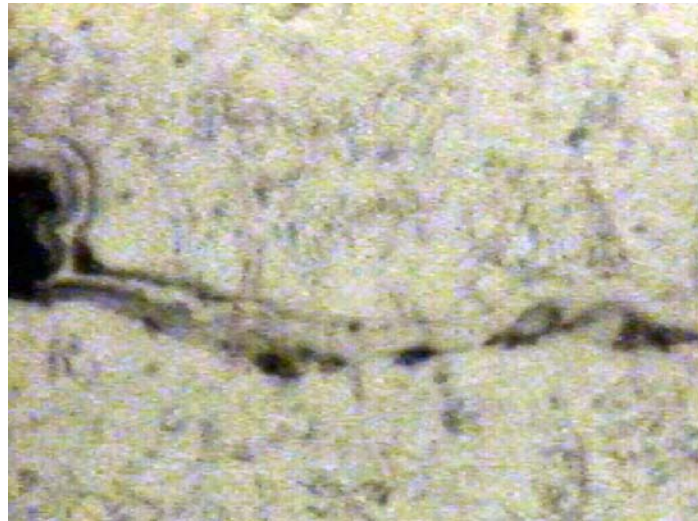
**Figure 7 - Precursor - Inclusions that Coalesce into Cracks – Two Cracks Forming**

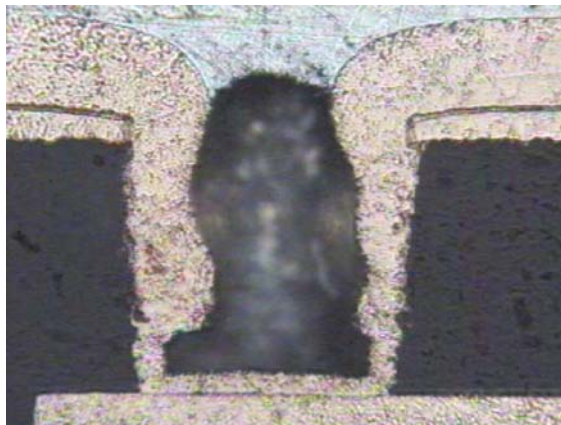
Another common observation is that the electroless and electrolytic copper quickly thins below the knee of the hole. Electroless that measured 120 millionth of an inch on the surface of the pad can be un-measurable at the base of the microvia. The thickness of the electroless and electrolytic coppers was reduced, in some cases dramatically, as the deposit descends into the microvia. The effect of thinning electroless can produce a condition commonly called step plating. Figure 8 demonstrate the reduction in electroless, which is plainly visible on top of the surface foil and only barely discernable at the base of the microvia. Figure 9 is an extreme example of wedge plating on a microvia processed with direct metalization.

**Figure 8 - Thinning of Electrolytic**

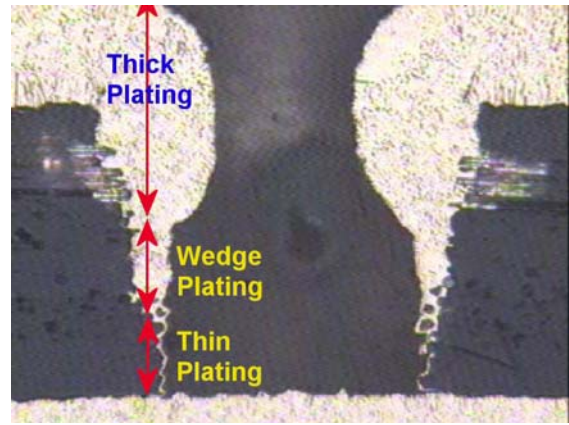
**Figure 9 - Electroless Copper Below the Knee of the Hole**

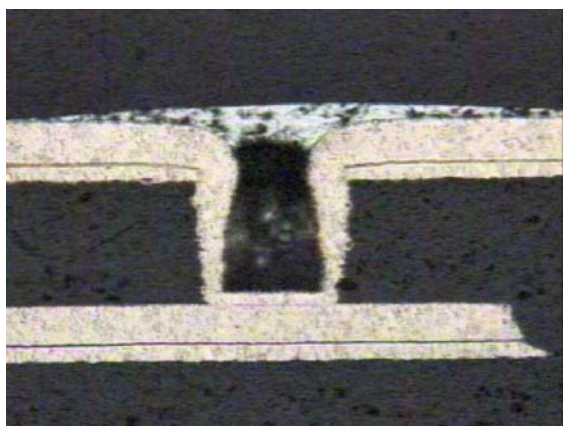
Another observation was that the shape of the microvia was also contributing to its robustness of a microvia. A dish shaped microvia appeared to have a more uniform copper distribution to the base, compared to a microvia shaped like a traditional cylinder. Dish shaped microvia were found to achieve higher cycles to failure.

**Figure - 10 Cylindrical Microvia**

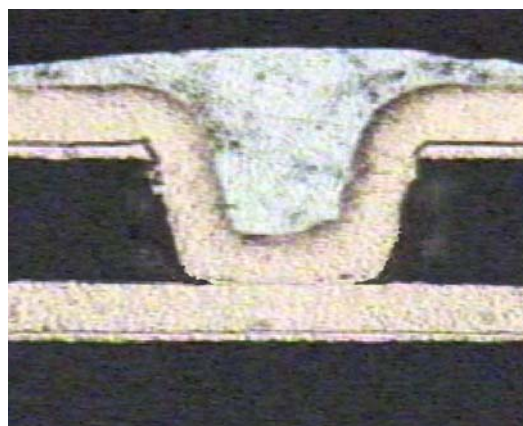
**Figure 11 - Dish Shaped Microvia**
