Telecommunications Case Studies Address Head-In-Pillow (HnP) Defects and Mitigation through Assembly Process Modifications and Control

Russell Nowland
Alcatel-Lucent
14000 Quail Springs Parkway, Suite 300
Oklahoma City, OK 73134-2620, USA
E-mail: russell.nowland@alcatel-lucent.com
Phone: 405-302-1660

ABSTRACT

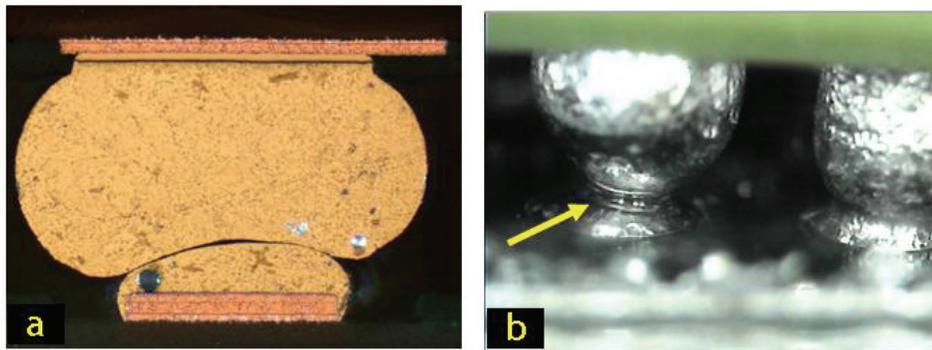
The HnP phenomena are characterized by complete melting of both the solder paste and the BGA solder ball but with insufficient coalescence to produce well-formed solder joints. Figure 1 shows examples of HnP defects using: a) an optical photomicrograph of a typical HnP metallographic cross section and b) an optical photomicrograph of the outer row of a BGA with an HnP defect. Figure 1a shows that the BGA ball sits on the solidified paste without forming a contiguous, well-formed solder joint. These are latent defects that are not detected using standard manufacturing test methods such as visual inspection, x-ray, and particularly electrical screening. The latter is important because these defects can pass in-circuit and functional test, only to fail completely or give an intermittent connection after some period of deployment in service.

Figure 1. Examples of HnP defects a) optical micrograph of solder joint cross section, and b) Side view of a row of BGA balls with HnP at arrow.

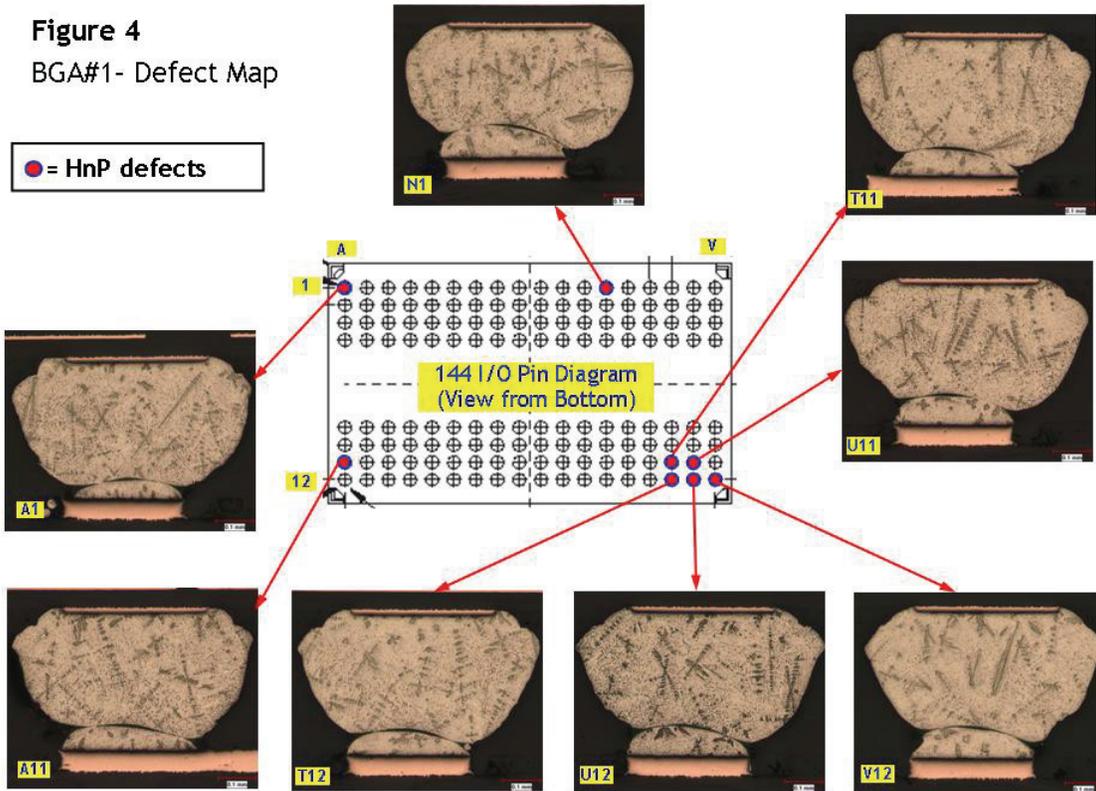
Figure 4
BGA#1- Defect Map

Figures 4 and 5. Defect maps and metallographic cross sections for two SnPb FBGA (labeled BGA #1 and #2) devices that exhibited severe HnP open joint failures.

A comparison of the defect maps for BGA #1 and #2 shows that an identical device can have very differently HnP signatures when assembled onto two different locations of the PCBA. When warpage is the root cause of HnP, the defects characteristically manifest themselves at the corner or outer row sites in BGA packages. While that is generally the case for these two BGAs, their defects are not limited to the corners or edges of the packages. It also is very obvious that the number of defects varies and the defect patterns are not symmetric for the two packages.

The defects are located not only at or near the outside of the package, but also outside the die shadow (see Figures 4 and 5). Contamination would be expected to produce a less localized pattern of defects, which focuses attention on package warpage as the most probable root cause of the HnP defects. Table 1 shows a summary of Shadow Moiré warpage [7] measurements on the 144 I/O FBGA package. There are a number of notable observations in these data. First, the peak warpage occurs at the SnPb (not Pb-free) peak soldering temperature. Second, the warpage is not symmetric around the peak temperature. Third, the warpage is not completely reversible or recoverable following the simulated reflow temperature cycling. Finally, although the room temperature warpage or coplanarity is 70-80 μm (3-4 mils) is quite acceptable, the warpage is substantially greater at the high temperatures in the reflow profile warpage, where HnP is known to occur.

Often there is no alternate device and package available when warpage is identified as a root cause of HnP. In those cases, a common corrective action is to modify the stencil printing to provide additional paste volume to bridge the gap (illustrated in Figure 6) at the potential HnP sites [6]. Such a recommendation for the 144 I/O FBGA is shown in Figure 7. This stencil recommendation was provided by the device supplier and was based on extensive Moiré studies of warpage in the 144 I/O FBGA package. Implementation of this stencil modification improved the manufacturing yields from approximately 10% to 80% but did not eliminate the HnP defects entirely. The stencil modification also introduced some solder bridge (short circuit condition) defects, which is an expected consequence of increasing paste volume with a fine pitch device.

A comparison of the stencil modification and the defect maps shown in the lower part of Figure 7 indicate that the increased paste volume will mitigate the HnP problem in only about 75% of the FBGA sites used in this telecommunications application (Note that these diagrams show the same package layout as those in Figure 4 and 5 but here they are viewed from above to coincide with the stencil pattern.). This result is consistent with both the yield improvement and with the observation that HnP defects were not eliminated completely. Despite the vast improvement, an 80% yield is unacceptably low. However, given the demonstrated ambiguity in all aspects of the HnP defect characterization, it is more critical to recognize that the 80% distribution may contain latent defects that can “escape” into service. In the absence of a definitive non-destructive detection technique, this produces an unknown risk in subsequent field failures.

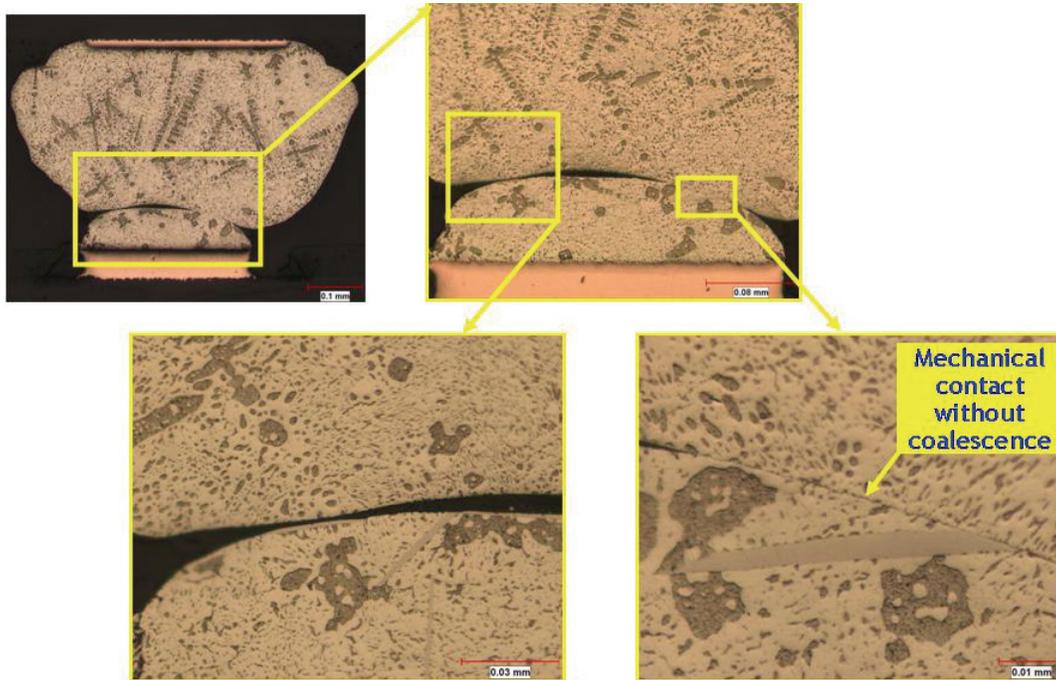
Figure 6 shows one of the HnP defects from BGA #1 at higher magnification. These photomicrographs illustrate the potential latent character of the HnP defects. There is good mechanical contact at the interface between the solidified ball and the paste even though there is no coalescence across the interface. This site is located on an inner row and is not likely to be detected with a visual or a detailed microscopic inspection. It definitely will pass electrical testing and may pass thermal screening if adjacent sites are properly soldered and support the integrity of the mechanical connection.

Figures 6. These photomicrographs illustrate the latent nature of the SnPb HnP defects. There is good mechanical contact at the interface between the solidified ball and the paste even though there is no coalescence across the interface.

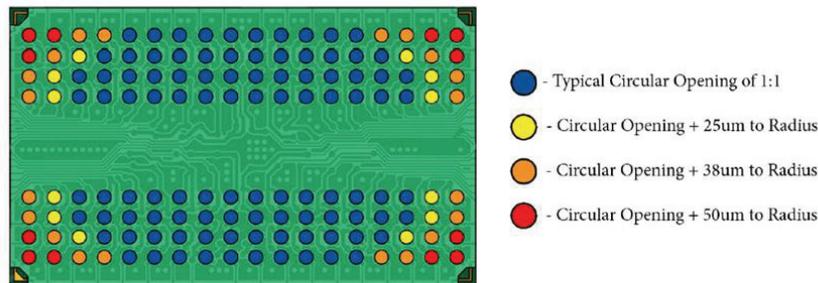
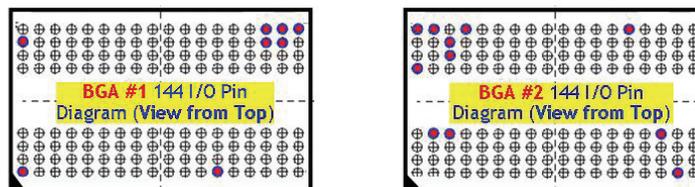
Proposed Stencil Modification for Mitigation of FBGA HnP Defects

Based strictly on the actual location of defects, the proposed modified stencil would provide additional solder paste volume on ~75% of the affected PCB pads.

Figures 7. Proposed stencil modifications and effectiveness in mitigating HnP defects in the telecommunication Case Study 2 application of the 144 I/O FBGA package.

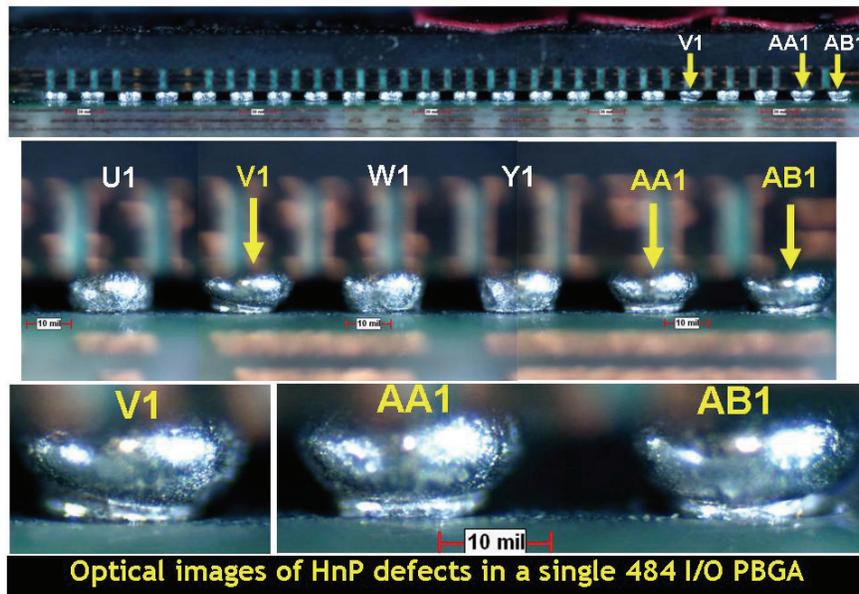
Figure 9. Optical images of multiple HnP defects in a single 484 I/O PBGA.

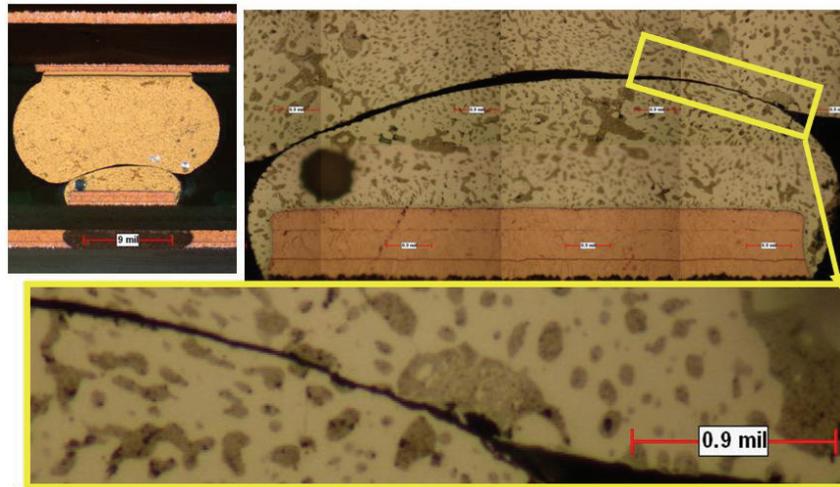
application, as well as the subtle and insidious latent character of HnP defects. The photomicrographs in Figure 10 show an HnP defect that will likely fail electrical testing due to the gap that exists at the interface between the solder ball and paste after resolidification. The photomicrographs in Figure 11 show an HnP defect that is very likely to pass electrical testing and may pass thermal screening and escape detection, only to fail after some undetermined time in service. The ball and paste in this solder joint are making good mechanical contact, but the highest magnification images show that there is no continuity in the solder microstructure across the interface. An argument could be made that a sub-microstructural, diffusion bond exists between the two masses of solder but there clearly has been no actual solder coalescence and solidification across the interface. The photomicrographs in Figure 12 show an HnP defect that will pass all routine factory testing. The ball and paste in this solder joint are connected across only about 30-40% of the area of a normal, well-formed solder. There are no existing data that could be used to predict the risk of failure for this solder joint in service.

Figure 10. A series of optical photomicrographs of an HnP defect in the 484 I/O PBGA. This HnP defect is likely to be detected in electrical testing in the factory due to the gap between the solder ball and paste following reflow and resolidification.

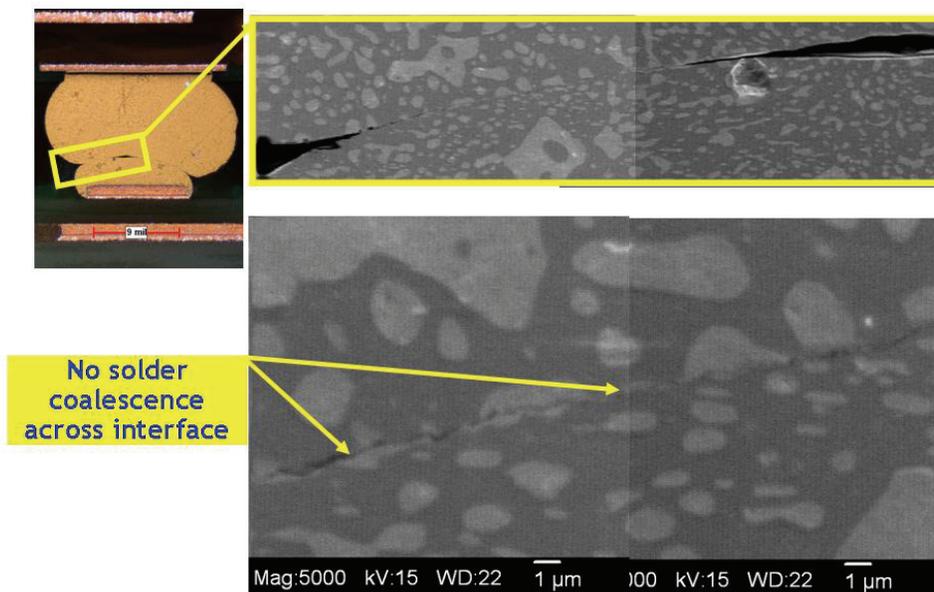
Figure 11. A series of optical and scanning electron micrographs of an HnP defect in the 484 I/O PBGA. This HnP defect may not be detected in the factory due to the good mechanical contact at the HnP interface between the solder ball and paste.

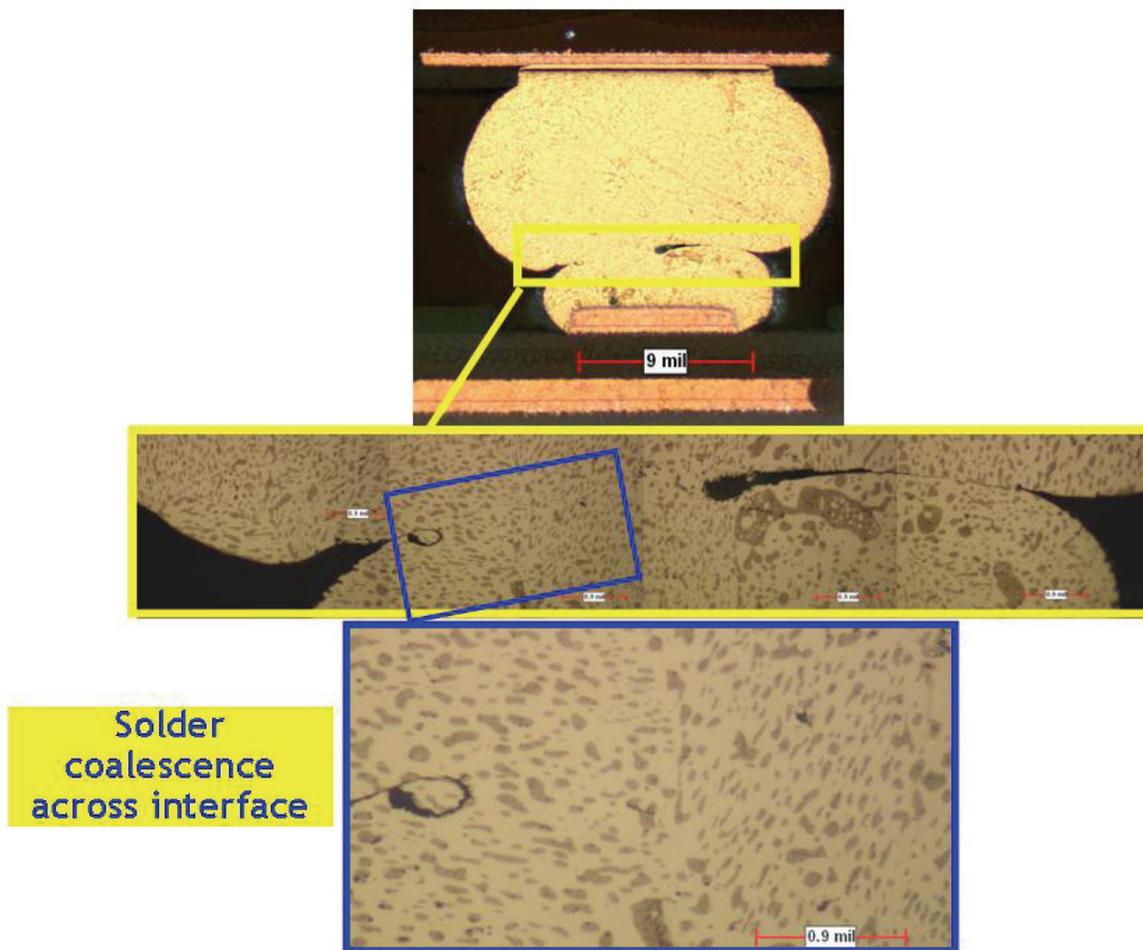
Figure 12. A series of photomicrographs of a HnP defect in the 484 I/O PBGA that will pass all routine factory testing. The ball and paste in this solder joint are connected across about 30-40% of the area of a normal, well-formed solder. The risk of failure of this latent defect cannot be quantified.

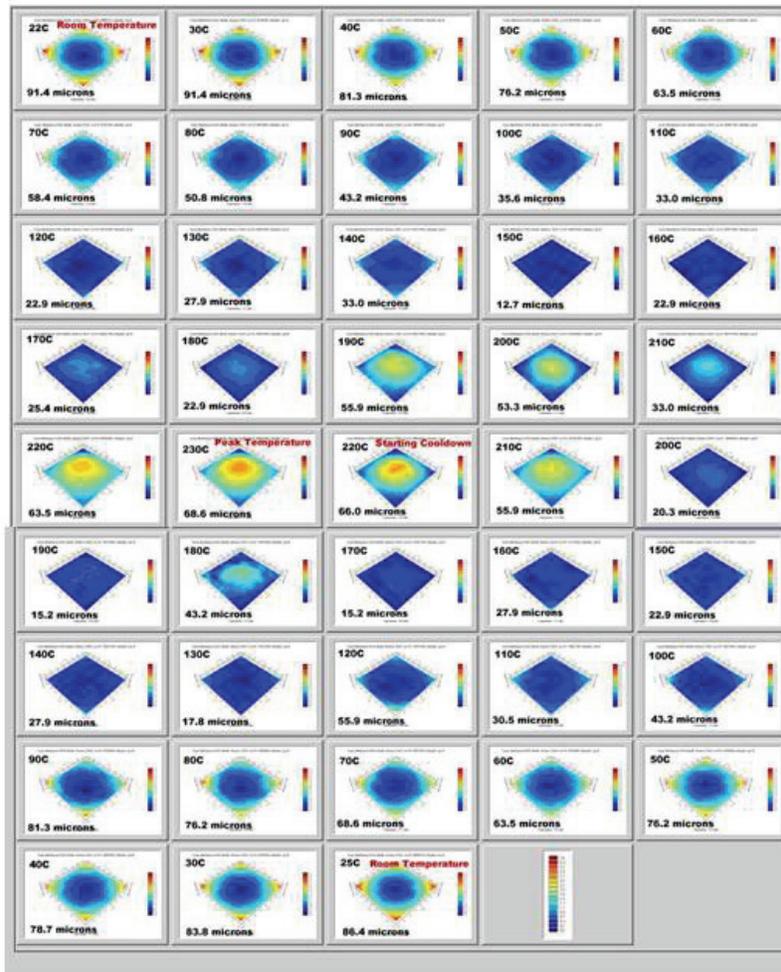
The results of the Moiré testing indicate significant package warpage occurs throughout the reflow process temperature range. Table 2 summarizes the Moiré results for four devices, showing the initial coplanarity measurements, peak coplanarity measurements, and the total variation through the reflow temperature range. The data in this table show there is a maximum coplanarity or warpage of 200.7 microns (7.9 mils) during the reflow process. Four additional devices were sent to the packaging house for independent confirmation of the Moiré measurements. Those results are summarized in Figure 14 and show a maximum warpage as great as 219.0 microns (8.6 mils) with a deviation from flatness of approximately 75 microns (3 mils) at SnPb liquidus. The second set of data provides confirmation of the findings from the initial set of measurements shown in Table 2. These Moiré data show similar trends as the 144 I/O FBGA discussed in Case Study 1. The warpage is not symmetric around the peak temperature and is not completely reversible or recoverable following the simulated reflow temperature cycling.

Figure 13. Example of a Shadow Moiré output scans for a 484 I/O PBGA.

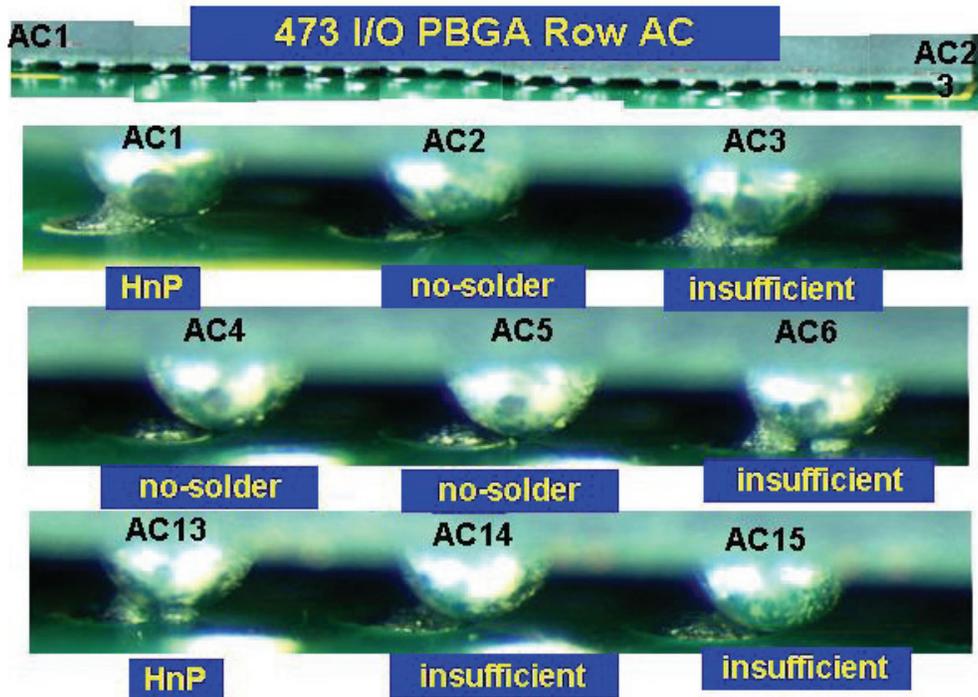
Figure 18. 473 I/O PBGAs in another NPI build exhibit various defect signatures than those in Figure 17.

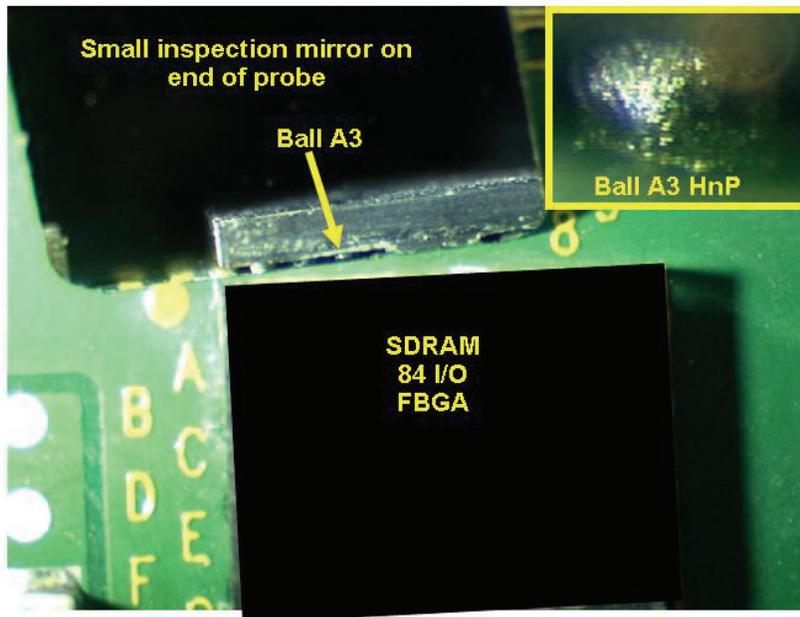
Figures 19 through 22 show HnP defects in 84 I/O FBGA and 64 I/O PBGAs on other NPI products. The HnP defect in Figure 20 could be detected using a small 45 degree inspection mirror on the end of probe or by using a BGA video inspection tool. An examination of the 84 I/O FBGA conventional 2D x-ray image in Figure 21, shows an apparent difference between the A3 HnP defect and surrounding ball sites. However, without the optical image the x-ray image is not sufficient to identify this solder joint anomaly as HnP. In fact, one would be hard pressed to determine from the x-ray image that this was a defective solder joint site.

Figure 19. HnP defect on 84 I/O SDRAM FBGA. The optical inspection system or microscope and mirror may be useful for a BGA not near the PCBA edge but these are difficult to use, have marginal image quality, and require operator skill and experience.

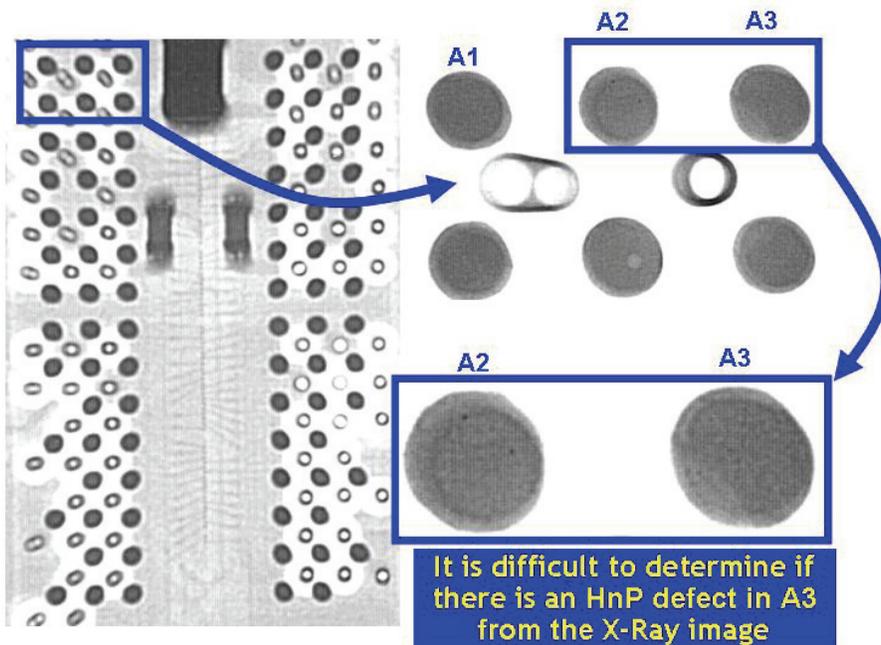
Figure 20. The HnP defect on the 84 I/O SDRAM FBGA is difficult to detect with x-ray inspection.

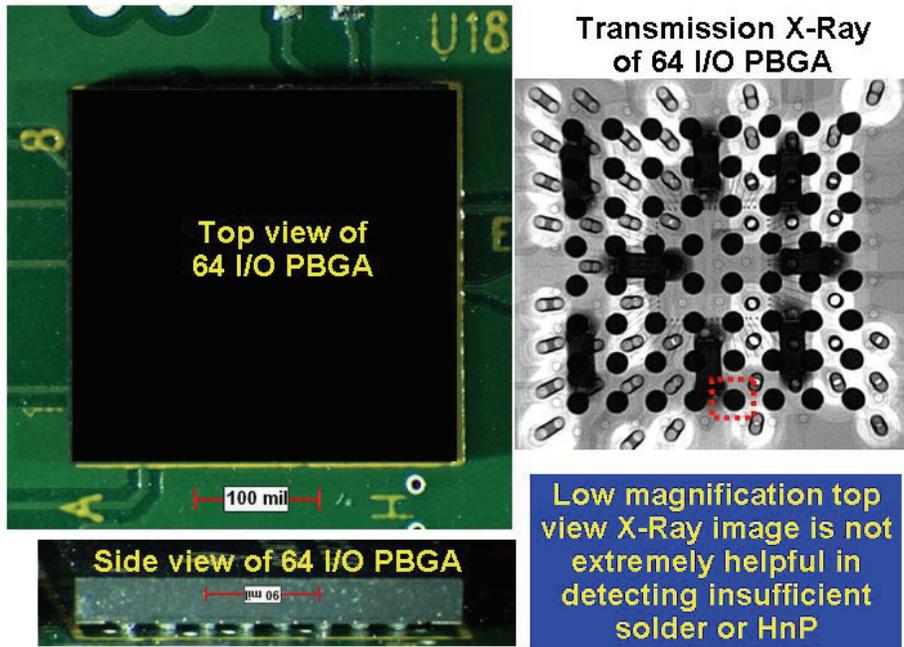
The conventional 2D x-ray image of defects on a 64 I/O PBGA presented in Figure 21 can not identify HnP or insufficient solder joints. In the absence of the optical inspection images shown in Figure 22, it would be impossible to determine that these sites had HnP and insufficient solder joint.

Figure 21. Conventional 2D x-ray imaging is not adequate for detecting HnP or insufficient solder defects.

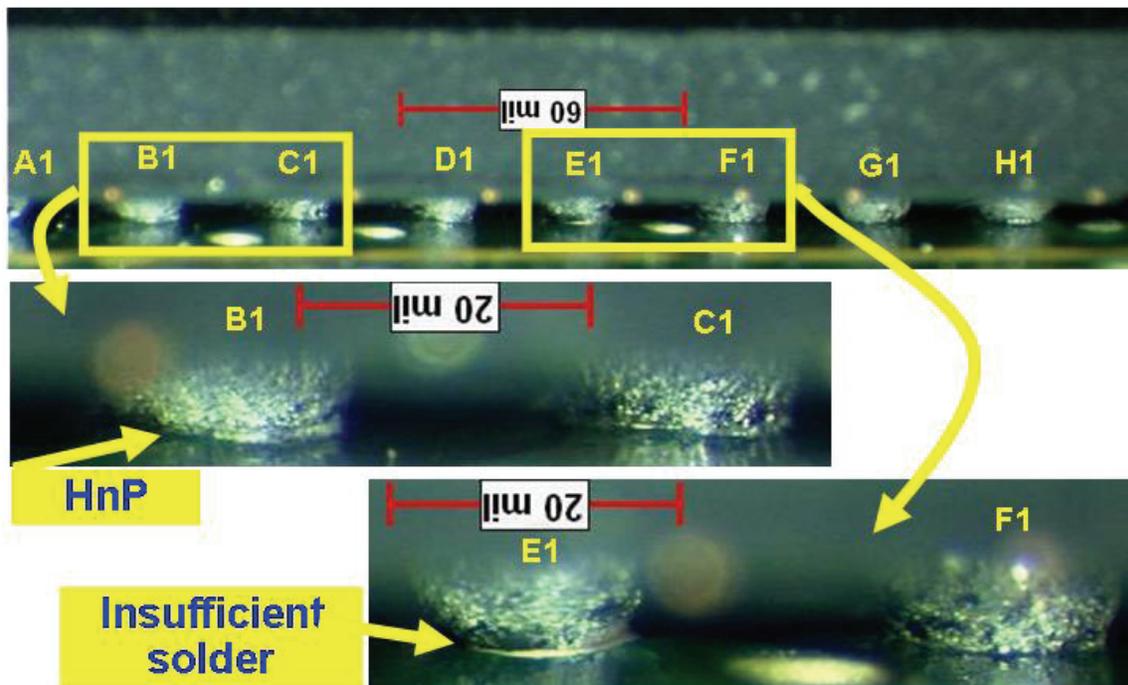
Figure 22. Optical inspection images of outer edges of BGAs is a time-consuming process but it may be necessary to detect HnP or insufficient solder defects.

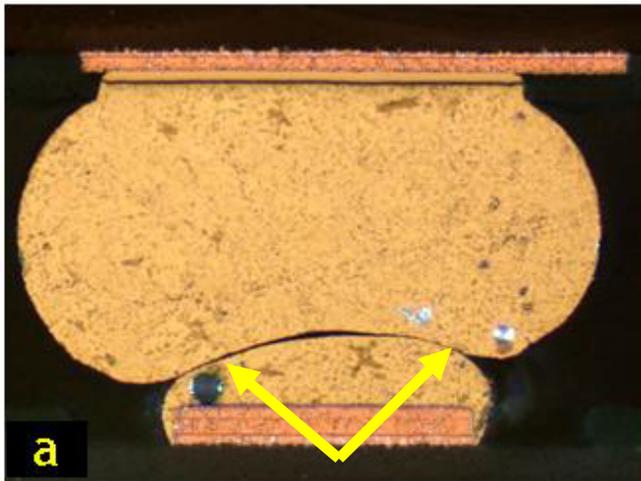
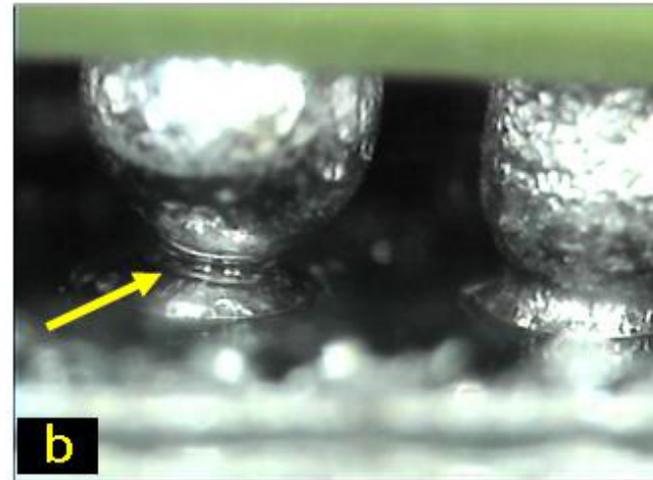
The solder ball and paste melted but did not coalesce.

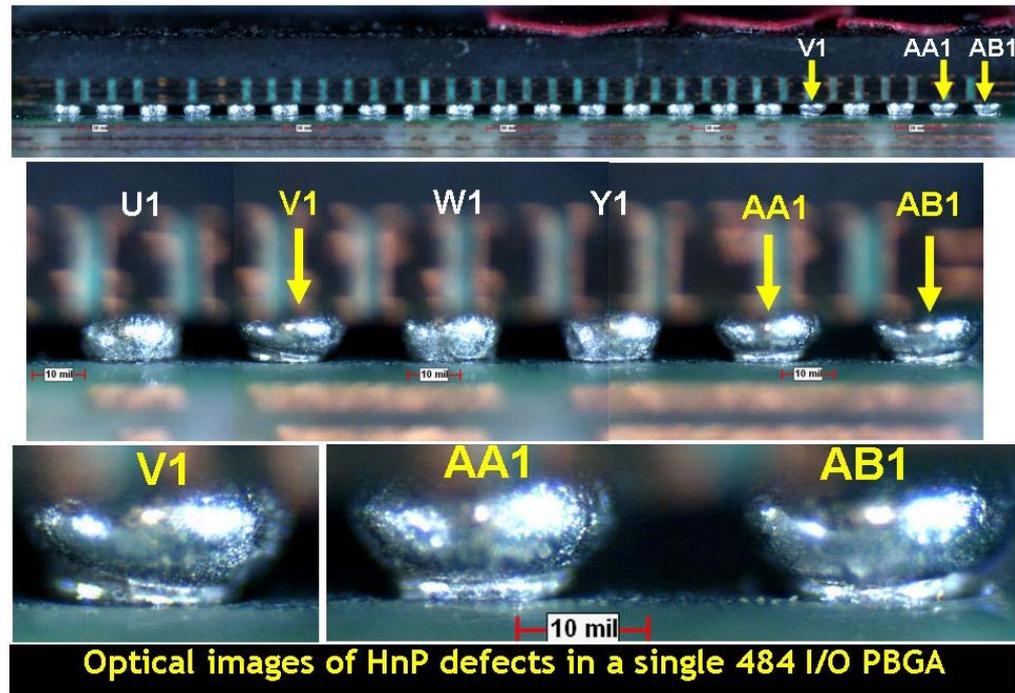
Optical images of HnP defects in a single 484 I/O PBGA

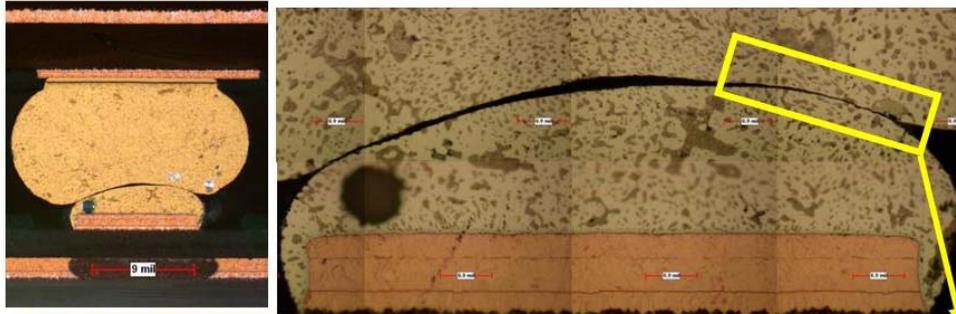
Open - Immediate failure

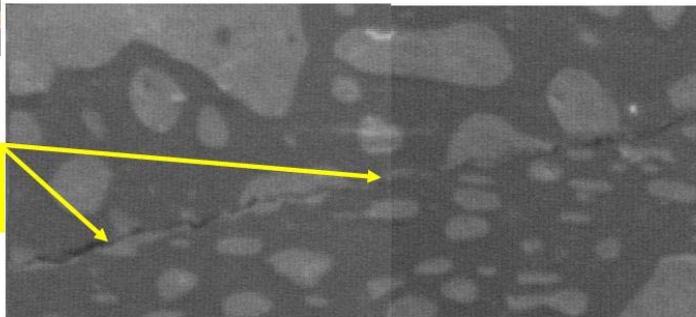
Contacting – Early failure risk (cold solder joint)

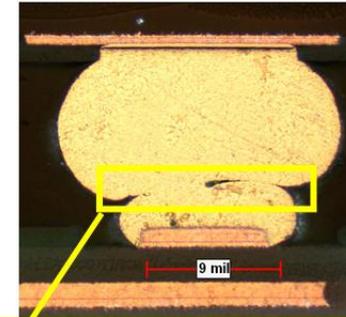
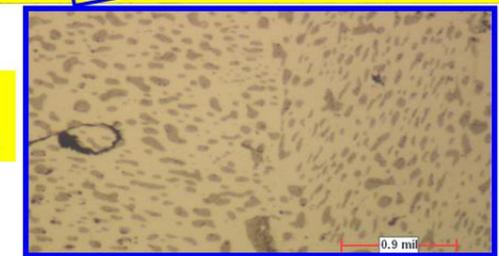
**Soldered – Possible long
term reliability risk**

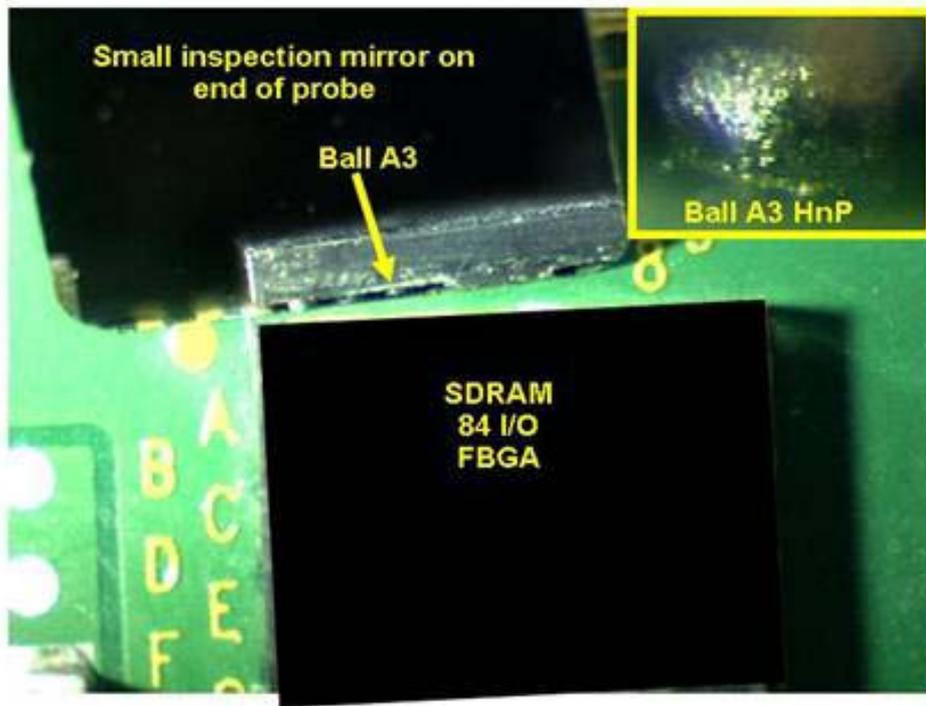
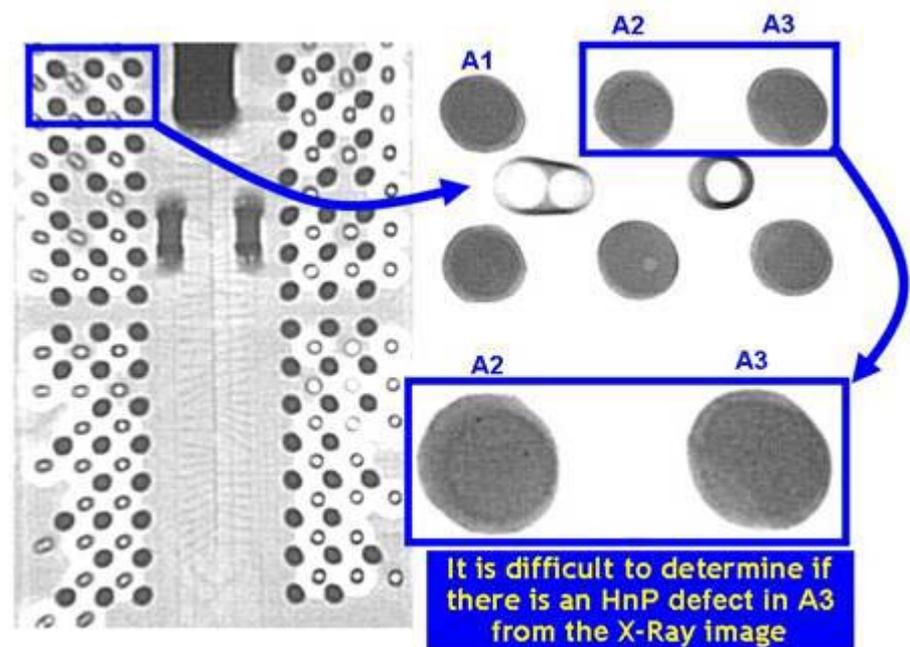
- HnP defects in 84 I/O SDRAM
- Note: HnP can not be identified with X-ray

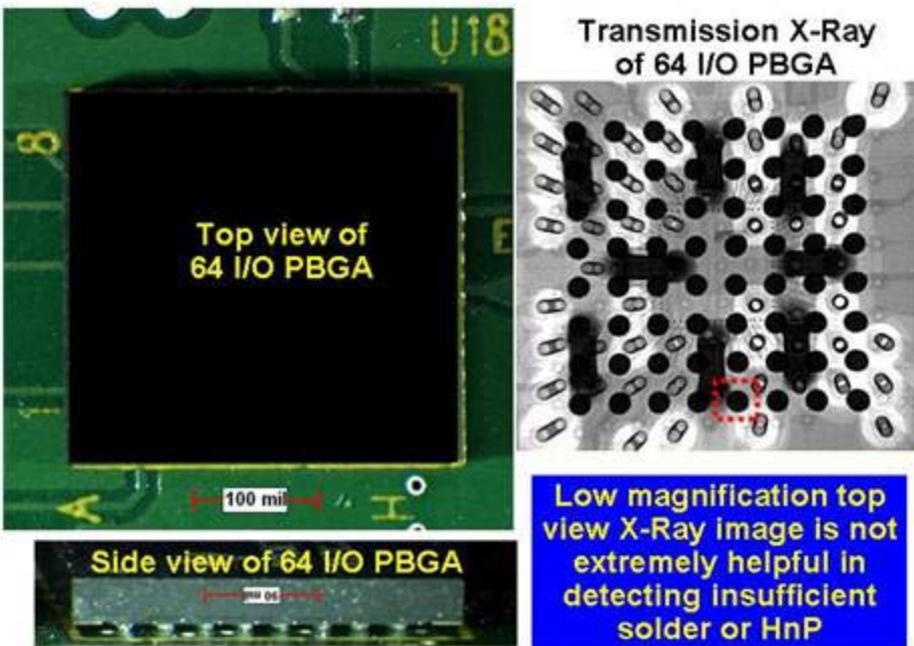
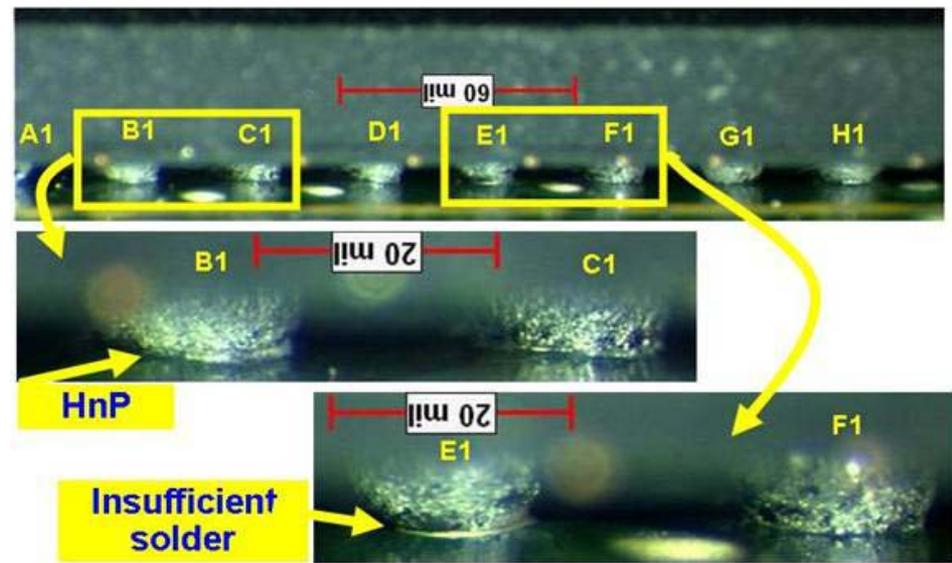
- HnP defects in 64 I/O PBGA can not be identified with 2D X-ray
- Time-consuming manual optical inspection may be required
