### **Root Cause of Corrosion on Aluminum Bond Pads**

Terence Q. Collier CVInc Richardson, Texas

# Root Cause of Corrosion on Aluminum Bond Pads

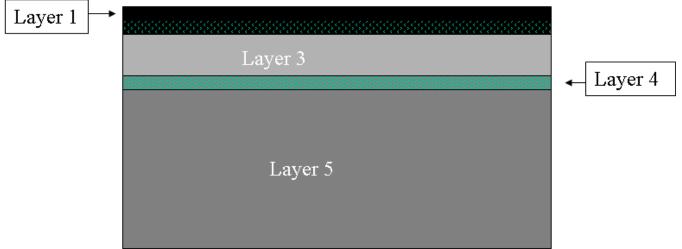
Figure 1. Bond Pad Stack with Corrosion and Contaminants by Layer (thickness of layers not to scale)

Layer two begins to show increased corrosion by products including high concentrations of fluorine and oxygen. AlOF and AlO are present with a higher percentage of fluorine containing materials. Layer three, typically a few hundred angstroms, shows higher oxygenated aluminum layers. Fluorine is present but is less. Layer four is primarily fluorine that has been driven into the aluminum during the plasma operation. Nitrogen is also present in this layer and some carbon can be detected. The levels of the C and N are low and pose no concerns. The fluorine can be detected at depths up to 400 angstroms before only aluminum metal is the only material found (ignoring N and C).

To prevent corrosion regrowth, all four layers have to be removed. If not the "thick" corrosion layer can grow back in less than a few days depending on storage or processing conditions. In operations where the humidity is high, basically everywhere except the dry box, an ample supply of moisture is present to prevent ESD/EOS problems. While high moisture is critical to minimize ESD/EOS problems, moisture quickly leads to scrap die.

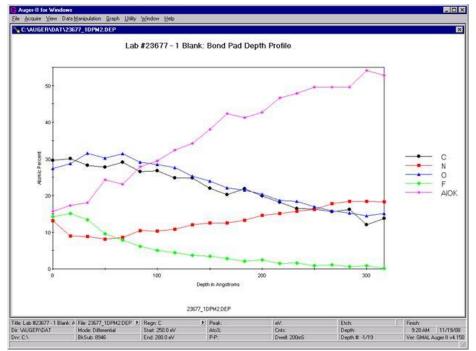
The data presented in figure two shows concentrations of carbon, nitrogen, oxygen, fluorine and aluminum by depth. The nitrogen is a non critical item that gets trapped in the grain boundaries and verified on both good and bad die to exist. Fluorinated carbon was found to be more a surface item contaminant whereas the additional carbon was ambient carbon. Oxygen is found in different forms at various levels. AIO, AIOF and OF are all corrosion products. Even with successful removal of OF corrosion AIO layers present problems. If the aluminum oxide layer is too thick then wire bonding is not successful. In cases where wirebond is successful one has to address the insulative nature of the bond on electrical performance. The results of an auger mill and profile demonstrate the necessity of to assure if an adoptive fluorine removal regiment might demonstrate improvement. These die were part of a wafer allowed to sit on an engineer's desk for over 12 months suggesting fluorine does not go to background levels until beyond 300 angstroms for this particular customer process. These samples were used to test the DOE process and process splits developed to look at reducing fluorine levels to zero.

Figure 2. Depth profile of CF<sub>4</sub> etched Al pad with no fluorine cleanup

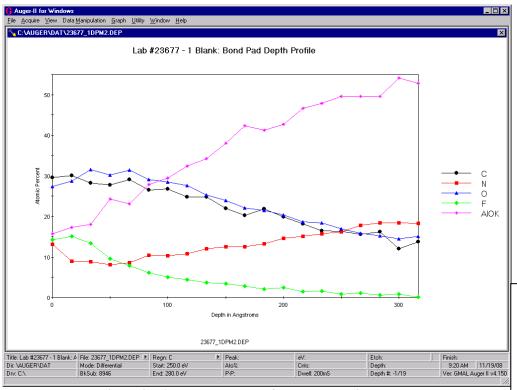
Figure 3. Ar etch bond pad after two weeks in dry box

A quick review of figure 3 and figure 4 show that cleaning has better long term results than argon cleaning. The process also has a low etch rate on the aluminum which means the parts can sit for hours in a bath with no damage to the die compared to 6 minutes in Ar and 30 seconds in PAN or OH etchants. Since the process is not energetic and focused on oxygenated compounds there is nil damage to the Si<sub>3</sub>N<sub>4</sub>, Si, BCB or other metals and organic packages.

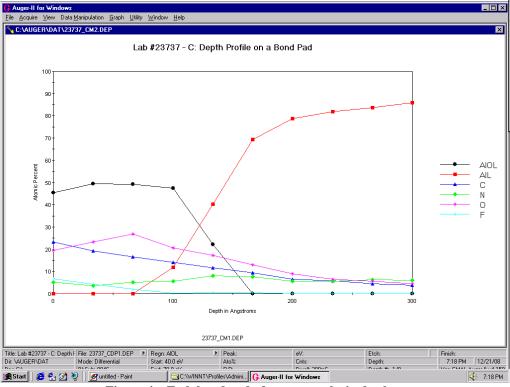
Figure 4. Etch bond pad after two weeks in dry box

The overall amount of Al is also higher in the lower image.

The figures also show that oxygen and oxygenated aluminum is high on the process and begins to drop off in the region where the fluorine goes to zero. The results suggest a possible AlOF layer which is possible after two weeks due to the fluorine corrosion process. Additional experiments will be run to optimize the process. It should also be noted that these wafers are an extreme case in which the material sat on a desk for over 1 year. Most material should be processed long before that to eliminate the fluorine early in the process. Early processing would reduce the oxide and oxyflouride growth resulting in a more streamlined and robust process.

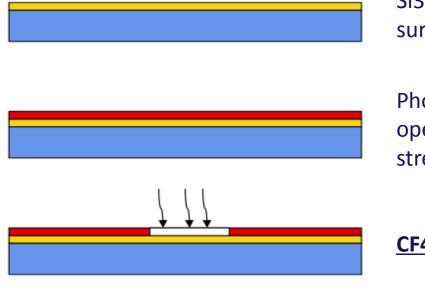
### **Bond Pad Fabrication Process**

Goal is to remove all the Si3N4 else probe, wirebonds, WLCSP processes are compromised

Si3N4 is completely removed from the Al pad but excess time on plasma converts some Al to AlF which is not volatized in the plasma

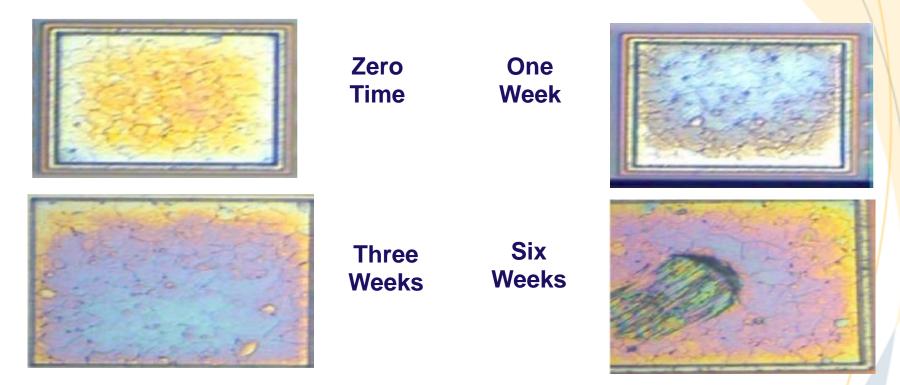
Residual fluorine on the bond pad leads to corrosion in the presence of moisture. Eliminate the F or corrosion will consume the entire bond pad. APEX Al Bond Pad Analysis At Various Times

Fluorine contamination is apparent at time zero from the fab. As time continues the pads become more corroded. Conditions of these pads are typical and are the root of poor contact resistance and bondability. If the pads are not cleaned then poor yield is likely as well as die and hardware damage.

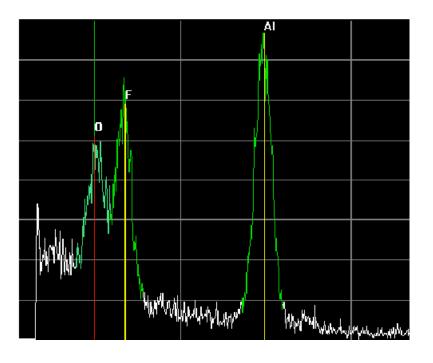
### Post saw corrosion - fails wire bond

EDX results show OF covers more of the surface than AI.

EDX is not as sensitive as Auger or XPS.

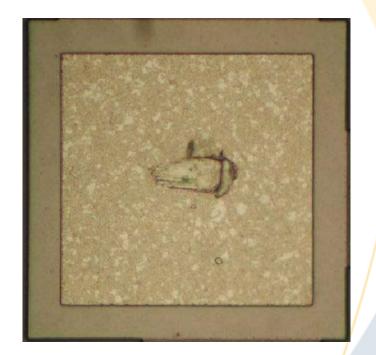
Optical image verifies that AI (white) is sparse. Fluorine corrosion regrowth in the probe mark.

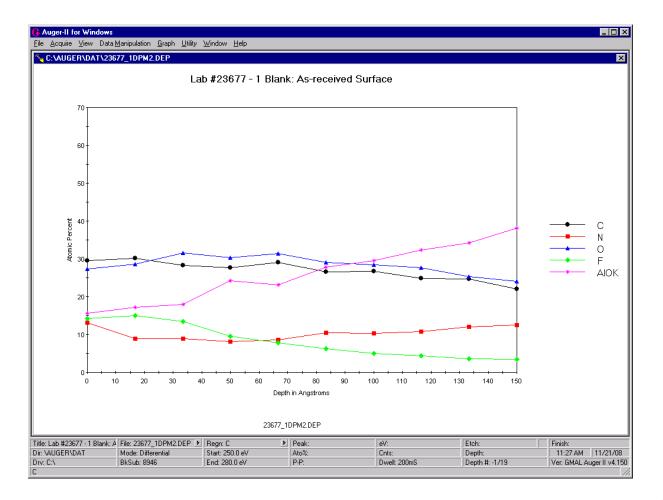
# Auger Layer Comparison As-Received Die

### No pure aluminum detected in the first 150A

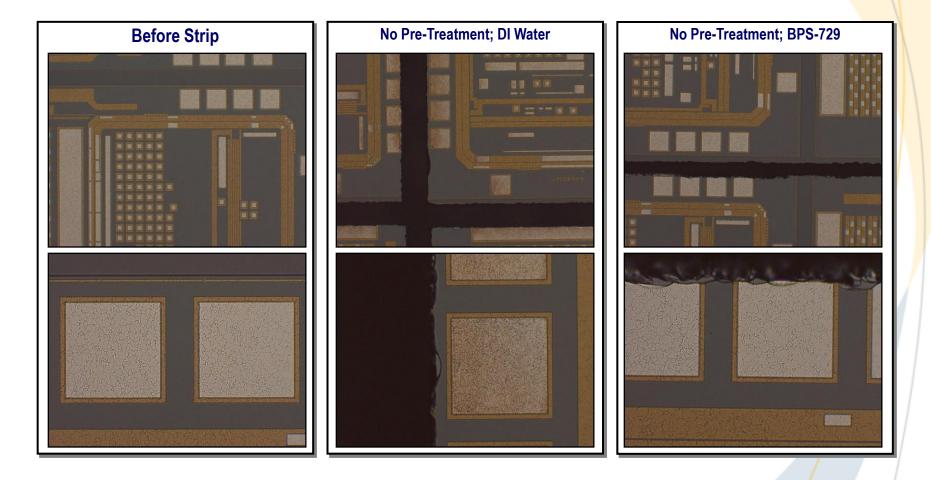
### Influence of F on Al Pads at Saw

### Initial corrosion layer helps protect pads

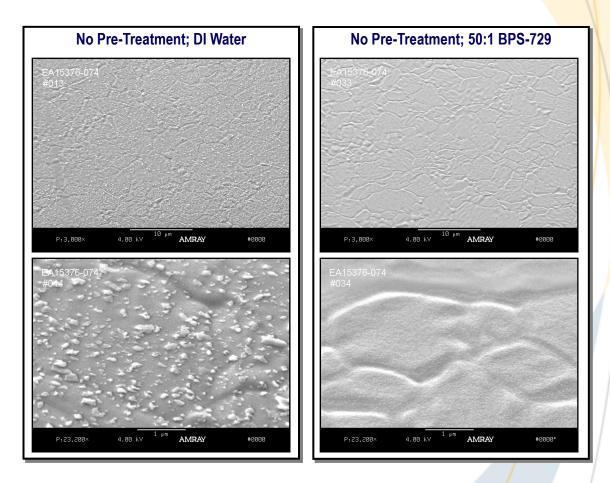
## **AI Tests Results**

Little to no silicon slurry from the saw contaminates or corrodes the bond pads making wire bonding less difficult.

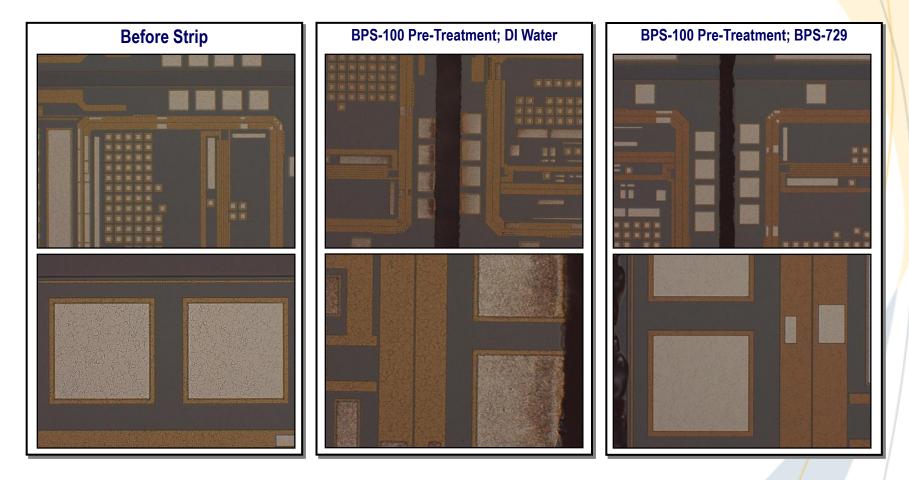
### **AI Tests with Pre -Treatment**

With corrosion layer stripped some protection is needed at saw.

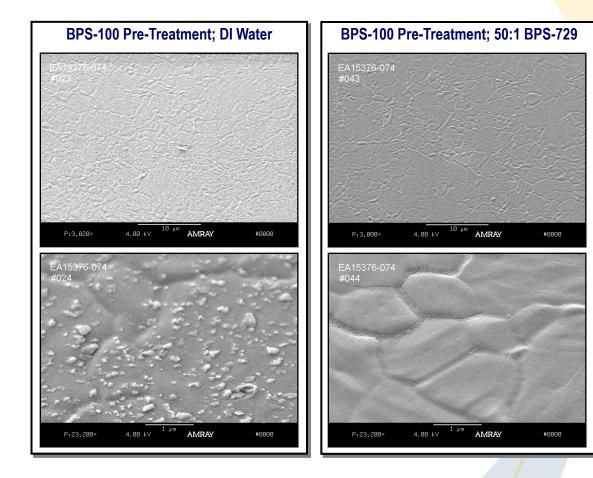
### AI Tests Results W/BPS100 To Saw

Stripping the fluorine corrosion can bring the bond pads back to time zero (after metal dep) conditions.

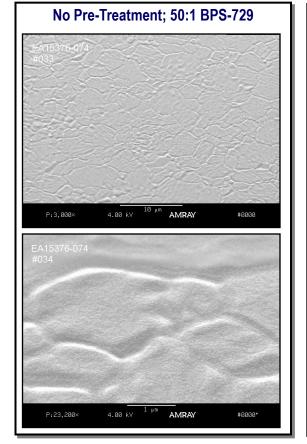
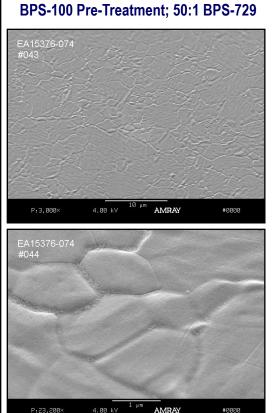
### **Fluorine Removal Comparison**

By providing an additive to saw bond pads can be improved. But most important is the conditions of the pad by removing the initial corrosion layers. Even after saw the grain boundaries are very visible; testament to the conditions of the pads.

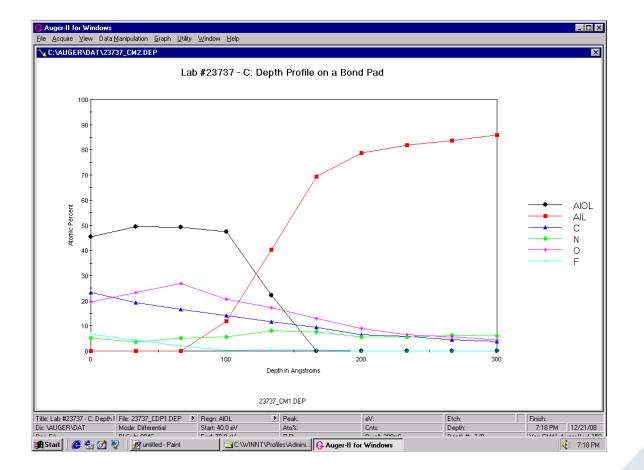
## First Run After Two Weeks.

Fluorine was only 15A deep into the sample, initially. Aluminum detected at 60A.
