Failure Analysis of Eutectic and Pb-Free Solder Alloys after High Stress Exposure

Christian Navarro and Harvey Abramowitz
Purdue University Calumet
Hammond, IN

Dennis Fritz
SAIC, Inc
Merrillville, IN

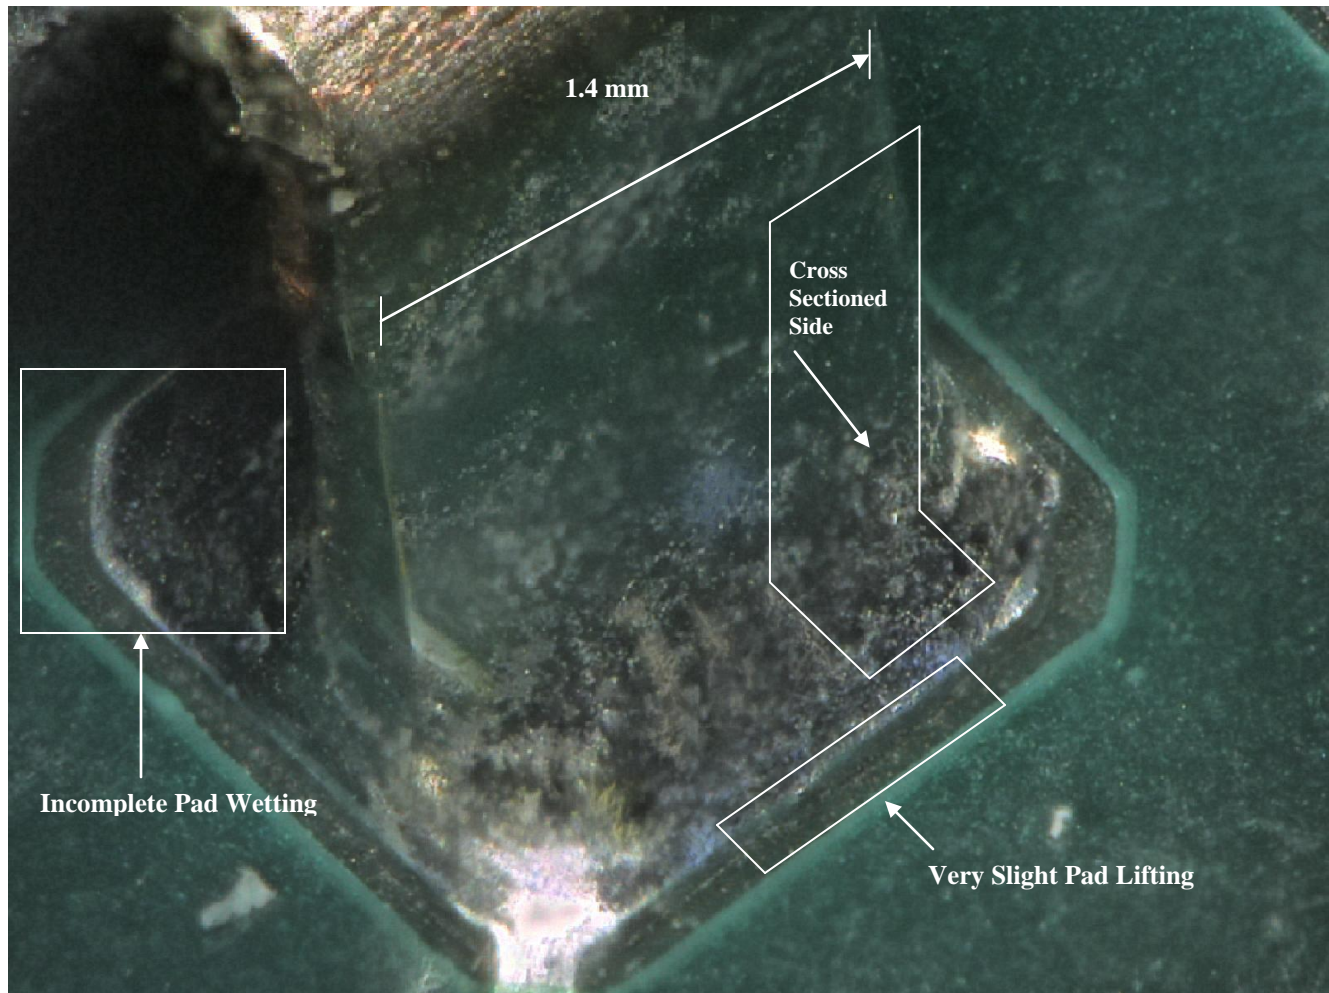
Figure 19 – PWB 50 - U59, Pin 3 (Au/Pd/Ni Finish)

From the digital microscope pictures, it was determined that pin 3 (Figure 19) showed evidence of small cracks developing as well as incomplete pad wetting and lifting. Pin 18 (Figure 20) showed some evidence of cracking in the surface of the solder and some evidence of incomplete pad wetting. The pins, which are parallel to each other, have different appearances.

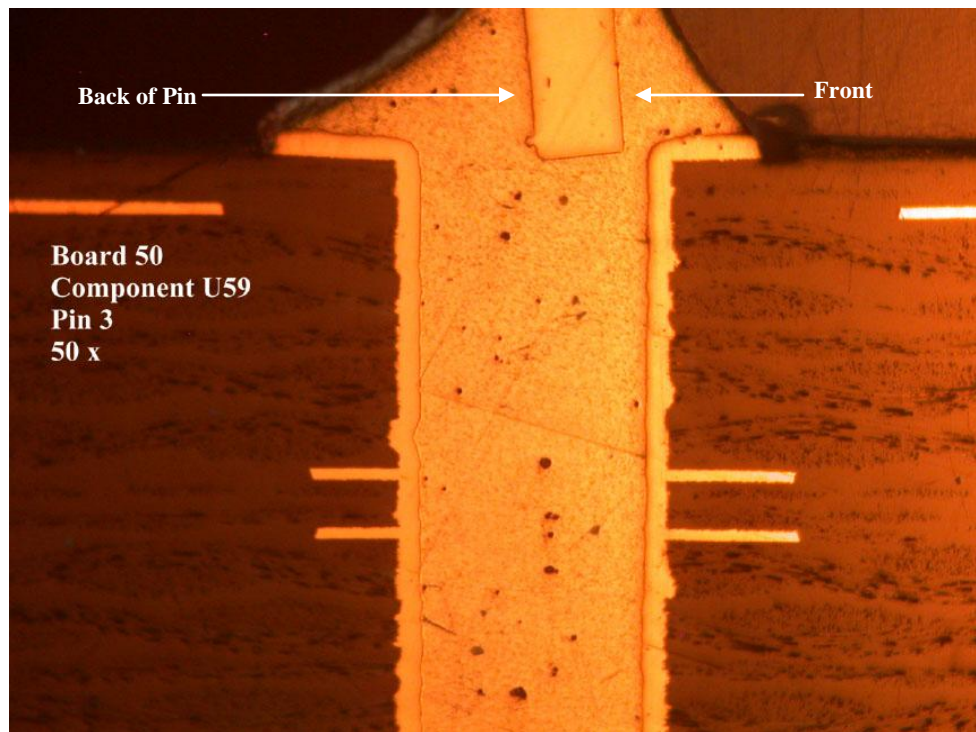
**Figure 21– PWB 50 - U59, Pin 3 Cross-Section**

The cross-section pictures (Figures 21 and 22) for the pins from component U59 showed no evidence of cracks or pad lifting in the solder joint. Pin 3 was cross sectioned and analyzed from the right side while pin 18 was cross sectioned and analyzed from the left side. This cross-section was used as the baseline for comparison with component U63. The pictures showed that pin 3 was ground too deep, which caused the pin to appear as if it did not go through the board hole. From the pictures, it appears that both pins would still be capable of functioning.

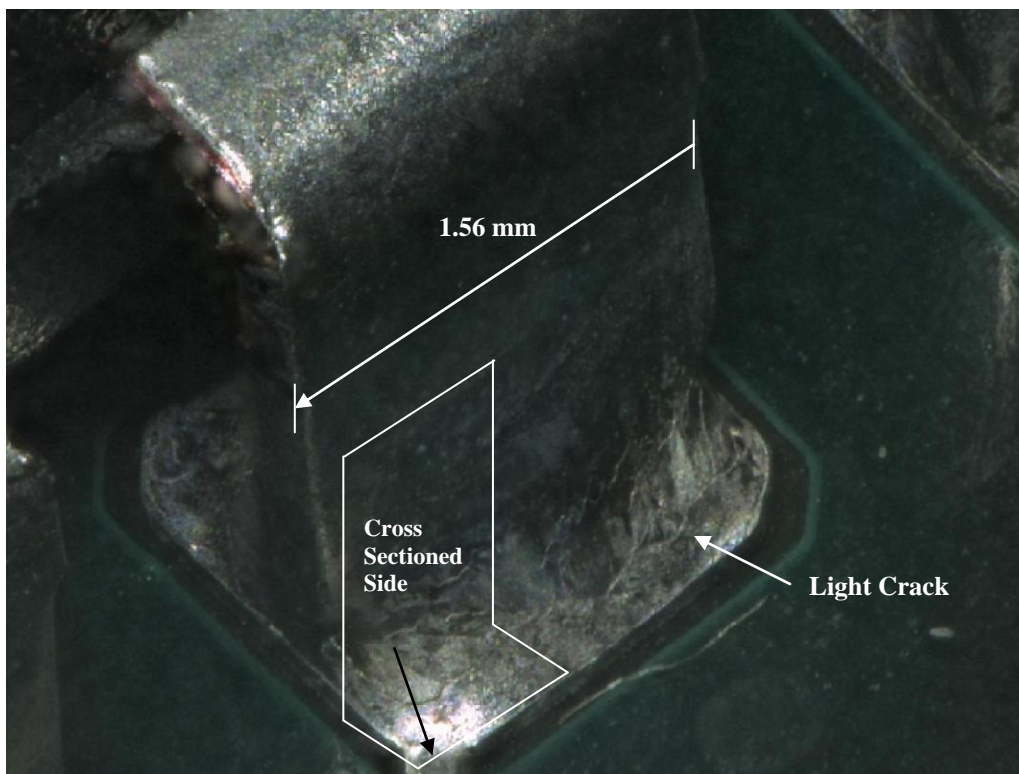
Figure 23 – PWB 50 - U63, Pin 3 (Sn Finish)

From Figures 23 and 25, it was determined there was some visual evidence of surface cracks in pins 3 and 18. There was also visual evidence of some pad lifting on the outer edge of pin 18. The pictures of pins 10 and 11, Figures 27 and 29, show visual evidence of cracks that may have gone deep into the solder joint. Figure 27 shows a small crater forming in one of the lower corners of its pad, while Figure 29 shows an upside down T-formation in the same location on its pad.

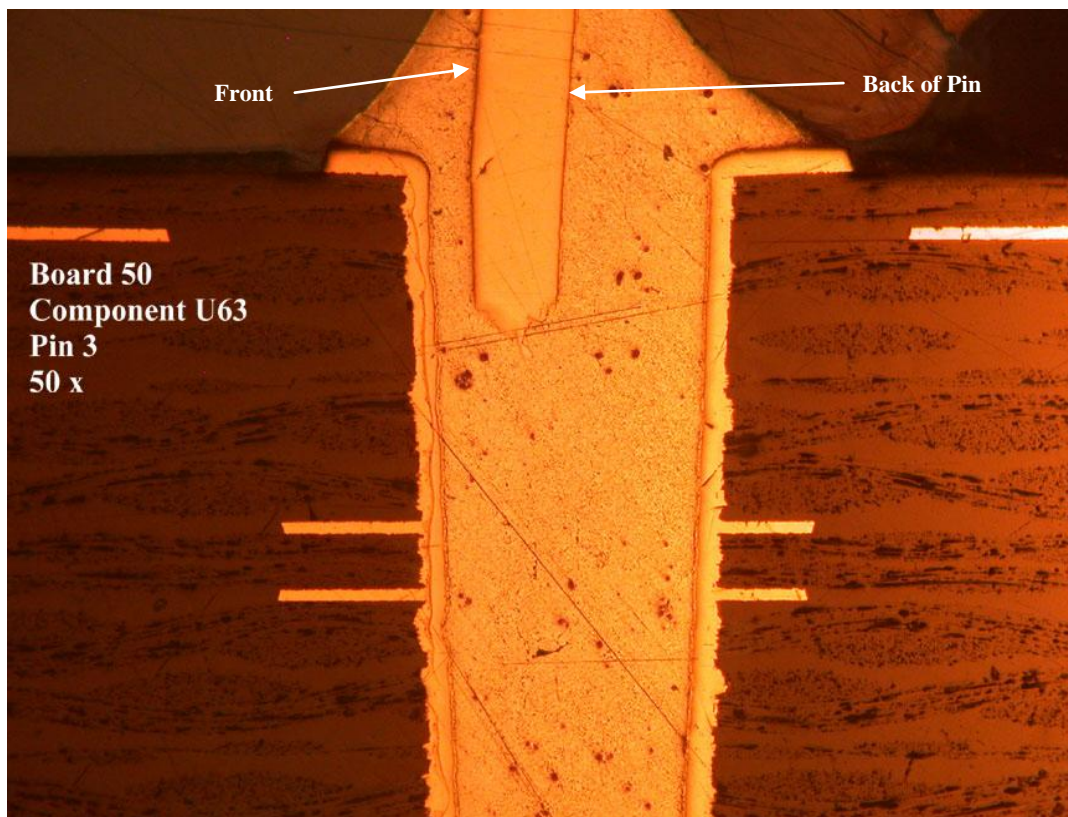
Figure 24 – PWB 50 - U63, Pin 3 Cross-Section

Pins 3 and 10 (Figures 24 and 28) were cross-sectioned and analyzed from the left side of the solder joint while pins 18 and 11 (Figures 26 and 30) were cross-sectioned from the right side. The pictures for pins 3 and 18 showed no evidence of cracking in the solder. Figures 27 and 29 show the pictures of pins 10 and 11 that were taken with the digital microscope before they were cross-sectioned while Figures 28 and 30 show pins 10 and 11 after they were cross-sectioned, ground, and polished. Pins 10 and 11 clearly show through cracks which are located above the barrel. The picture for pin 11 revealed that the sample was ground too deep, with part of the sample being completely removed. The cross-section pictures revealed only component U63 on PWB 50 had cracks through the solder joints and pins. As a result, the component would fail if it were in use. In general, visual evidence of other anomalies such as pad and fillet lifting, cracking in the knees, and awkward solder formation was noticeable in the pictures of the cross-sections.

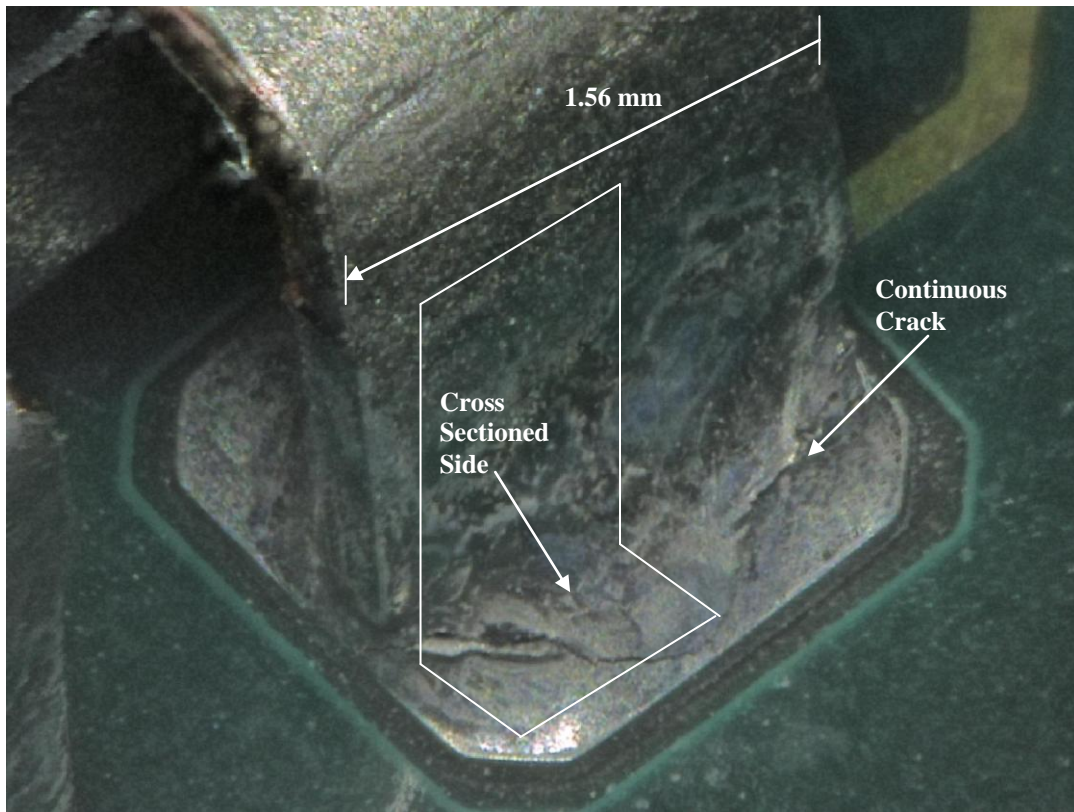
Figure 27 – PWB 50 - U63, Pin 10 (Sn Finish)

The resistance measurements taken from adjacent pins on U63 gave readings between 0.3 – 0.4 Ω (Table 2). Pins 3 and 18 on U63 had resistance measurements similar to those taken from the same pins on U59. As a result, it was determined that pins 3 and 18 would be cross sectioned on U63 to see if there were any similarities with these pins on component U59. The other pins that were cross-sectioned on U63 were 10 and 11. These pins were cross sectioned due to a number of high readings, in addition to the visual evidence of deep cracking. The resistance between pins 9 and 10 and pins 11 and 12 were off scale on the ohm meter used (> 1 M Ω) which indicated breaks in continuity inside the component (see Figure 3). Since the readings were normal between pins 8 and 9 and pins 12 and 13, which were externally connected, pins 10 and 11 were suspected of failure. Even externally connected, the resistance between pins 10 and 11 was 94 Ω , indicating a problem with a trace or the joints/pins themselves.

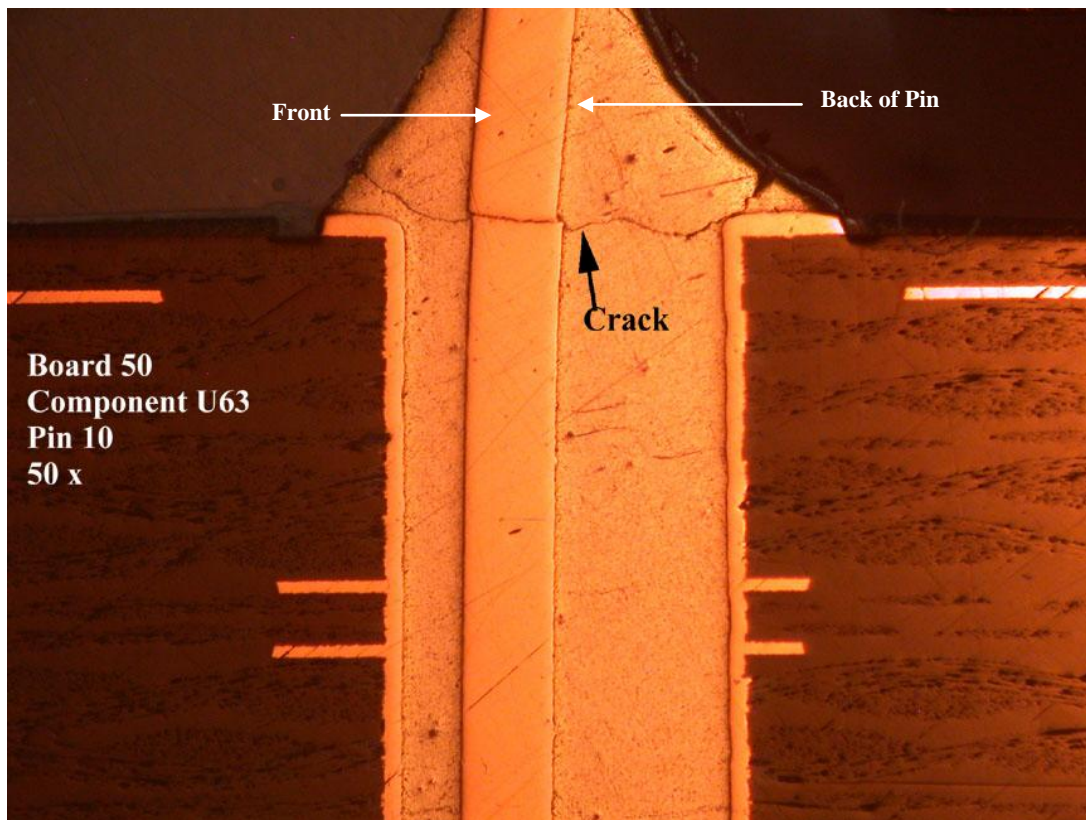
Figure 28 – PWB 50 - U63, Pin 10 Cross Section

The indications that a component could have failed were indicated from the surface cracking, along with the resistance measurements. Cross-sections were still necessary to verify through or no through cracking and damage. For U63, severe surface cracking did indeed indicate through cracks, as verified by cross-sections.

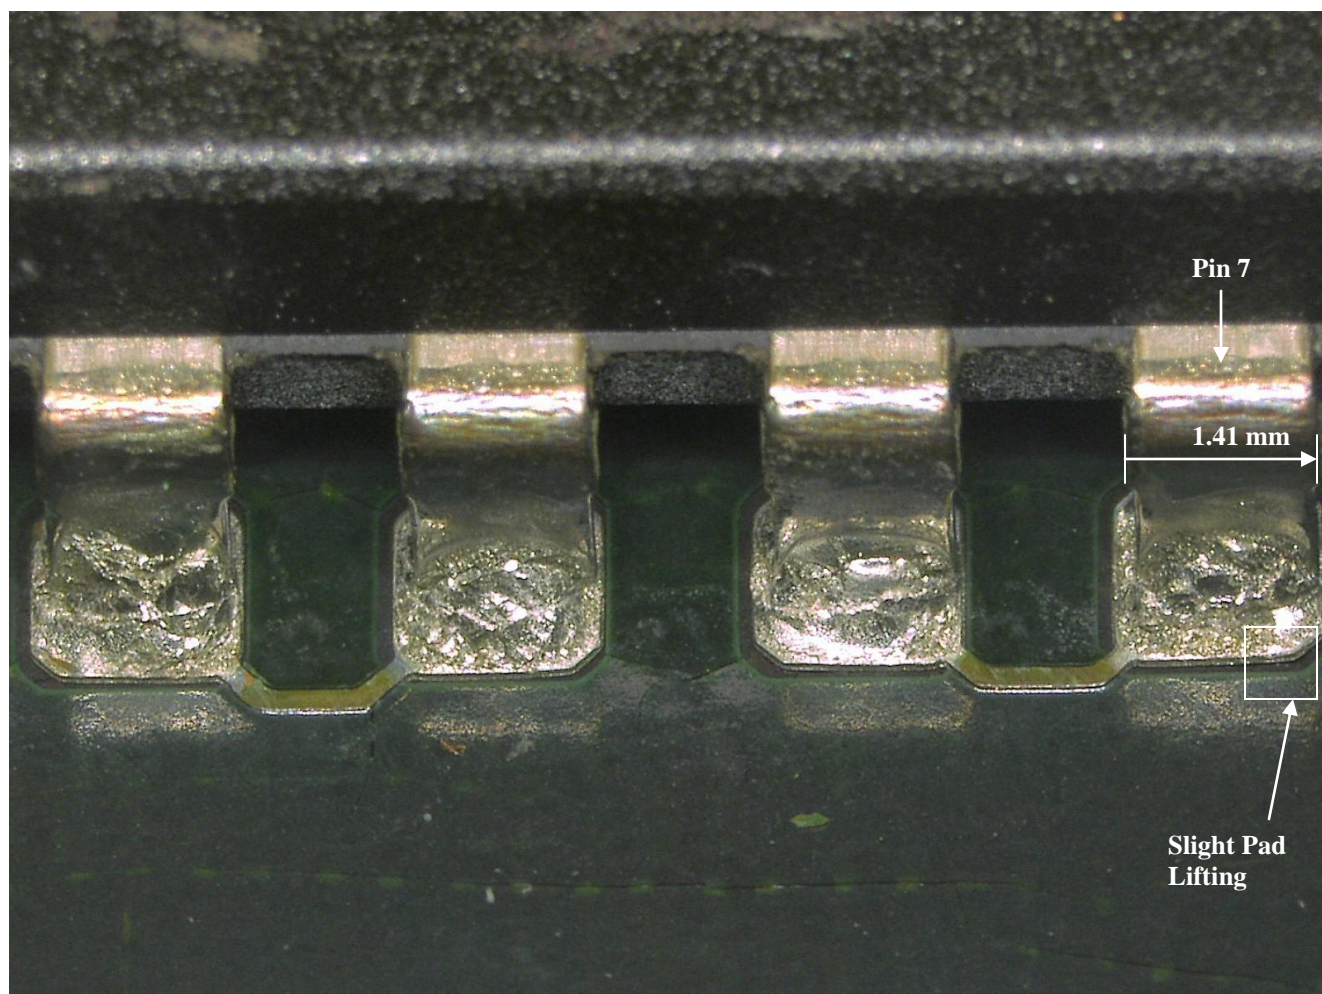
Figure 31 – PWB 191 - U59, Pins 4 - 7

All the pins were checked visually with the digital microscope. This inspection revealed a need to further examine pins 7 and 14. There was very little evidence of cracking in the solder on pin 7, but some indication of pad lifting, solder deformation and possible incomplete pad wetting (Figure 31). Small cracks and craters formed in the solder on pin 14, with some incomplete pad wetting on the edges of the lower corners of the solder joint.

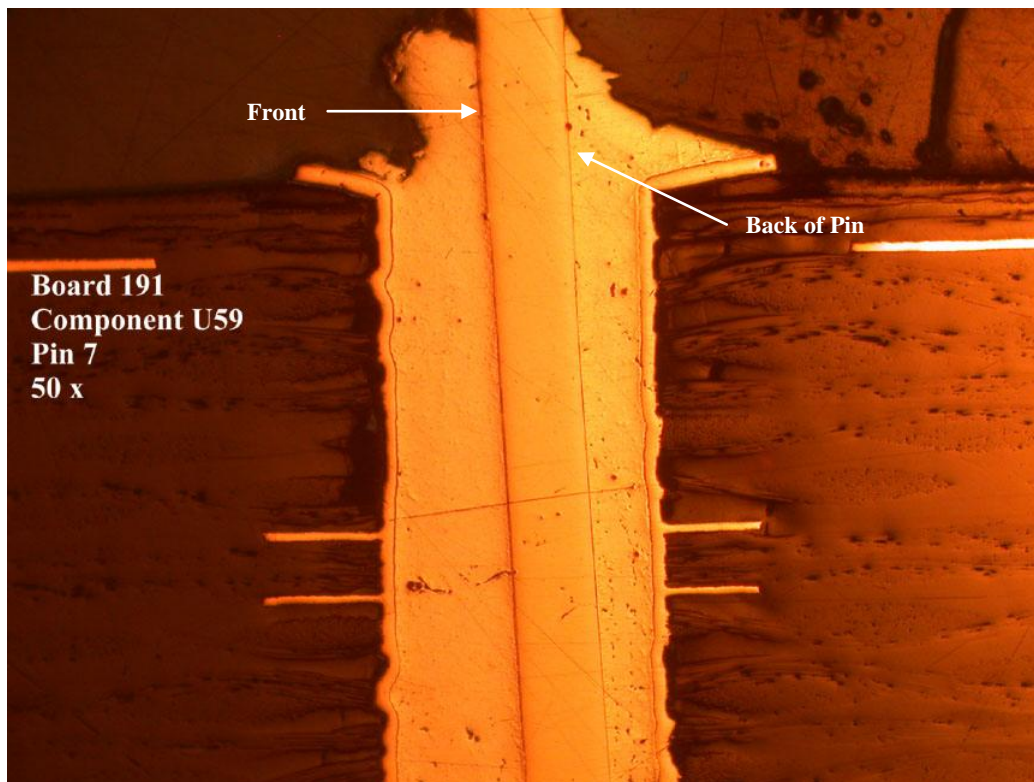
**Figure 33 – PWB 191 - U59, Pin 7 Cross-Section**

The 3D digital microscope images (Figures 31 and 32) showed evidence of small cracks and pad lifting that could have been capable of causing serious damage to the component. Pin 7 was cross-sectioned and analyzed from the left side of the solder joint while pin 14 was cross-sectioned and analyzed from the right side. The cross-section for pin 7 (Figure 33) showed visual evidence of severe pad lifting and incomplete pad wetting, but the cracks didn't appear to have caused much damage in the solder joint. For pin 14, the cross-section (Figure 34) revealed that the pin was ground too deep and there was no evidence of cracking in the solder. The cross-sections for both pins revealed some cracking in the knees, lifting in the pad, and barrel distortion.

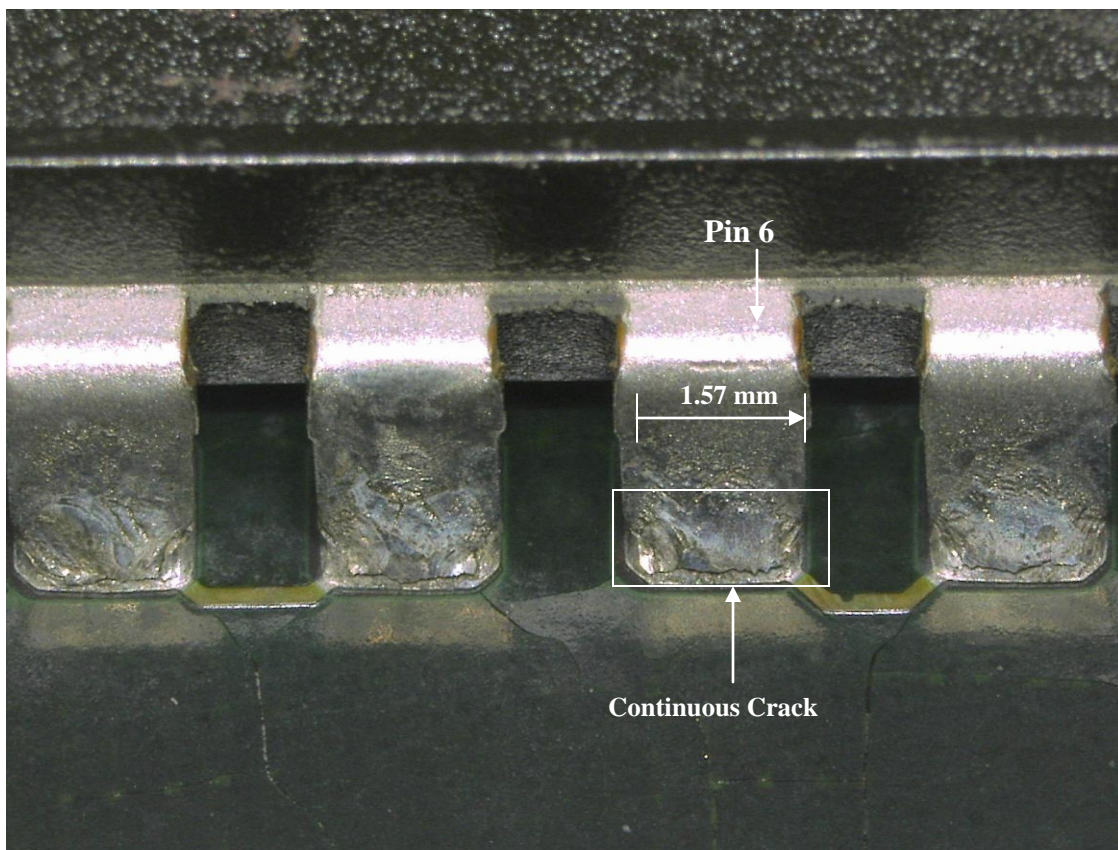
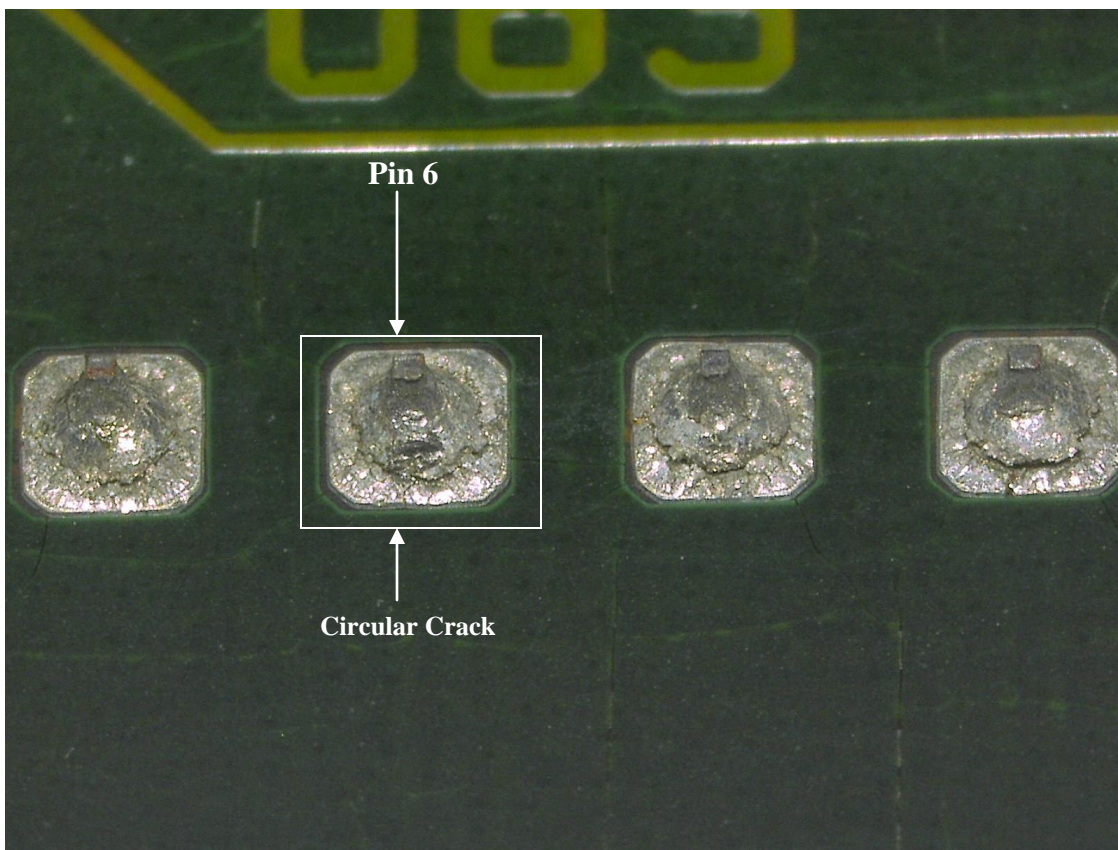
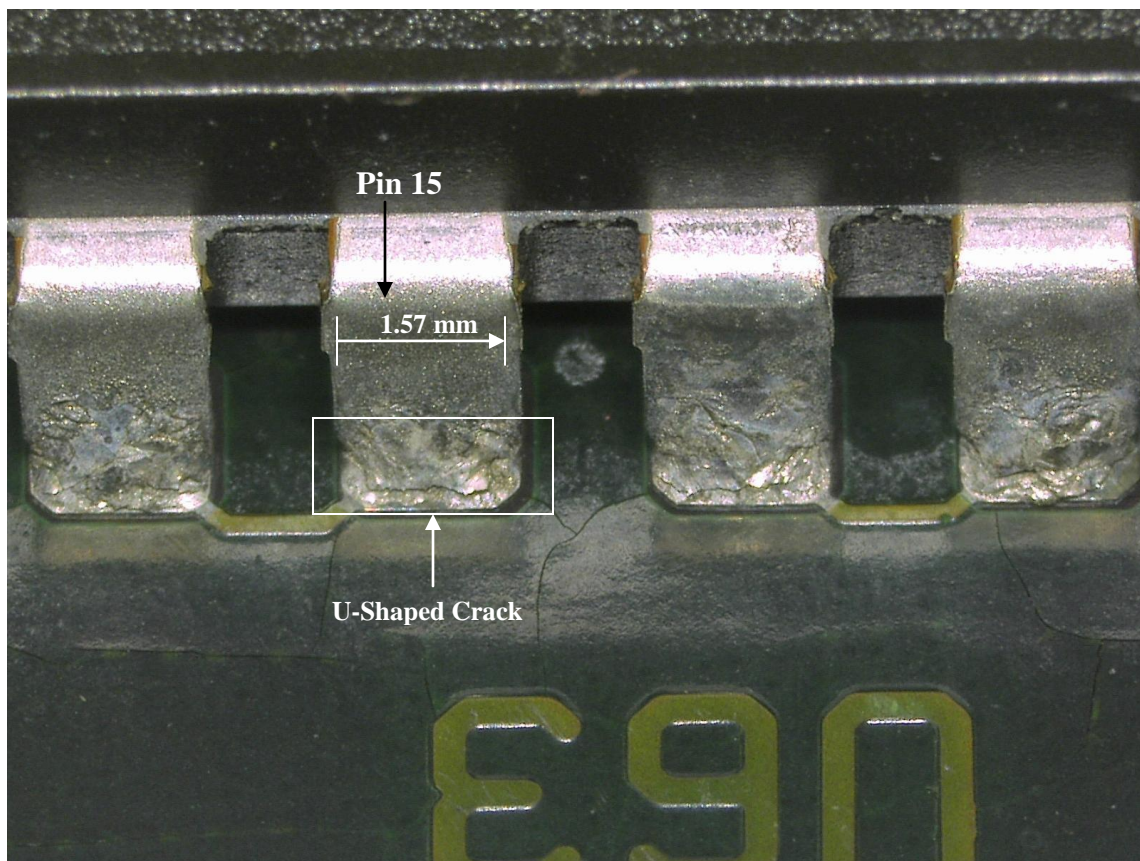
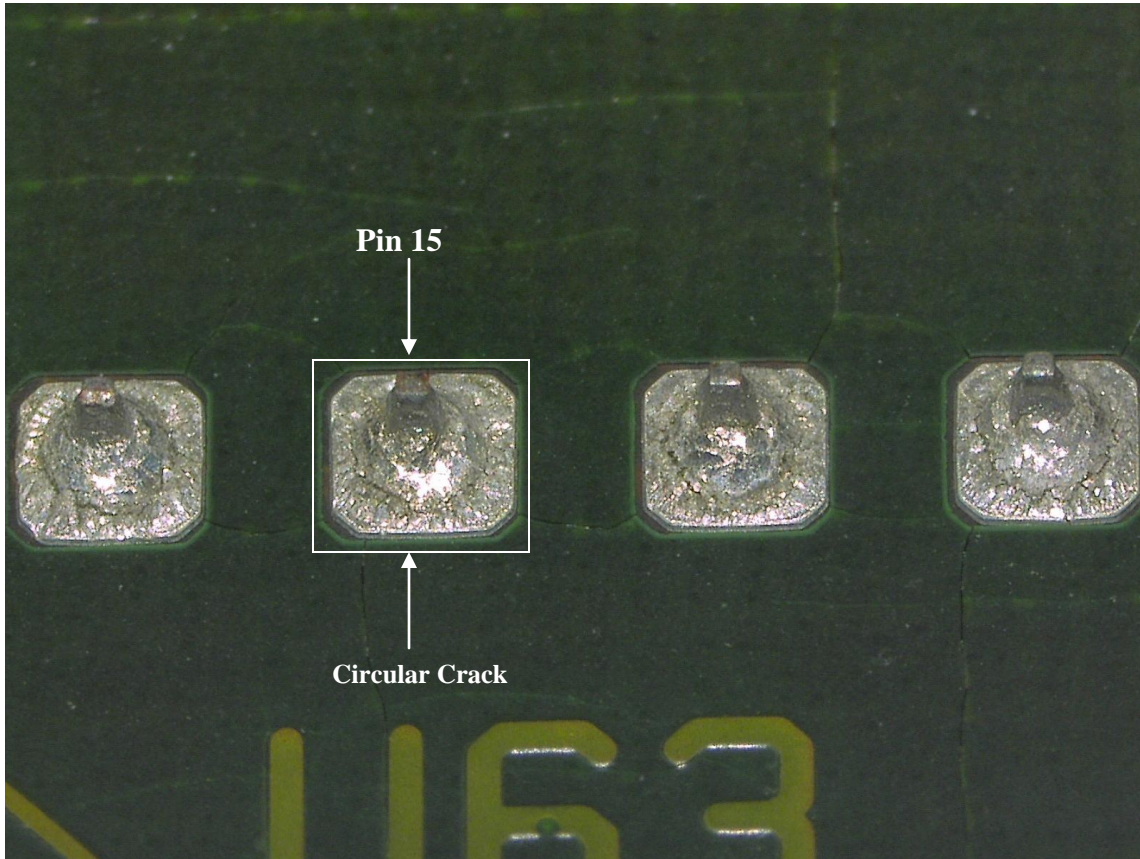
From the digital microscope pictures (Figures 35 - 38) pins 6 and 15 showed visual evidence of surface cracking and some pad lifting. The pins next to 6 and 15 on both the wave solder and the component side of the board showed similarities in crack patterns.

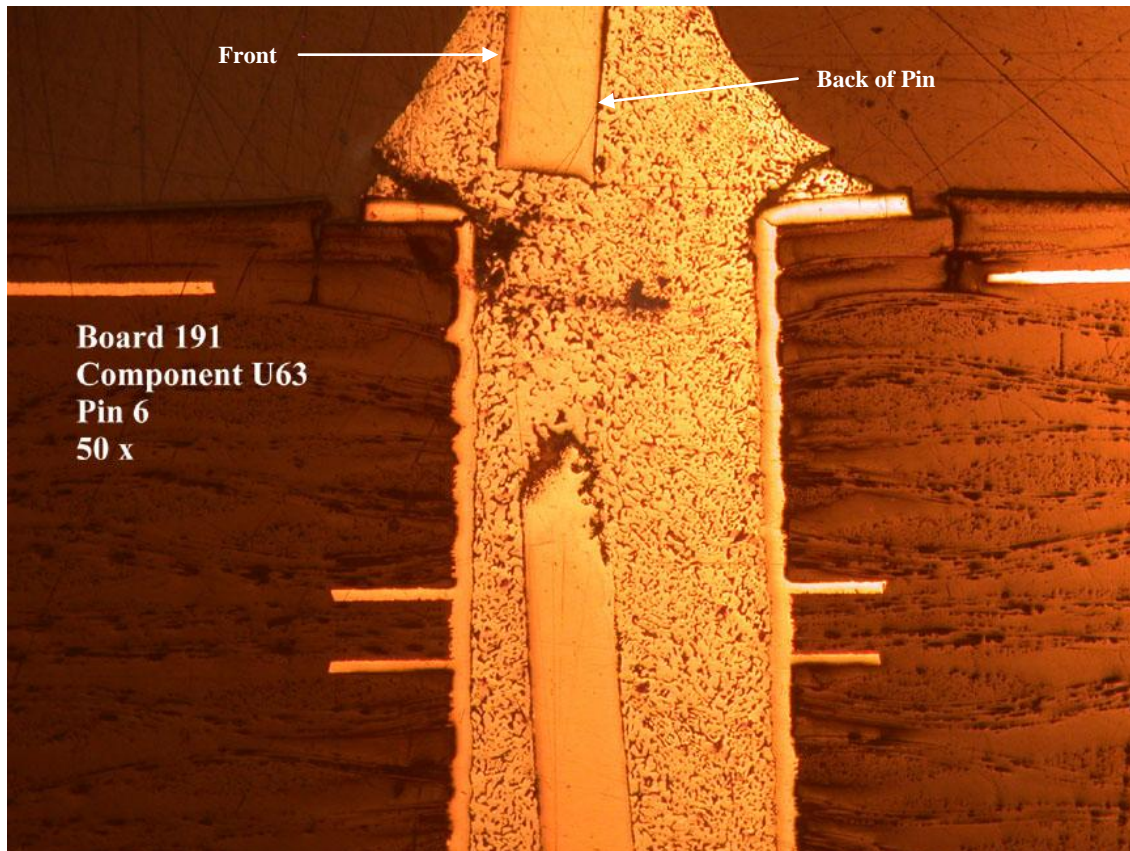
Figure 39 – PWB 191 - U63, Pin 6 Cross-Section

Pin 6 (Figure 39) was cross-sectioned and analyzed from the left side of the solder joint while pin 15 (Figure 40) was cross-sectioned and analyzed from the right side. It is apparent that some cracking did occur in these solder joints. However, these pins would still be capable of functioning since the cracks did not penetrate the entire solder joint or the component's pins. Both pictures also showed visual evidence of cracking in the knees and pad lifting. For the cross-sections from this board, there was some cracking and pad lifting apparent, but components U63 and U59, were both declared electrically sound.

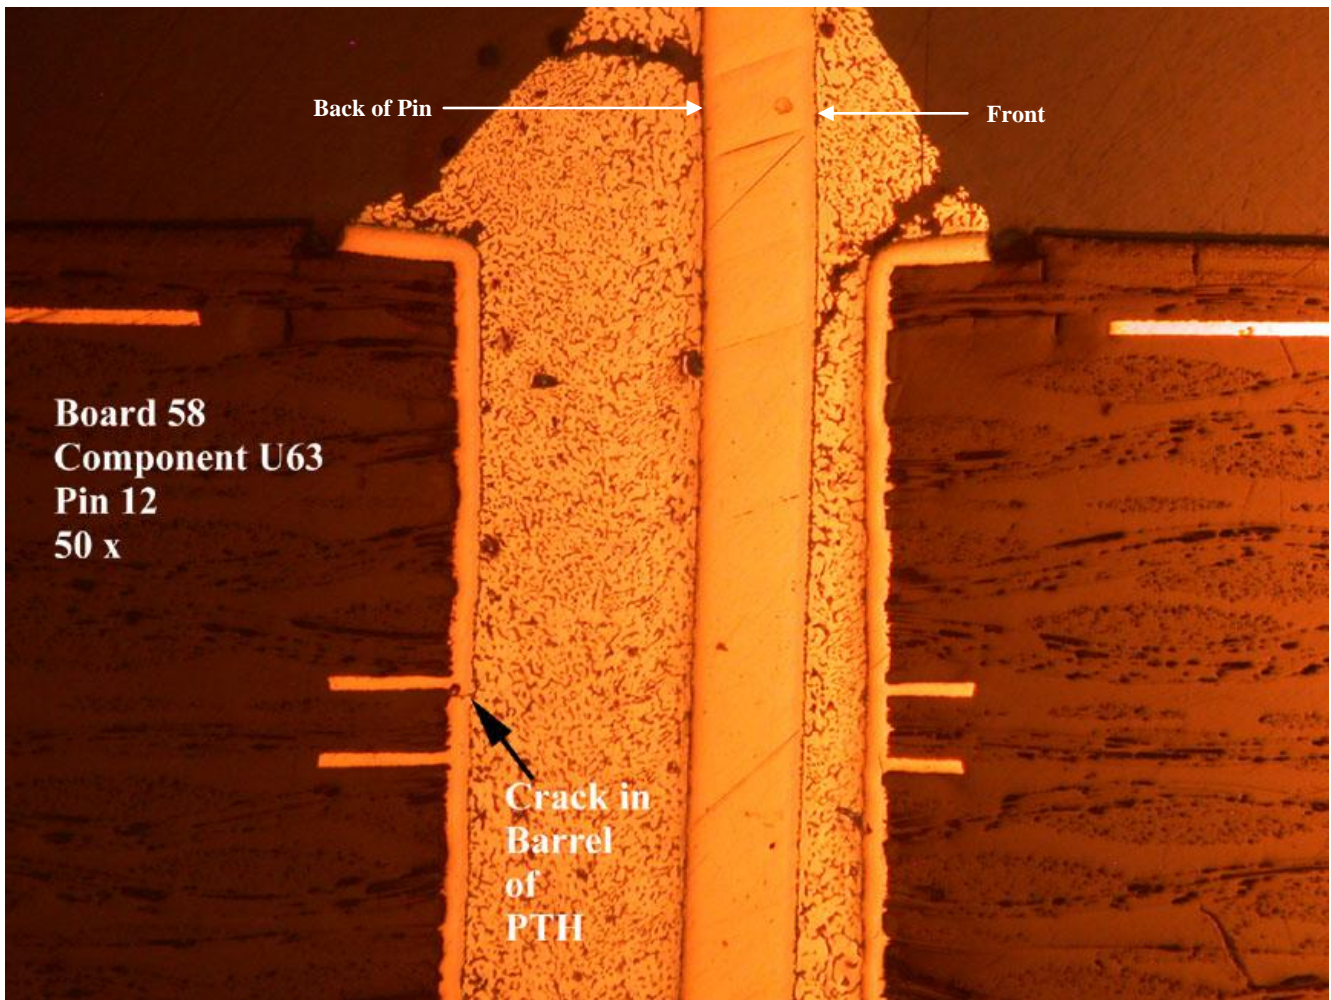
Figure 41 – PWB 58 - U63, Pin 12 Cross-Section

Cross-sections of non-critical components revealed a few areas where the components that did not fail had cracks in their solder joints. Some pictures revealed a coarse solder structure or the development of damage such as cracking in the barrel (Figure 41), or bad fillet lift (Figure 42). Even though the components began to crack during testing and started to develop other forms of damage in their solder joints, they were still capable of functioning. To gain a better understanding of what happened in the solder, the cross-sectioned samples will need to be further examined on the wave solder side. This will help to make a better comparison with the digital microscope images regarding how cracks, lifting, and other anomalies occurred during testing. It will also provide information on the depth of cracks, lifting, and other damage in the solder joints or their pads.
