# Contamination of Hydrocarbon Ceramic Dielectric

Michael Vernoy, Patrick Case, Mahendra Gandhi, Eric Hong  
Northrop Grumman  
Redondo Beach, CA

## Abstract

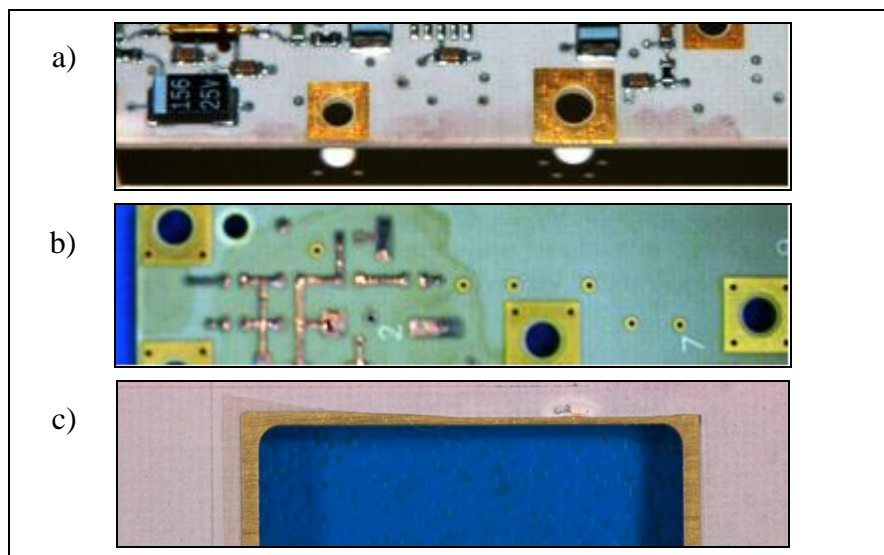
In the course of PWB population, several assembled PWBs were discovered that showed the presence of unknown contaminants and stains on their dielectric surfaces. Such stains violate the acceptability criteria contained within IPC-6012<sup>2</sup>. Stains typical of those observed are shown in Figure 1. Through subsequent analysis, the contaminants and discolorations were found to be the result of a number of causes. In one case, it is believed that purple stains were the result of gold plating rework. In another, brown stains resulted from prolonged exposure to RMA flux. In a third example, staining resulted from the processing involved in construction of the multilayer PWB. All PWBs were fabricated from IPC-4103/10<sup>6</sup> hydrocarbon-ceramic dielectric. As this dielectric is white in color, the discolorations were highly visible and resulted in holds being placed on the assemblies following visual inspection. This paper will discuss three types of contamination discovered; the analyses performed to identify the contaminants, and will discuss any reliability impact due to their presence.

**Figure 1 – (a) Purple staining on an assembled printed wiring board's edge. (b) Brown staining on an unassembled PWB. (c) Staining around periphery of cutout in PWB.**

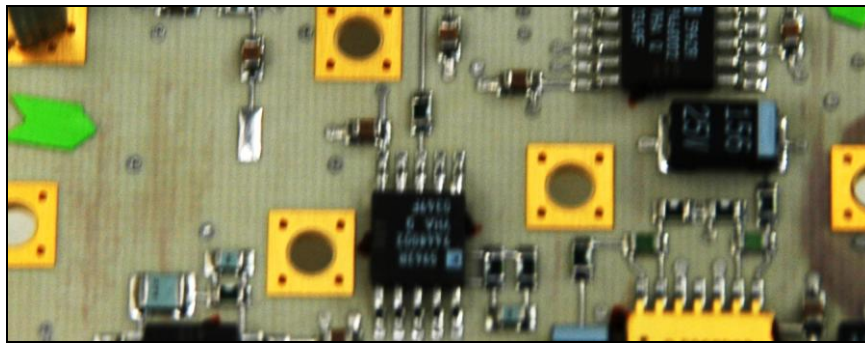
One aspect of the purple stained PWBs was that they consistently appeared on boards near gold plated mounting bosses. Due to the proximity of the stains to the gold surfaces, the stains were conjectured to be the result of plating solution residue from the touch-up of gold surfaces.

**Figure 2 – Purple staining on a populated PWB. The staining is most prominent around the gold plated surfaces.**

To verify that the source of the stains was plating solution, several unstained coupons from affected and unaffected PWB lots were exposed to gold plating solution. After prolonged exposure, the coupons did not immediately exhibit the purple stains that affected populated assemblies did. However, after the coupons underwent a soldering simulation in a convection reflow oven, all appeared stained purple. It is believed that the purple color is brought out when stained boards are exposed to heat such as during convection reflow.

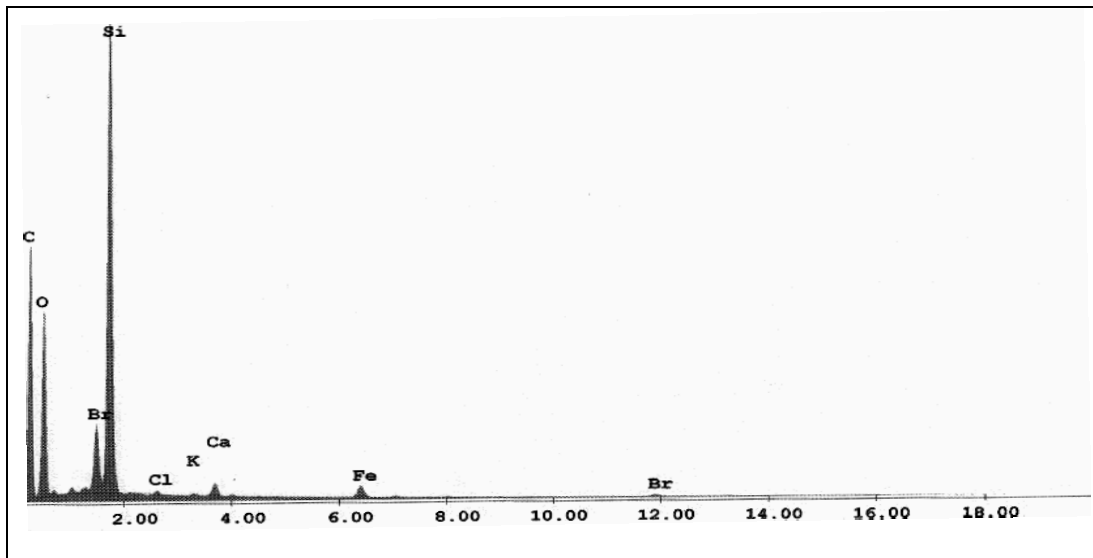
**Figure 3 – EDX spectrum of purple stained dielectric.**

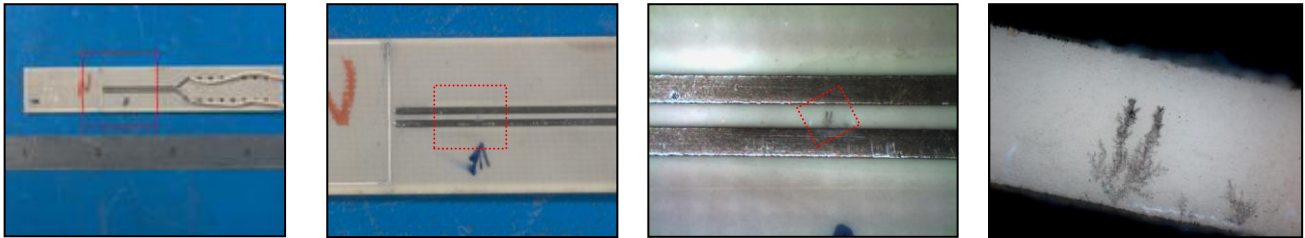
Although often subjective, stained coupons seemed to grow more dendrites, a longer distance, in a shorter period of time than the unstained control group. However, no differences between the two groups were significant. A typical dendrite formation is shown in Figure 5. Results are plotted in Figures 6 through 8.

**Figure 5 – Photos from a stained E coupon following 30 seconds under a 20V bias. Magnification of photos increases as you move to the right.**

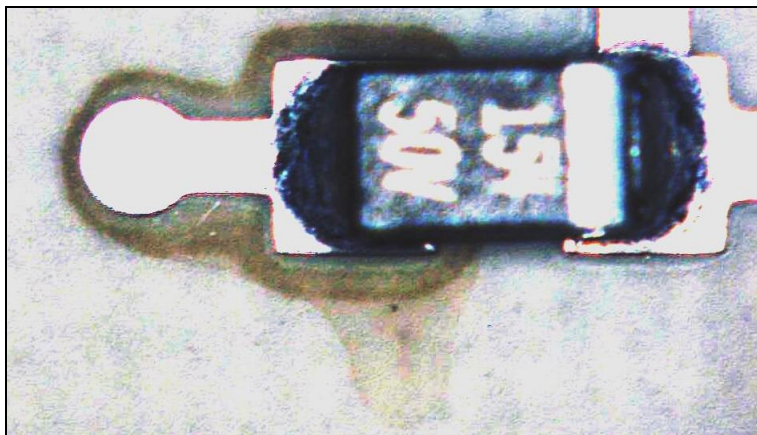
The second type of stains discovered was also found on boards following component population and mass-reflow processes. Visual inspection revealed brown-colored staining on the white dielectric surface of RF PWBs, see Figure 9. As this condition had occurred multiple times, efforts were taken to both characterize the brown-colored residue and develop a procedure with which to remove the contamination. Once again, the discoloration was of concern due to the possibility of ionic contamination leading to electromigration that could cause the bridging of component pads and ultimately short electrical connections.

Figure 9 – Close-up photo of brown stain on assembled board.

Due to the color of the stains and their proximity to solder pads, rosin mildly active (RMA) solder flux was suspected. In an attempt at reproducing the brown-colored stain, flux was applied to a solder sample board, sent through a convection reflow oven two times, and then cleaned with IPA, see Figure 10. The brown-residue that remained after cleaning was then analyzed by Fourier Transform Infrared (FTIR) Spectroscopy.

The 75% Methylene chloride/25% Methanol solution and acetone were both effective in removing the brown discoloration. Since acetone is a milder solvent, its use is recommended over the methylene chloride/methanol solution when cleaning populated boards.

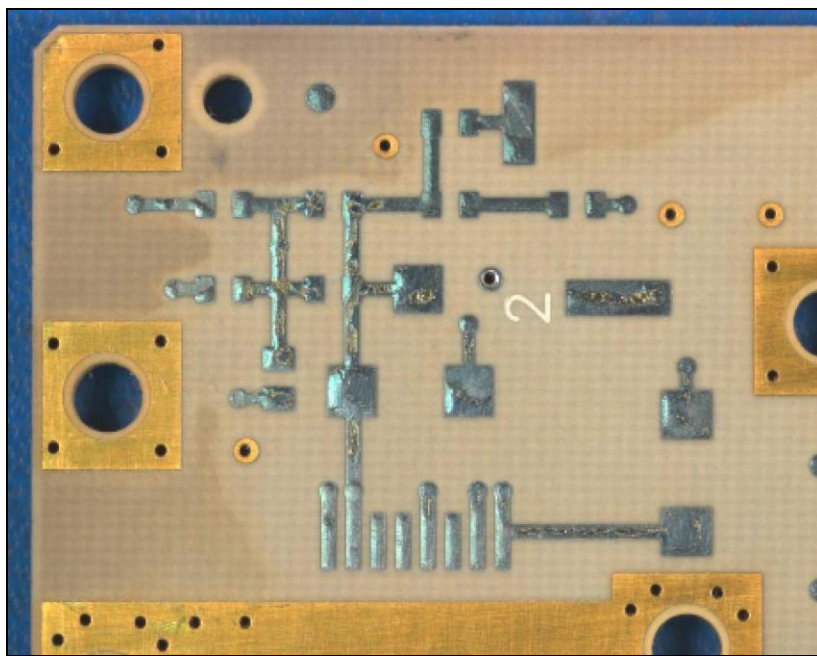
**Figure 10: PWB following application of RMA solder flux and exposure to soldering heat.**

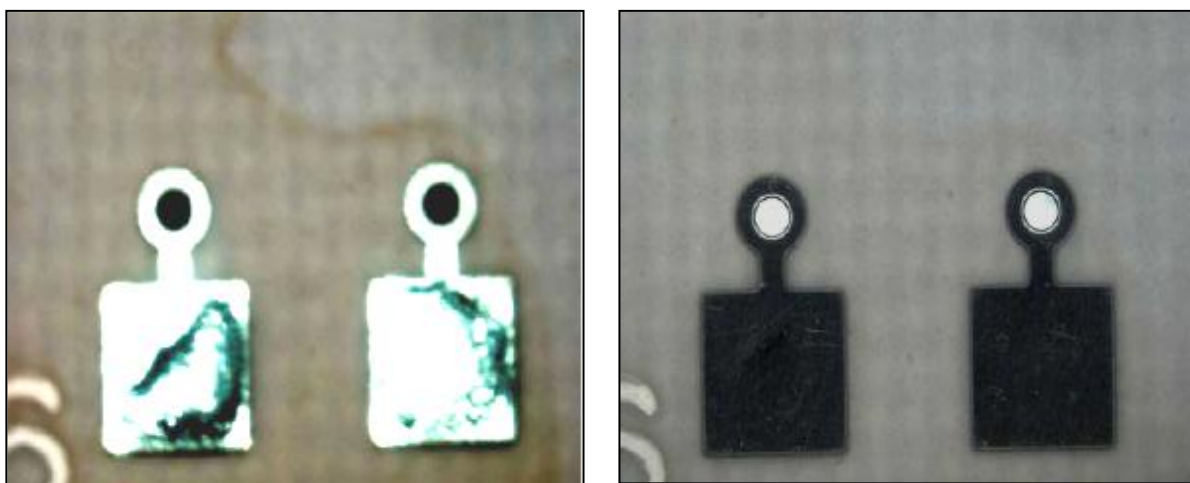
To obtain the FTIR spectrum, the stained board was placed in a clean glass tray and submersed in a solution of 75% methylene chloride and 25% methanol until the PWB was completely covered. Then, the tray was placed into an ultrasonic bath for 20 minutes. The solvent was removed and the procedure was repeated until most of the stain was removed. A non-volatile residue (NVR) analysis was preformed on the combined extracts and found that 16 $\mu\text{g}/\text{cm}^2$  of residue was removed. A beaker blank was carried through all analyses as a control. Following NVR determination, the residue was characterized by FTIR by resuspending the residue in isopropyl alcohol and transferring the result to an aluminum-coated glass slide for analysis. The sample's spectrum was collected using 128 scans of the slide in reflectance mode using a clean portion of the slide as a background. Through FTIR characterization, the residue was determined to be consistent with rosin oil, see Figures 12 and 13.

**Figure 11 – Same brown stained area before (left) and after (right) methylene chloride/methanol solvent extraction.**

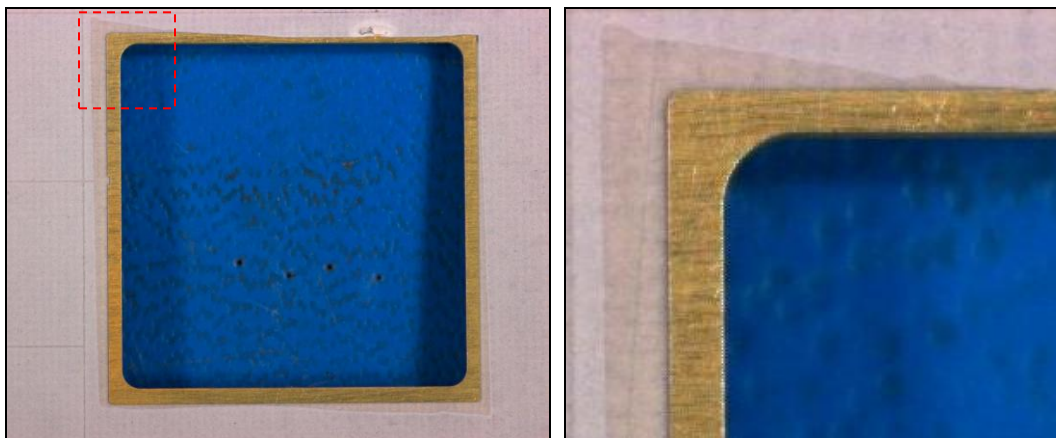
The final anomaly discovered involved what appeared to be dielectric with an underlying shadow. Figure 14 shows a portion of a PWB with a gold plated cutout. Surrounding the cutout area is what appears to be a shadow. It is believed that the majority of the laminate was bleached from bus bar etching. The product required the image/bus bars to be plated and etched prior to the nickel-gold plating process. The bars were placed in the location where the apparent shadow exists. After etching, the bare laminate was exposed to additional chemical processing. This processing included resist striping for etch protection, tin-lead stripping, and pumice scrubbing for the selective Ni/Au image. After the Ni/Au processing, the panels were again resist stripped and roughened by hand pumice scrubbing for the bus bar etch process. The PWB was then resist laminated to expose only the bus bars that needed to be removed. After etching the bus bars, you can see the color difference in the laminate where the copper protected the laminate from additional chemical processing and baking cycles. This appearance is related to the additional chemical processing that bleaches out the material. Although no reliability risk is associated with this condition, it often leads to questions when PWBs are initially inspected. Concerns regarding the possibility of contamination or the homogeneity of the material often must be addressed.

**Figure 14 – Photo showing shadowing surrounding the gold plated cutout (detail is shown in the image at right). The white area in the upper right of the photo on the left is a laminate defect.**

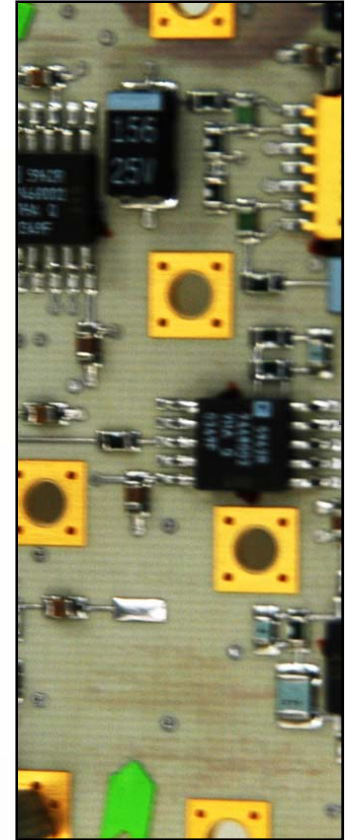
- Stains were discovered on populated multilayer PWBs with Sn-Pb surface finishes and Au mounting locations.
- All PWBs were inspected prior to assembly.
- Conjectured to be Au plating solution residue from touchup.

Gold plating touchup was suspected in purple staining of PWBs.

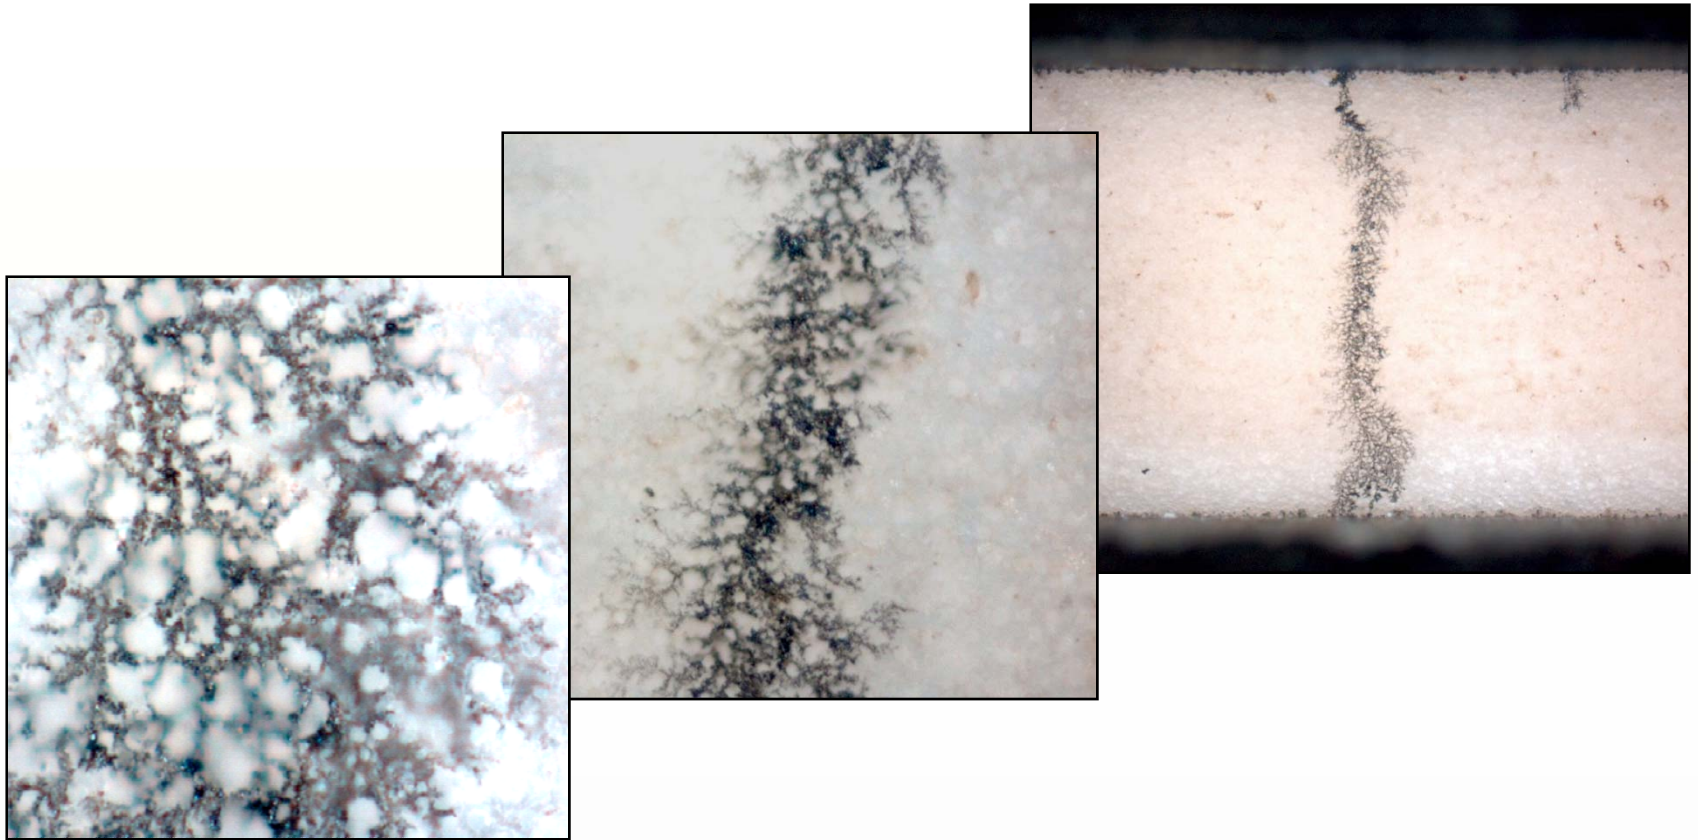
Dendrites easily bridged the electrodes.

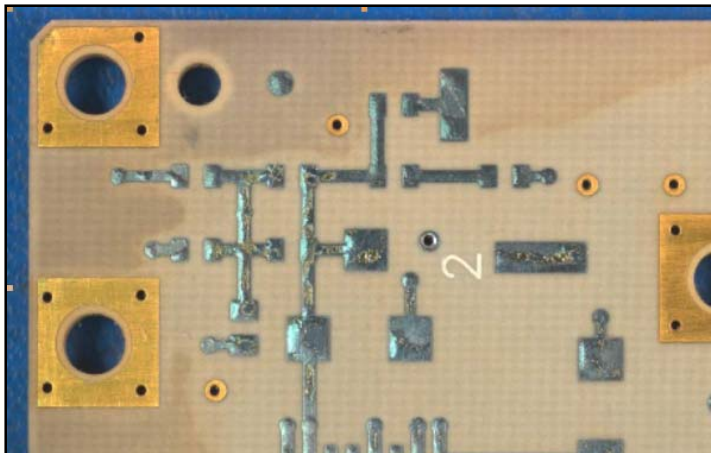
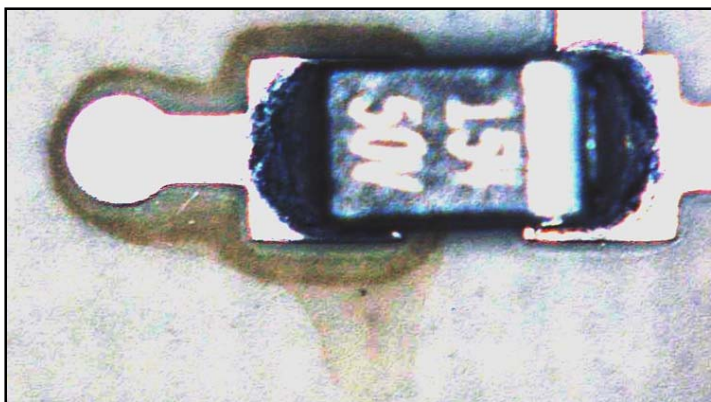
- Visual inspection revealed brown-colored staining on the white dielectric surface of RF PWBs.
- Again, the discoloration was of concern due to the possibility of ionic contamination.
- Due to the color of the stains and their proximity to solder pads, rosin mildly active (RMA) solder flux was suspected.

Solder flux residue was suspected to cause brown stains.

Acetone is recommended when cleaning populated boards.

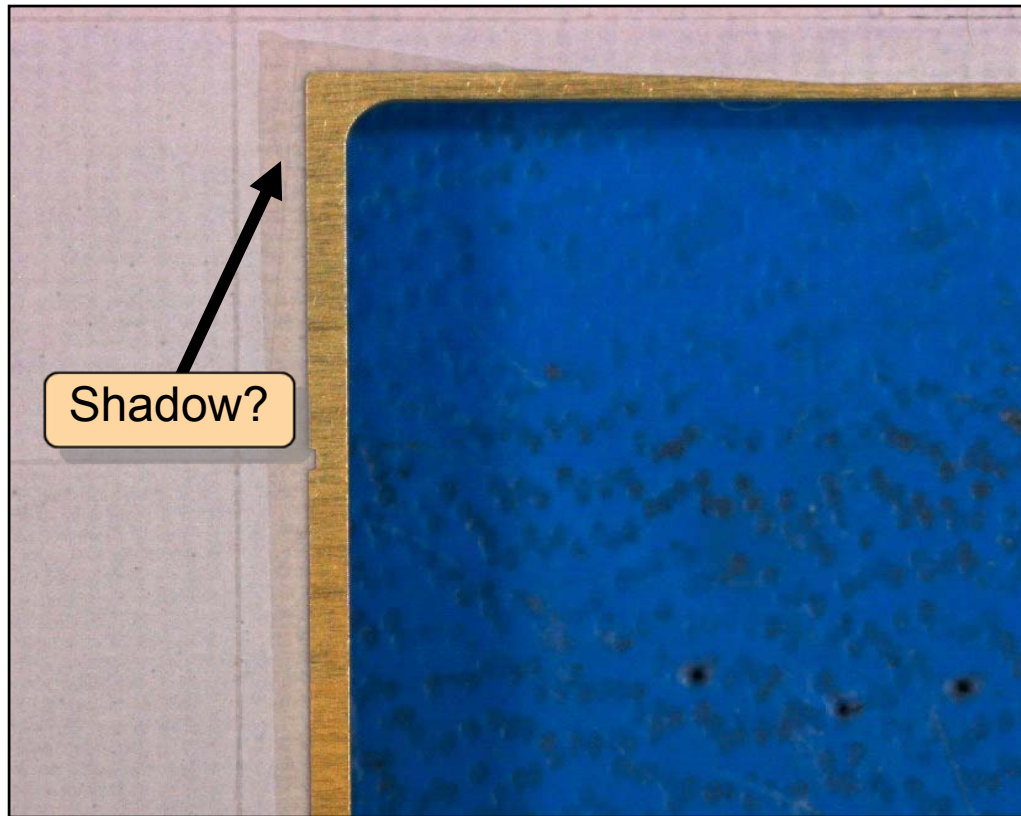
- An anomaly was discovered that appeared to be dielectric with an underlying shadow.
- It is believed that the majority of the laminate was bleached from bus bar etching.

“Shadowing” has been observed near gold plated areas.
