# A Reliability Comparison of Different Lead-Free Alloys and Surface Finishes in SMT Assembly

## Jignesh Rathod and Daryl Santos, Ph.D. Binghamton University Binghamton, NY

Prashant Chouta, Joe Belmonte and Alan Rae, Ph.D. Cookson Electronics Foxborough, MA

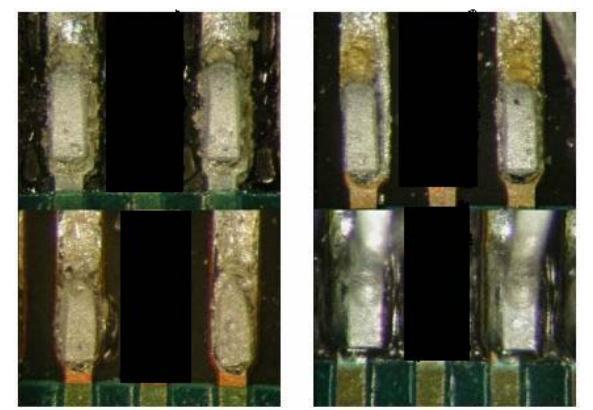
The following images in Figure 13 show the solder joint sites that were pull-tested. The top two images show pulled QFP208 joints that were thermally stressed up to 1008 cycles. All the failures for the thermally stressed components have occurred at the lead-solder interface, whereas baseline SZB conditions showed failures near both the solder-pad and the lead-solder interfaces.

The SZB/FST condition showed enormous voiding in the pulled joints. This voiding can be seen in the bottom two images of Figure 13. The top-left image belongs to the SAC305/OSP condition and the top-right image belongs to the Sn-Pb/OSP condition. Both of these images show voiding. SAC305/OSP showed less tensile strength than Sn-Pb/OSP, which could be because of voiding present in the solder joints of SAC305/OSP conditioned boards, whereas tensile strength remained unaffected for Sn-Pb/OSP.

Figure 13 - Condition of Solder Joints at the Sites of the Pulled Leads

Some conditions demonstrated pad lifting during the lead-pull testing. Some of the prevalent conditions to show this phenomenon are SAC305/I-Ag, SAC305/FST, Sn-Pb/OSP, Sn-Pb/I-Ag and Sn-Pb/FST. Whether the pad-lifting phenomenon suggests better solder-joints is yet to be determined.

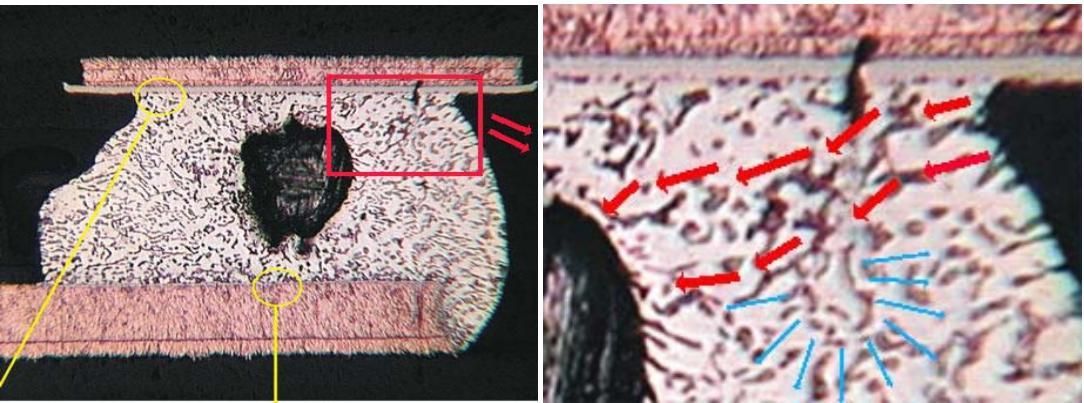
Figure 15 is a cross-sectional view of a SZB alloy with OSP board surface finish BGA36 solder joint that has seen 300 thermal cycles in the LLTS chamber. The image on the right hand side is that of a magnified right corner of the same joint shown inside the red rectangle. With an increase in the number of thermal cycles, grains start to grow in all directions. As the growth occurs throughout the solder-mass, neighboring grain boundaries merge into each other and become longer. If the same joint would have been exposed to more cycles (say, an additional 300 cycles), it could have failed with a probable partial crack running parallel to the red arrows. We rarely see a crack propagating through the bulk of a spherical solder joint, the reason being that a crack initiates in the maximum stressed portion of a joint. The bulk of a solder has uniformly distributed stress, however, increased regional stresses are seen near sharp edges, corners or different-material interfaces. In addition to these inherent properties of a joint, a solder joint is already under stress right after it is reflowed due to mismatch in thermal coefficient, which is exacerbated by the thermal shock treatment near the solder-component interface.

Figure 15 - Result of Increasing Grain Boundaries

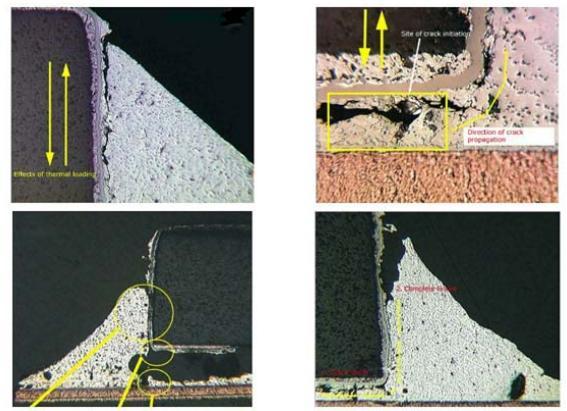
Cracks and failed solder joints were prominent in the "open" failures cases of chip resistors and the PBGA225s. Whereas PLCC28 and QFP208, that were classified either as "open" or transient failures, hardly showed any presence of cracks. The following images of chip resistors and BGAs with cracked solder joints reveal areas that are prone to cracking.

In Figure 16, the first two images are that of the same component. The arrows show the direction of loading during thermal exposure. The top-right image shows a box where a crack initiates due to combined effects of thermal loading, thermal coefficient mismatch and highly stressed material transition area.

Figure 16 - Cracks found in R1206 Chips

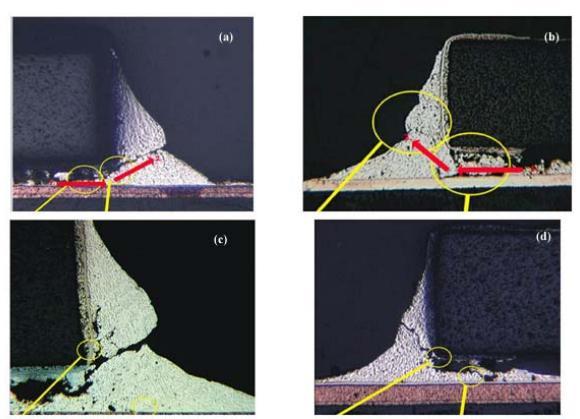
The chemistry of the solder alloy used seems to have a peculiar effect on the failure mode. The images in Figure 17 are those of failed chip resistors soldered with the Sn-Ag alloy. All of these solder joints have been exposed for 1008 cycles. Only solder joints of Sn-Ag and SZB alloys have showed the above type of failure mode in which the crack propagated through the solder bulk. This could be due to two possible reasons.

Figure 17 - Failures in Sn-Ag R1206 Solder Joints

Such failure, in one scenario, could be due to weakening of joints as a result of Sn-migration in the solder joints at the higher temperatures during the thermal exposures. In the other scenario, the location of the Pb-rich phase would guide the crack through the solder bulk. It is more likely for the low melting point Pb-rich phase to solidify near the bottom corner of the chip or in a layer by the vertical chip termination face. This needs to be verified with the help of a Scanning Electron Microscope (SEM) having Energy Dispersive X-ray Spectroscopy (EDX) feature.

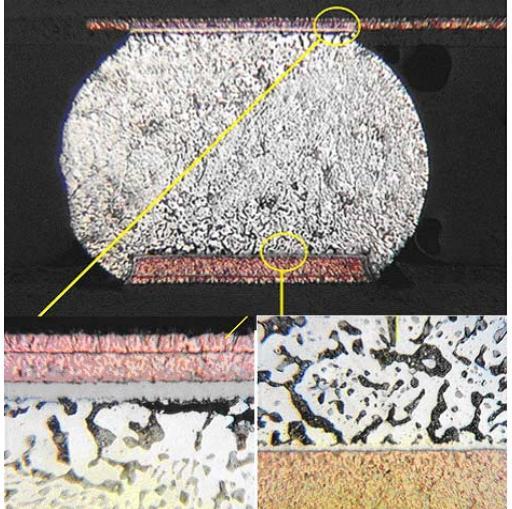
PBGA225s and BGA256s are the other types of components that have revealed cracked joints upon the thermal shock treatment. The guiding factors of the failure mechanism for BGAs are the same as those for the discrete components. Almost all the failures that we have noticed in this study showed crack initiation from the solder/component interface. This is likely due to the interface having minimum cross-sectional area (parallel to the plane of the substrate) and thus offering the least resistance to the induced thermal stress. This is one of the main reasons as to why it does not fail at the solder/substrate interface. Also, another probable reason could be that the package thickness is less than the board thickness and warps more at higher temperature, which induces greater stresses at the solder/component interface.

The coarsened grains can be easily seen in the magnified images of Figure 18. The figure validates the difference in crosssectional area at the solder/component and solder/substrate interfaces. Even though solder bumps on the components before reflow are spherical, they get modified into the shape seen here under the package's own weight when solder is in the liquidous state at the time of the reflow process.

Figure 18 - Failed PBGA225 with SAC-Bi/OSP Solder Alloy Exposed to 1008 Cycles

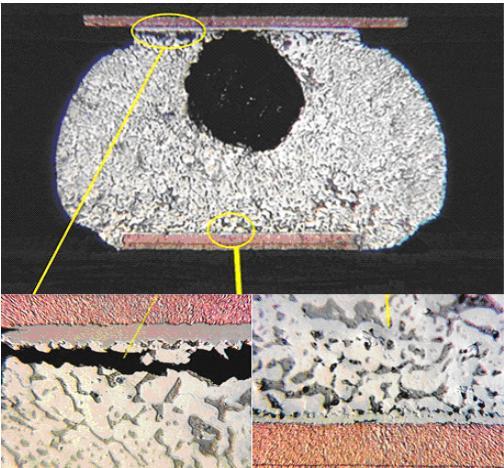
Figure 19 reveals a huge void present in the center of the solder joint. However, it did not seem to affect the performance of the joint during an earlier part of the shock treatment as it failed only during the last interval of the exposure.

Figure 19 - Failed PBGA225 with SAC-Bi/FST Solder Alloy Exposed to 1008 Cycles

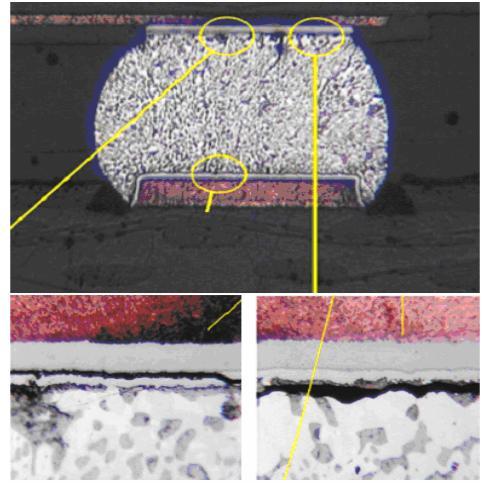
In Figure 20, we see an abnormal type of failure mode in which the failure occurred at both the intermetallic layers.

Figure 20 - Failed PBGA256 with Sn-Pb/OSP Solder Alloy Exposed to 1008 Cycles
