Rework and Reliability of High I/O Column Grid Array Assemblies

Reza Ghaffarian, Ph.D. Jet Propulsion Laboratory, California Institute of Technology Pasadena, CA <u>Reza.Ghaffrian@JPL.NASA.Gov</u> (818) 354-2059

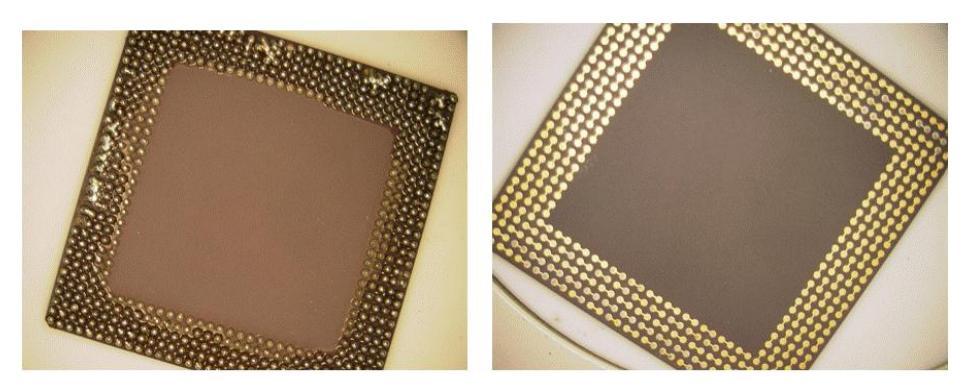
- CGA packages with and without corner staking were successfully removed from assembled TVs. In the first attempt, corner stakes induced minor damage to the board at corners away from the pads since the direction for removal was not clearly given to operator. Damage to board was minimized through providing a more detail procedure for reworking. Figure 2 depicts photomicrographs of packages after removal showing remains of columns on the interposer and daisy chain pattern for the exposed package pads.

Fig. 2. Optical photomicrographs of a removed CGA560 package after rework showing removed/shorted columns (left) and package daisy chain pattern without interposer (right).

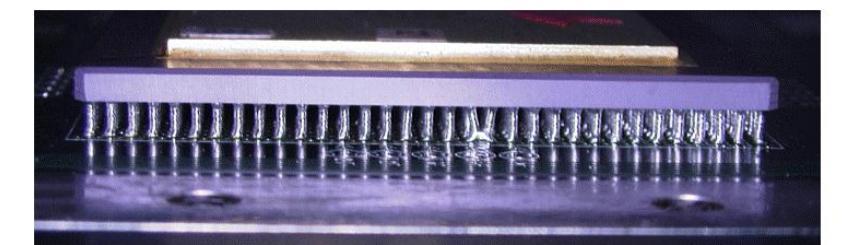
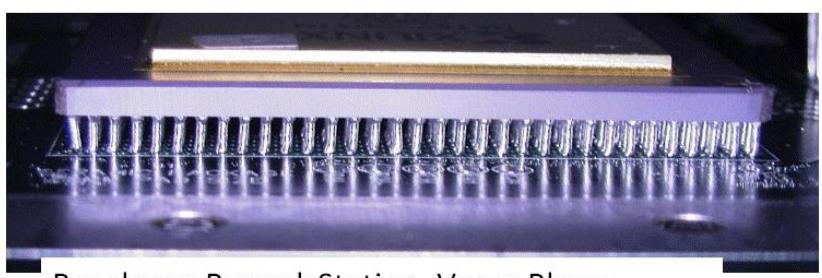
Photomicrographs were taken after all test vehicles were reassembled to document quality of solder joints, including those with various workmanship defects. Figures 5 shows optical photomicrographs for re-columned CGA560 packages assembled under various conditions. Several processing defects are noticeable from these photos, including the following:

- Photomicrographs comparing quality of solder joints reflowed by vapor-phase machine or rework station. In a case where solder paste was not reflowed by rework, station was reflowed using reflow machine.
- Significant column shift when the package is assembled on relatively smaller pads designed for its PBGA package assembly.
- Solder short between the two columns in the middle of package outer row.
- Corner column shift and also the appearance of solder column separation at the package side (not shown at high magnification).
- Solder balls on the package in addition to the board side (photomicrographs not shown here); their source was not identified.

Fig. 5. Representative of optical photomicrographs for re-columned 560 I/O package assemblies.

The soldered column separation from the package side is a significant failure and is unusual. This might be due to the weakness in re-column attachment, which might have been exacerbated by another reflow during re-assembly causing solder separation at the pads. Note; however, that the new columns have much smaller diameter that are placed on relatively larger package pads allowing more movement of columns during reflow. Follow-on test results for strength reduction on re-columned packages with and without additional reflow and subsequent aging at 125°C all indicated lack of significant interfacial degradation. Consequently, the tensile test results reject the possibility of failure due to weakness of solder joints at interfaces. Another possibility is that the smaller re-column size relative to the large package size and weight causes elimination of self-alignment, which is a key advantage of the area array package. Daisy chain connections between the pads at the package side also are not representative of a working part and may contribute to such interfacial failure. Solder on daisy chain traces can possibly further facilitate column shifting to the neighboring pads during solder reflow.

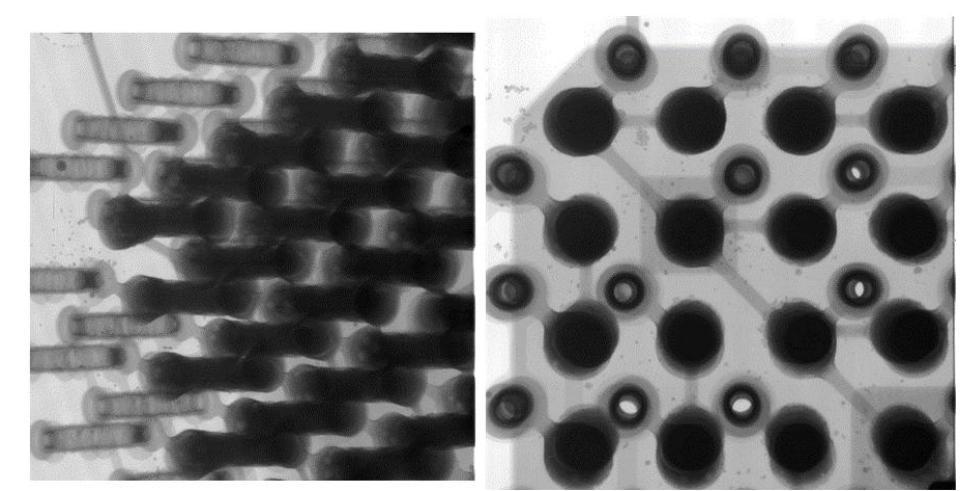
A real time, 2-D X-ray system with a stationary microfocus source intensity and off-axis rotational capability was used to determine the damage states of re-columned CGA560 assemblies. Figure 6 shows an X-ray photomicrograph for an assembled CGA560 after thermal cycle exposure. The X-ray technique clearly detects abundance of solder balls but no indication of other defects; neither solder damage nor solder separation at pads due to thermal cycling.

Fig. 6. X-ray photomicrographs for re-columned and re-assembled CGA560 after thermal cycle exposure showing solder balls, but no separation at package pads detected visually.

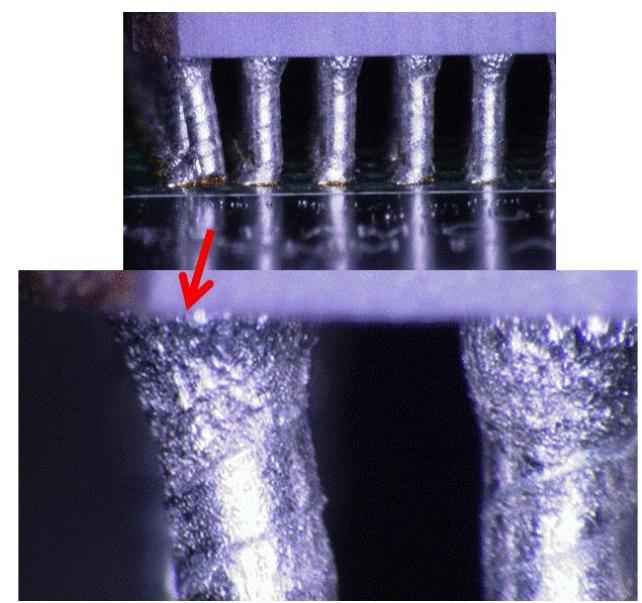
Damage progress with thermal cycling was established using optical microscope. Figure 7 presents a representative photomicrograph showing workmanship defects due to manufacturing as well as damage due to thermal cycling. Based on all inspected solder joints, there were various defects due to re-assembly that are categorized as follows:

- Solder balls at the package and board sides are apparent from low and high magnifications of re-column attachments. Coalescence of a large number of solder balls was observed at the package side at higher magnification. The sources of these solder balls are not clear, but they could be the result of solder splash from paste during solder reflow.
- Several displaced columns showing a larger corner column shift are apparent. Magnified photomicrographs clearly show signs of damage and microcracking due to thermal cycling at the package side.
- Several columns were shifted after thermal cycling. Photomicrographs of these at higher magnification clearly show pad separation from the package. This failure is unusual since microcracking generally occurs in the solder, as shown in the previous figure.

As discussed, soldered column separation from package side is considered an unusual and significant failure. Tensile test results exhibited no such failure mechanisms and no indication of interfacial weakness. Possible reasons for such a failure mechanism may be an unusual package size/weight and use of a smaller-column diameter.

Fig. 7. Optical photomicrograph re-columned and reassembled CGA 560 I/Os after thermal cycles showing microcracks in solder at the package side.

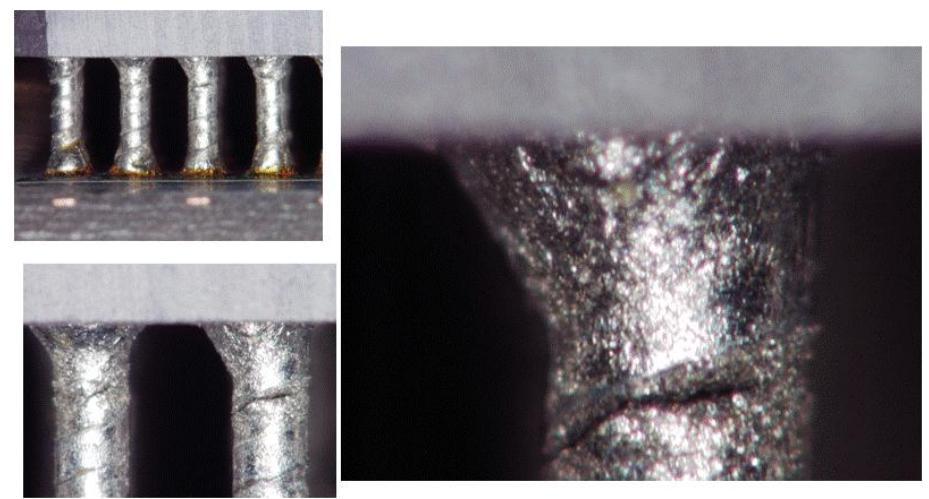
After thermal cycle completion, one sample was cut at its periphery in preparation for additional optical, SEM, and cross-sectioning. Figure 8 depicts representative optical photomicrographs of the assembly prior to cross-sectioning. Damage and microcracks exhibit better resolution since optical lenses now can get close to the package with no interference from the board. Figure 9 depicts representative SEM backscatter photomicrographs of column attachments at various magnifications up to 1,000 times. Cracks at the package side in solder interfaces are clearly apparent. Figure 10 depicts a photomicrograph at much higher magnification showing at least three types of microcracks. Potential mechanisms include: a) the large microcracks at the package interface surrounding the pad interface are due to the weak re-column attachment; b) the microcracks close to Cu spiral are due to weak Cu/solder interface and local CTE mismatch; and c) the microcracks parallel to interface between solder and column are due to the overall package/board CTE mismatch.

Fig. 8. Optical photomicrographs of re-columned and reassembled CGA 560 I/Os after thermal cycles and prior to X-sectioning showing microcracks in columns and solders at the package side.

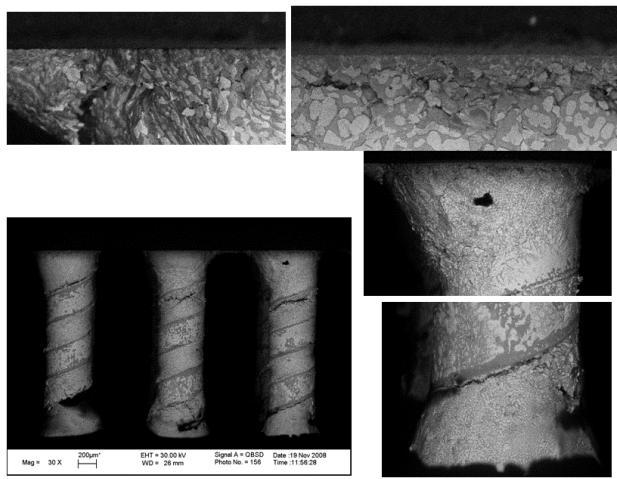
Fig. 9. SEM photomicrographs of re-columned and reassembled CGA560 after thermal cycles and prior to X-sectioning showing microcracks in columns and solders at the package side.

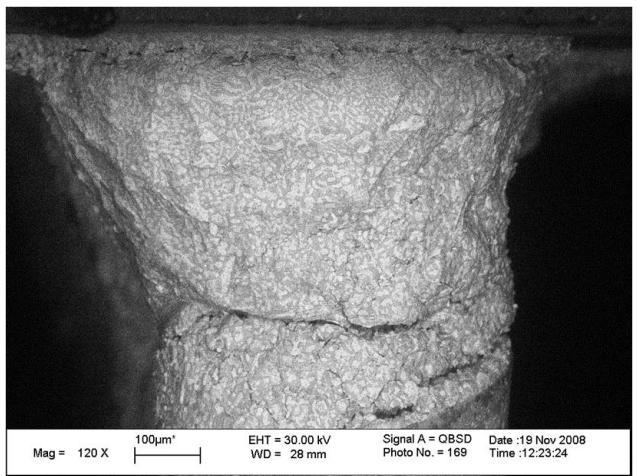
Fig. 10. SEM photomicrograph of re-columned and reassembled CGA560 after thermal cycles and prior to X-sectioning showing different types of microcracks in column and solder at the package side.

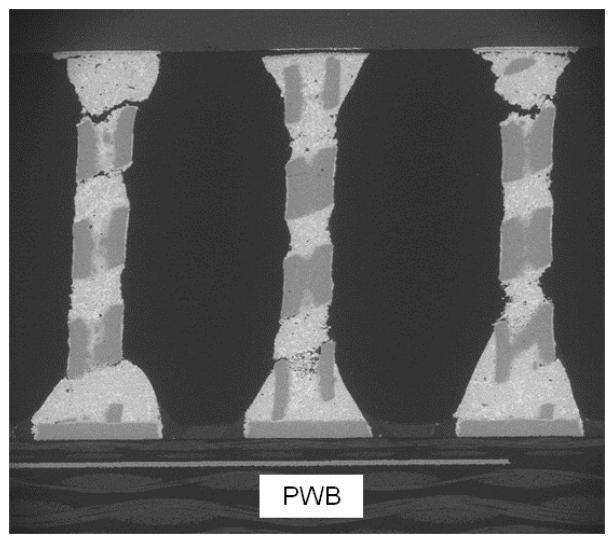
X-section photomicrographs for the three corner columns are shown in Figure 11. It clearly shows significant damage and minor-to-full cracking, more often at the package sides.

Fig. 11. X-section photomicrographs of re-columned and reassembled CGA560 after thermal cycling showing microcracks and separation mostly at the package side (top).

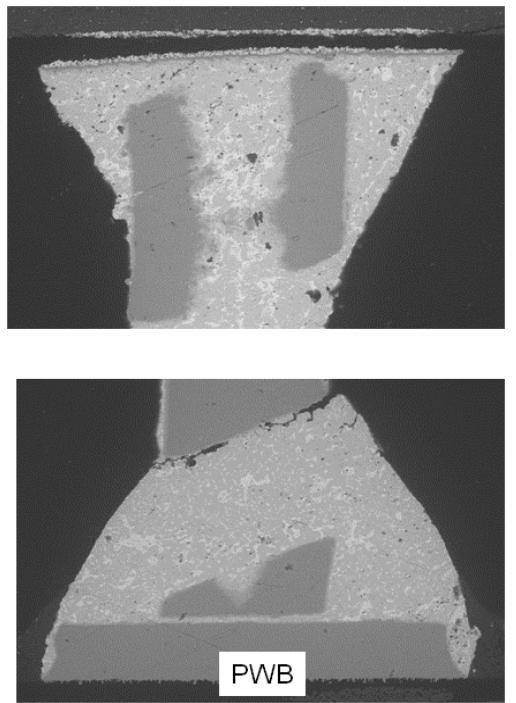
Figure 12 depicts SEM photomicrographs at higher magnifications, showing interfacial damage conditions both at the package and at the PCB sides. Separation at the package pad interface with minimum solder remnant at the pad is possibly an indication of weaker metallurgical bond due to re-columning and second reflow due re-work/re-assembly. More damage and cracking at the package side may also be due to a larger local CTE mismatch between the ceramic and solder at the package side in comparison to polymeric PCB and solder at the board level.

Fig. 12. X-section photomicrograph of re-columned and reassembled CGA560 after thermal cycling showing interfacial condition at package and PCB sides. Full cracking at the package side is apparent.

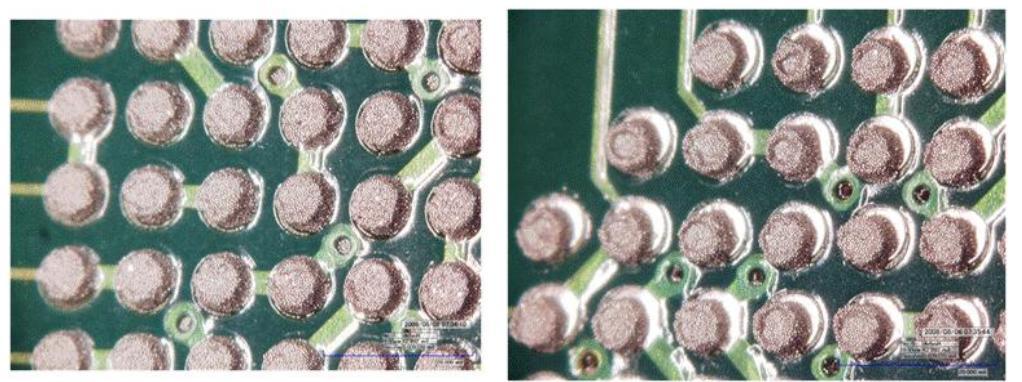
rare occasion, quality of paste deposition was improved by adding a small amount of paste when insufficient paste was detected. When bridging was discovered, solder paste was removed to open the bridge. In some cases, when the prints had offsets larger than acceptable levels, they were cleaned and reprinted for the second time. Figure 15 depicts optical photomicrographs showing acceptable paste deposition quality (left) and reject quality (right).

Fig. 15. Optical photomicrograph of paste deposition with mini-stencil with acceptable solder paste quality (left) and reject (right).

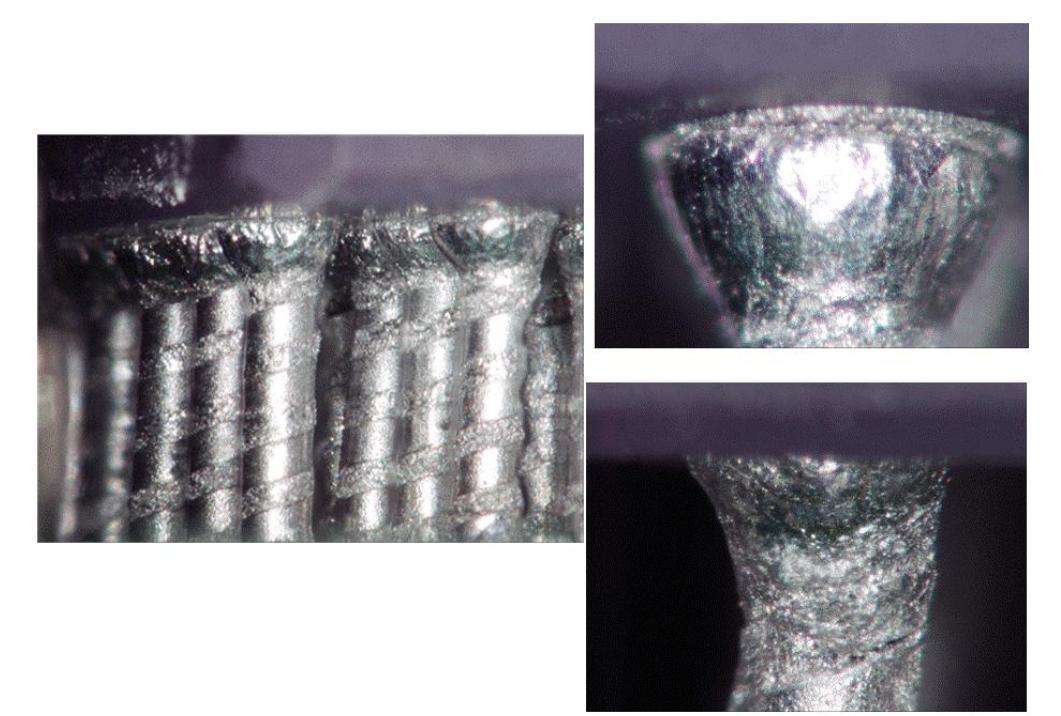
To better characterize microcrack formation of re-columned package assemblies, two packages were cut close to the package body for optical, SEM, and cross-sectioning. Because of potential failure of re-columns at the package side, it is critical to be able to inspect them; however, it is generally difficult to inspect assemblies at the package side because of board obstruction. Inspection of solder joints at the board side is easier since solder joints are blocked only by package periphery. For this reason, a thorough optical inspection was performed for two package assemblies after cycling and cutting for X-sectioning. Representative optical photomicrographs of the solder joints at the package side from the cut sample are shown in Figure 19. This figure also includes the pseudo 3-D optical photomicrograph, which is a compilation of images from different optical focus layers. If the optical lenses are aligned correctly with solder joints at the package interface, it is possible to reveal finer microcracks that are generally difficult to detect for a non-cut package assembly.

Photomicrographs clearly depict damage at the package side and even microcracks near the pad interface taken at much higher magnifications. Note that these microcracks could not have been detected during routine optical microscopy evaluation since they are fine and also close to the package interface, making it difficult to detect, as mentioned earlier. Note that these microcracks were first revealed during SEM evaluation at much higher magnifications, and then searched for during an optical inspection.

Figure 19. Representative optical photomicrographs, including those with pseudo 3-D optical photomicrograph, showing damage and microcracks at the package side.
