IPC-9691

User Guide for the IPC-TM-650, Method 2.6.25, Conductive Anodic Filament (CAF) Resistance Test (Electrochemical Migration Testing)

Developed by the Electrochemical Migration Task Group (5-32e) of the Cleaning and Coating Committee (5-30) of IPC

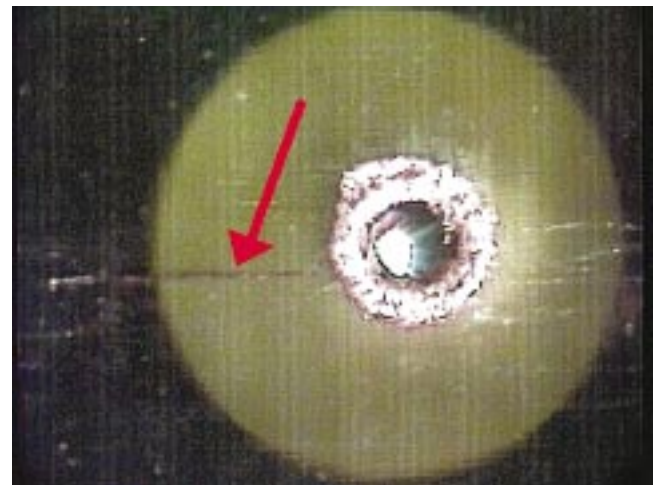
Figure 4-1 Conductive Filament Example

The high magnification photo, Figure 4-1 below, shows a PCB with layer 1 (top layer) removed, revealing a near shorting condition between the plated-through hole and layer 2 ground plane. [Photo courtesy of Matsushita]

Poor press lamination and/or defective prepreg material may contribute to conductive filament formation if the resin/reinforcement bonding strength and resistance to mechanical stress is reduced.

Where large conductive filament growth is visible under a microscope, often there is some adjacent laminate material fracturing or defect that contributed to its formation. Examples of such visible filament growth follow. Only Figure 4-4 may show a true atacamite filament, however all examples shown in Figures 4-1, 4-2, 4-3 and 4-4 would fail the temperature, humidity, and bias conditions selected to determine multilayer board reliability between internal features.
