Liquid Tin Corrosion and Lead Free Wave Soldering

Jim Morris
Speedline Technologies, Inc.,
Matthew J. O'Keefe, Ph.D., Martin Perez, PhD
University of Missouri

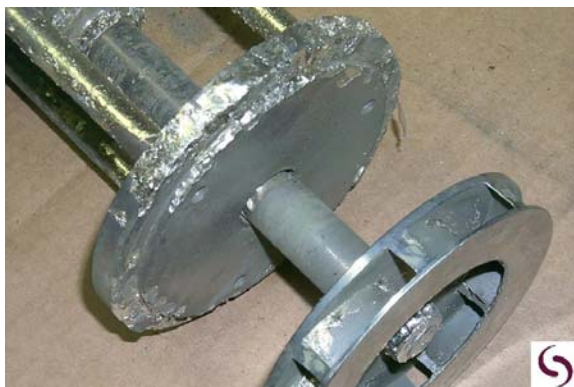
Figure 1 – Unprotected Stainless Steel

The initial conversion to lead free in mainstream electronic assemblies began in the late 1990's. Early adopters discovered that the Sn/Cu and Sn/Ag solders caused severe corrosion of the solder pot components. Stainless steels used for soldering equipment at that time would quickly degrade with high tin (Sn) lead free alloys. Figure 1 shows the result of unprotected stainless steel running in Sn/Ag solder for approximately six months.

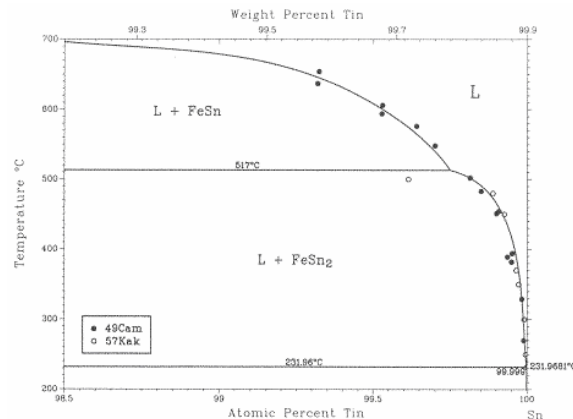
Gray Cast Iron – Gray cast iron has proven to be a material that resists tin corrosion and is a preferred material for solder pot construction. One way to estimate the dissolution of one material to another is through use of phase diagrams. The more soluble one material is to another (as indicated by the phase diagram), the more likely erosion or corrosion will occur. Figure 2 below shows the Sn/Fe phase diagram in the range of 99.5% to 100.0% Sn.

Figure 2 - Sn Rich Part of Fe-Sn Phase Diagram²

Per the phase diagram, Sn can only hold a maximum of 0.001% Fe in solution at 265°C (510°F). This very low amount of Fe that can be held by the molten tin is a good indicator that Fe would not be easily dissolved by molten Sn at soldering temperatures.

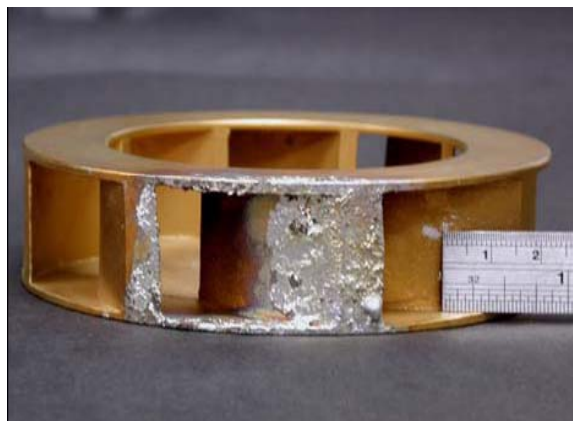
Evaluation of TiN coated samples in Pb-free solders has been conducted⁷. To determine suitability for use in lead free solder, a sample solder pump impeller was coated with titanium nitride and exposed to SAC solder for six weeks at 316°C (600°F). At the conclusion of the exposure the sample was subjected to a tape adhesion test. The solder easily peeled away from the

coated sample, indicating no signs of wetting to the TiN coated sample. The sample was then sectioned, polished, and examined by metallography, X-ray diffraction, Auger analysis, electron microscopy, and chemical analysis⁷. Figure 6 below shows the test sample after exposure to SAC solder.

Figure 6 – TiN coated 316 stainless steel impellor
