Effect of Conformal Coating on Tin Whisker Growth

Vijay Kumar and Linda Woody
Lockheed Martin

ANALYSIS OF CONFORMAL COATINGS FOR MITIGATING TIN WHISKER GROWTH
2004 – 2007 Test Data

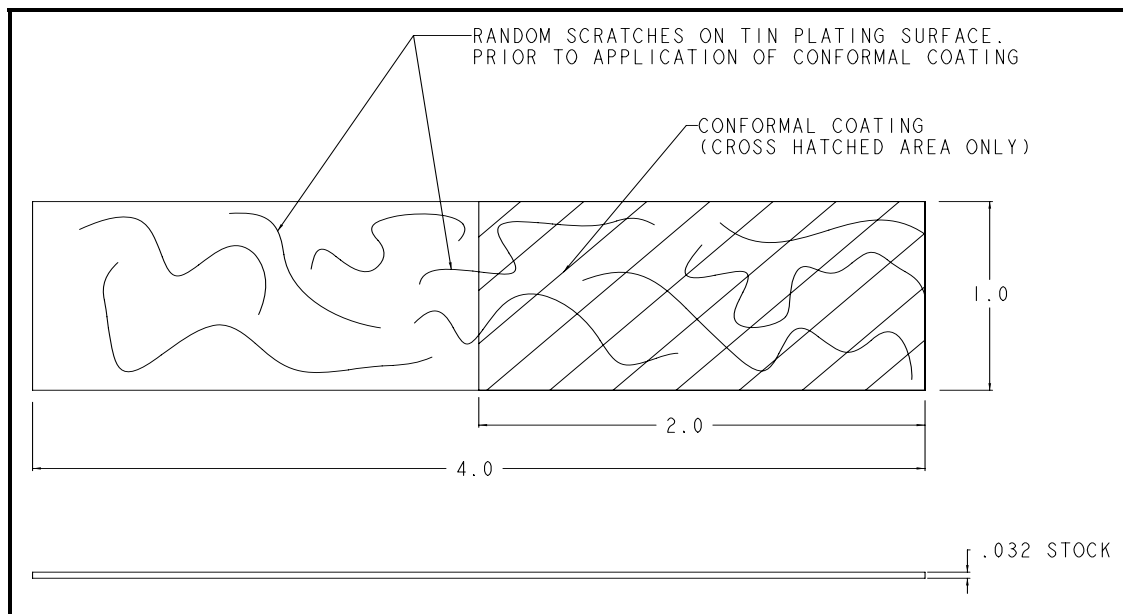
Figure 1 –Individual Test Coupon Dimensions/Scratched Surfaces & Coating Area

Copper C110 sheet stock and the Alloy 42 sheet stock was used to cut 1" x 4" test coupons. (see Figure 1), 99 test coupons from each material were used (198 total coupons).

- Copper C110 and Alloy 42 test coupons were plated with Bright Tin plating finish. Test coupons were plated with the Bright Tin to a thickness of 215 - 225 micro inches.
- After plating, using the procedure described below, random 'light' scratches were created on the surface of the Bright Tin plating on 138 coupons as shown in Figure 1. (69 each Copper C110 and 69 each Alloy 42)

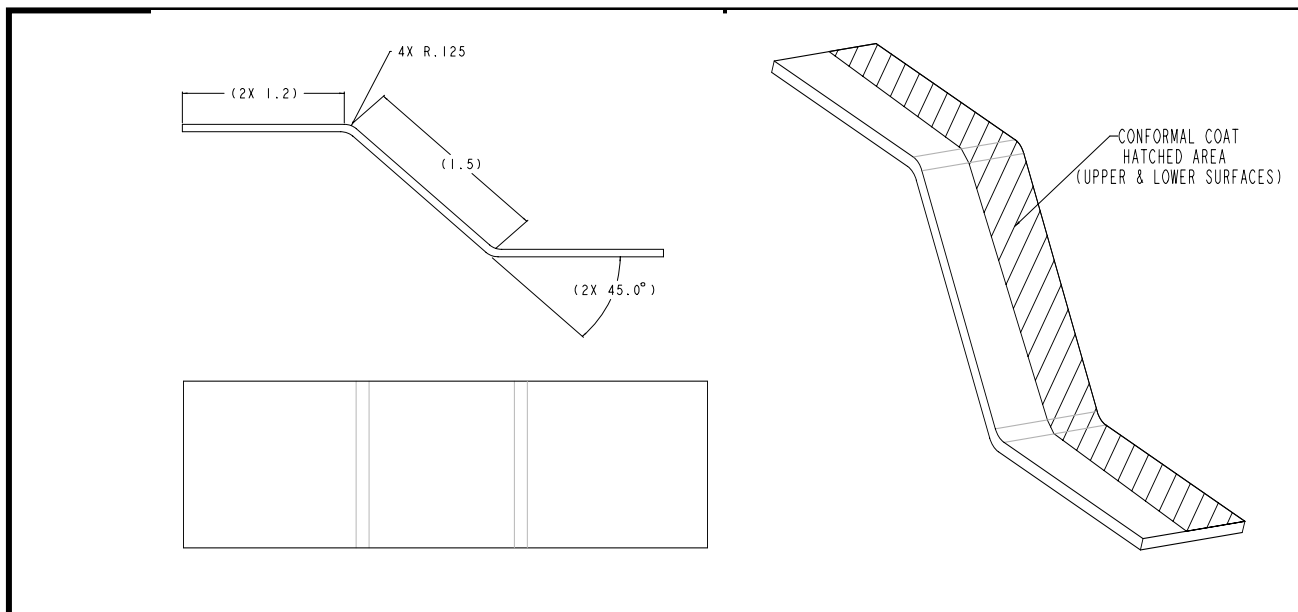
FIGURE 2 – Angled Test Coupon

- On the other 60 test coupons (30 from Copper C110 and 30 from Alloy 42), 45° bends were made at 2 places as shown in Figure 2 using a machine vise with appropriate protection applied to the jaws of the vise (i.e. Teflon tape or equivalent). This bend was intended to put the Tin plating under stress (i.e., compressive stress on the inside bend and tensile stress on the outer bend). Necessary precautions were taken to protect the transfer of metal to the tin plating during the bending process. Note: These coupons did NOT have scratches in the Tin plated surfaces.

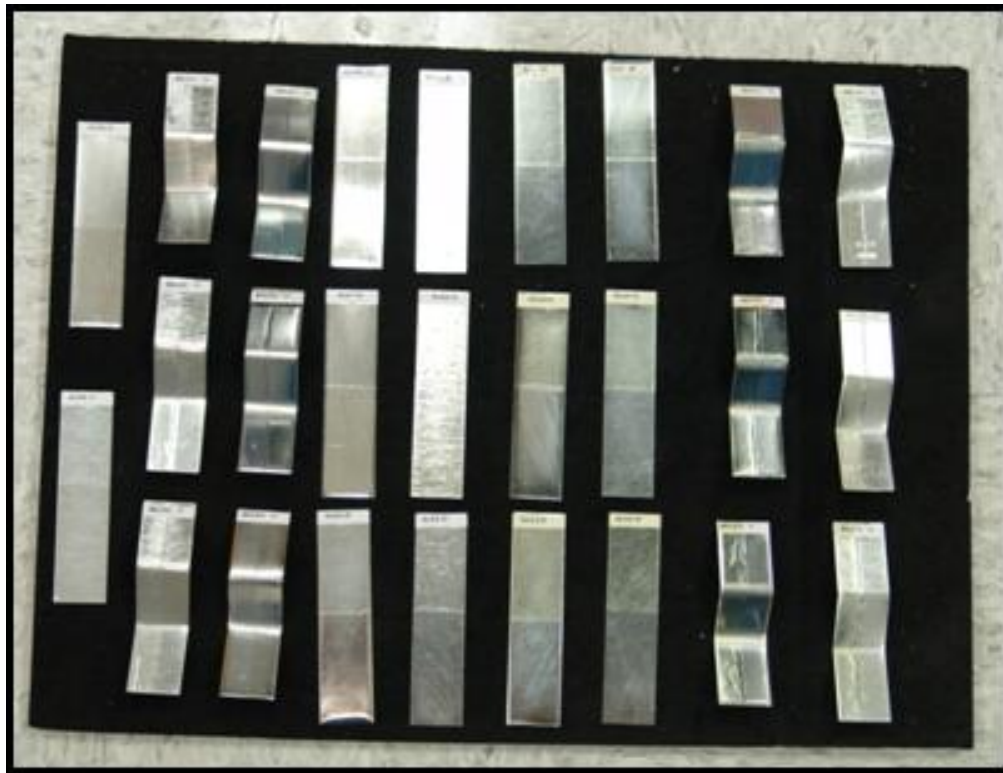
Figure 3 – Sample Lot

- All 198 test coupons were placed in the environmental chamber that was set to $50^{\circ} \pm 10^{\circ} \text{C}$ and the humidity to 50% 15% RH. Chamber status (Temperature and Humidity), was electronically monitored.
- Approximately every 1,000 hours the test coupons were evaluated for Tin Whisker growth by removing one tray of coupons consisting of one from each of the categories (straight/flat and angled/bent coupons), from each of the material types, and from each of the individual coatings and thicknesses. Evaluation consisted of visual evaluation, photomicrographs, and SEM analysis with photos. See figure 3 for a sample lot.

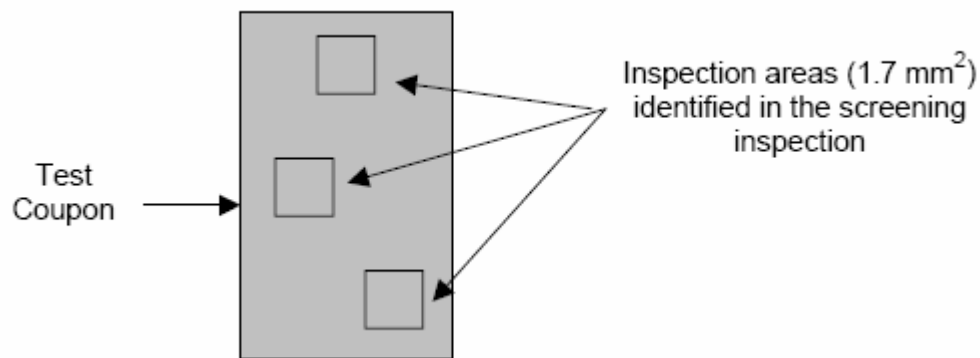
Inspection areas as required through JEDEC Standard No. 22A121. "Measuring Whisker Growth on Tin and Tin Alloy Surface Finishes." Pgs. 18-20. JESD22A121. JEDEC Solid State Technology Association. Arlington. 2005. See figure 4.

The coupons were inspected using an optical and Scanning Electron Microscope. The entire region of the coupon was observed and any information was recorded. Figure 4 represents JEDEC Standard No. 22A121 on required size and amount of inspection areas needed to be observed on the test coupons. The results obtained in this report were gained through inspection areas smaller and of greater quantity than what is required through the standard published.

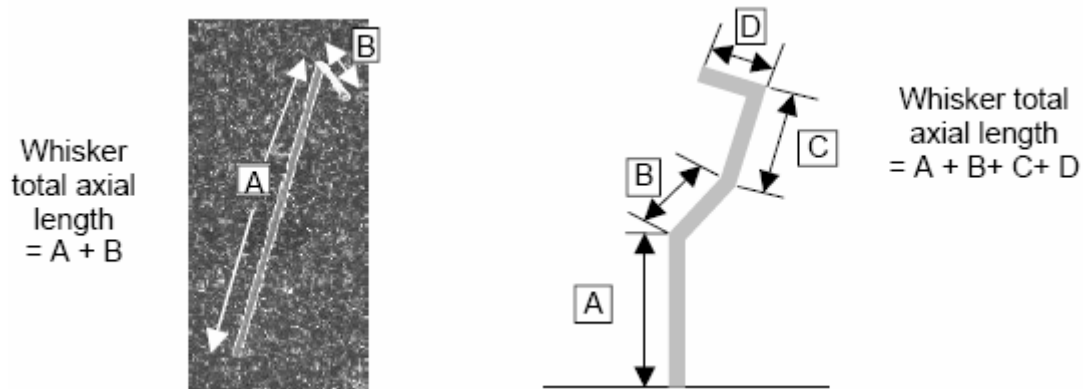
Figure 5

Measuring technique for total axial length of tin whiskers. "Measuring Whisker Growth on Tin and Tin Alloy Surface Finishes." Pgs. 18-20. JESD22A121. JEDEC Solid State Technology Association. Arlington. 2005.

Tin whiskers that were observed using the Scanning Electron Microscope were estimated and measured using the method below. These lengths include the total axial length of the Tin Whisker. See figure 5.

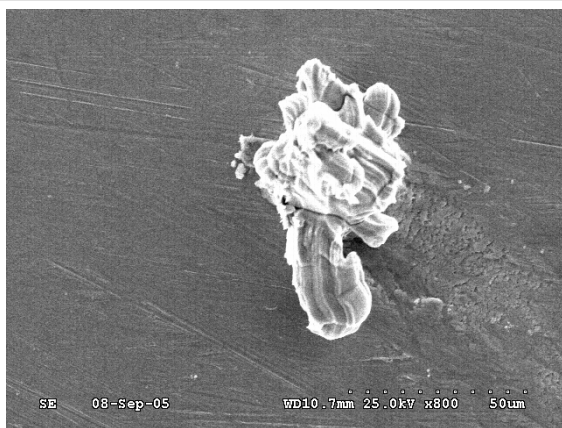
CU-U-3 06
Whisker formation

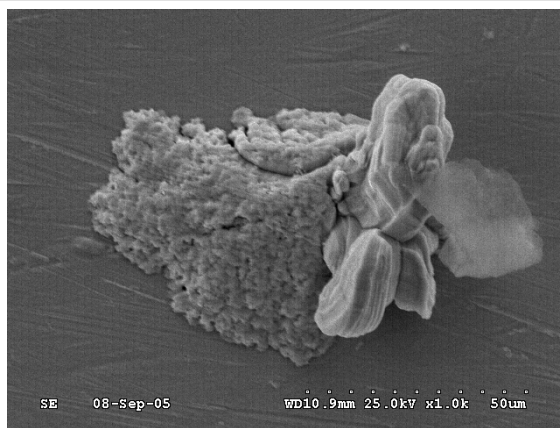
CU-U-3 06
Whisker forming from hillock surface

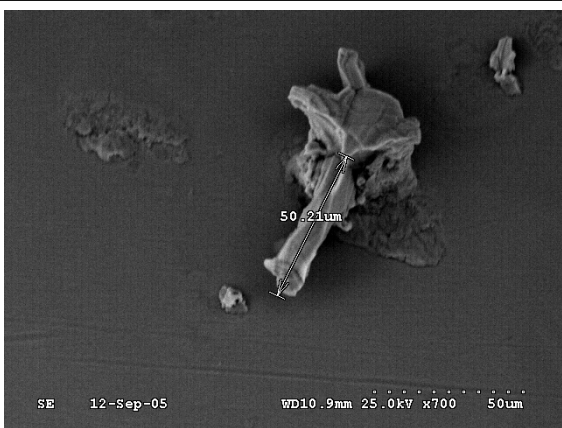
CU-A-1 06
Straight whisker formation from a hillock surface
– Protruding 50.2 um

| Sample information | Detailed Observations (non-coated region): | | |
|---|---|---|---|
| CU-A-1-06 | Low | 50 | -Near other Hillocks -Near edge of sample -Hillocks |

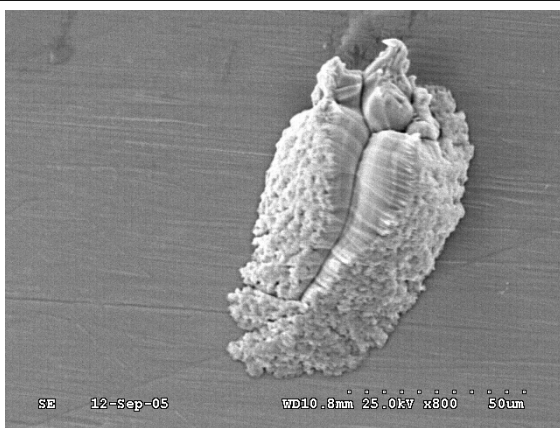
CU-A-1 06
Whisker forming from hillock surface

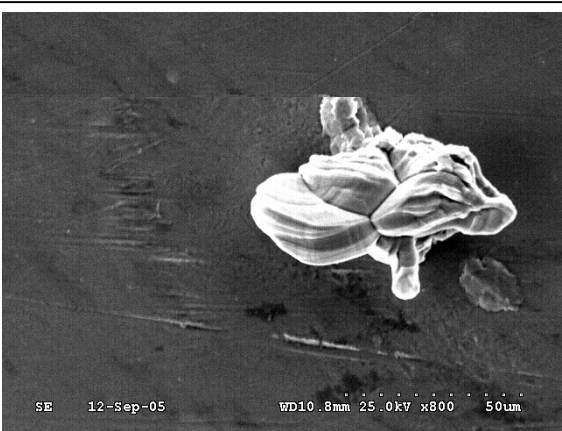
CU-A-1 06
Whisker formation

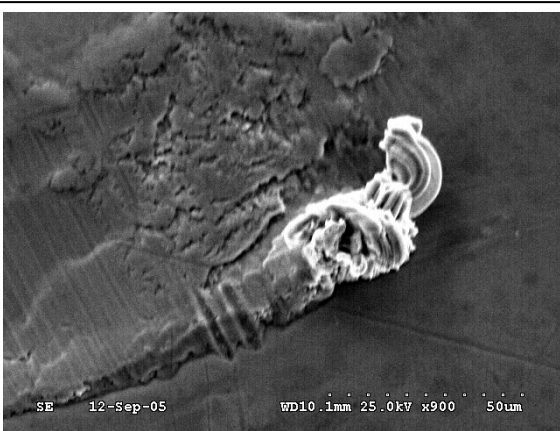
CU-A-2 06
Whisker formation

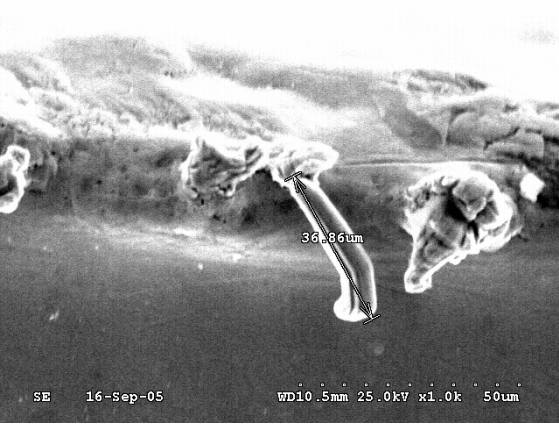
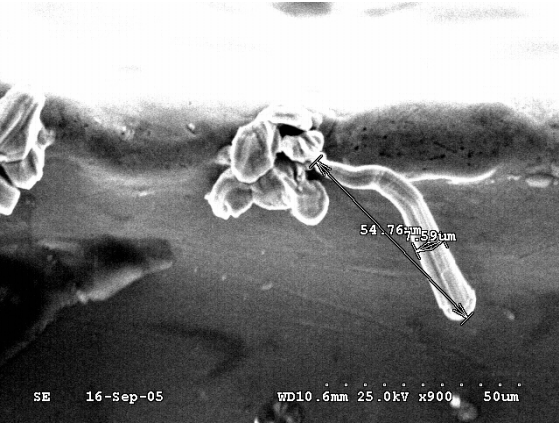
| <p>NO I.D. CU Straight whisker forming from hillock surface - Protruding 37 um</p> | <p>NO I.D. CU Curved whisker forming from hillock surface - Protruding 55 um with a 7.6 um diameter</p> |

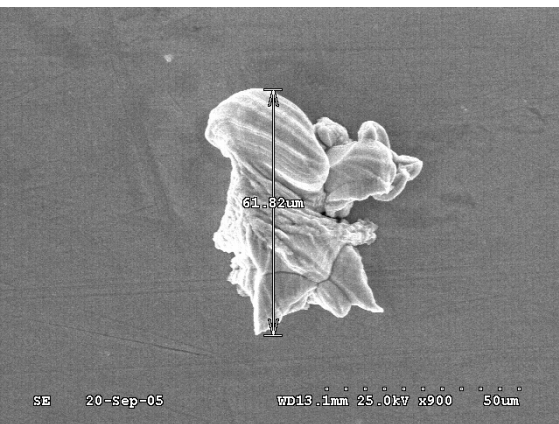
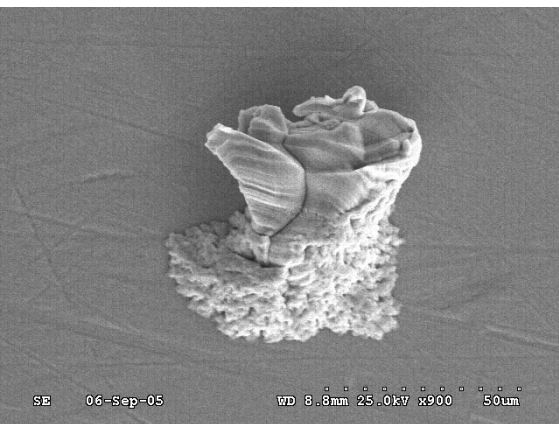
| <p>CU-U-1 06 Whisker formation on hillock surface - 62 um in length</p> | <p>AL-P-5 06 Whisker formation from hillock surface</p> |

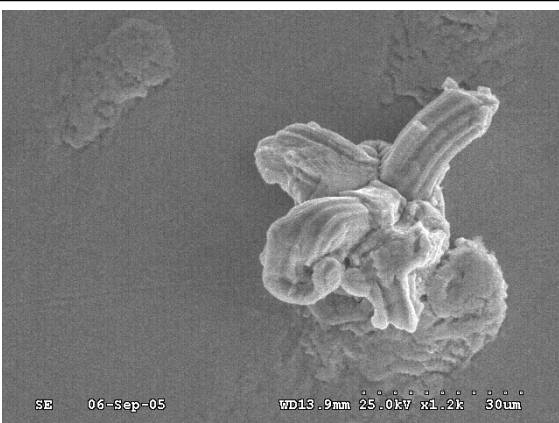
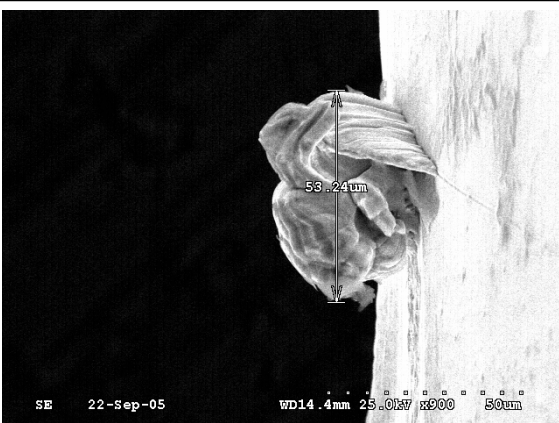
| <p>AL-U-1 06 Three-way branched whisker forming from hillock surface - Protruding 20 um from hillock surface on three sides</p> | <p>CU-U-2 06 Hillock surface – 53 um diameter</p> |

| Sample information | Detailed Observations (non-coated region): | | |
|---|---|---|---|
| AL-U-1-06 | Low | 20 | -3-way branched whisker -Hillocks |

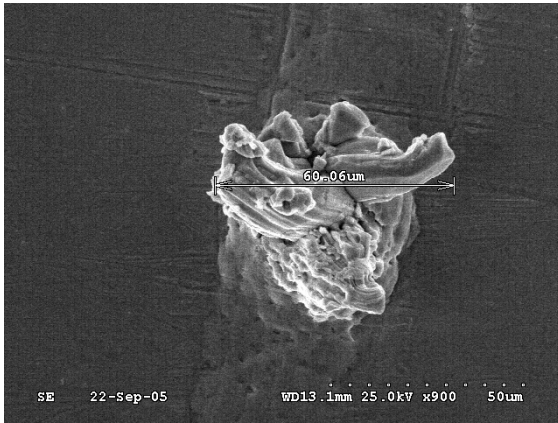
CU-U-2 06
Whisker forming from hillock surface
- Protruding 60 um diameter hillock

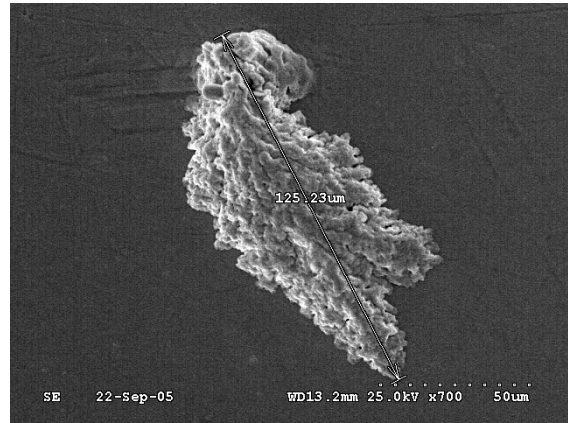
CU-U-2 06
Hillock surface – 125 um length

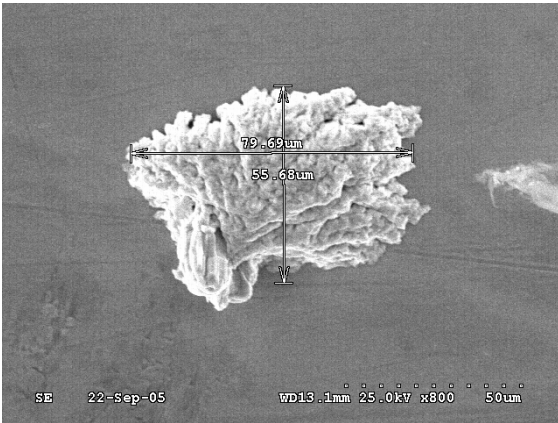
CU-U-2 06
Hillock surface – 4480 μm^2 area

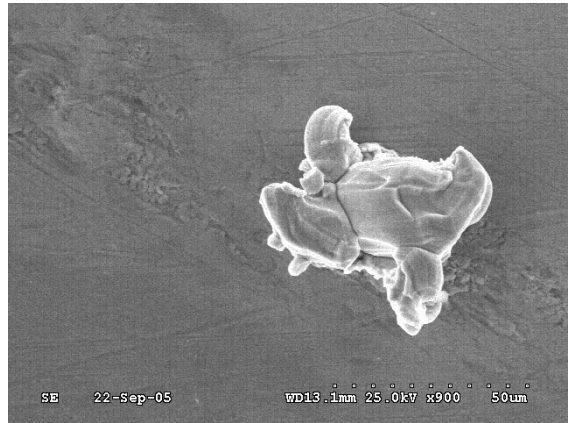
CU-U-2 06
Hillock surface – 50 um diameter

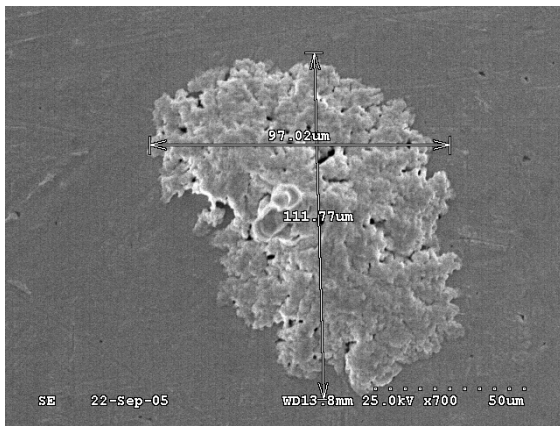
CU-U-2 06
Hillock surface – 112 um length and 97 um width

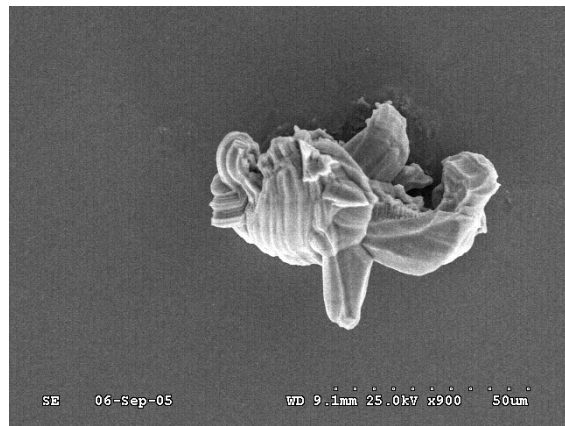
CU-P-5 06
Curved long whisker formation on hillock surface –
Protruding 40 um

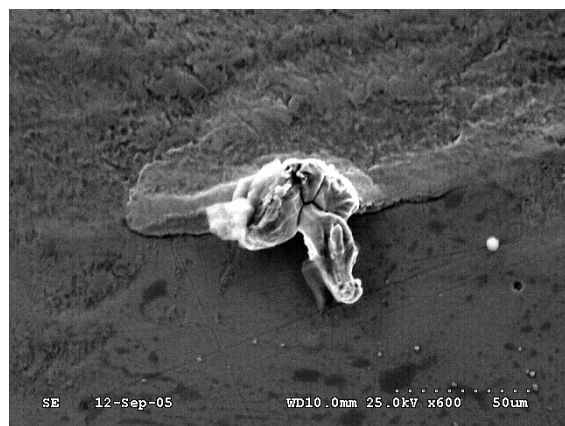
CU-A-2 06
Whisker formation

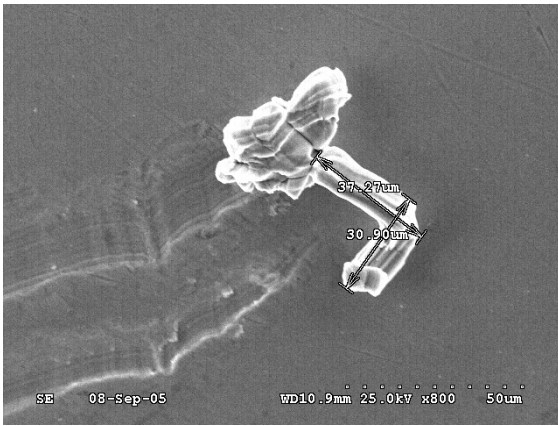
CU-P-5 06
Kinked whisker protrusion – 68 um axial length

| Sample information | Detailed Observations (non-coated region): | | |
|---|---|---|---|
| CU-P-5-06 | Low | 68 | -Sharp 90 deg bend -Irritated surface -Hillocks |

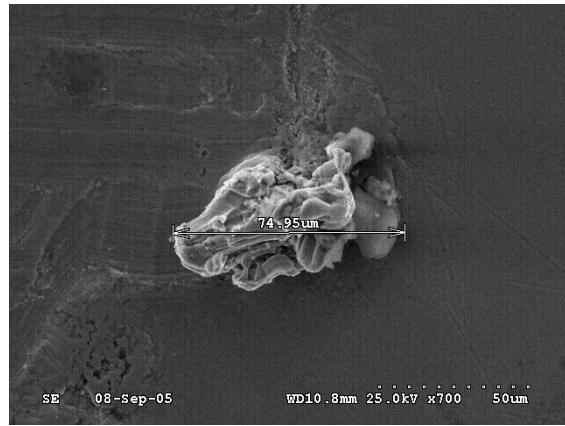
CU-U-3 06
Hillock surface – 75 um in length

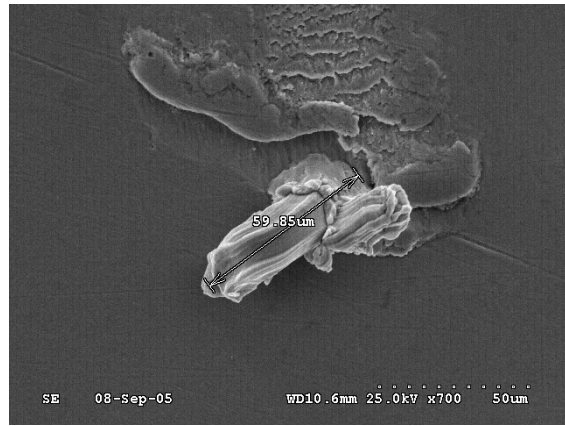
CU-U-3 06
Straight whisker protrusion – 60um axial length

| Sample information | Detailed Observations (non-coated region): | | |
|---|---|---|---|
| CU-U-3-06 | Low | 60 | -On scratched region -Hillocks |

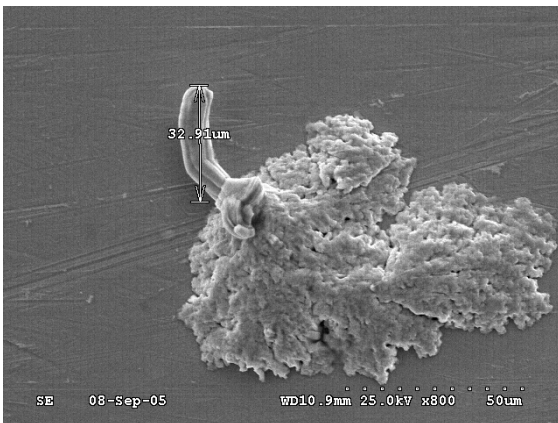
CU-U-3 06
Curved whisker protrusion from hillock – 35 um axial length

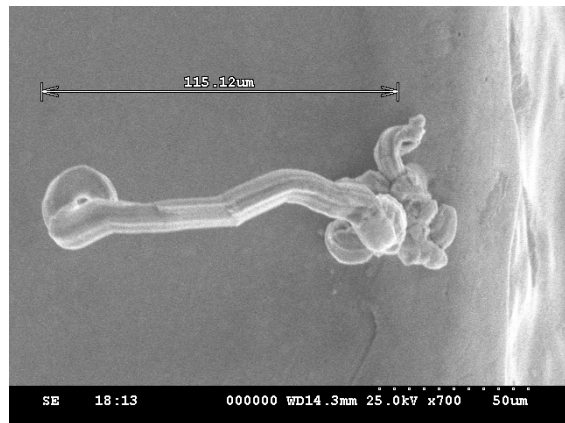
CU-A-3 06
Kinked long whisker – 130um in length

| Sample information | Detailed Observations (non-coated region): | | |
|---|---|---|---|
| CU-A-3-06 | Low | 130 | -On edge of sample -Hillocks |

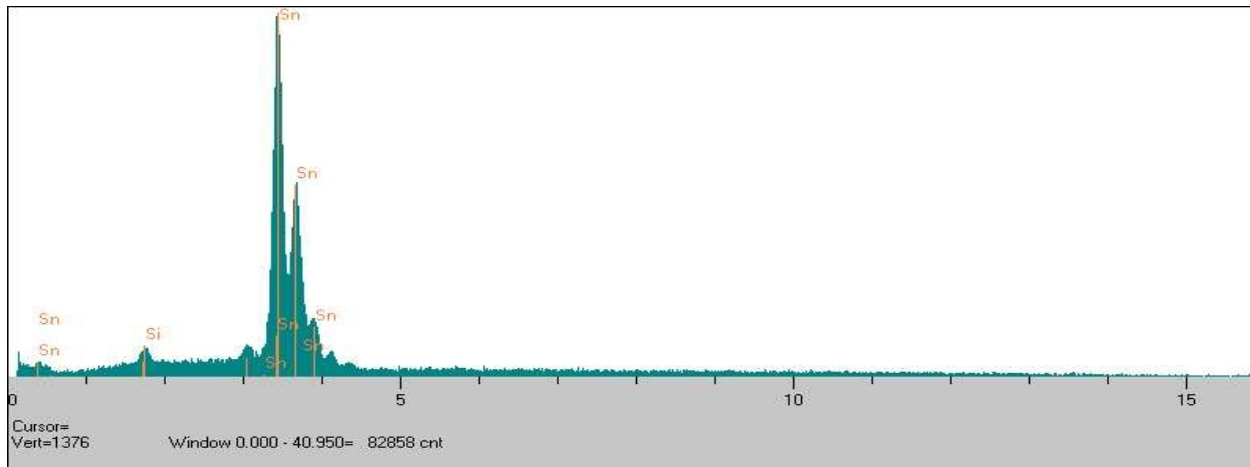
This representative EDX spectrum is verification of “Proto-whiskers to be made up of Tin (Sn).

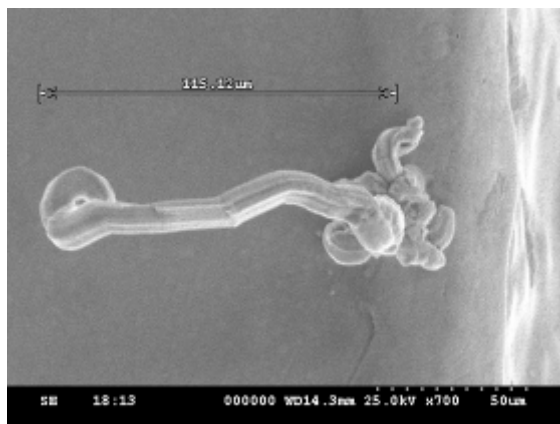
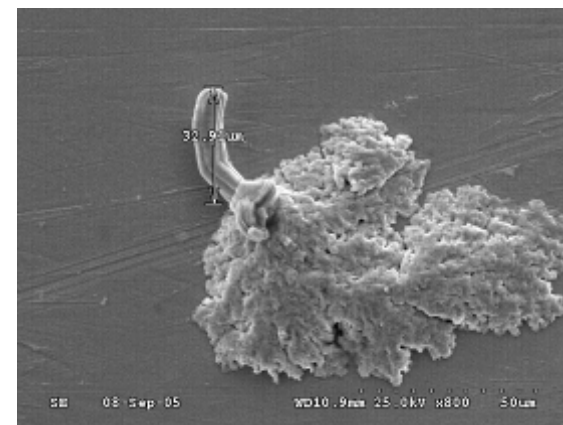
- Results after > 13,000 hours of 50/50 temperature/humidity exposure
 - Whisker growth observed on uncoated areas of numerous coupons
 - No whiskers observed on coated areas

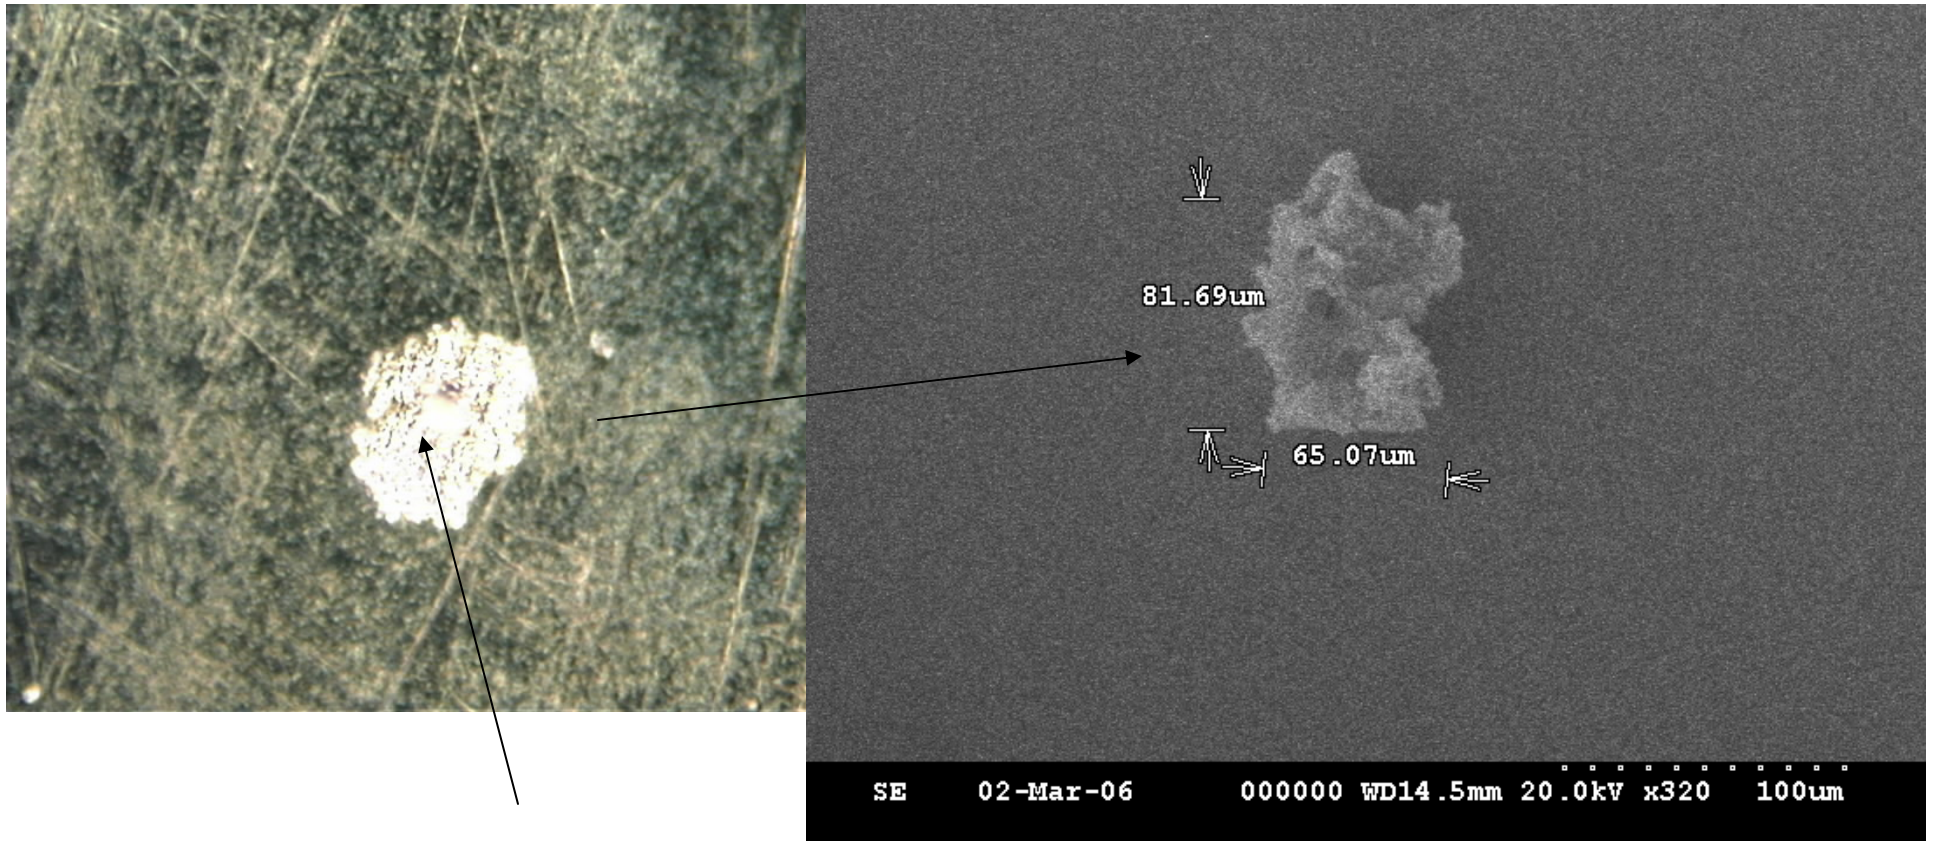
CU-U-1 07 Un-Coated

Protrusion

* Could be a true whisker Hillock – EDS analysis in process

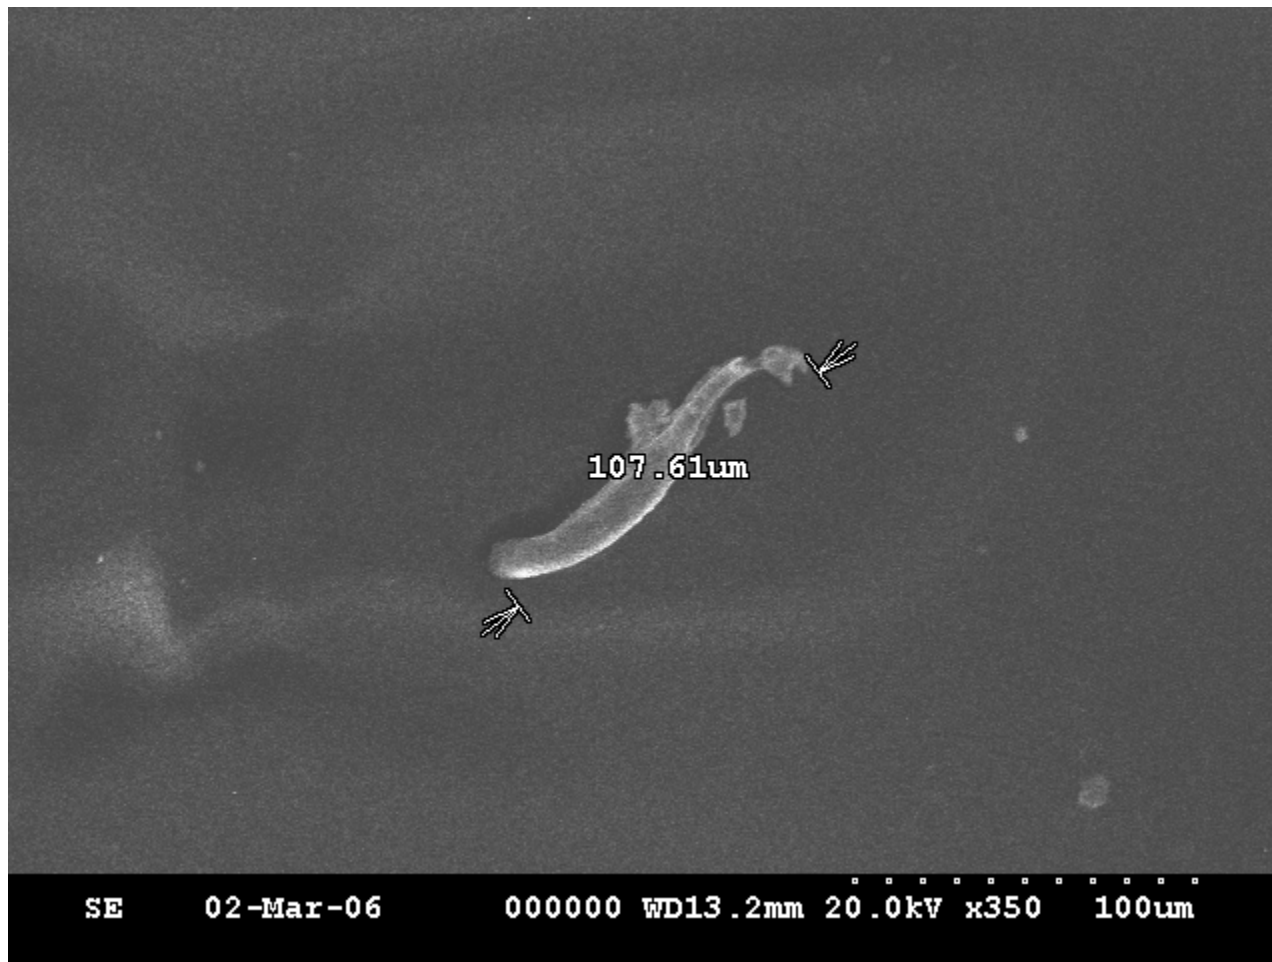
AL-U-3 07 coated

* Probably a fiber (debris) – EDS analysis in process

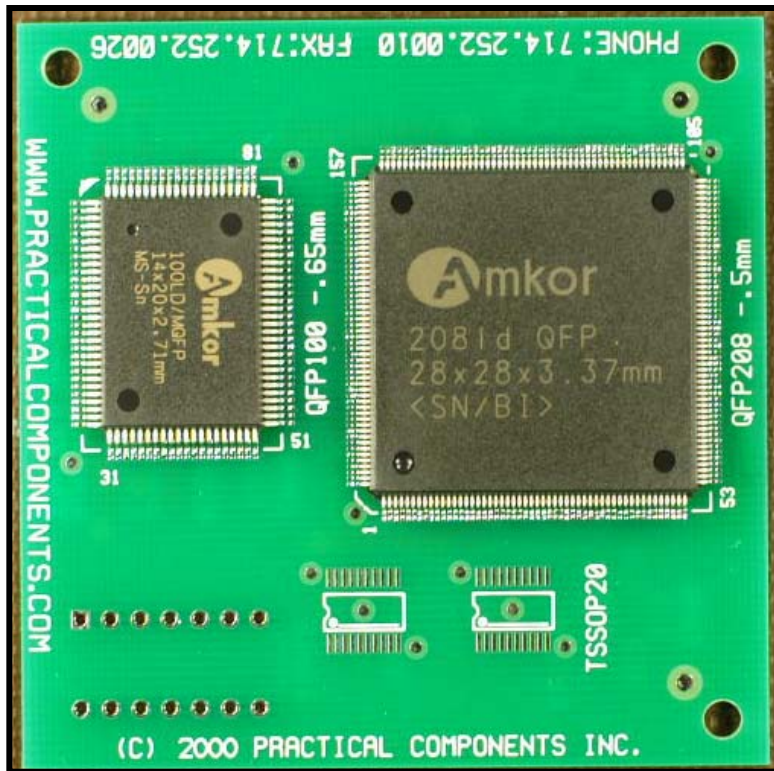
Side A

- qty. 6 with QFP208 and QFP100 (bottom side)
- qty. 6 with DIP 14, SOIC8, PLCC44, SOT23, QFP44 - .8,
- 0603, SOT143, SOIC20, and 1206 (top side)

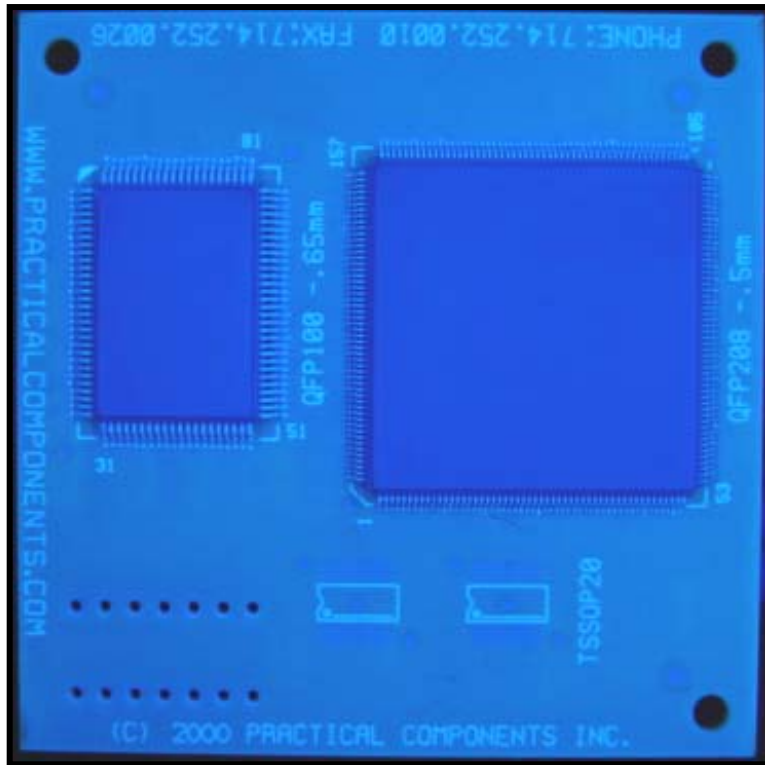
After conformal coating with 1A33

Each set of boards were coated with a different thickness, a set of boards consisting of one A side and one B side board. The coating thicknesses were, 1 to 3 mils, 3 to 5 mils, and 5 to 7 mils.

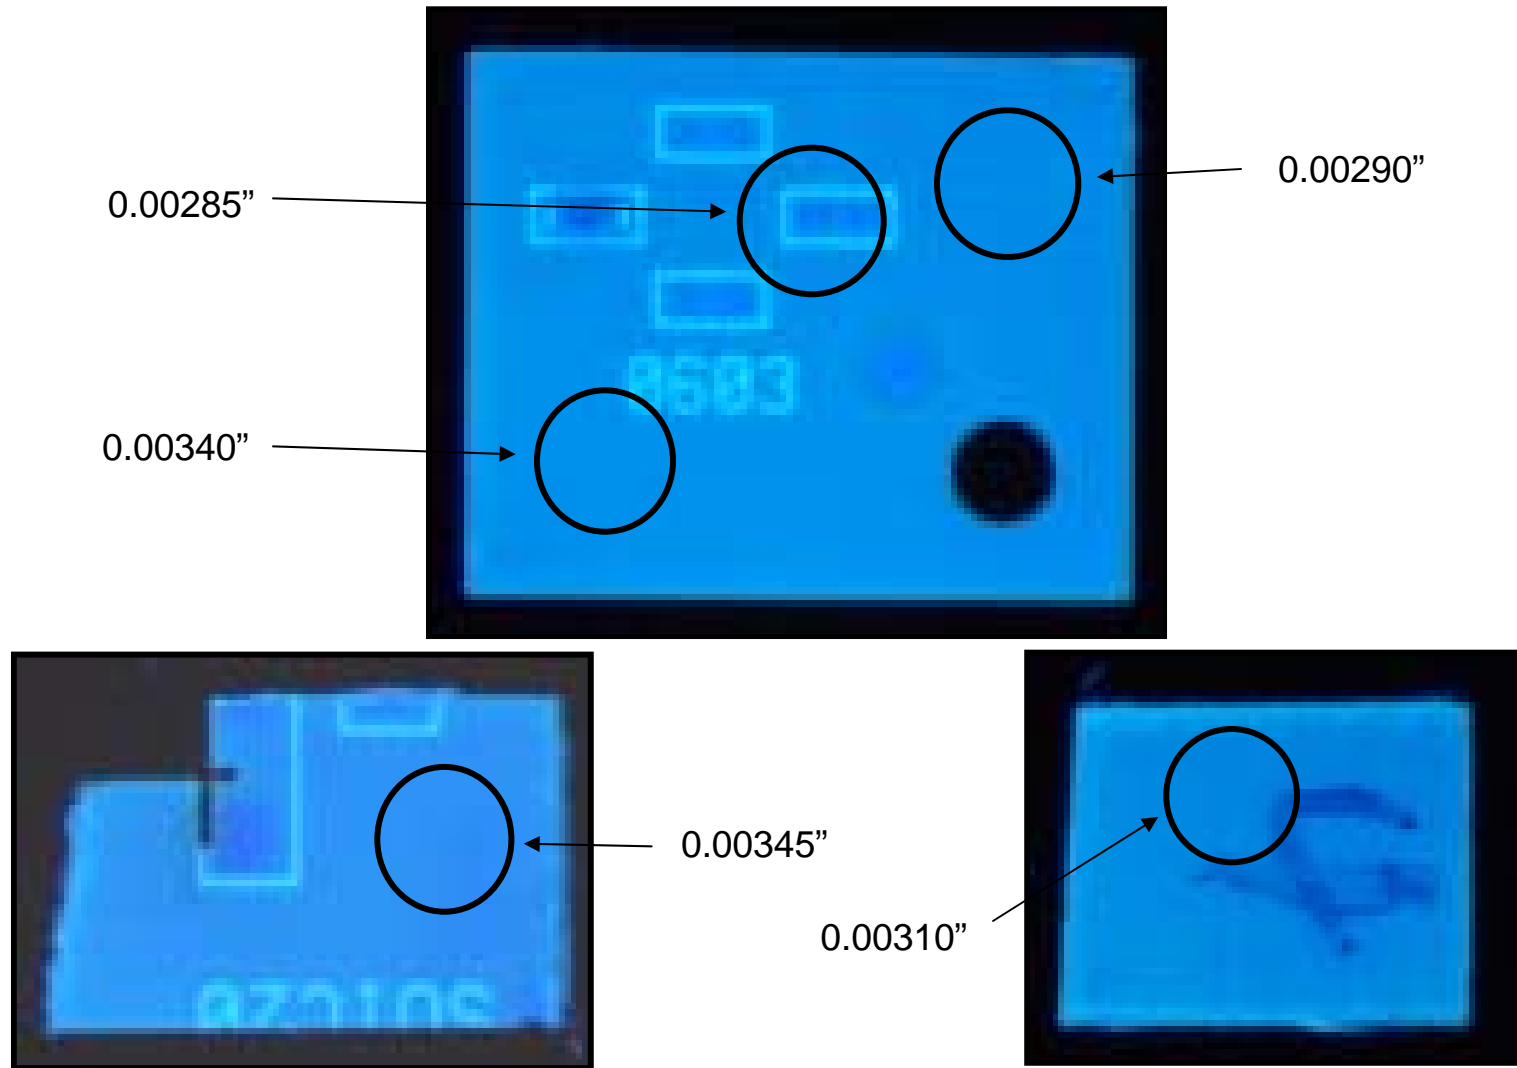
Surface Measurements with Micrometer on Boards Coated with 1 to 3 mils.

Overall thickness of boards before coating is 0.061" thick. Coating was removed from one side to enable correct measurements / Avg. thickness of coating minus the board = .00 314"

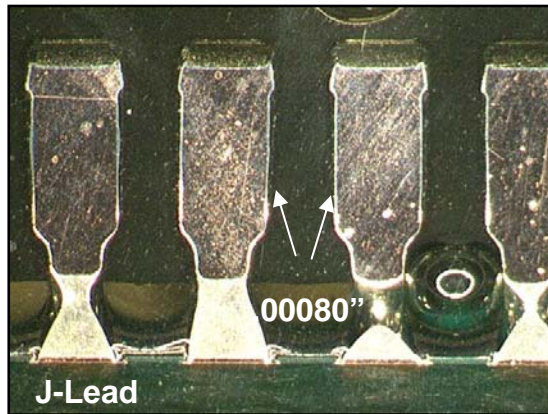
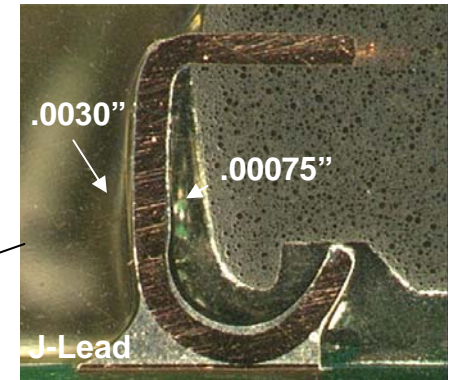
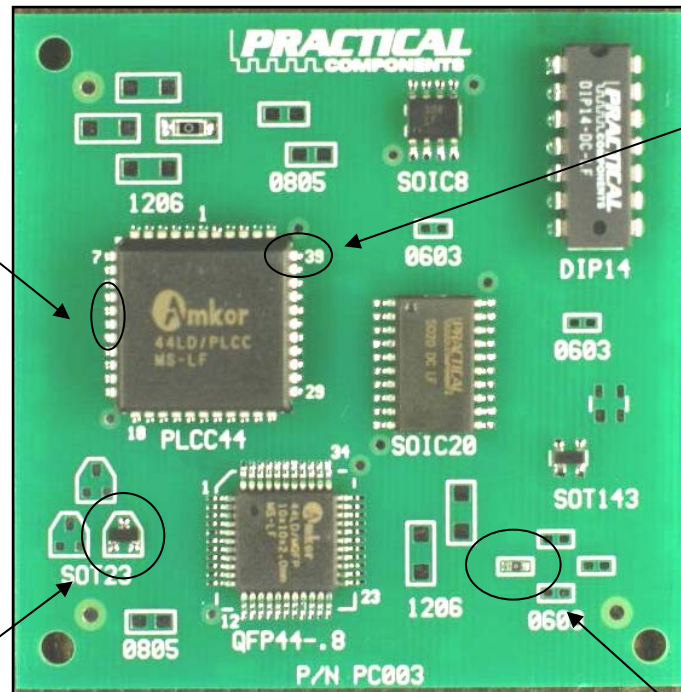
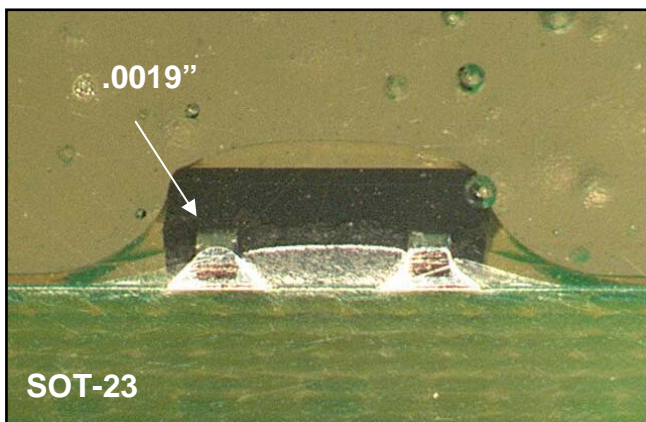
Coating thickness application, 3.0 to 5.0 MILS
(test coupon averaged 4.6 MILS)

Dimensions are averaged
and vary from lead to lead

- 3-5 mil samples had 100% coverage with an average of 1 mil of coating on the sides of fine pitch leaded packages
- Other packages (ie. passives, SOT-23, etc.) also exhibit 100% coverage of the exposed conductive surfaces
- 5-7 mils exhibit excessive coating bridging between leads of fine pitch leads
- 5-7 mils type UR is not recommended per the vendor due to cracking during operational life

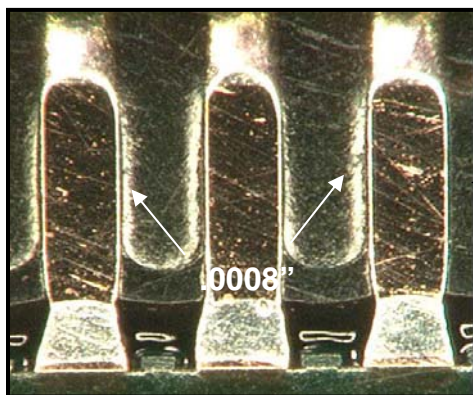
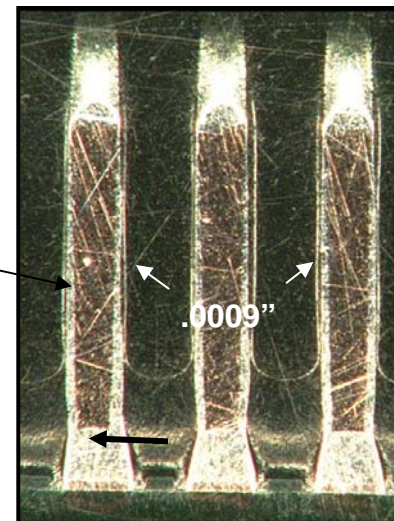
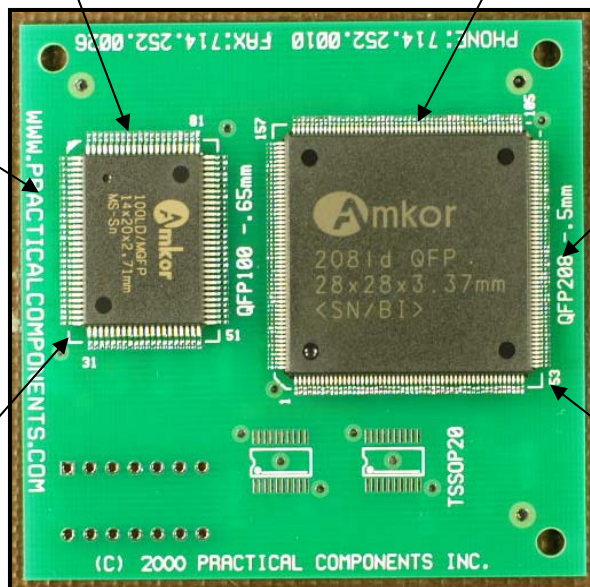
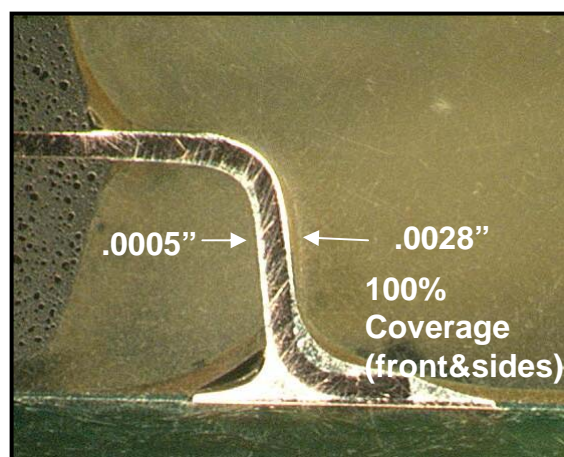
Coating thickness application, 3.0 to 5.0 MILS
(test coupon averaged 4.6 MILS)

25 mil pitch

20 mil pitch

Dimensions are averaged
and vary from lead to lead

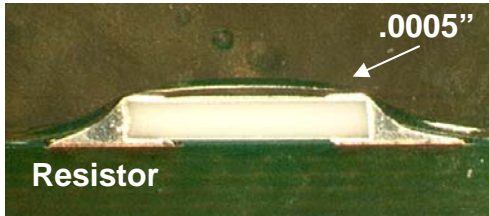
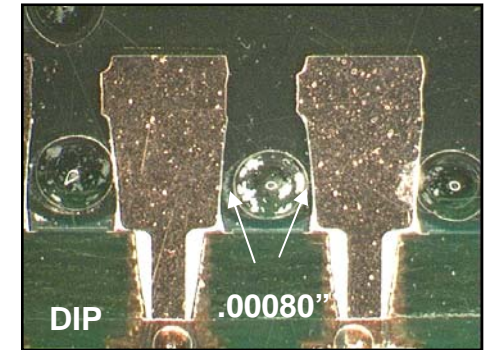
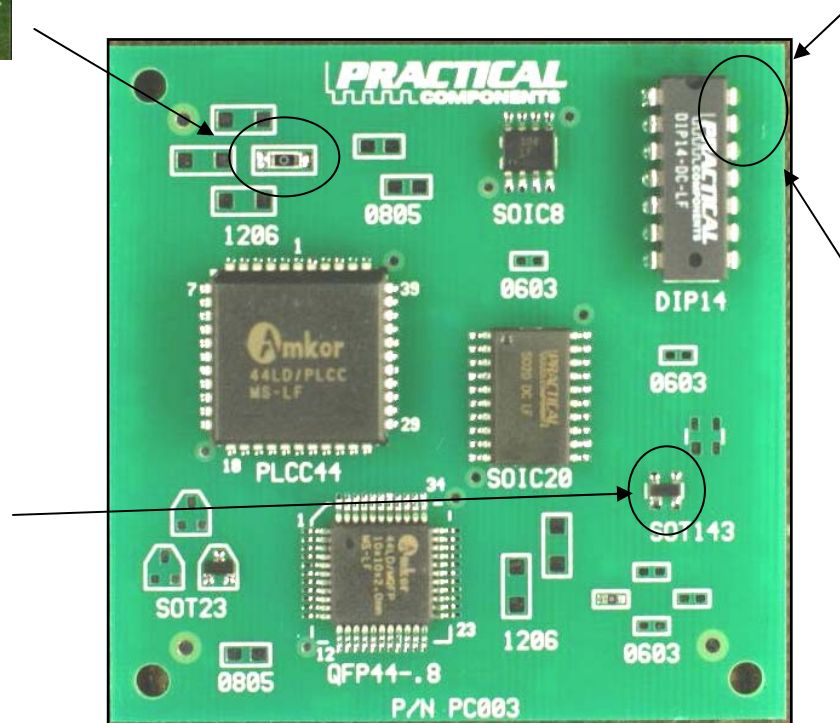
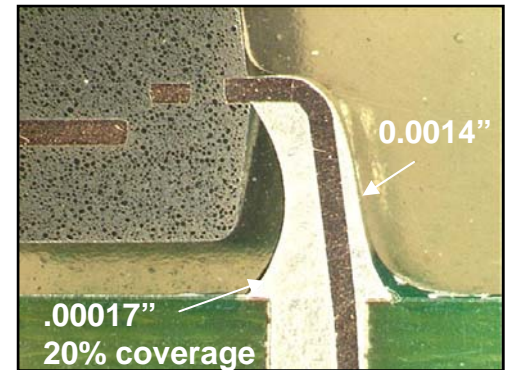
Coating thickness application, 3.0 to 5.0 MILS
(test coupon averaged 4.6 MILS)

Dimensions are averaged and
vary from lead to lead
