Cleaning a No-Clean Flux on Contaminated Hardware as a Recovery Plan

Eric Camden
Foresite, Inc

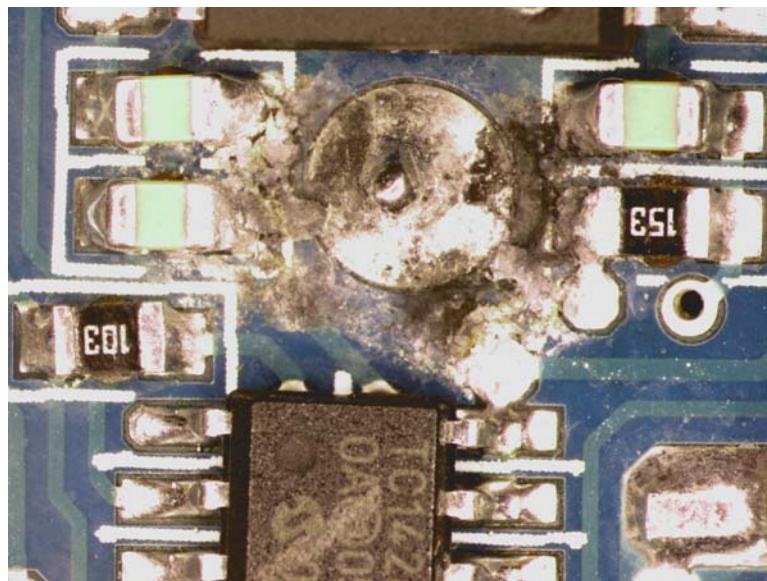
Figure 1

The visual element of a corrosive no-clean residue effect is pictured in Figure 1. This particular result was caused by hand solder of a thru-hole component that did not fully complex. When the assembly was powered up in a humid environment the residue caused dendrites in a short period of time with failure soon to follow.

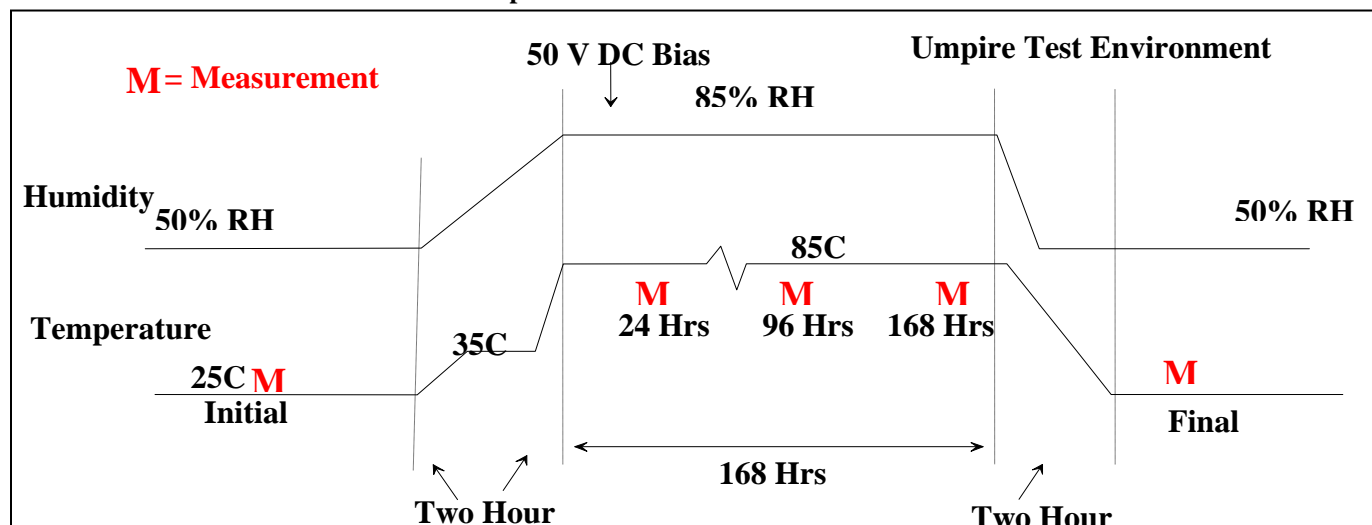
Graph 1 - SIR Environment 168 hours

Measurements were made with test specimens in the chamber under the test conditions of temperature and humidity at 24, 96 and 168 hours. When taking these measurements, the 45 - 50v DC bias voltage source was removed from the test specimen and a test voltage of -100v. DC was applied.

1. Each comb pattern on each test specimen was evaluated by the insulation resistance values obtained at 96 and 168 hours. If the control coupon readings were less than 1000 megohms, a new set of test coupons were obtained and the entire test repeated. The reading at 24 hours could fall below the required value provided that it recovers by 96 hours. Graph 1 illustrates the cycle for temperature, relative humidity, and measurements. At the 96 and 168 hour measurement points we are looking for values greater than 1.0e8 ohms or resistance.

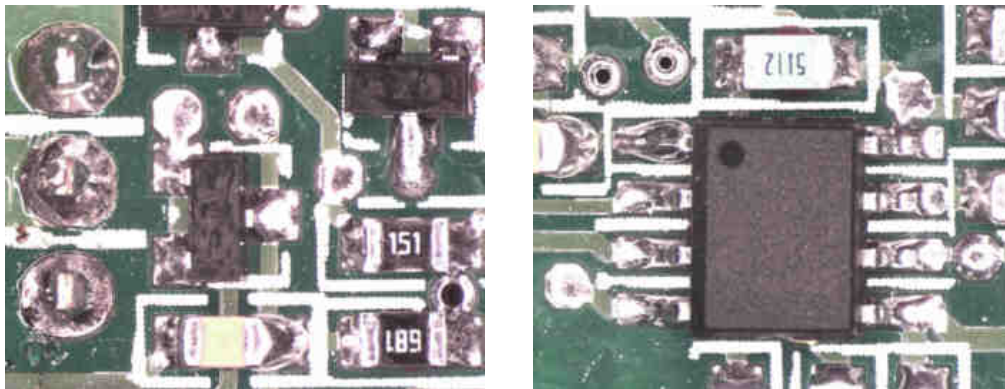
Fifty industrial power units were supplied for the study and were a mix of field returns (14 units-intermittent failures) and units warehoused for more than 6 months (36 suspect units). These boards were processed with no-clean bottom side SMT and hand soldered thru-hole. The hand solder areas were cleaned with a brush and a chlorinated solvent. These particular PCB's have a large heat sink that easily became faded with exposure to any sort of saponifier and was unacceptable to the end customer. This meant that conventional methods of cleaning were immediately eliminated. The cleaning plan became to take the boards and, instead of sending them through the in-line wash section, soaking them to just below the level of the heat sink in a small heated stainless steel tank that contained 10% saponifier for two minutes. Then we used steam energy to push the saponifier under the components and in between the leads to remove the no-clean residues. Since the problems resulting from the residues were contained to the bottom side of the board, we were able to concentrate the cleaning to one side and not expose the heat sink to any saponifier. After steaming, the unit went through the normal DI rinse and air knife procedure. An oven bake for one hour at 85°C was added to ensure complete drying. Figure 2 shows the two main areas of concern affected by the residues before cleaning and Figure 3 shows the same two areas after cleaning. Ion chromatography testing was performed before and after cleaning on problem areas of each board using a spot extraction method. Tables 1 and 2 show IC results from some of the worst case areas and Sample # 27 shows both areas of concern before and after wash.

Figure 2 – Sample # 27 Areas of concern 1 and 2 before washing

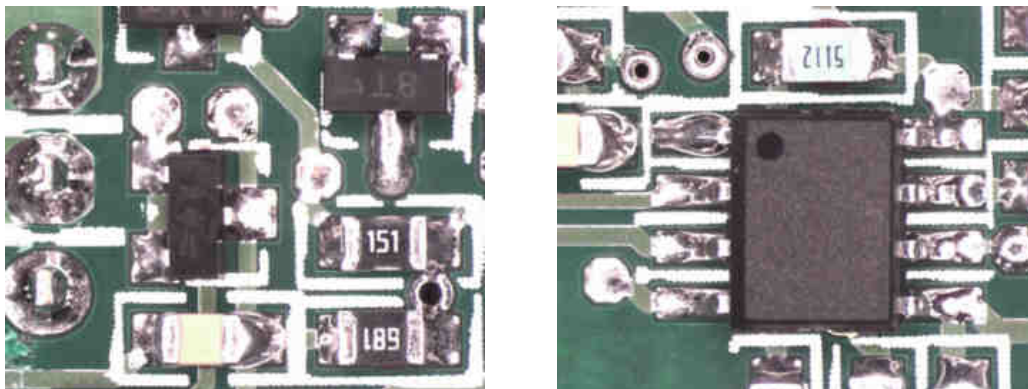
Figure 3 – Sample # 27 Areas of concern 1 and 2 after washing

The IC results show that the units have been recovered to a level of acceptable hardware and pose a minimal risk of electrochemical migration. The boards also improved visually with shiny solder joints, less process residues, etc. These units were then placed back into environmental chamber testing and 49 of the 50 units were totally functional, the one exception was a unit that had a burnt SOT and not even the best cleaning process can fix that.

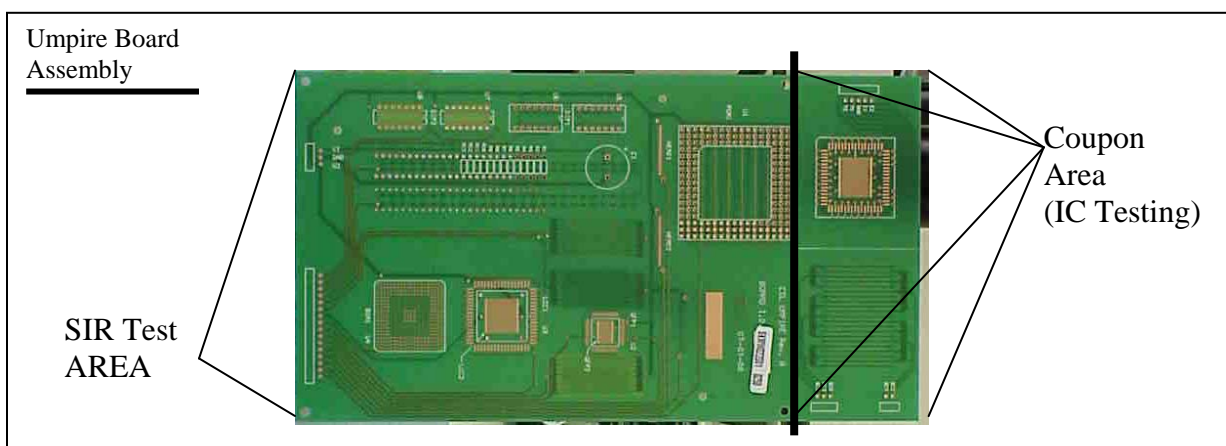
The second part of this study used Umpire boards built by Foresite using both thru-hole and surface mount parts. They were standard FR-4, immersion silver boards using an industry available water soluble paste for SMT components. The boards were then cleaned at Foresite so they all had the same starting baseline cleanliness. Next, the boards were processed with liquid no-clean flux. Then the boards were divided into three different cleaning process groups. The first was DI wash only. Boards were ran through an in-line cleaner at 2 FPM, 40 PSI (top and bottom) and DI wash at 85°F. The second process was the same as the first; however a saponified wash step was added. An industry available saponifier was used at 10% and 150°F. The third process was the same as the first two, with steam between the wash and rinse steps added. The steam is a constant 190 PSI and each component was exposed to steam by an experienced operator. The steam was “pushed” under each component from an angle, close to the board surface ensuring that the saponifier was working under the part. Figure 4 shows the Umpire board used in this experiment, the right portion of the Umpire shows the break off coupon that includes the 68 pin

Figure 4 - Umpire Board with Break Off IC Coupon

The IC testing was performed on a built in break off coupon, shown in figure 4, designed just for the purpose of qualifying a build process. J-STD-001C Appendix B, B-3 calls for qualification testing to be performed on circuitry similar to the IPC-B-36, in this case we used a 68 pin LCC. The pass/fail criteria for SIR results are any readings that are less than 1000 megohms at 96 and 168 hours, per IPC-TM-650 2.6.3.3a, 5.5.1. The IC and SIR results logically show that the more cleaning energy applied to the boards the better the results. The group of DI water wash only shows that the opportunity for dendritic growth or leakage path was very high and the SIR 96 hour numbers for the same group showed hard failures. The same can be said for the group with DI and saponified wash, with some improvement but failures just the same. The third group shows passing levels on both IC and SIR results. Groups 1 and 2 did not have sufficient energy to penetrate the tight spacing between leads or package body and board surface. The no-clean flux creates a dam of sorts between leads and even with heated saponified wash there isn't enough contact time to break down the flux and flow under the parts where the most detrimental of the residues can be hidden and given the proper environment cause problems such as no trouble found failures and intermittent shorts. Unless you physically remove the parts to get a better look at the residues under the package body, you may not really know what is going on since to the naked eye and even under a microscope the boards may look clean between the leads.

The IC testing was performed on a built in break off coupon, shown in figure 4, designed just for the purpose of qualifying a build process. J-STD-001C Appendix B, B-3 calls for qualification testing to be performed on circuitry similar to the IPC-B-36, in this case we used a 68 pin LCC. The pass/fail criteria for SIR results are any readings that are less than 1000 megohms at 96 and 168 hours, per IPC-TM-650 2.6.3.3a, 5.5.1. The IC and SIR results logically show that the more cleaning energy applied to the boards the better the results. The group of DI water wash only shows that the opportunity for dendritic growth or leakage path was very high and the SIR 96 hour numbers for the same group showed hard failures. The same can be said for the group with DI and saponified wash, with some improvement but failures just the same. The third group shows passing levels on both IC and SIR results.

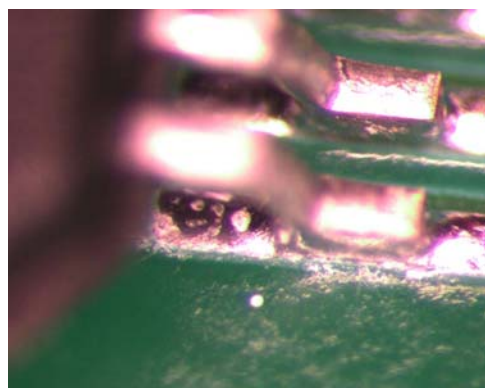
LCC for IC testing. Figures 5, 6, and 7 shows the Umpire boards TQFP area under magnification with the different processes after the cleaning. The IC and SIR data in table 3 shows the results after the various cleaning processes.

Figure 5 - DI Only

Groups 1 and 2 did not have sufficient energy to penetrate the tight spacing between leads or package body and board surface. The no-clean flux creates a dam of sorts between leads and even with heated saponified wash there isn't enough contact time to break down the flux and flow under the parts where the most detrimental of the residues can be hidden and given the proper environment cause problems such as no trouble found failures and intermittent shorts. Unless you physically remove the parts to get a better look at the residues under the package body, you may not really know what is going on since to the naked eye and even under a microscope the boards may look clean between the leads.

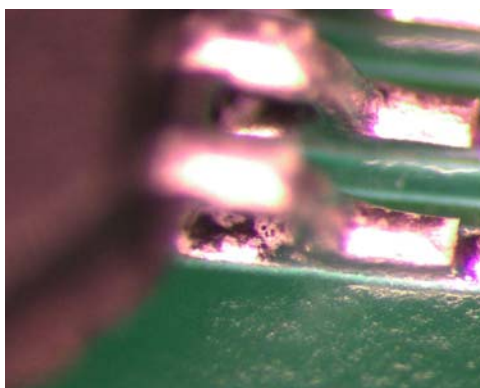
Figure - 6 DI and Saponifier

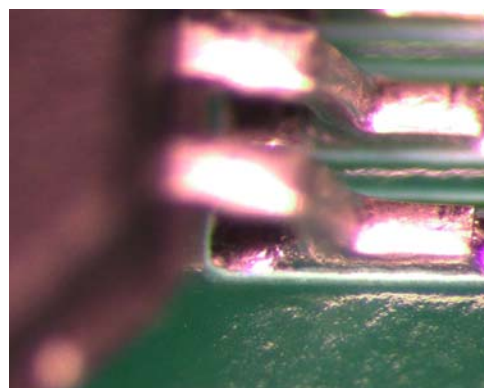
Figure - 7 DI-SAP-Steam

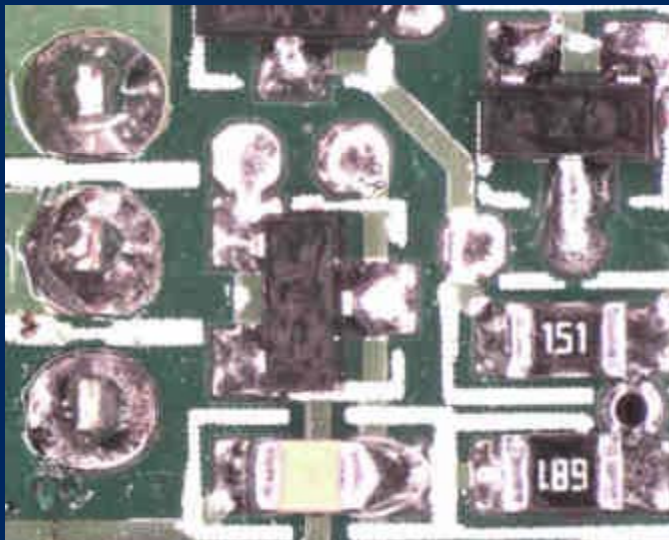
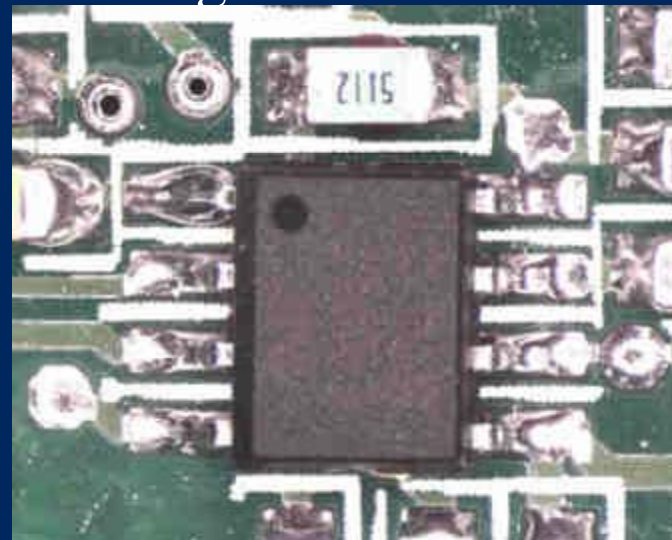
Before Cleaning

50 industrial power units were the subject of the first part of the study with 14 units exhibiting some level of intermittent failures and the remaining 36 suspect units being warehoused for over 6 months. IC testing was performed before and after cleaning.

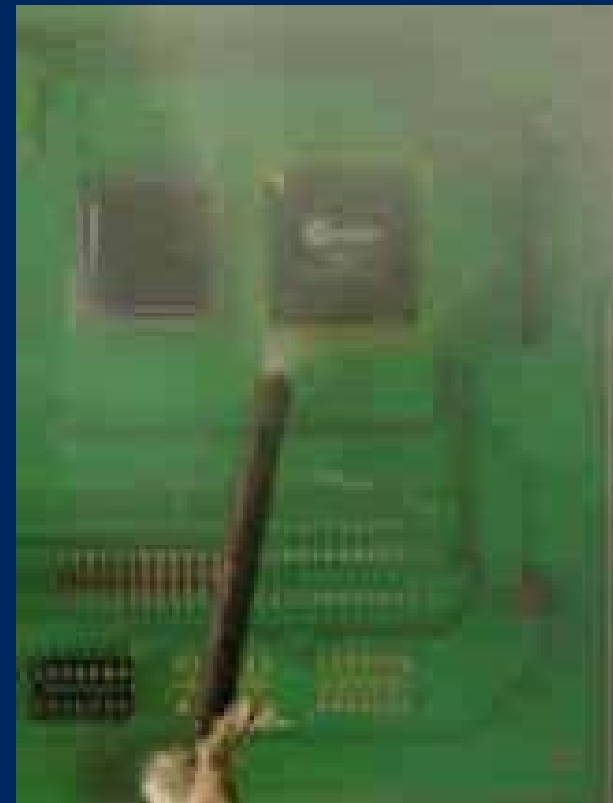
- These boards have a saponifier intolerant part on them so that ruled out conventional cleaning methods
- Boards were soaked just over the topside in 10% saponifier for two minutes at 150°F
- The boards were then cleaned with a COTS steaming unit that provided a constant 190 psi of pressure

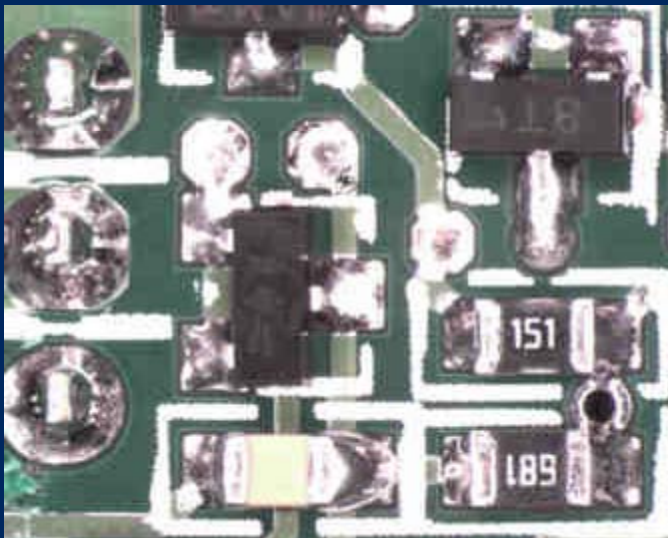
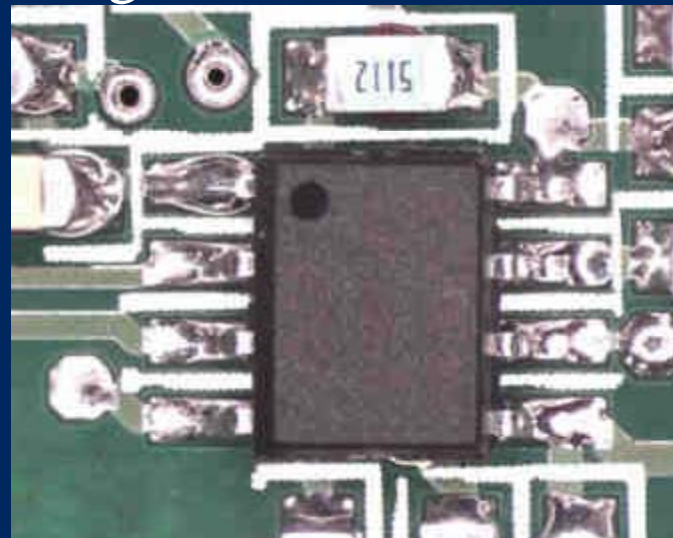
After Cleaning

The IC results show that the units have been recovered to a level of acceptable hardware and pose a minimal risk of electrochemical migration. The boards also improved visually with shiny solder joints, less process residues, etc. These units were then placed back into environmental chamber testing and 49 of the 50 units were totally functional, the one exception was a unit that had a damaged SOT and not even the best cleaning process can fix that.

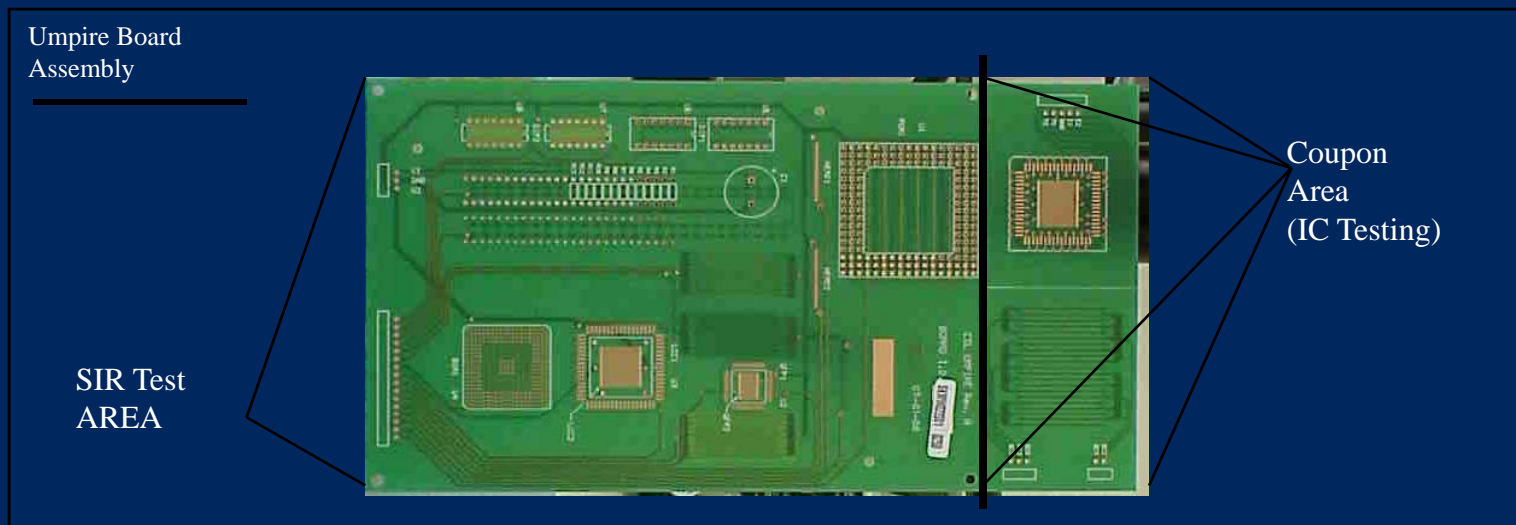
Parts Placed: LCC(2),BGA,TQFP,DIP(4)
