Do Measles Cause CAF?

Randy Reed and Juan Araneda
Corporate Reliability Lab
Merix Corporation

Validate measles result in conductive anodic filament (CAF) failures.

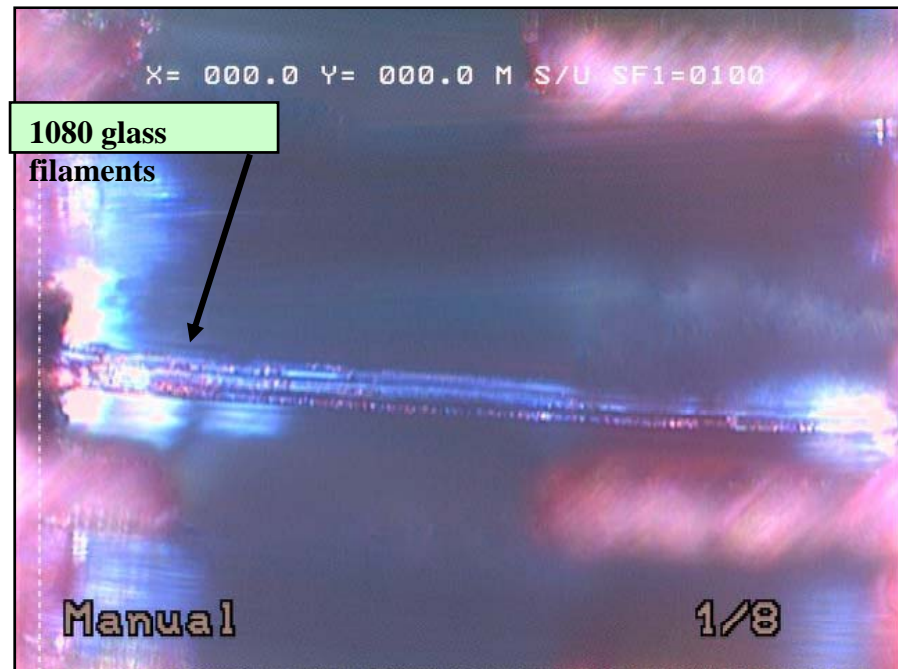
Board Number	1
Pattern Location	A3
CAF Pattern	PTH to PTH
Spacing	5 mils
Material	FR406

Measle Conditioning	None
Measle Evident at Failure Location	NO

Failed Layer	Prepreg Layer 13 to 14
Glass Style	1080
