Effects of BGA Rework Cycles on PCB Assembly Reliability

J. Liang, G. Barr*, N. Dariavach*,
and D. Shangguan***

* EMC Corp, Hopkinton, MA 01748

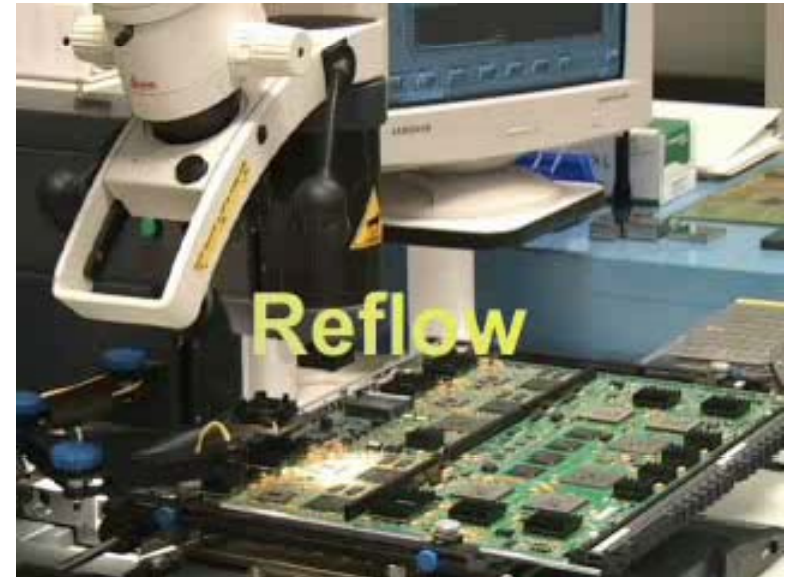
- BGA removal and replacement are required during product development, and for manufacturing and field returns.
- BGA multiple revisions during a product development may force development boards to go through multiple removal and replacement cycles on the same BGA locations.

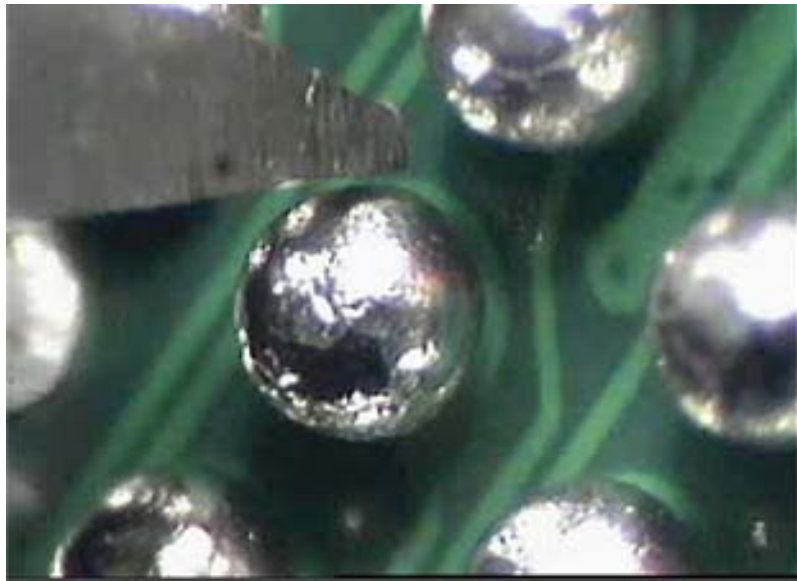
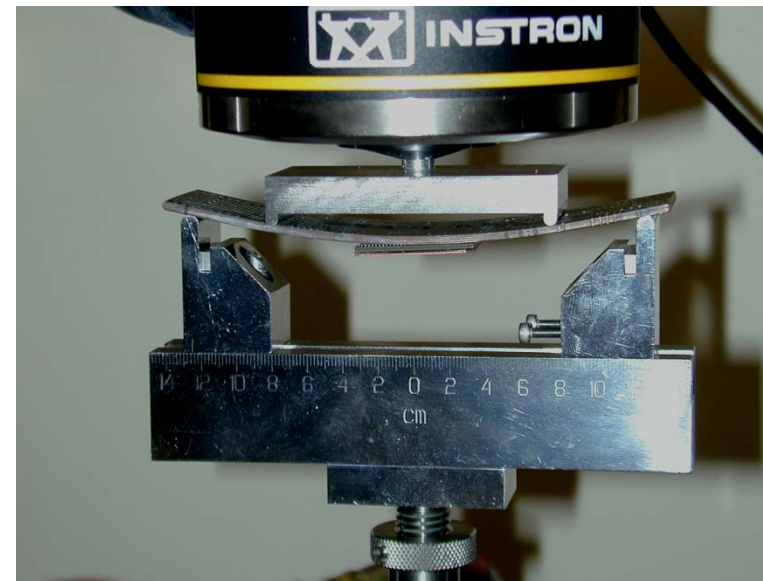
BGA Ball Shearing Test **Four point bending test fixture and setup**

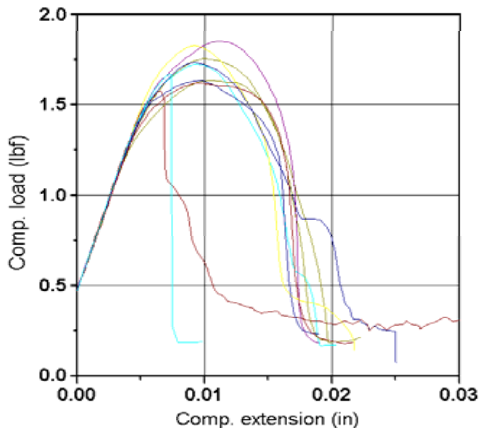
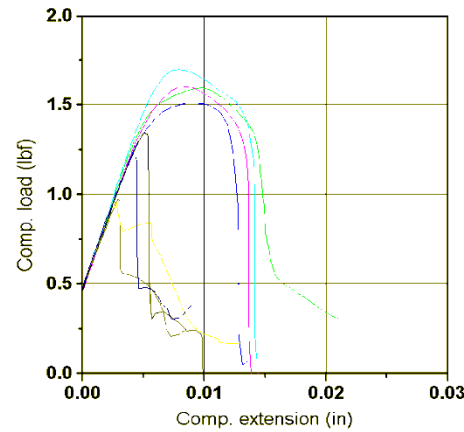
Ball shearing test results for BGA balls with:
a) zero rework
b) one rework
c) two rework
d) three rework
e) 5 rework

- BGA solder ball strength was not reduced significantly after repair / rework operation from one up to five cycles.
- There is no indication from mechanical tests and cross-section optical / SEM analyses that this thick intermetallic layer would reduce the strength of BGA solder balls
- The bonding strength of the copper pads to the laminates is reduced with rework/repair operation.

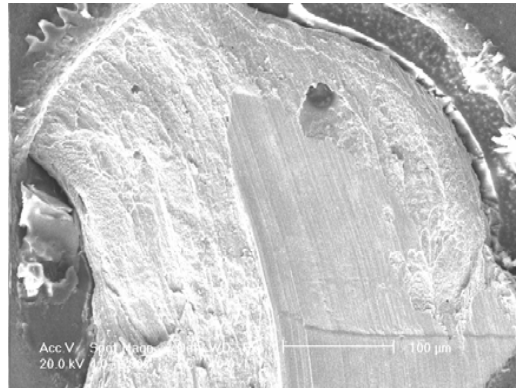
SEM pictures of pad's surfaces after ball shear tests

Ball shearing test
results for BGA balls
with:

- a) zero rework
- b) one rework
- c) two rework
- d) three rework
- e) 5 rework
