# Reliability of Embedded Planar Capacitors: A Review

Michael H. Azarian, Ph. D.

**Center for Advanced Life Cycle Engineering (CALCE)**

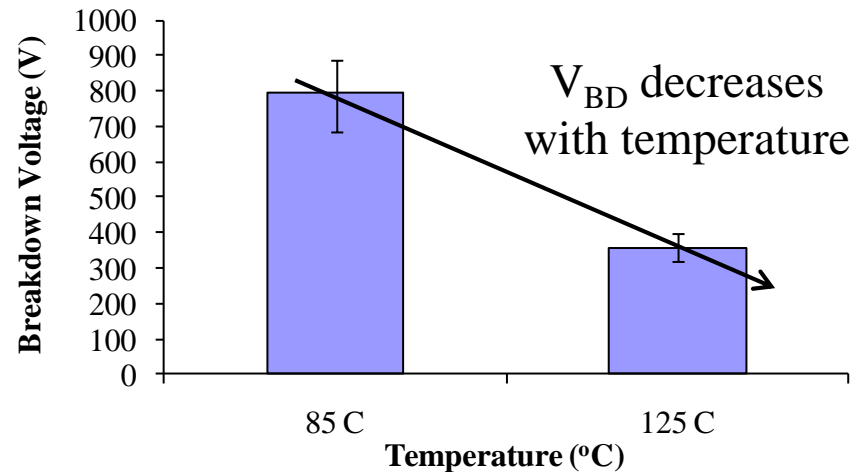
Measurement of breakdown voltage ( $V_{\text{BD}}$ ) on 10 small capacitors

- The reduction in the breakdown voltage with temperature can be explained by an increase in free volume of the polymer matrix.

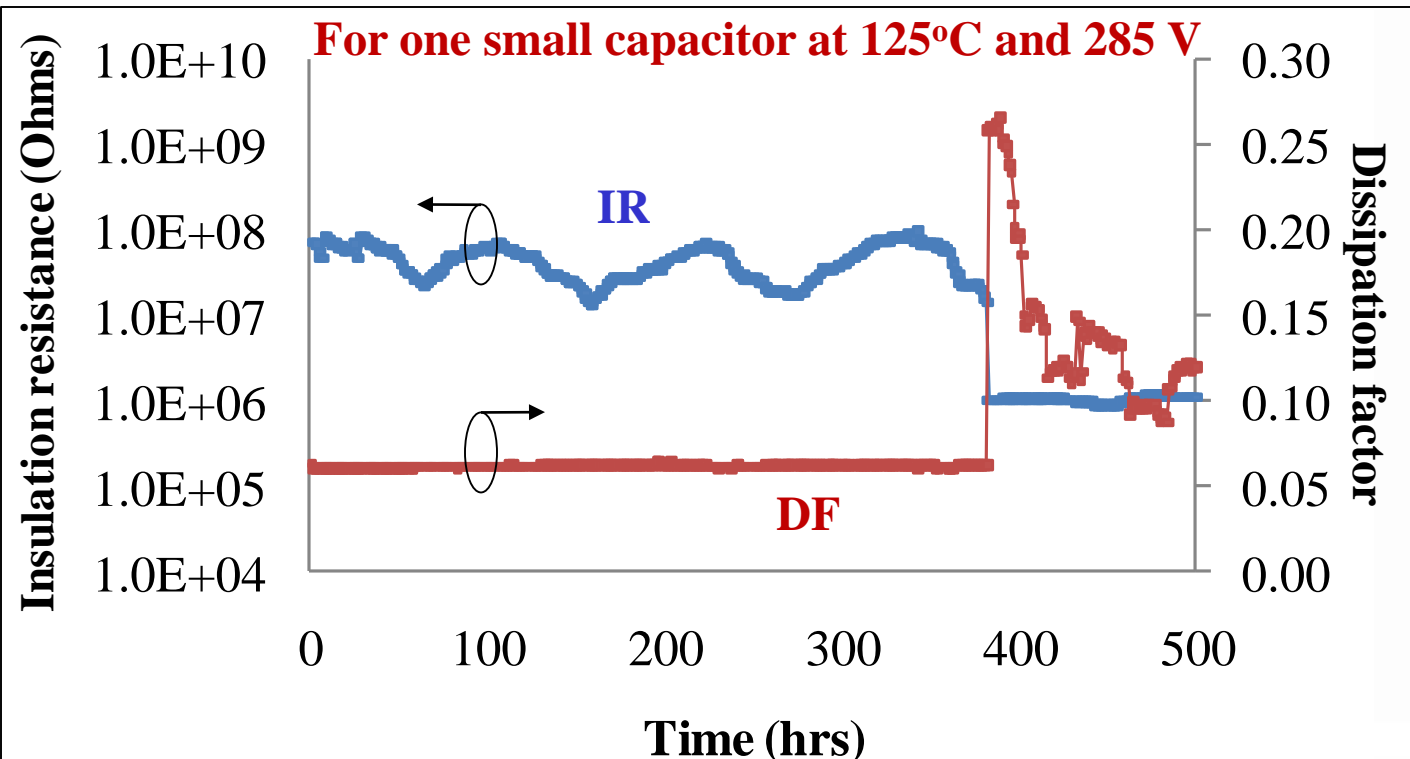
Avalanche breakdown of  
the dielectric

- There was no trend in the values of IR or DF before failure.

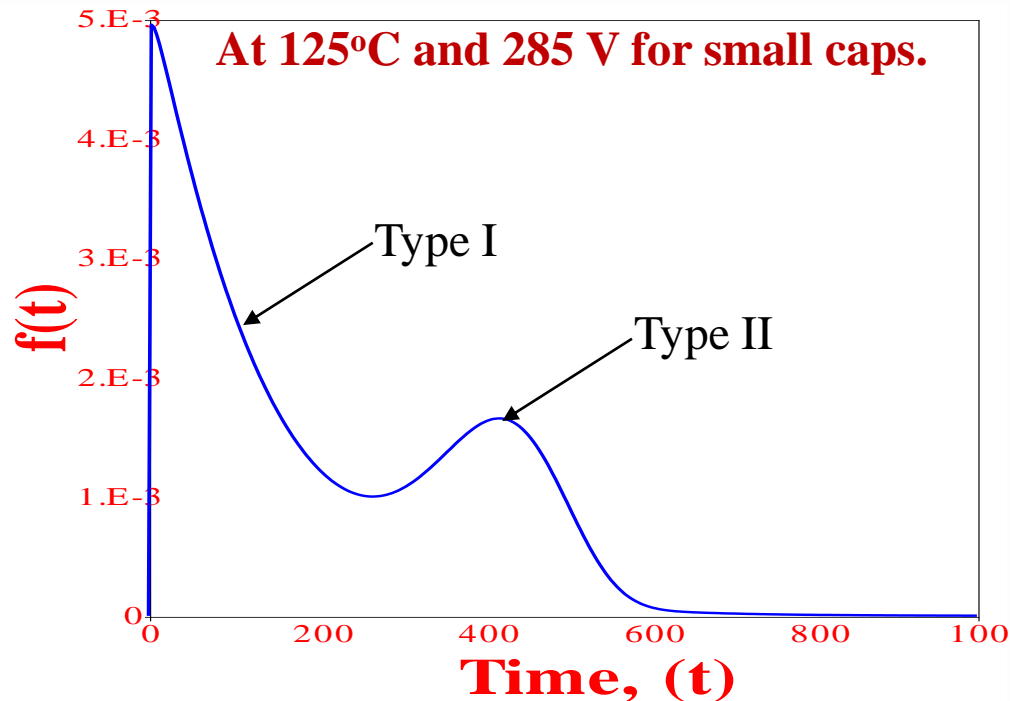
# Lifetime Modeling of Avalanche Breakdown Failures

- At all stress levels, the time-to-failure was observed to follow a **bimodal distribution**:
  - A mixed Weibull with 2 subpopulation was used to calculate the mean time to failure (MTTF).

- A shorter time-to-failure (all Type I) of large capacitors implies that their failures were defect driven, whose probability increases with capacitor area.**
- Statistical analysis was not performed on large capacitors due to small sample size (4).

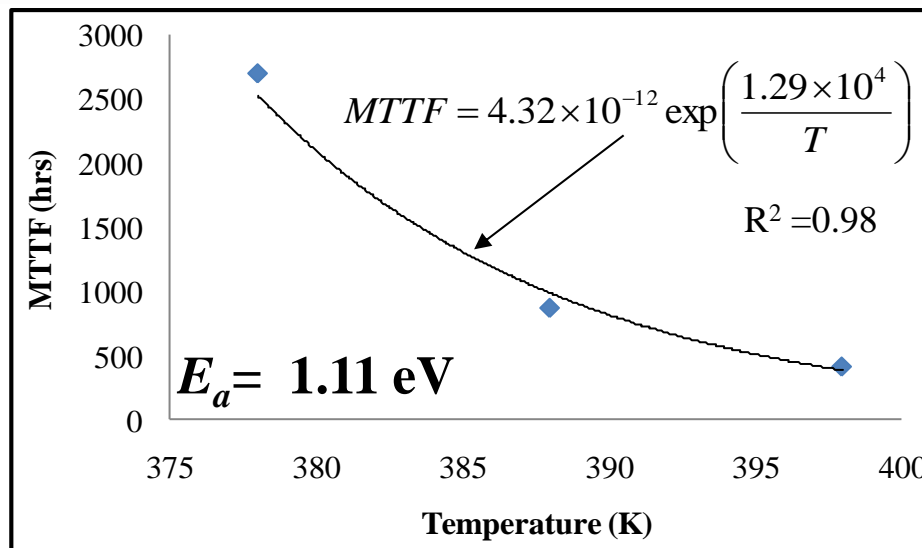
# Activation Energy ( $E_a$ ) of the Prokopowicz Model

Type I failures seem to be **random** ( $\beta \sim 1$ ) and Type II represent a **wear-out** mechanism ( $\beta > 1$ ) so only Type II failures were modeled.

$$MTTF = A \exp\left(\frac{E_a}{kT}\right)$$

- Type II (wear-out): Prokopowicz model is applicable
      - Values of constants  $n = 6.5$ ,  $E_a = 1.1$  eV; material, not size, dependent
  2. Gradual decrease in capacitance (*C*)

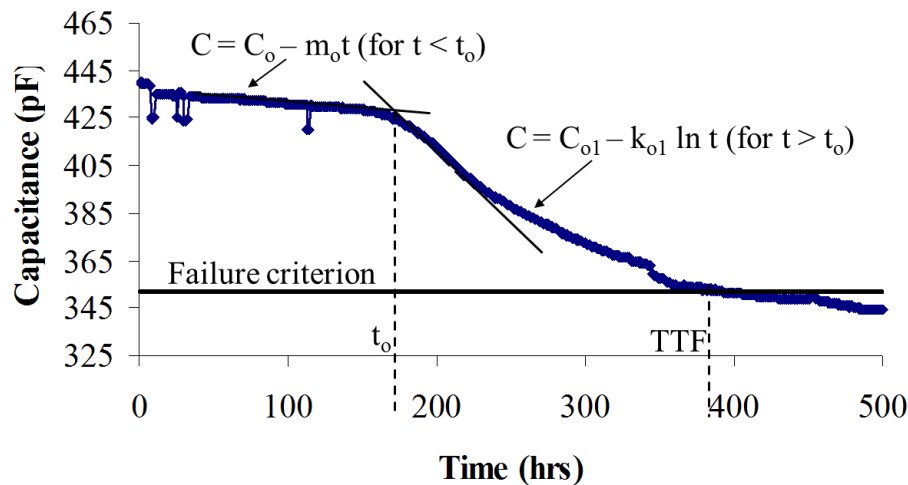
# Gradual Decrease in Capacitance

(Plot of Capacitance at 125°C and 285 V for Group B Capacitor)

- In small capacitors (group A) the onset of logarithmic degradation was delayed by a time which is referred to as  $t_o$ .
- The linear degradation region was absent in group B (large) capacitors.

Failures were not observed in group B (large) capacitors due to a large value of initial capacitance ( $C_{o1}$ ) as compared to group A.

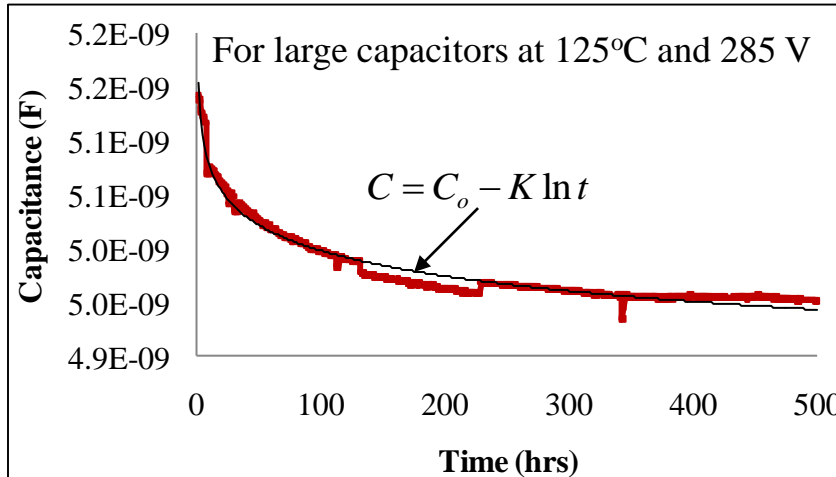
# Modeling the Decrease in Capacitance During HALT

Dielectric  
aging rate ( $K$ )

- Time-to-failure as a result of 20% decrease:

Initial capacitance ( $C_o$ ) of large capacitors was an order of magnitude higher

Dielectric aging rate ( $K$ ) is approximately the same for both capacitors

**No failures were observed in large capacitors (group B).**

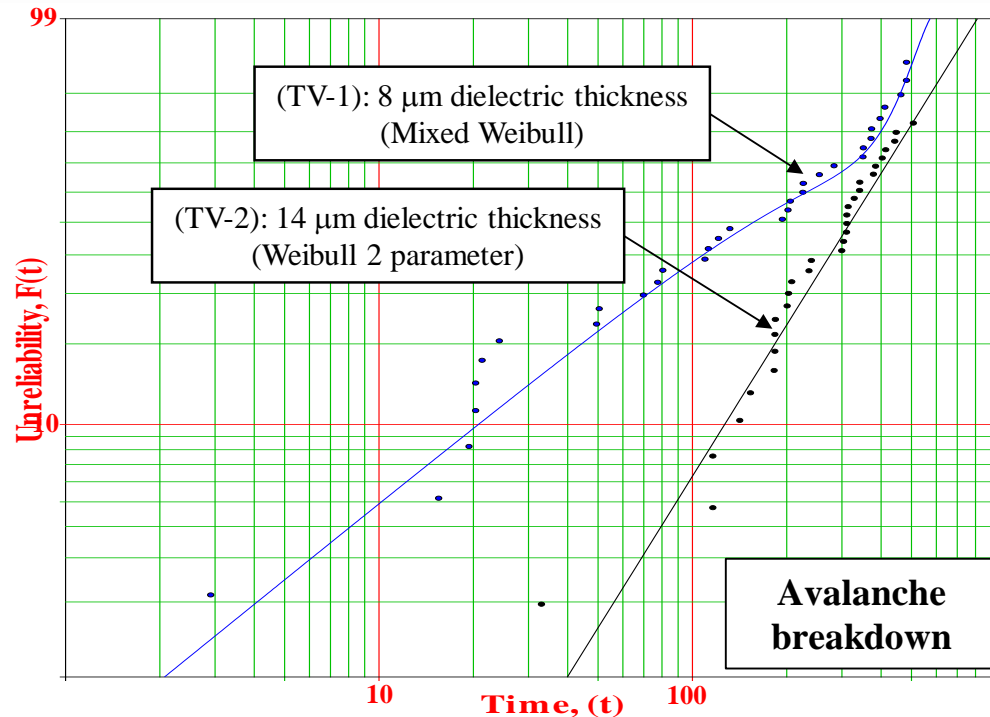
# Thickness Effect: 8 $\mu\text{m}$ versus 14 $\mu\text{m}$

Type I failures were not  
observed in TV-2 (14  $\mu\text{m}$ )

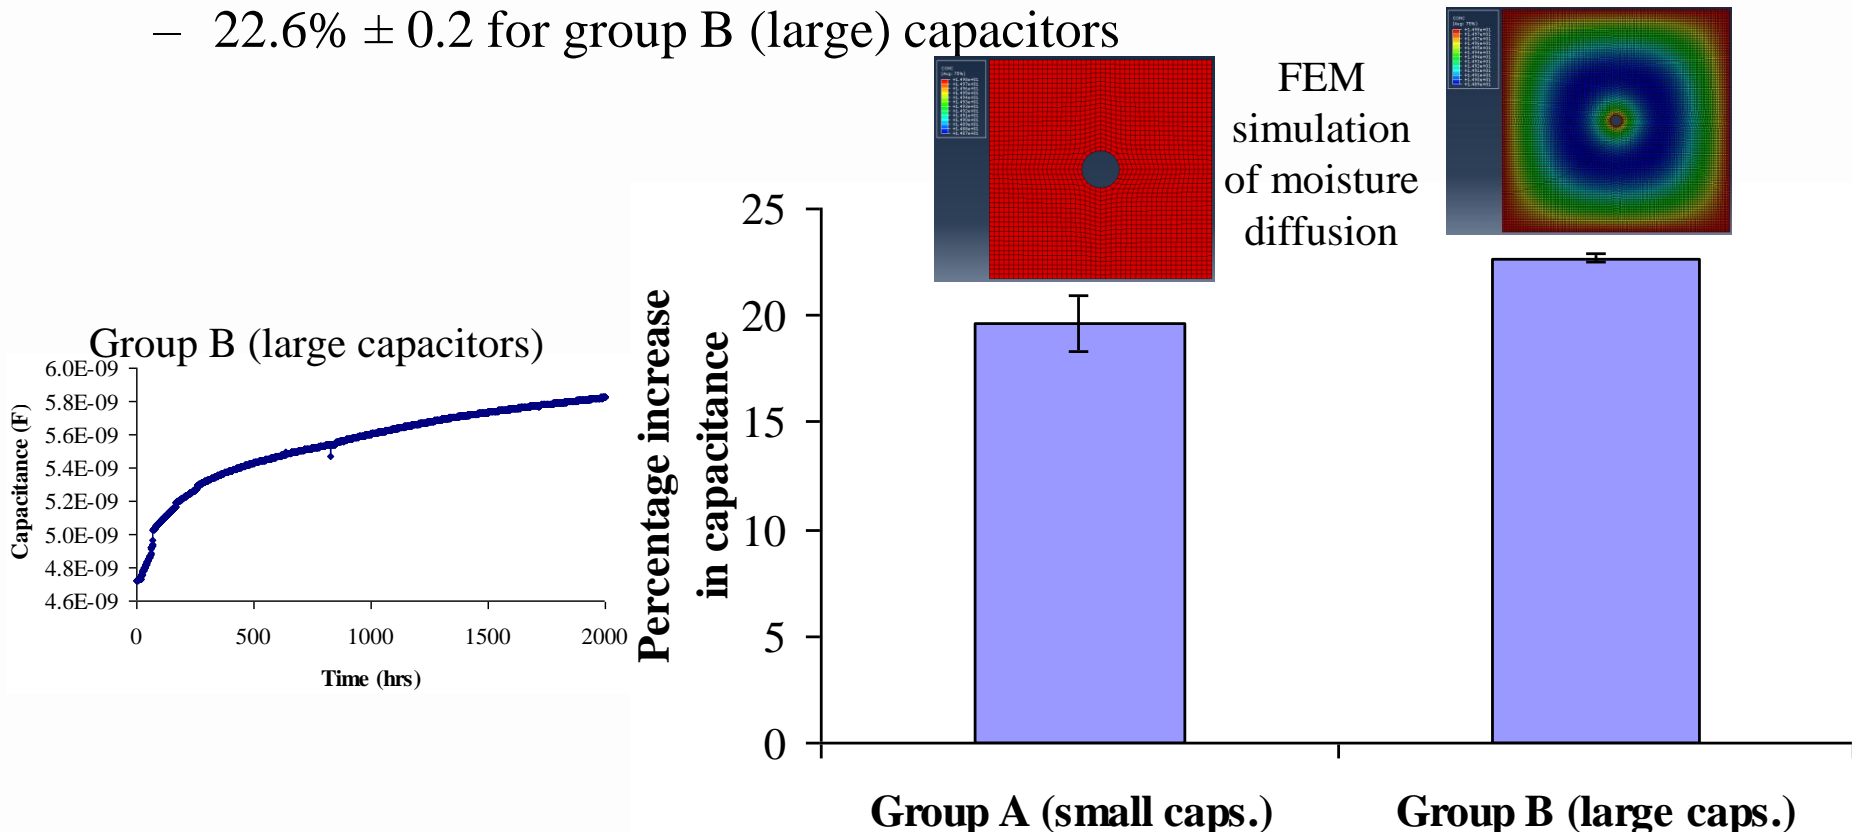
## Percentage Increase in Capacitance

- The increase in capacitance at 85°C, 85% RH and 0 V after 2000 hrs was
  - 19.6%  $\pm$  1.3 for group A (small) capacitors
  - 22.6%  $\pm$  0.2 for group B (large) capacitors

- The capacitance returned to its pre-THB value during a bake at 125°C in about 20 hrs.

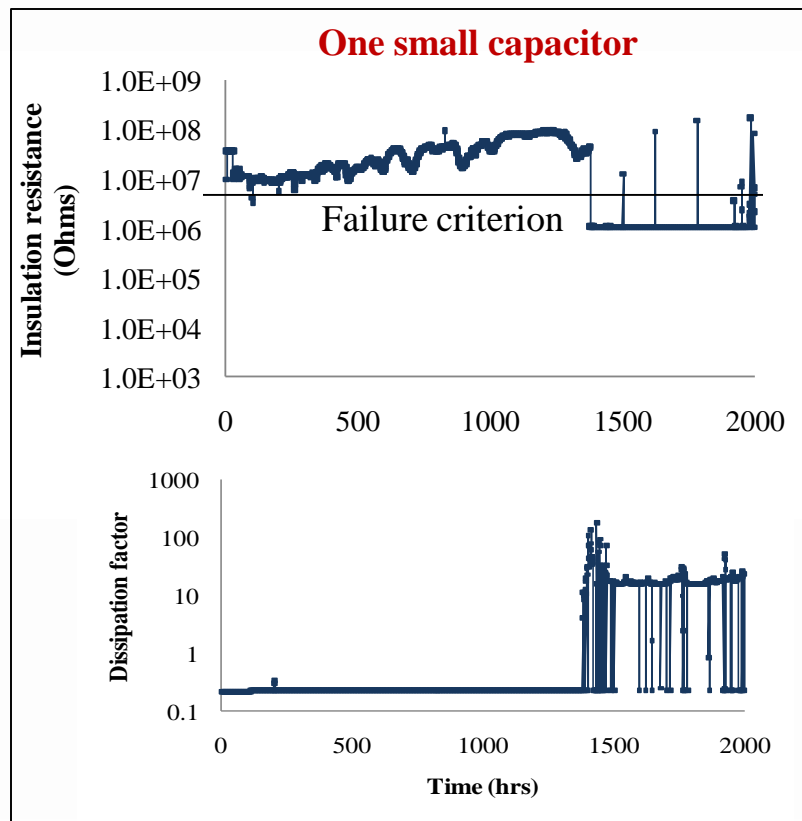
# Results of Temperature-Humidity-Bias (THB) Tests (85°C, 85% RH, and 5 V)

IR failures as a result of formation of a conduction path were observed :

- **6/36** small capacitors and **2/4** large capacitors failed by this mode.

All failures as a result of formation of a conduction path disappeared after baking at 125°C for several days.

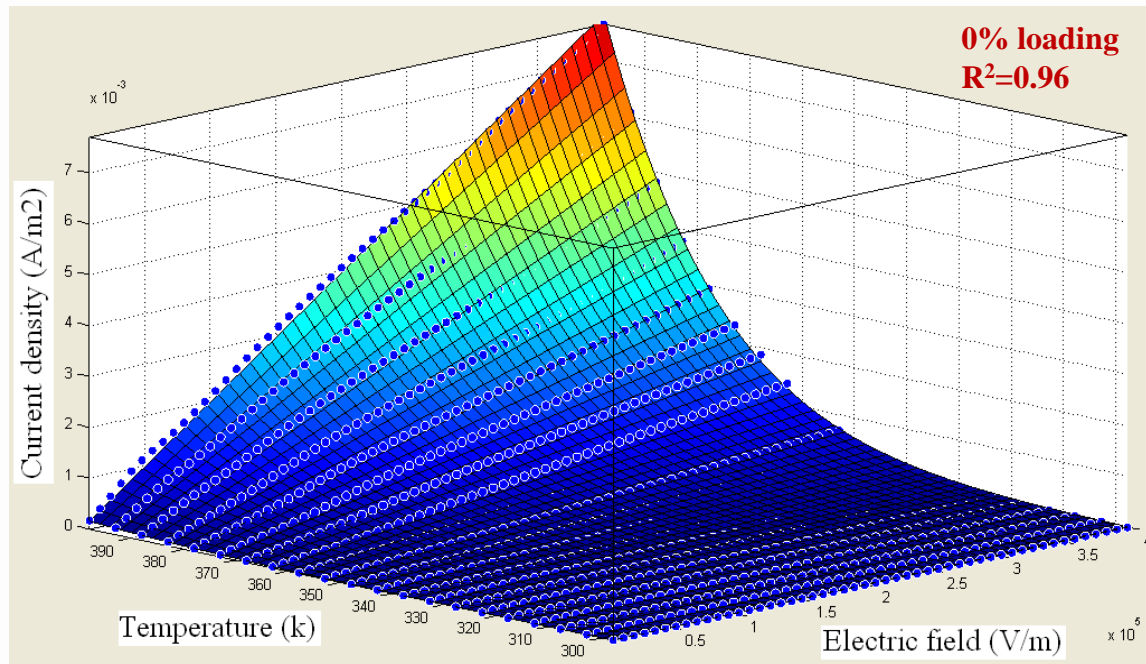
## 3D Regression of the Leakage Current Data (To Calculate the Activation Energy of Ionic Hopping)

- 3D regression was performed on the leakage current data.
- The goodness of fit ( $R^2$ ) for ionic hopping conduction was greater than 0.90 for all loading conditions, which indicated that hopping was the dominant conduction mechanism (as opposed to Schottky or Poole-Frenkel).

$$J \approx A \left( \frac{E}{T} \right) \exp \left( - \frac{E_a}{kT} \right)$$

$E_a$  is a function of particle diameter and loading ( $\sim 0.9$  eV,  $< 40$  vol%).

- The leakage current was found to be governed by the **ionic hopping mechanism**
- The activation energy for ionic hopping was determined
  - $E_a$  is a function of particle diameter and loading
  - $E_a \approx 0.9$  eV, for loadings less than or equal to about 40 vol%
- The leakage current in the dielectric was found to increase
  - with an increase in the ceramic loading
  - with an increase in the particle diameter
