## **JCAA/JG-PP No-Lead Solder Project: -55°C to +125°C Thermal Cycle Testing Status Report**

David Hillman and Sarah Olson  
Rockwell Collins Inc.  
Cedar Rapids Iowa

### **Abstract**

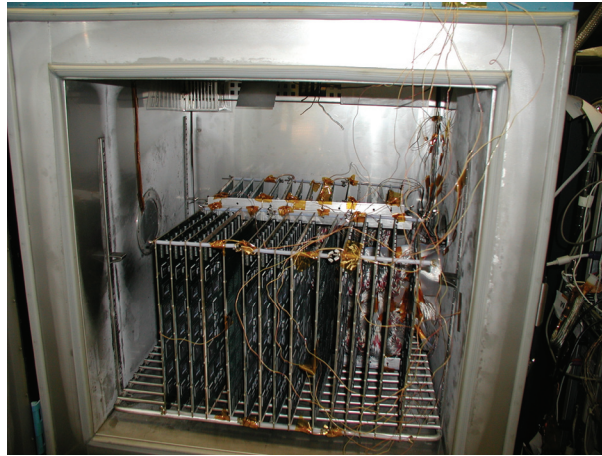
**Figure 4.** Test vehicles loaded into the -55°C to +125°C test chamber.

Once a solder joint was designated a failure, the event detection system software excluded it from the remainder of the test. Detailed temperature profiling was conducted prior to the beginning of the thermal cycle conditioning to insure that each test vehicle was subjected to uniform, consistent exposure to the test chamber temperatures. In the Rockwell Collins testing, a total of 15 manufactured test vehicles and 15 legacy test vehicles were placed in the chamber. Figure 3 illustrates the thermal cycle temperature profile for the -55°C to +125°C testing and the resulting measured test vehicle temperatures with a time lag due to thermal inertia. Figure 4 illustrates the test vehicles positioned in the -55°C to +125°C test chamber.

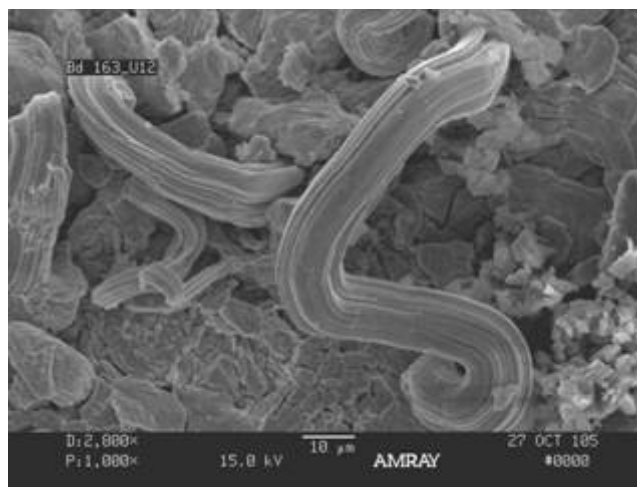
**Figure 12. High magnification SEM image of TSOP component with SnCu surface finish showing individual tin whisker on upper knee of lead (Component U12, test vehicle 163)**

Figures 10-14 illustrate typical tin whiskers found on the TSOP components with SnCu surface finish. This TSOP component was from the legacy test vehicle. It was originally reflow soldered with a SnPb solder alloy and then manually reworked with a SAC solder alloy as part of the overall rework impact segment of the investigation test matrix (Figure 2). Tin whiskers were found on lead surfaces that were not soldered (the upper knees of the component leads and lead faces) and would be characterized as dense fields with a “worm-like” appearance. SEM EDX analysis was used to confirm that the whiskers were comprised of tin (Figure 15).
