## JCAA/JG-PP Lead Free Solder Project: Combined Solder Project: Combined Environments Test

Jeff Bradford, Joe Felty, Bill Russell  
Raytheon Company  
McKinney, Texas

A combined environment testing was conducted for the Joint Council on Aging Aircraft/Joint Group on Pollution Prevention Lead free Solder project. The purpose of the project was to validate and demonstrate lead free solders as potential replacements for conventional tin-lead solders used on circuit card assemblies against the requirements of the aerospace and military electronics community.

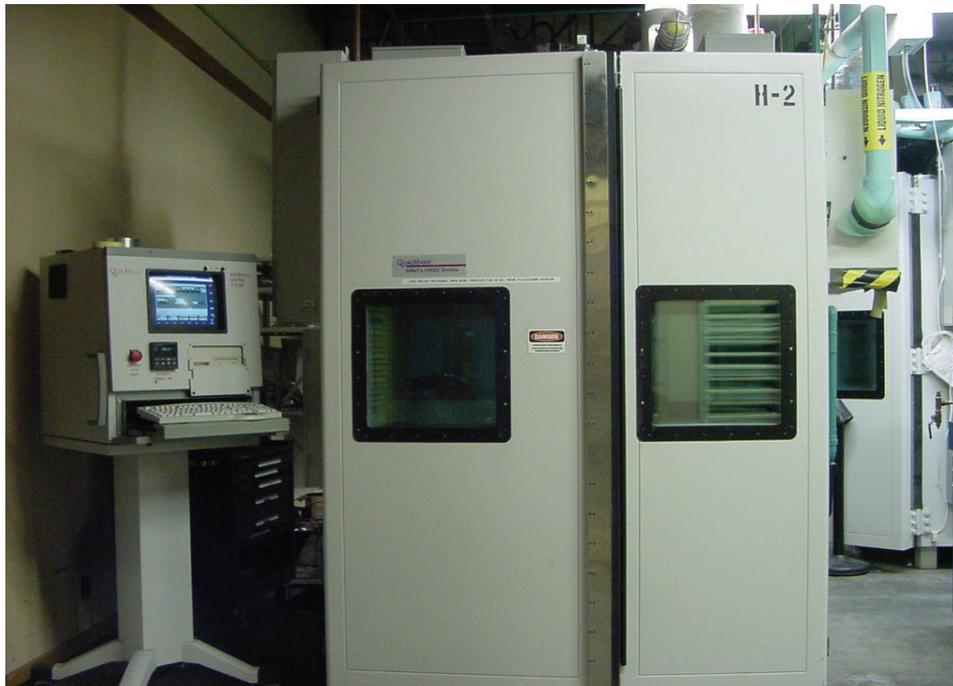
**The CET was conducted using a QualMark Model OVS-4 HALT/HASS chamber. The chamber was located in the Raytheon Environmental Test Laboratory (ETL) in McKinney, Texas. A photograph of the chamber is provided in Figure 1.** The chamber utilizes liquid nitrogen for cooling and nichrome heater elements for heating. The chamber has thermal capability ranges from -100 to 200 degrees Celsius with ramp rates of up to 60 degrees Celsius per minute. The pseudorandom vibration spectra is generated by pneumatically driven vibrators attached to the bottom of the table with maximum levels of 60 g<sub>rms</sub> and six degrees of freedom (X, Y, & Z axes with rotation in each axis simultaneously). The thermal and vibration environments can be applied separately or combined.

**Figure 1 - Qualmark Model OVS-4 HALT/HASS Chamber**

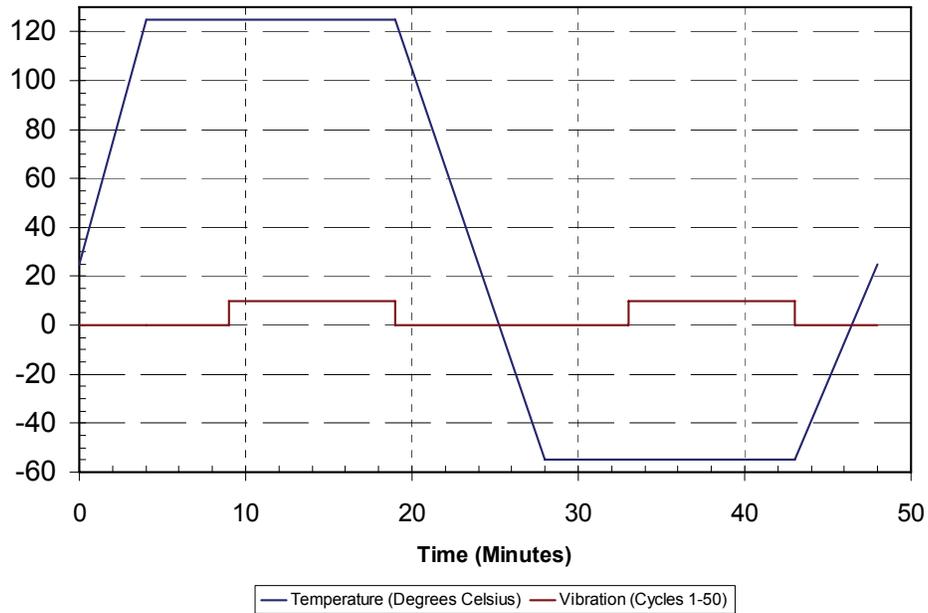
Figure 2. If significant failure rates were not evident after 50 cycles, the vibration levels were increased by 5 g<sub>rms</sub> and cycling was continued for an additional 50 cycles. This process was repeated until a significant number of solder joints failed or 55 g<sub>rms</sub> was reached. During cycles 501 through 550, vibration stress was applied continuously at 55 g<sub>rms</sub> during the thermal cycle. The test was stopped after 550 cycles.

Figure 2 - Initial Combined Environments Test Profile

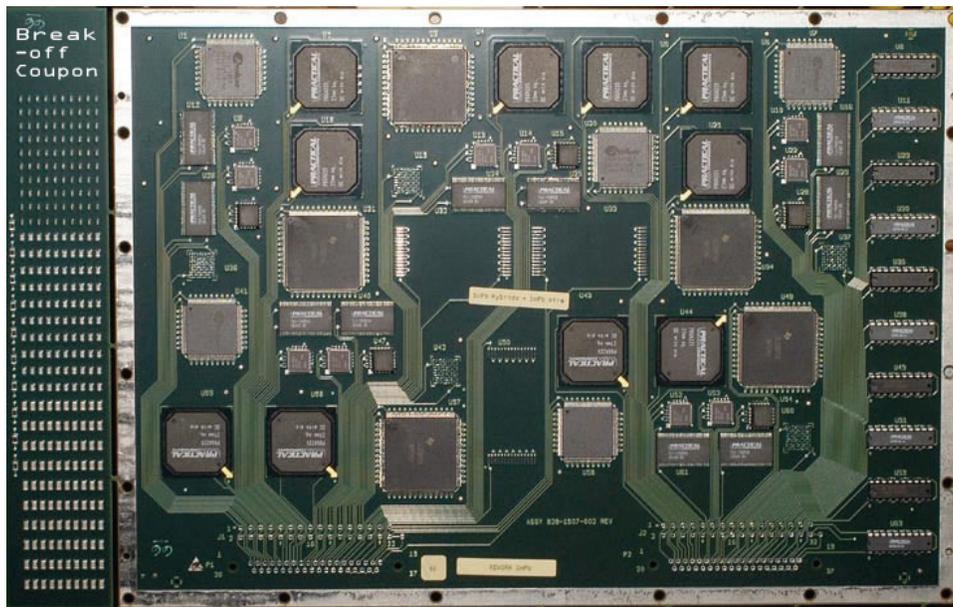
**Figure 3 - Manufactured Test Vehicle**

The test vehicle printed circuit board was designed with daisy-chained pads that were complementary to the daisy chain in the components. Therefore, the solder joints on each component were part of a continuous electrical pathway that was monitored during testing by an event detector. To eliminate premature failures that might be caused by vias and plated-through holes, each component had its own distinct circuit trace on the top surface of the board. Failure of one solder joint on a component during testing broke the continuous electrical pathway and was recorded as an event.

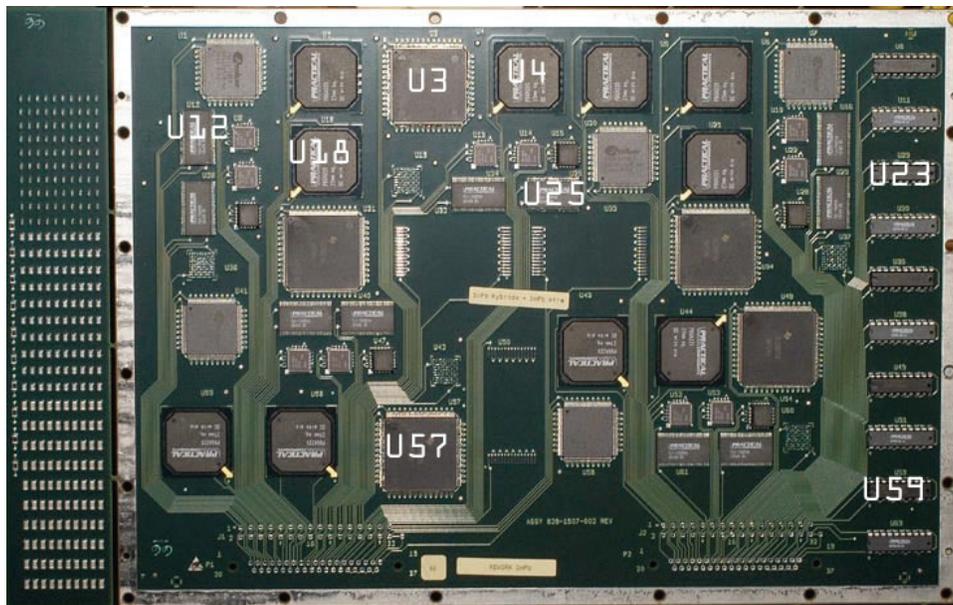
The purpose of the rework test vehicle was to simulate the construction of older, legacy military circuit card assembly technology for testing the suitability of using lead free solder in repairing older hardware built with tin-lead solder. The reason for including rework test vehicles in the test program was to determine if mixing lead free and a tin-lead solder on the same circuit card assembly had an adverse effect on part reliability. The rework consisted of component replacement on tin-lead assemblies using lead free solder.

**Figure 4 - Rework Test Vehicle Showing Reworked Component Reference Designators**

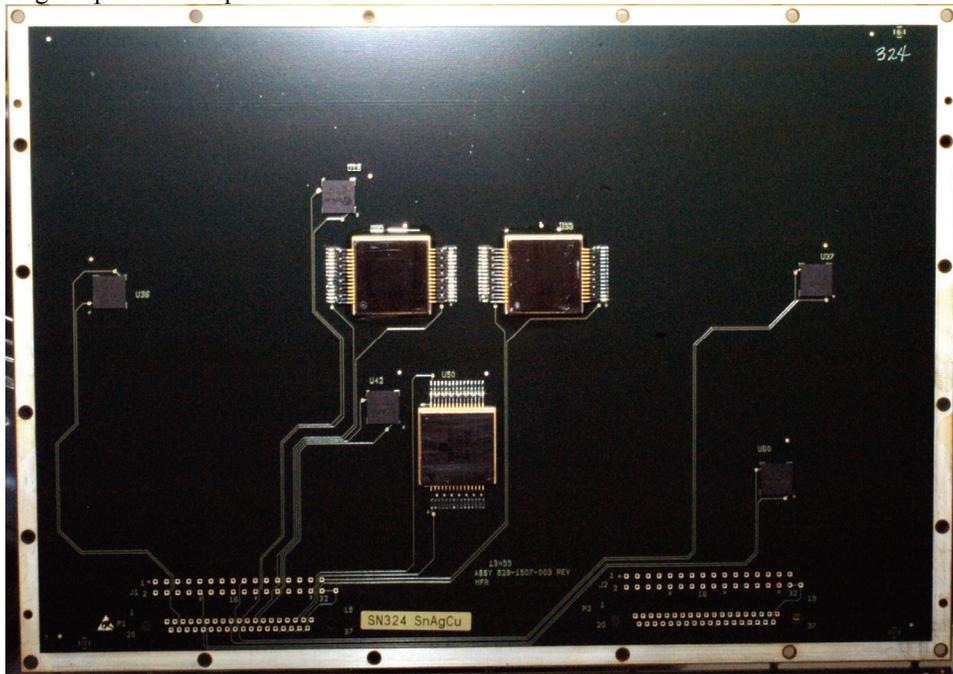
Figure 5. The board included three hybrid and five chip scale package components. The test vehicle did not have the break-off coupon containing the passive components.

**Figure 5 - Photograph of Hybrid Test Vehicle**

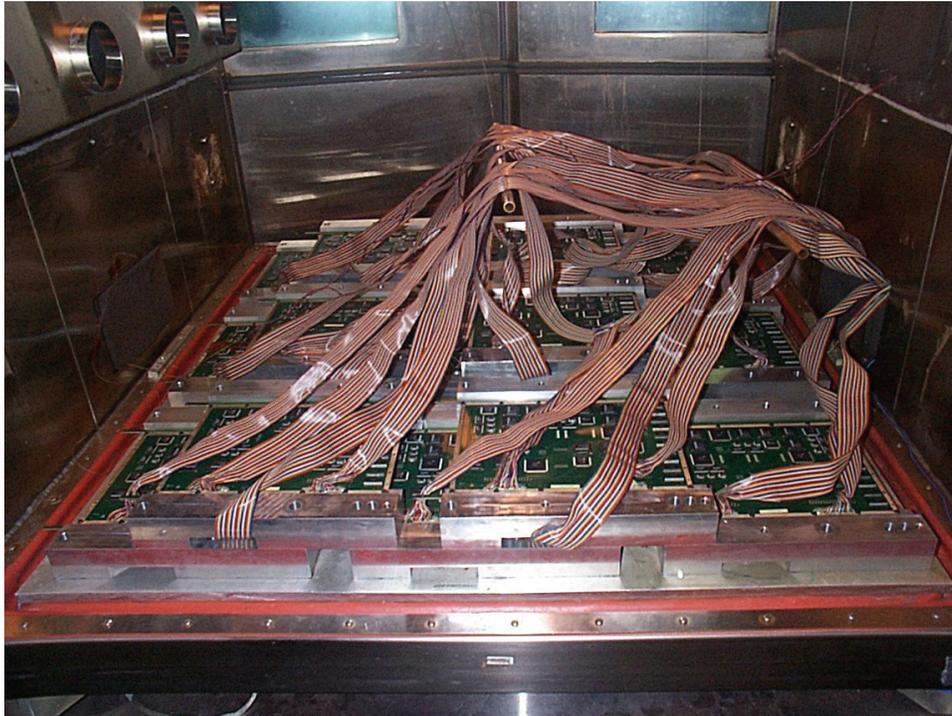
Figure 6). The test vehicles were loaded in the fixture in random order.

**Figure 6 - Test Vehicle Layout in Test Chamber**

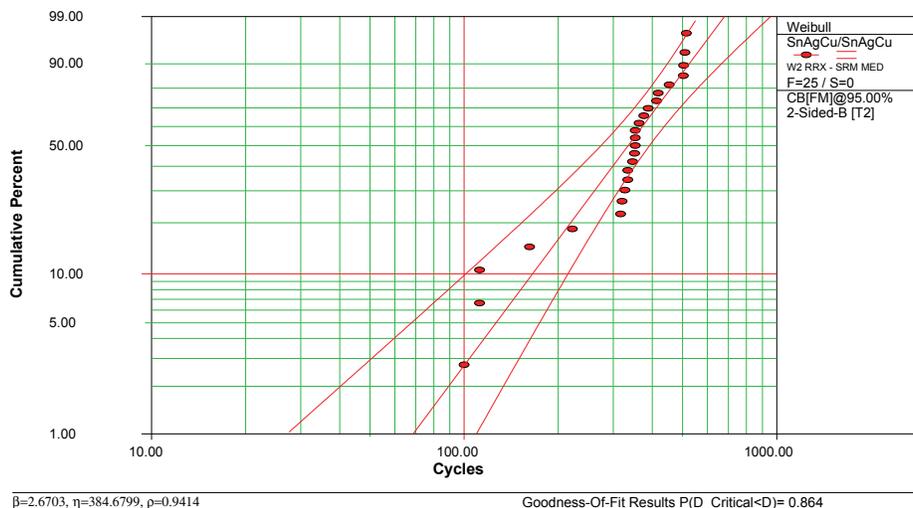
**Figure 7 - Tin-Silver-Copper BGA-225 with Tin-Silver-Copper Solder Paste on Manufactured Test Vehicles**

data indicating possible changes in stresses applied to the test vehicle or multiple failure modes in the solder joint failures. This stairstep was evident on other Weibull plots for other components. Many of the vertical jumps in the data occur where step increases in the vibration levels occurred as part of the test plan. The test logs were reviewed for potential chamber problems or test procedural issues. No other common cause for the stairstep could be identified.

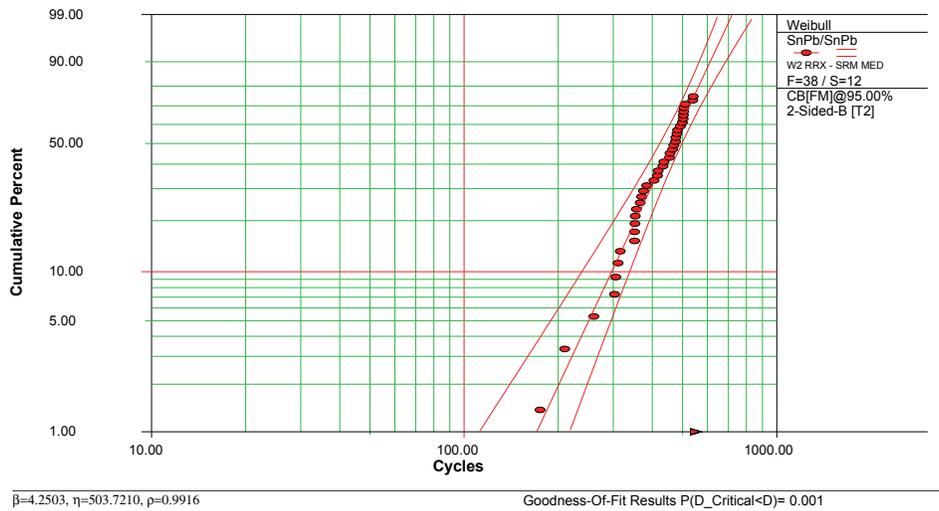
Figure 8. The 2-parameter Weibull model is an excellent fit of the data since all of the data fit inside the 95-percent confidence limits and the goodness-of-fit result is near zero. The improved fit is probably a result of the larger sample size for these components. As a result of the test vehicle and experimental design, there were twice as many tin-lead soldered tin-lead BGA-225 components as the lead free BGA-225 component combinations (50 vs. 25).

**Figure 8 - Tin-Lead Soldered Tin-Lead BGA-225 on Manufactured Test Vehicles**

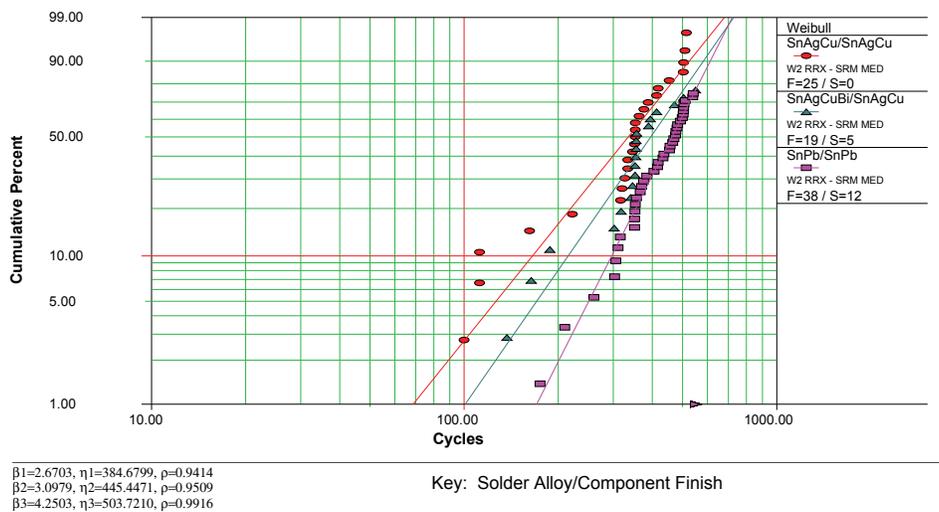
Figure 9 contains Weibull plots of tin-silver-copper BGA-225 components soldered with lead free solders compared to tin-lead BGA-225 components soldered with tin-lead solder. The plot shows tin-lead solder performed best with tin-silver-copper-bismuth solder ranked second and tin-silver-copper solder ranked last.

**Figure 9 - Lead free Soldered Tin-Silver-Copper BGA-225 Compared to Tin-Lead Soldered Tin-Lead BGA-225 on Manufactured Test Vehicles**

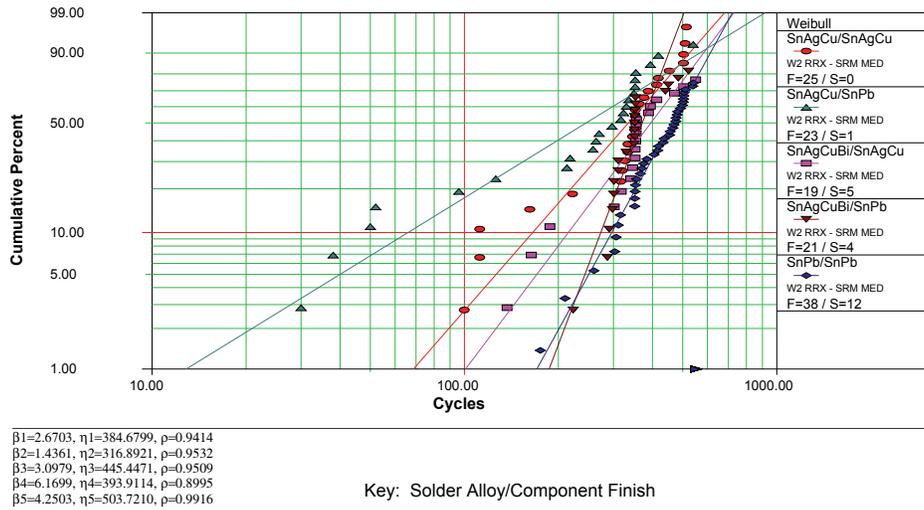
Figure 10 contains the Weibull plots for all of the combinations of component finish and solder alloy for the BGA-225 components on the manufactured test vehicles. Overall, tin-lead soldered tin-lead BGA-225 components were the most reliable.

Figure 10 - BGA-225 on Manufactured Test Vehicles

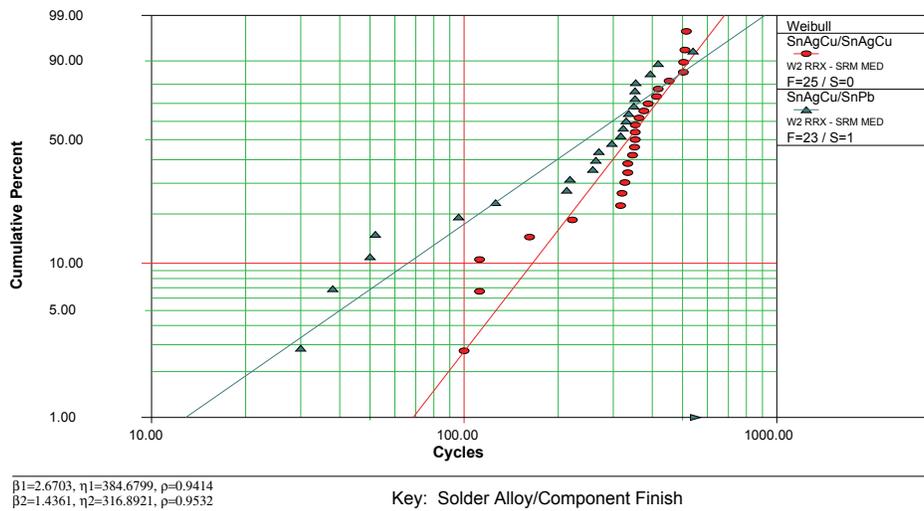
The effect of tin-lead contamination on tin-silver-copper soldered BGA-225 components is shown in Figure 11. The plots show tin-lead degrades the early life performance of tin-silver-copper while the N(63%) values are similar.

Figure 11 - Effect of Tin-Lead Contamination on Tin-Silver-Copper Soldered BGA-225 on Manufactured Test Vehicles

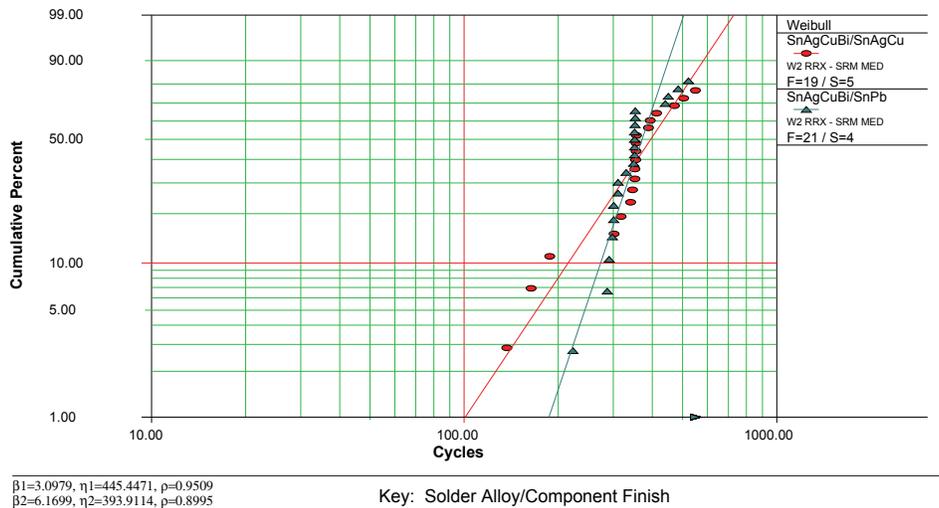
**Figure 12 - Effect of Tin-Lead Contamination on Tin-Silver-Copper-Bismuth Soldered BGA-225 on Manufactured Test Vehicles**

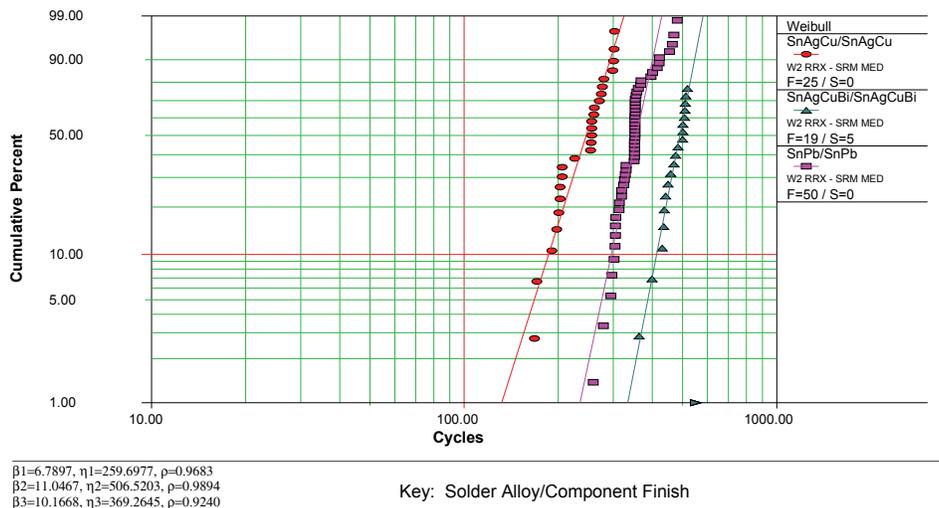
Figure 13 contains Weibull plots of tin-silver-copper CLCC-20 components soldered with tin-silver-copper and tin-silver-copper-bismuth CLCC-20 components soldered with tin-silver-copper-bismuth compared to tin-lead CLCC-20 components soldered with tin-lead. The results were distinguishly different between the three samples. CLCC-20 components soldered with tin-silver-copper-bismuth solder performed best. CLCC-20 components soldered with tin-lead solder were ranked second and CLCC-20 components soldered with tin-silver-copper solder ranked last.

**Figure 13 - Lead free Soldered Lead free CLCC-20 Compared to Tin-Lead Soldered Tin-Lead CLCC-20 on Manufactured Test Vehicles**

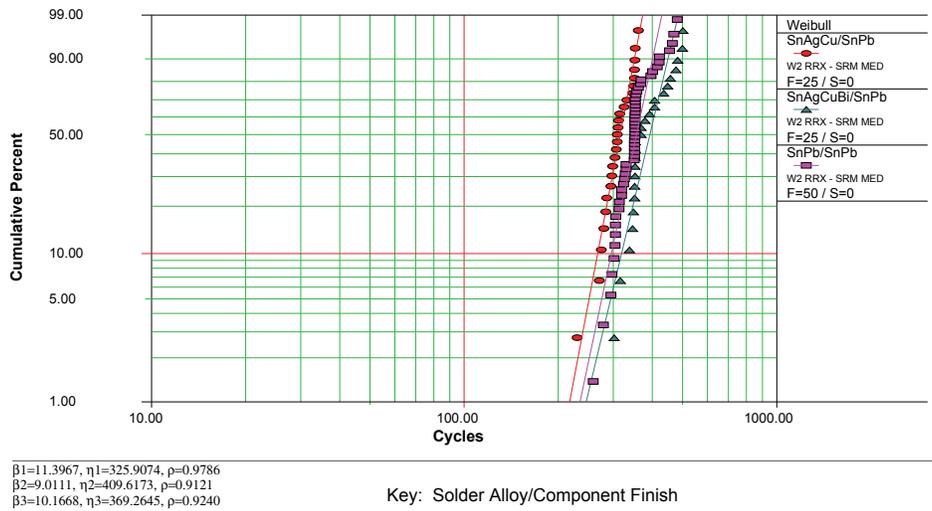
Figure 14 combines Weibull plots of tin-lead CLCC-20 components soldered with lead free solders compared to tin-lead soldered tin-lead CLCC-20 components. The plot shows similar results in the ranking of reliability performance for the three solder alloys as the previous plot but with smaller separation between the three fitted lines.

**Figure 14 - Tin-Lead CLCC-20 on Manufactured Test Vehicles**

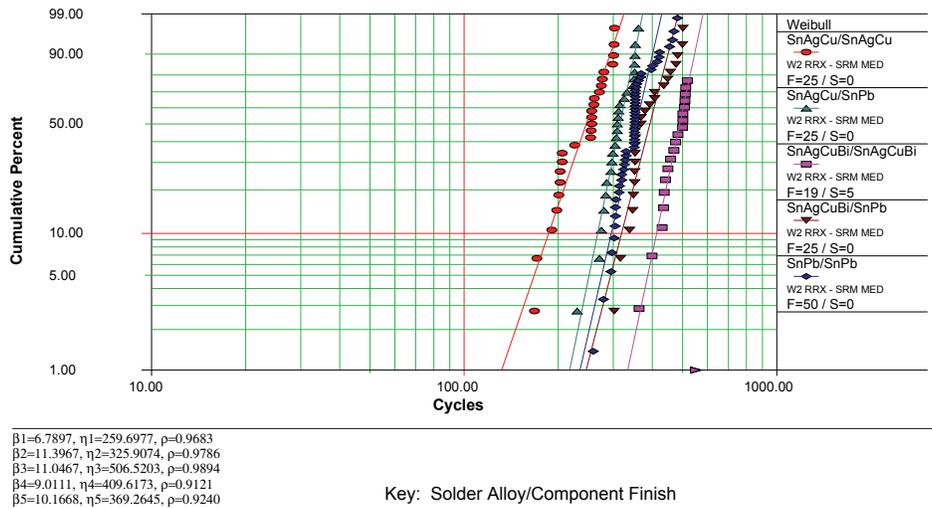
Figure 15 contains the Weibull plots for all of the combinations of component finish and solder alloy for the CLCC-20 components on the manufactured test vehicles. Overall, tin-silver-copper-bismuth solder performed better than tin-lead solder and tin-lead solder performed better than tin-silver-copper solder. Specifically, the tin-silver-copper-bismuth CLCC-20 components soldered with tin-silver-copper-bismuth exhibited the best reliability. The tin-lead CLCC-20 components soldered with tin-silver-copper-bismuth were ranked second. The tin-lead CLCC-20 components soldered with tin-lead were ranked third. The tin-lead CLCC-20 components soldered with tin-silver-copper were ranked fourth. The tin-silver-copper CLCC-20 components soldered with tin-silver-copper were ranked last. While the tin-lead finish on the CLCC-20 appears to degrade the reliability when soldered with tin-silver-copper-bismuth solder, the tin-lead finish appears to improve the reliability with tin-silver-copper solder.

**Figure 15 - CLCC-20 on Manufactured Test Vehicles**

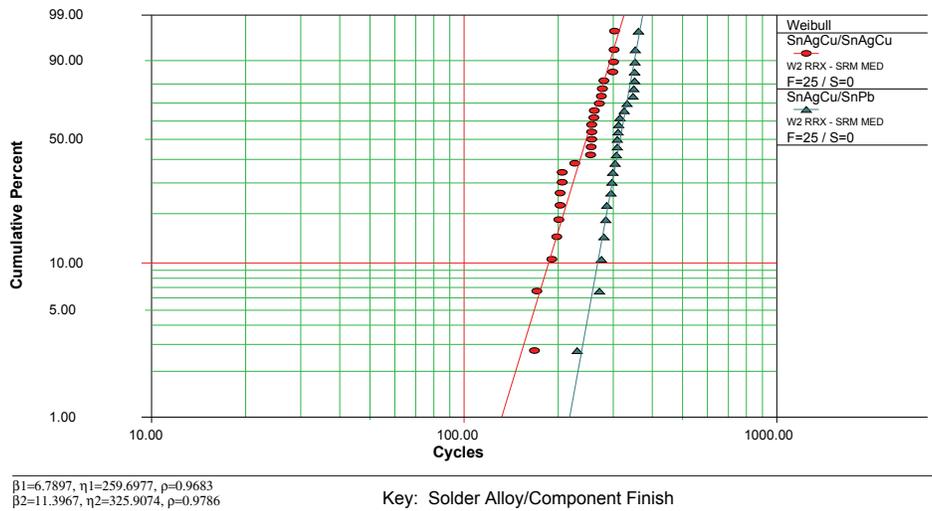
The effect of tin-lead contamination on tin-silver-copper soldered CLCC-20 components is shown in Figure 16. The presence of tin-lead appears to improve the reliability of the tin-silver-copper solder joint.

**Figure 16 - Effect of Tin-Lead Contamination on Tin-Silver-Copper Soldered CLCC-20 on Manufactured Test Vehicles**

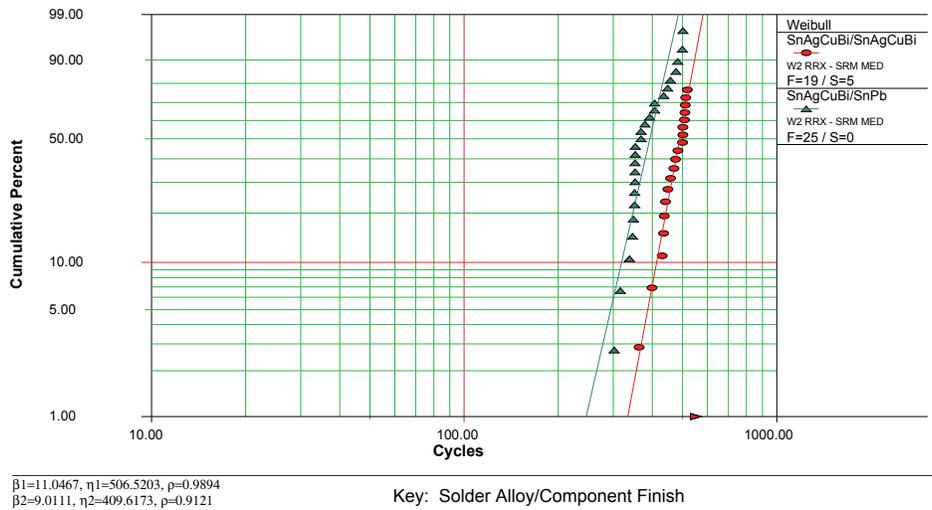
The effect of tin-lead contamination on the tin-silver-copper-bismuth soldered CLCC-20 components is shown in Figure 17. The presence of tin-lead appears to degrade the reliability of the tin-silver-copper-bismuth solder joint.

**Figure 17 - Effect of Tin-Lead Contamination of Tin-Silver-Copper-Bismuth Soldered CLCC-20 on Manufactured Test Vehicles**

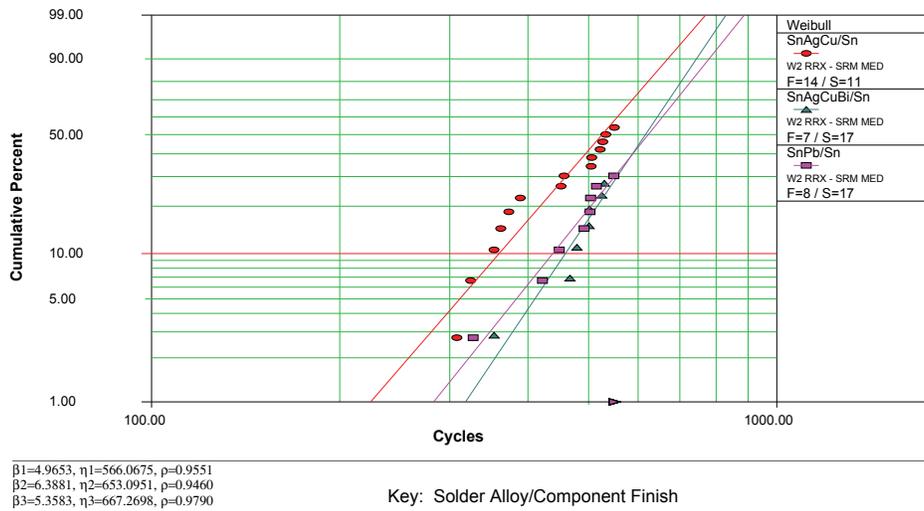
Figure 18 contains Weibull plots of tin-silver-copper and tin-silver-copper-bismuth soldered tin TQFP-144 components compared to tin TQFP-144 components soldered with tin-lead. The plot shows tin-silver-copper-bismuth solder performed equally as well as tin-lead solder and tin-silver-copper solder performed the worst.

**Figure 18 - TQFP-144 on Manufactured test vehicles**

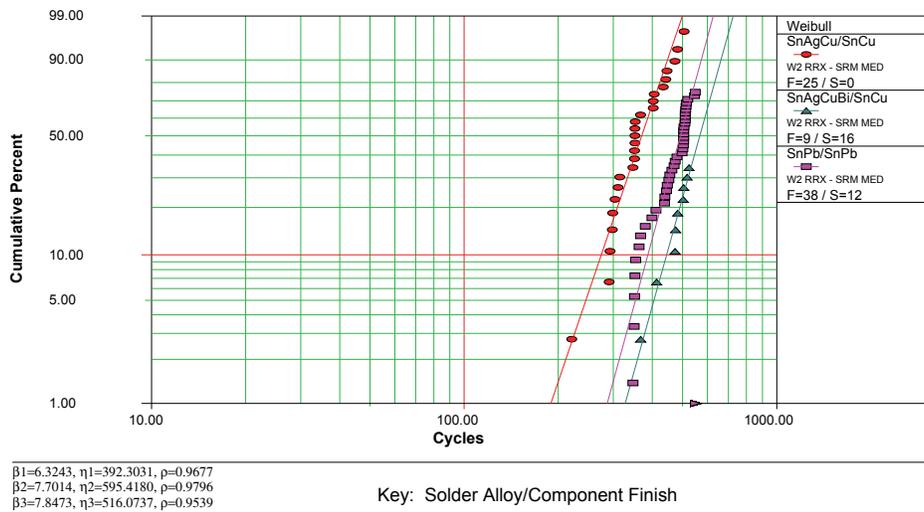
**Figure 19 - Lead free Soldered Tin-Copper TSOP-50 Compared to Tin-Lead Soldered Tin-Lead TSOP-50 on Manufactured Test Vehicles**

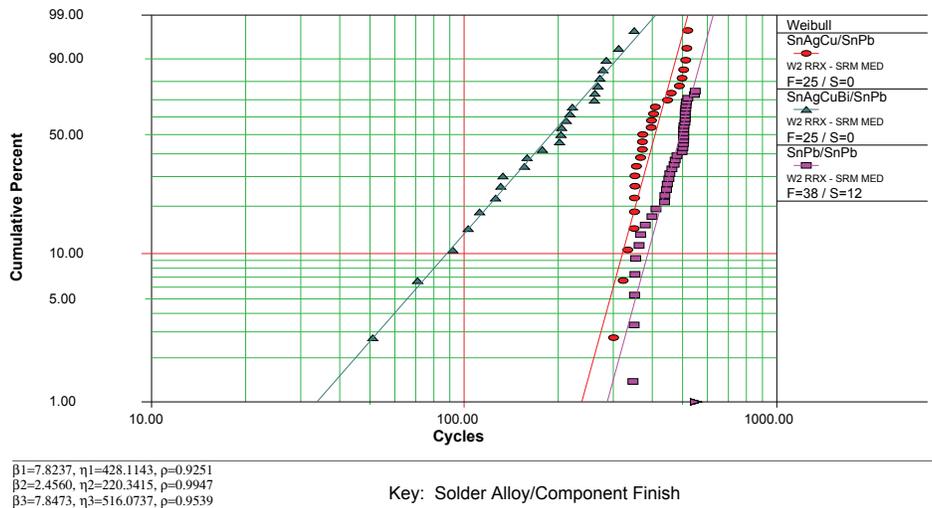
Figure 20 combines Weibull plots of tin-lead TSOP-50 components soldered with lead free solders compared to tin-lead soldered tin-lead TSOP-50 components. The plot shows tin-lead solder performed the best with tin-silver-copper ranked second and tin-silver-copper-bismuth ranked last.

**Figure 20 - Tin-Lead TSOP-50 on Manufactured Test Vehicles**

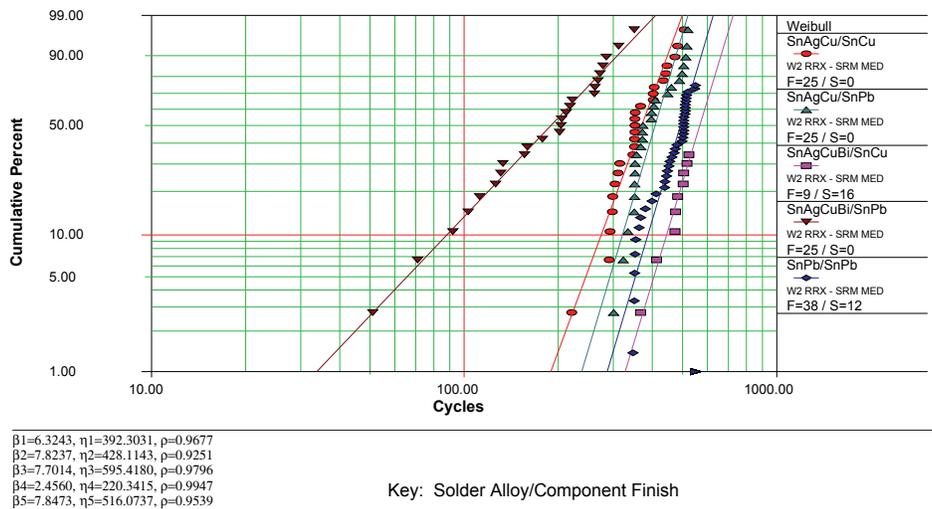
Figure 21 contains the Weibull plots for all of the combinations of component finish and solder alloy for the TSOP-50 components on the manufactured test vehicles. Overall, the tin-silver-copper-bismuth soldered tin-copper TSOP-50 components performed better than tin-lead soldered tin-lead TSOP-50 components. Tin-silver-copper soldered tin-lead TSOP-50 performed better than tin-silver-copper soldered tin-copper TSOP-50 components. While the tin-lead finish on the TSOP-50 appears to dramatically degrade the solder joint reliability when soldered with tin-silver-copper-bismuth solder, the tin-lead finish appears to slightly improve the reliability with tin-silver-copper solder.

**Figure 21 - TSOP-50 on Manufactured test vehicles**

This phenomenon is similar with the observation made on the CLCC-20 components. However, the degradation of tin-silver-copper-bismuth solder joint reliability due to tin-lead component finish appears to be inversely proportional to the amount of tin-lead finish on the component. The amount of tin-lead on the CLCC-20 component is much greater than the amount of tin-lead on the tin-lead TSOP-50 components relative to the resulting solder joint. This effect should be further investigated with destructive physical analysis of the tin-silver-copper-bismuth soldered tin-lead CLCC-20 and TSOP-50 components. Microsection analysis may reveal an intermetallic compound that is formed in the presence of lower lead contamination levels and that reduces the overall solder joint reliability.

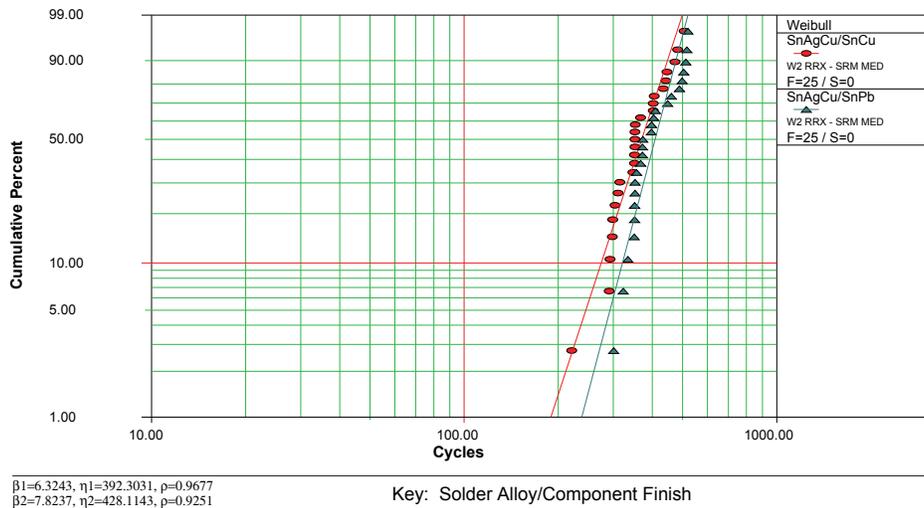
**The effect of tin-lead contamination on the tin-silver-copper soldered TSOP-50 components is shown in Figure 22.** The presence of tin-lead appears to slightly improve the reliability of the tin-silver-copper solder joint.

**Figure 22 - Effect of Tin-Lead Contamination of Tin-Silver-Copper Soldered TSOP-50 on Manufactured Test Vehicles**

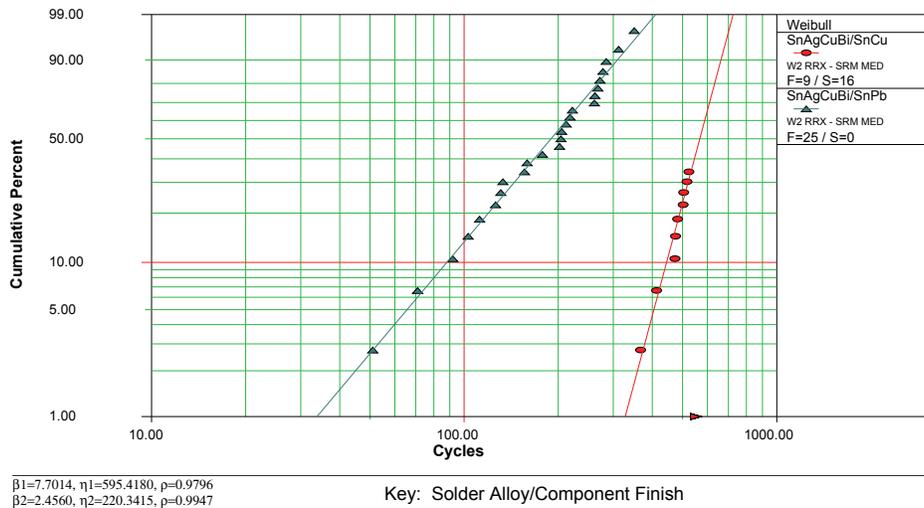
The effect of tin-lead contamination on the tin-silver-copper-bismuth soldered TSOP-50 components is shown in Figure 23. The presence of tin-lead appears to severely degrade the reliability of the tin-silver-copper-bismuth solder joint.

**Figure 23 - Effect of Tin-Lead Contamination on Tin-Silver-Copper-Bismuth Soldered TSOP-50 on Manufactured Test Vehicles**

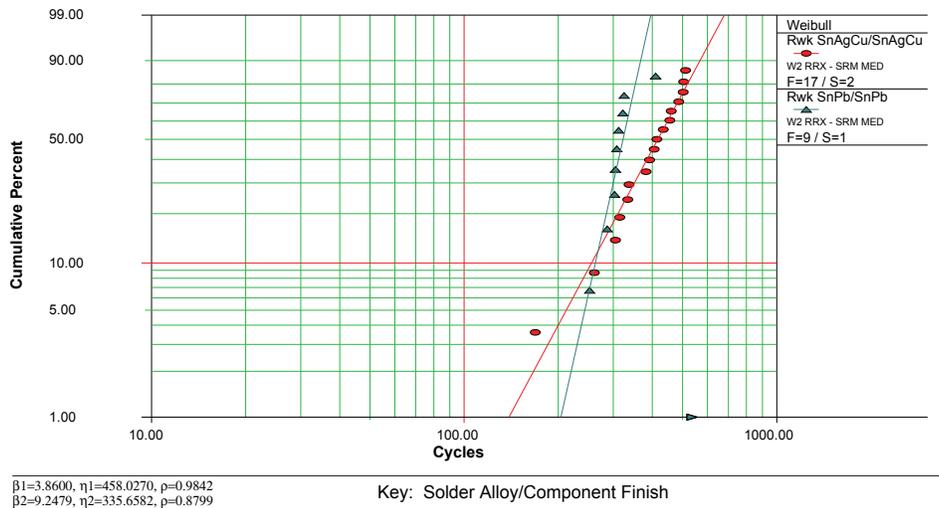
Figure 24 contains Weibull plots of reworked tin-silver-copper BGA-225 components compared to reworked tin-lead BGA-225 components. The plot shows both samples had performed similarly.

**Figure 24 - Reworked BGA-225 on Rework Test Vehicles**

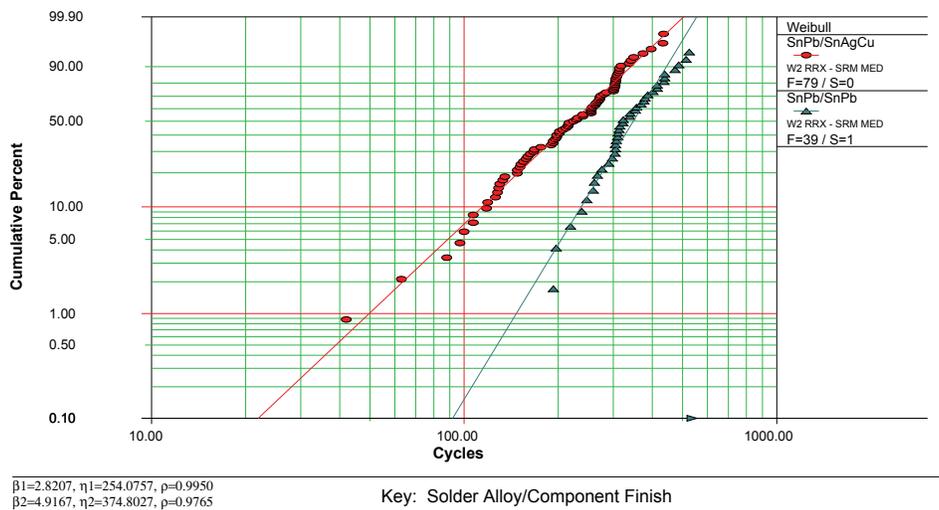
**Figure 25 - Unreworked BGA-225 on Rework Test Vehicles**

Figure 25 combines Weibull plots of unreworked tin-lead soldered tin-silver-copper BGA-225 components compared to unreworked tin-lead soldered tin-lead BGA-225 components. The plot shows tin-lead soldered tin-lead BGA-225 components perform better than the tin-lead soldered tin-silver-copper BGA-225 components. The use of a tin-lead solder profile during the solder reflow process may have been insufficient to cause the tin-silver-copper ball on the BGA-225 components to properly fuse with the tin-lead solder paste.

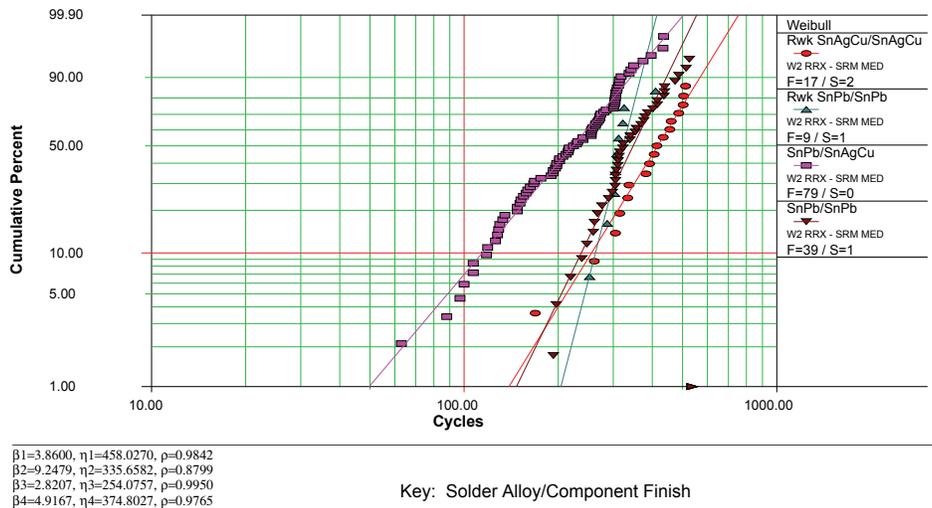
Figure 26 contains the Weibull plots for all of the combinations of rework status, component finish and solder alloy for the BGA-225 components on the rework test vehicles.

Figure 26 - BGA-225 on Rework Test Vehicle

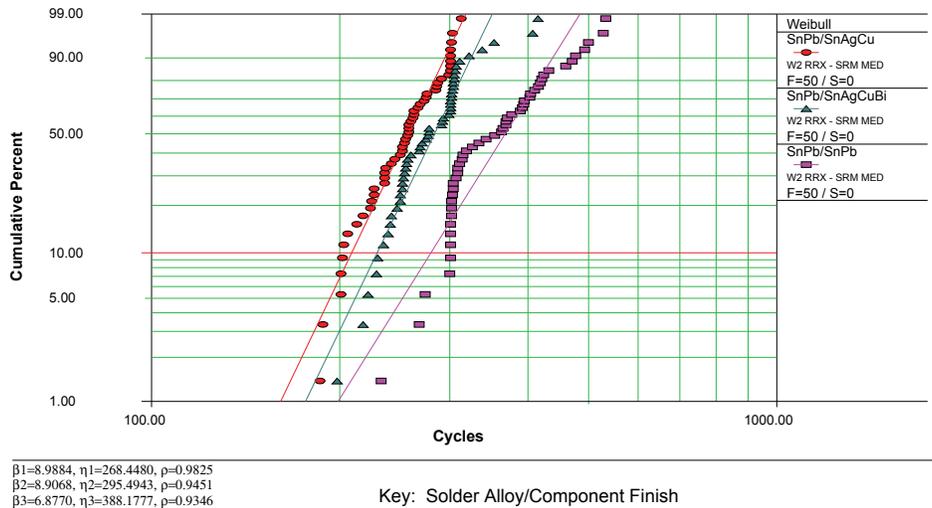
Figure 27 - CLCC-20 on Rework Test Vehicles

Figure 27 contains Weibull plots of tin-lead soldered tin-silver-copper and tin-lead soldered tin-silver-copper-bismuth CLCC-20 components compared to tin-lead soldered tin-lead CLCC-20 components. The results are distinguishably different for the three samples. Tin-lead soldered tin-lead CLCC-20 components performed best with tin-lead soldered tin-silver-copper-bismuth CLCC-20 components second and tin-lead soldered tin-silver-copper CLCC-20 components last. The use of a tin-lead solder profile during the solder reflow process may have been insufficient to cause the tin-silver-copper and tin-silver-copper-bismuth lead finishes on the CLCC-20 components to properly fuse with the tin-lead solder paste. In addition, the large amount of lead contamination on the tin-silver-copper-bismuth tinned CLCC-20 components did not appear to degrade the solder joint reliability as much as the degradation with the tin-lead TSOP-50 components soldered with tin-silver-copper-bismuth on the manufactured test vehicles.

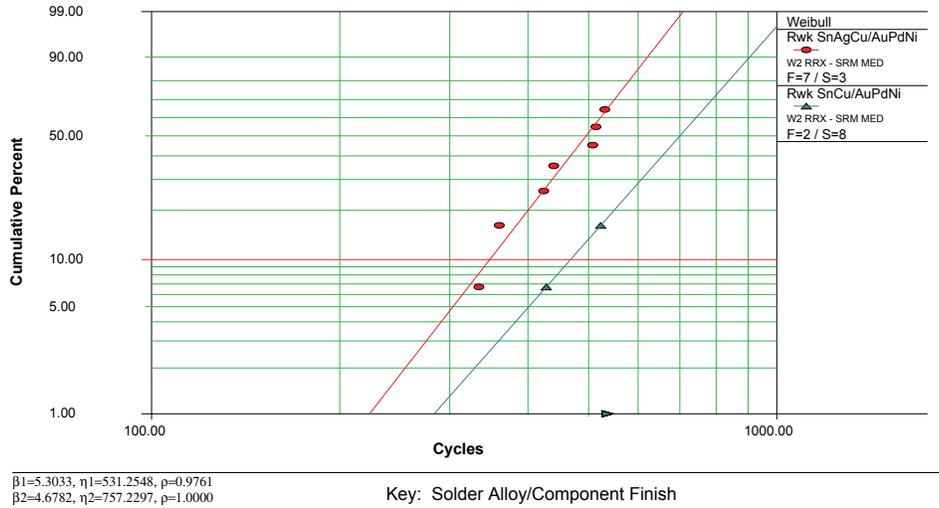
Figure 28 contains Weibull plots of reworked tin-silver-copper soldered gold-palladium-nickel and reworked tin-copper soldered gold-palladium-nickel PDIP-20 components. Since only one reworked tin-lead soldered tin-lead PDIP component failed, a Weibull plot could not be generated and used as a baseline. While rework with tin-copper solder may be more reliable than rework with tin-silver-copper, there is not a sufficient sample size in which to draw statistically sound comparisons in solder alloy performance.

**Figure 28 - Reworked PDIP-20 on Rework Test Vehicles**

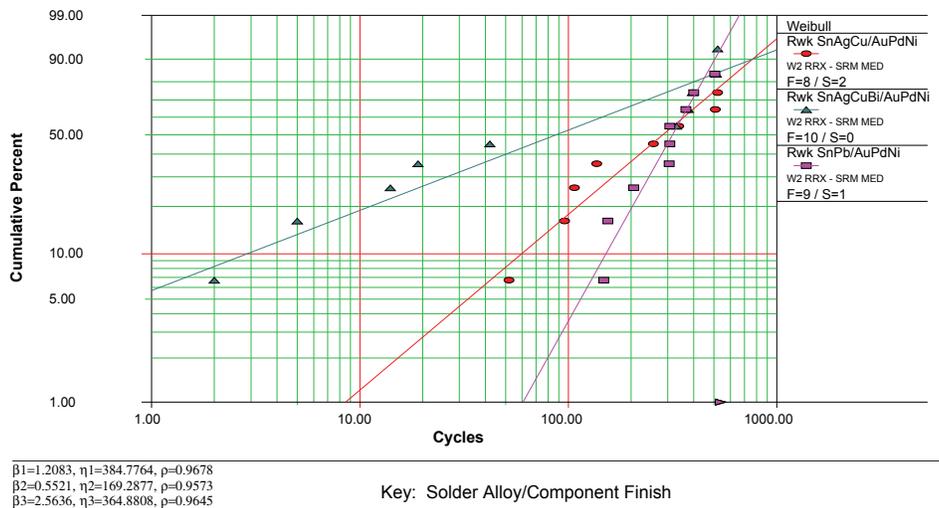
Figure 29 contains Weibull plots of gold-palladium-nickel TQFP-208 components reworked with tin-silver-copper, tin-silver-copper-bismuth and tin-lead solders. The plots show TQFP-208 components reworked with tin-lead solder performed best, TQFP-208 components reworked with tin-silver-copper ranked second and TQFP-208 components reworked with tin-silver-copper-bismuth solder ranked last.

**Figure 29 - Reworked TQFP-208 on Rework Test Vehicles**

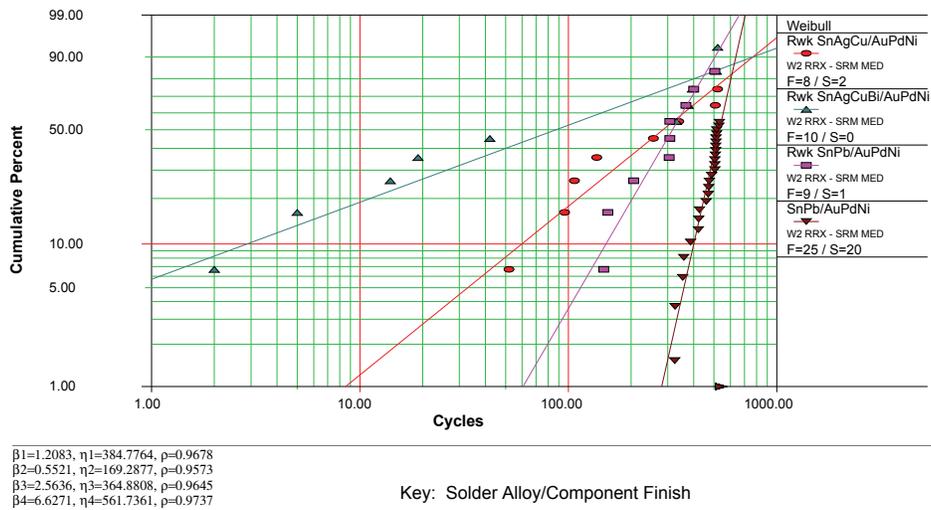
components ranked third and reworked tin-silver-copper-bismuth soldered gold-palladium-nickel TQFP-208 components ranked last.

Figure 30 - TQFP-208 on Rework Test Vehicles

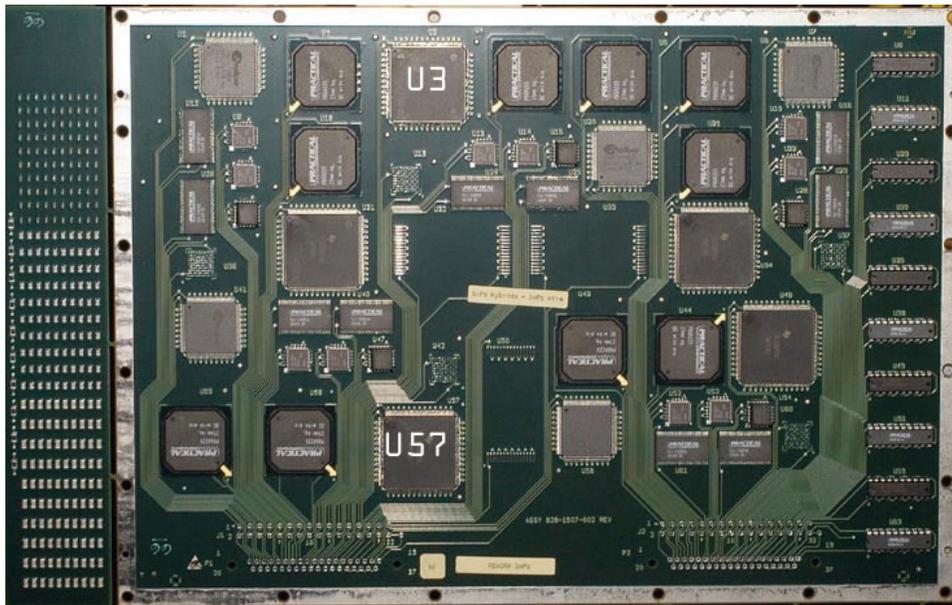
The reliability of the reworked tin-silver-copper-bismuth soldered TQFP-208 components was negatively impacted by the poor reliability of the reworked components at location U3 (see Figure 31).

Figure 31 - Locations of U3 and U57 Reworked TQFP-208 Components

Further investigation in terms of destructive physical analysis and microsection analysis are recommended for the reworked components and in particular the lead free solder reworked U3 and U57 TQFP-208 components.

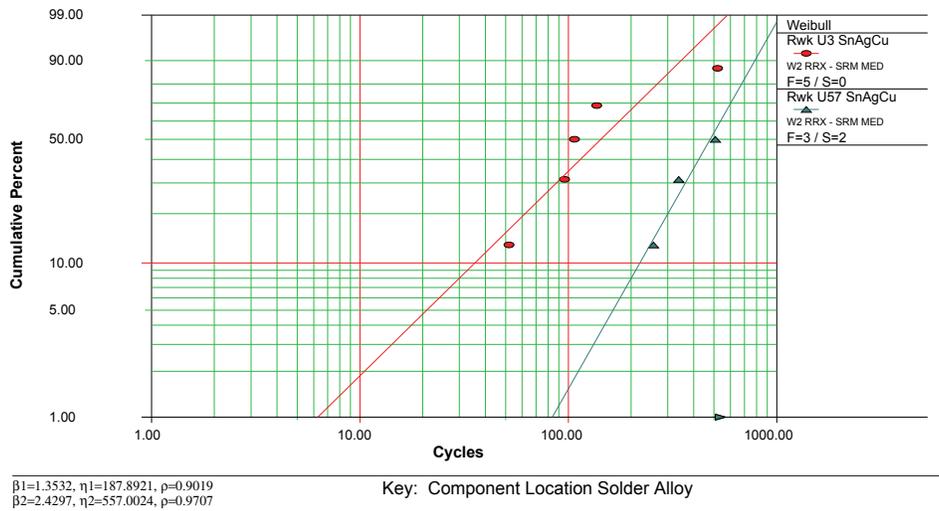
The failure data for the reworked components were further subdivided by component location and analyzed. Figure 32 shows the Weibull plots of U3 and U57 TQFP-208 components reworked with tin-silver-copper solder. The plot shows the U3 components failed faster than the U57 components.

**Figure 32 - Reworked U3 vs. U57 TQFP-208 with Tin-Silver-Copper Solder Wire on Rework Test Vehicles**

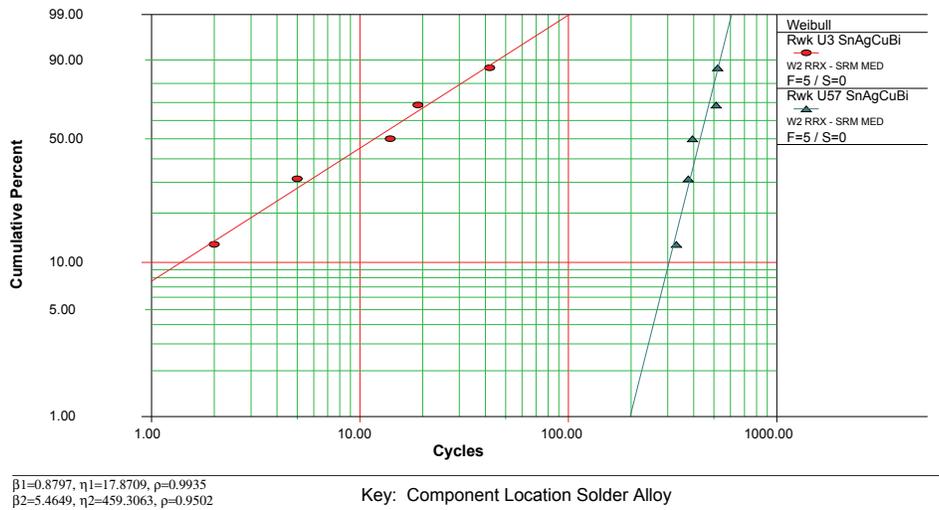
Figure 33 shows the Weibull plots of U3 and U57 TQFP-208 components reworked with tin-silver-copper-bismuth solder. The plot shows the U3 components failed much faster than the U57 components.

**Figure 33 - Reworked U3 vs. U57 TQFP-208 with Tin-Silver-Copper-Bismuth Solder Wire on Rework Test Vehicles**

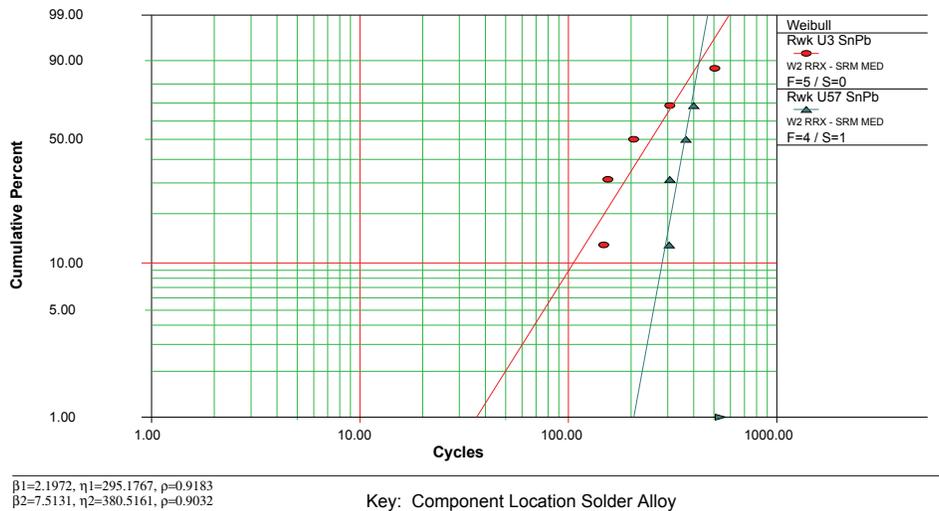
Figure 34 shows the Weibull plots of U3 and U57 TQFP-208 components reworked with tin-lead solder. The plot shows the U3 components failed slightly faster than the U57 components.

**Figure 34 - Reworked U3 vs. U57 TQFP-208 with Tin-Lead Solder Wire on Rework Test Vehicles**

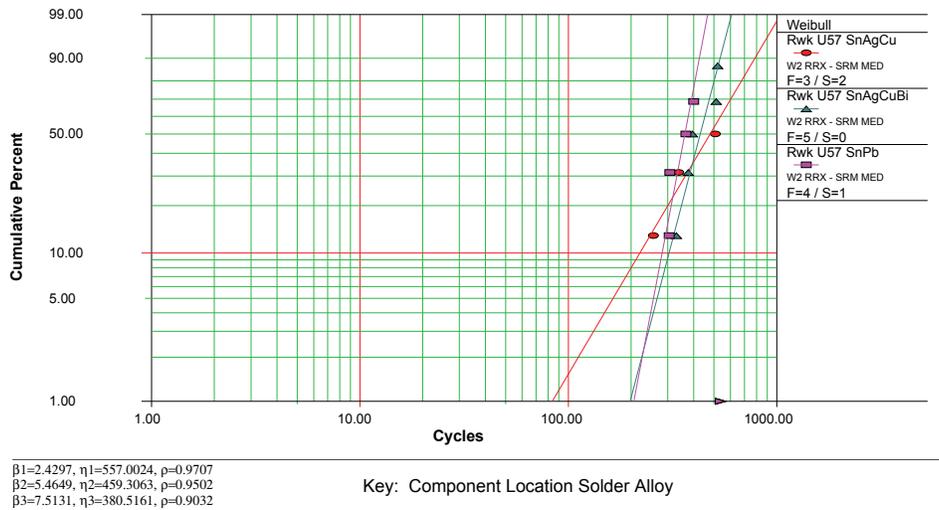
Figure 35 shows the Weibull plots of U57 components reworked. The plot shows similar performance for the three solder alloys.

**Figure 35 - Reworked U57 TQFP-208 on Rework Test Vehicles**
