## JCAA/JG-PP Lead Free Solder Project: Combined Solder Project: Combined Environments Test

Jeff Bradford, Joe Felty, Bill Russell  
Raytheon Company  
McKinney, Texas

A combined environment testing was conducted for the Joint Council on Aging Aircraft/Joint Group on Pollution Prevention Lead free Solder project. The purpose of the project was to validate and demonstrate lead free solders as potential replacements for conventional tin-lead solders used on circuit card assemblies against the requirements of the aerospace and military electronics community.

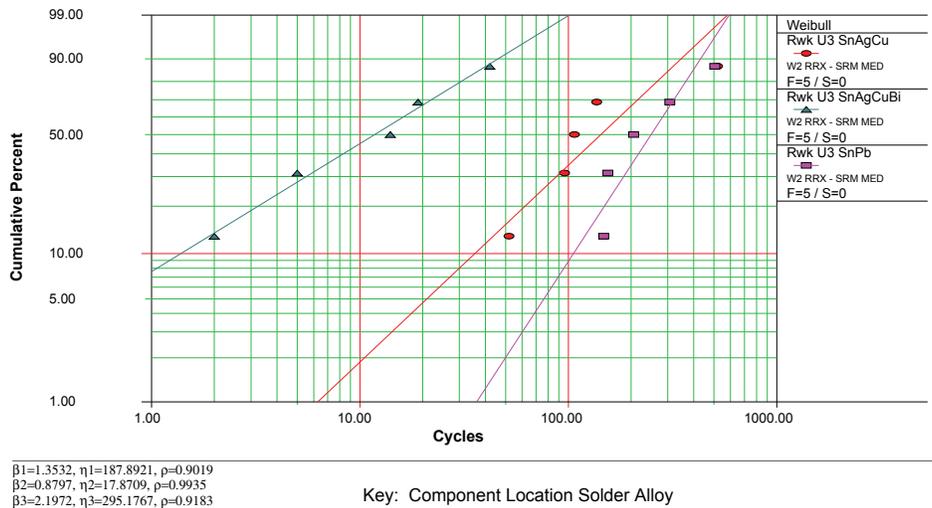
Figure 36 shows the Weibull plots of U3 reworked components by rework solder alloy. The plot shows a large variation in solder alloy performance for U3 components. U3 components reworked with tin-silver-copper-bismuth failed much sooner than U3 components reworked with tin-silver-copper solder. U3 components reworked with tin-lead solder performed the best. This data indicate the U3 location: 1) had a negative influence in solder joint reliability; 2) had a greater impact on the lead free solder alloys in general, and 3) greatly degraded the performance of tin-silver-copper-bismuth solder. Organic contamination or intermetallic formation on the U3 printed circuit board pads may be the cause of the solder joint reliability degradation. Destructive failure analysis is recommended to determine the actual cause.

**Figure 36 - Reworked U3 TQFP-208 on Rework Test Vehicles**

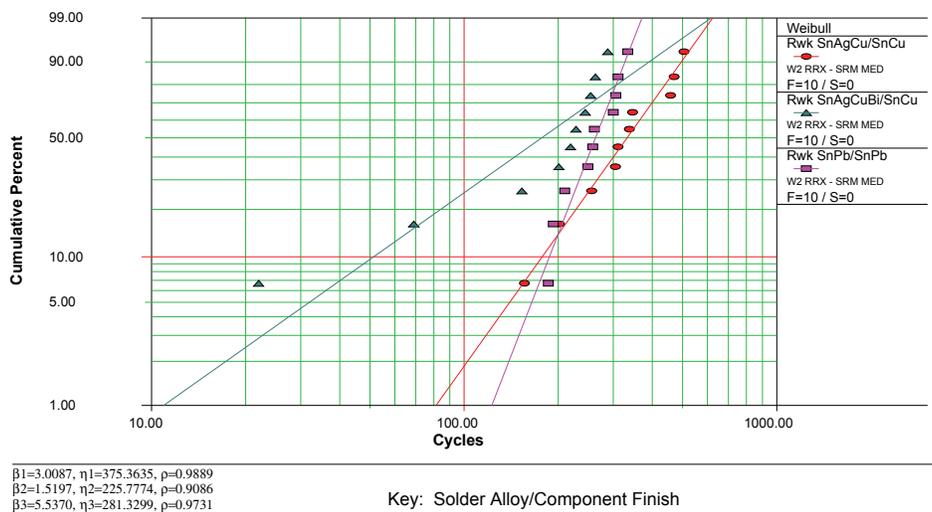
**Figure 37 - Reworked TSOP-50 on Rework Test Vehicles**

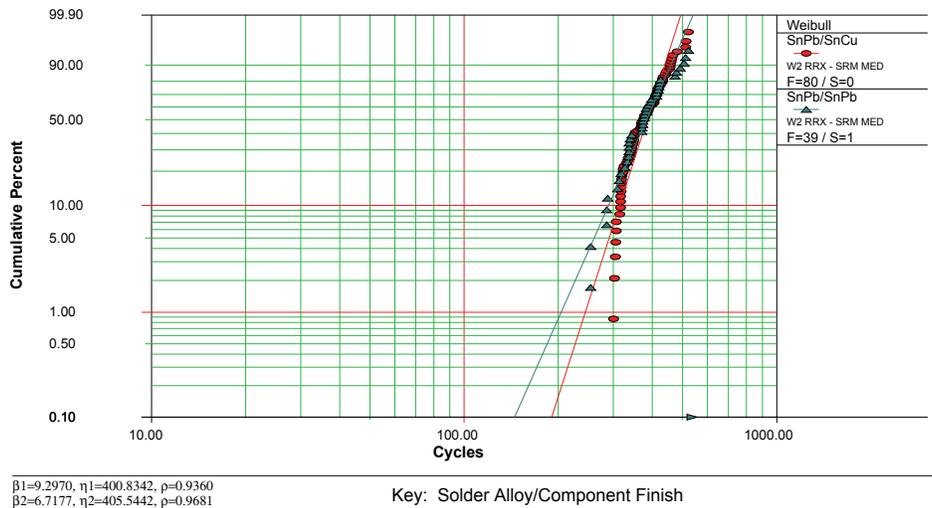
Figure 38 combines Weibull plots of unreworked tin-copper and tin-lead TSOP-50 components soldered with tin-lead solder paste. The plot shows the lead finish did not affect the solder joint reliability of the TSOP-50 components.

**Figure 38 - Tin-Copper vs. Tin-Lead TSOP-50 with Tin-Lead Solder Paste on Rework Test Vehicles**

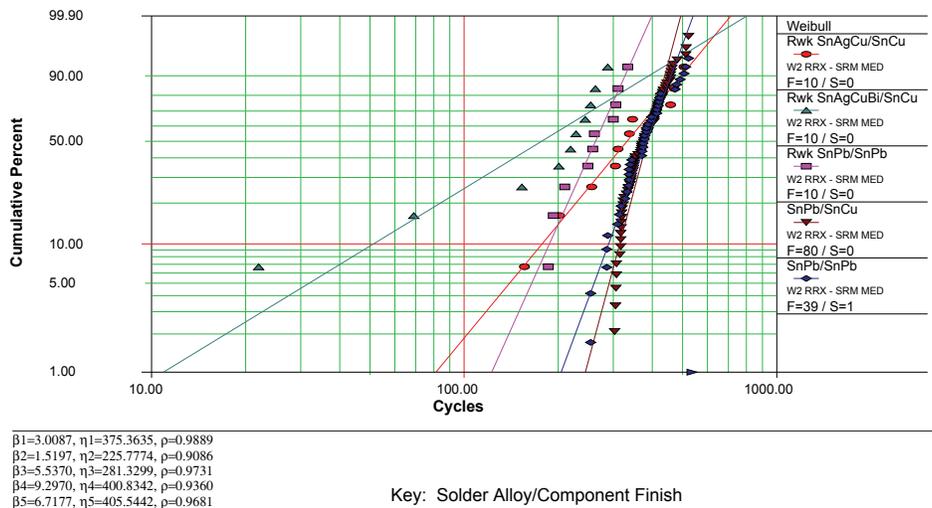
Figure 39 contains the Weibull plots for all of the combinations of rework status, component finish and solder alloy for the TSOP-50 components on the rework test vehicles. Overall, the unreworked tin-lead soldered tin-copper and unreworked tin-lead soldered tin-lead TSOP-50 components performed better than the reworked TSOP-50 components. Reworked tin-silver-copper soldered tin-copper TSOP-50 components performed as well as reworked tin-lead soldered tin-lead TSOP-50 components. Reworked tin-silver-copper-bismuth soldered tin-copper TSOP-50 components performed the worst. Residual tin-lead solder left on the component pads appears to dramatically degrade the reliability of reworked TSOP-50 when soldered with the tin-silver-copper-bismuth solder.

**Figure 39 - TSOP-50 on Rework Test Vehicles**

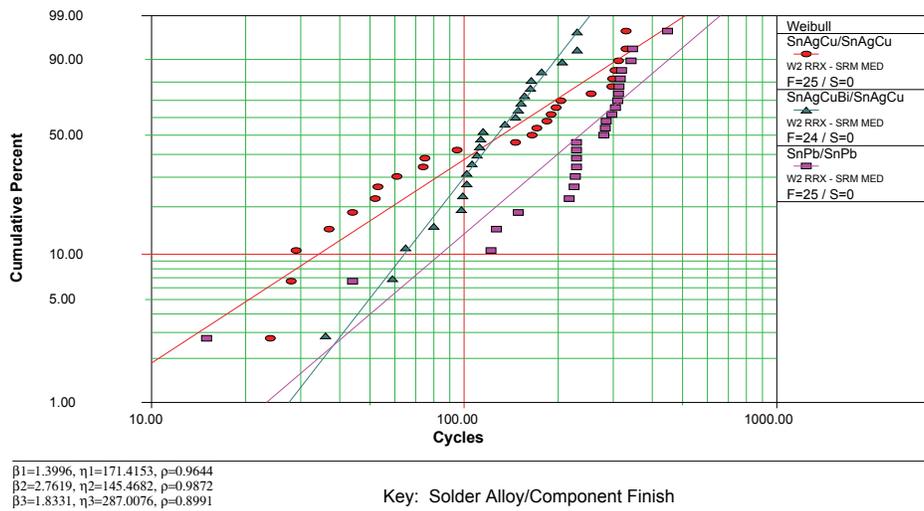
Figure 40 contains Weibull plots of tin-silver-copper CSP-100 components soldered with lead free solders compared to tin-lead soldered tin-lead CSP-100 components. The plot shows the fitted line for the tin-silver-copper-bismuth solder crosses the other fitted lines making comparative analysis difficult and dependent on which part of the plots are used for the analysis. Based on ten percent cumulative failures, tin-lead solder performed best with tin-silver-copper-bismuth solder ranked second and tin-silver-copper solder ranked last.

**Figure 40 - CSP-100 on Hybrid Test Vehicles**

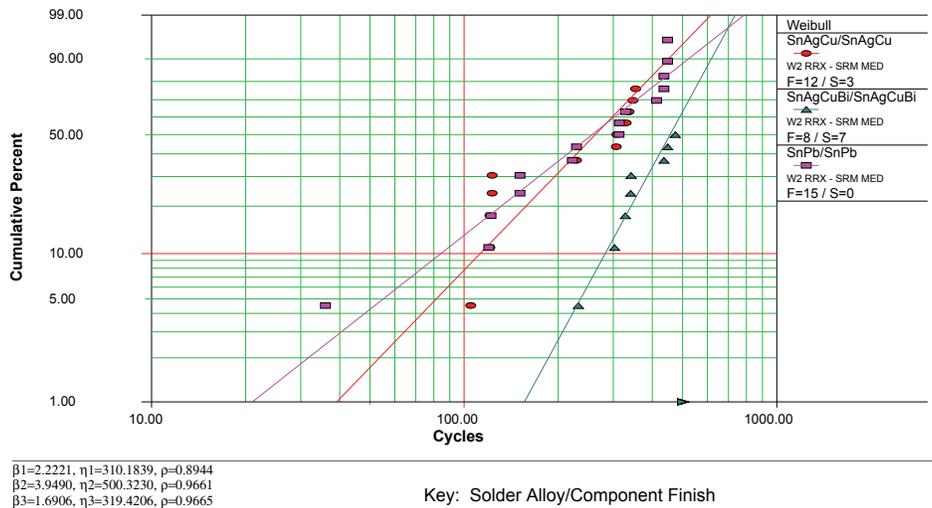
Figure 41 contains Weibull plots of tin-silver-copper soldered tin-silver-copper and tin-silver-copper-bismuth soldered tin-silver-copper-bismuth hybrid-30 components compared to tin-lead soldered tin-lead hybrid-30 components. The plot shows tin-silver-copper-bismuth solder performed best, tin-silver-copper solder ranked second best and tin-lead solder ranked the worst.

**Figure 41 - Hybrid-30 on Hybrid Test Vehicles**

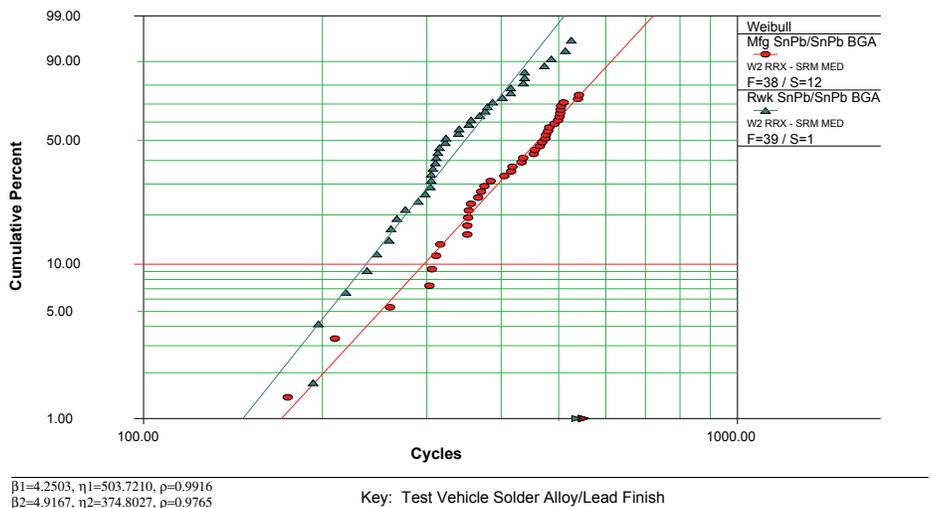
**Figure 42 - Comparison of Tin-Lead Soldered Tin-Lead BGA-225 on Manufactured and Rework Test Vehicles**

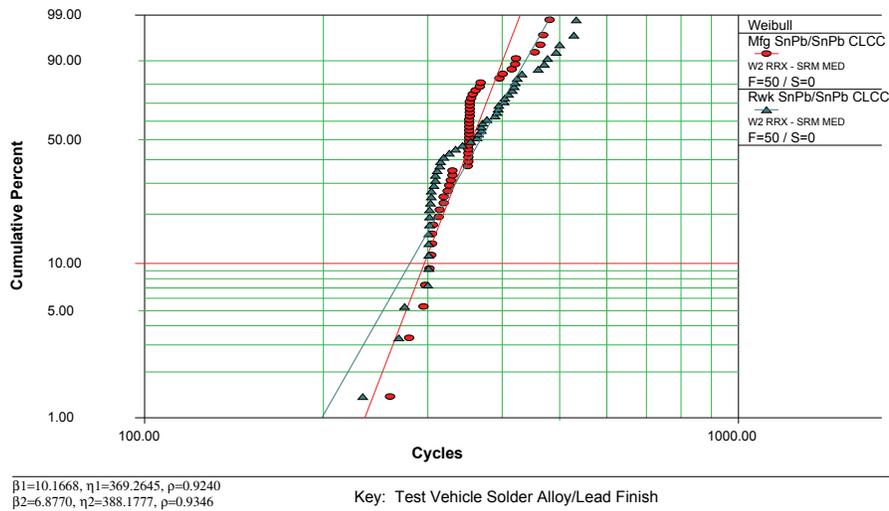
**Figure 43 - Comparison of Tin-Lead Soldered Tin-Lead CLCC-20 Components on Manufactured and Rework Test Vehicles**

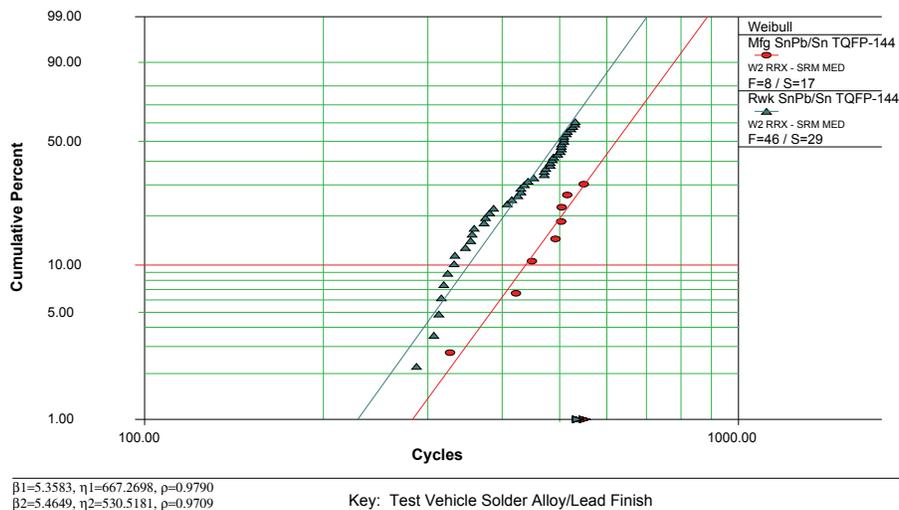
**Figure 44 - Comparison of Tin-Lead Soldered Tin TQFP-144 Components on Manufactured and Rework Test Vehicles**

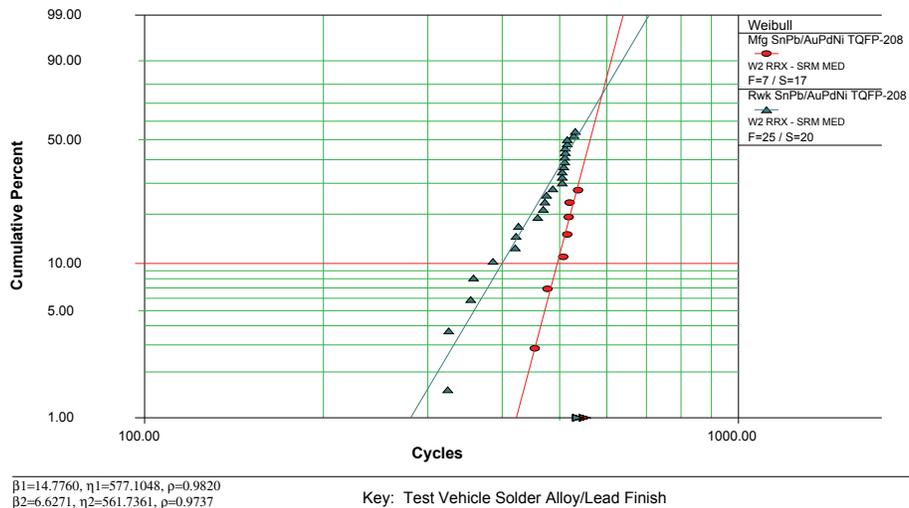
**Figure 45 - Comparison of Tin-Lead Soldered Gold-Palladium-Nickel TQFP-208 Components on Manufactured and Rework Test Vehicles**

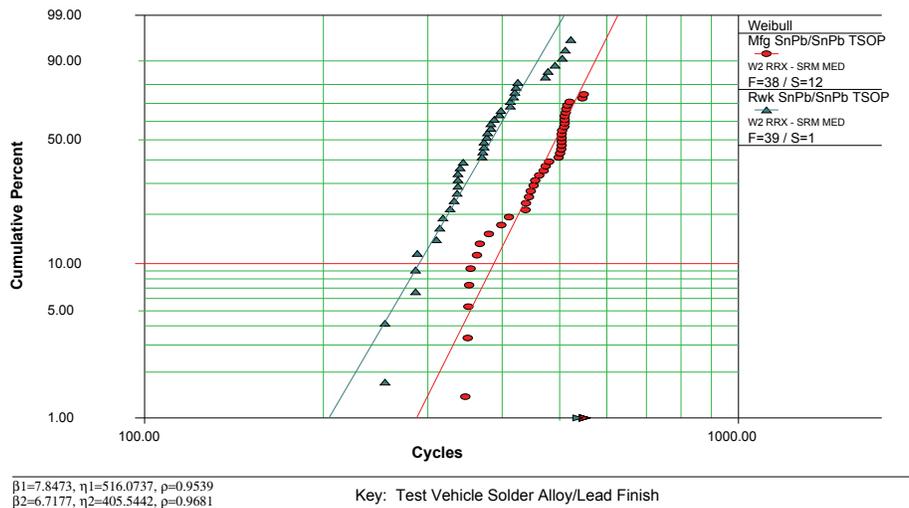
**Figure 46 - Comparison of Tin-Lead Soldered TSOP-50 Components on Manufactured and Rework Test Vehicles**

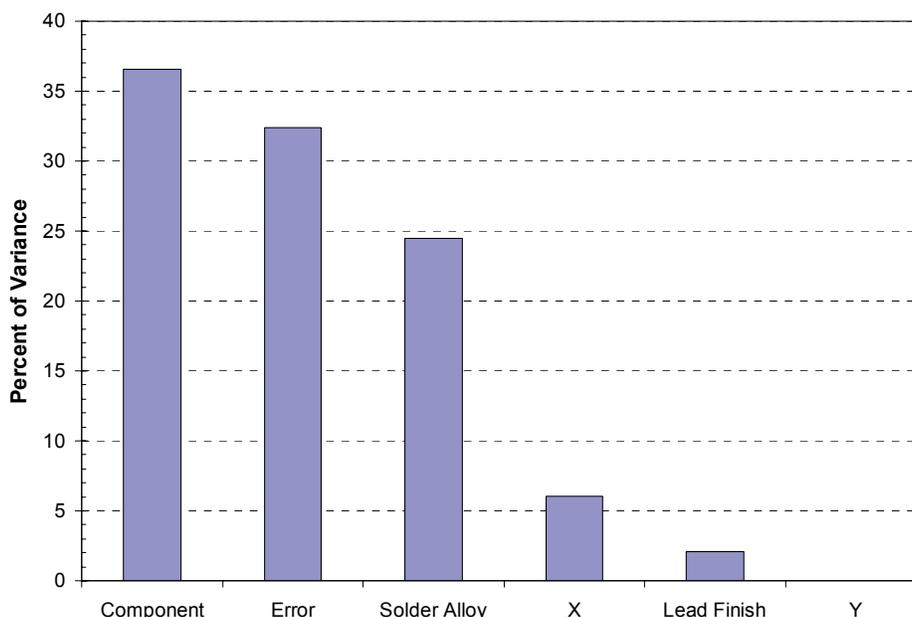
Figure 47. The analysis of variance table divides the variance of the cycles to failure into 5 components, one for each factor. Each factor after the first is nested in the one above. The goal of such an analysis is usually to estimate the amount of variability contributed by each of the factors, called the variance components. The factors included: solder paste; lead finish; component location along the x-axis (long axis of the board); component location along the y-axis; component type; plus unexplained error. The analysis shows that solder joint reliability was influenced by the choice of solder paste, but it was

probably less than either the choice of component or random noise. The analysis was only an approximate estimate since censored values (samples that did not fail) were left at their last measured cycle. The random noise would include other factors not included in the experiment or analysis. The analysis further shows that the influence due to lead finish or component location is very low.

**Figure 47 - Chart of Variance Components Analysis**

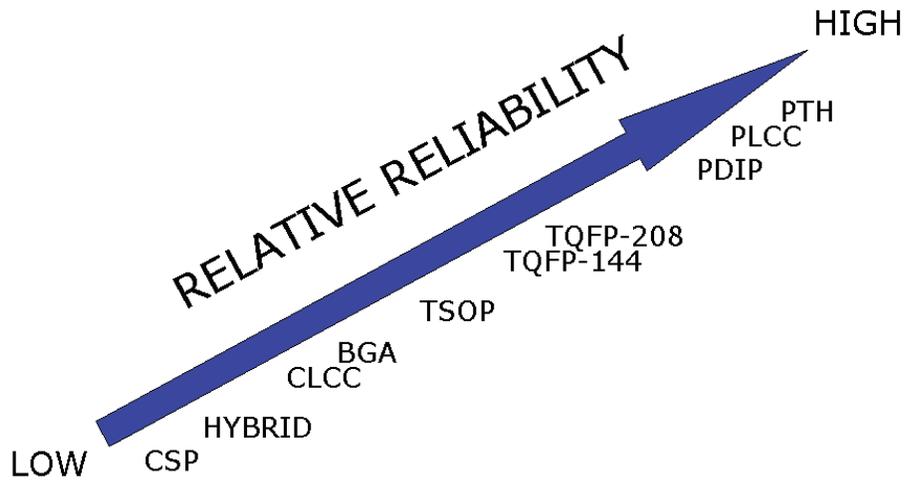
**Figure 48 - Relative Reliability of Components for Tin-Lead Solder on Manufactured and Hybrid Test Vehicles**

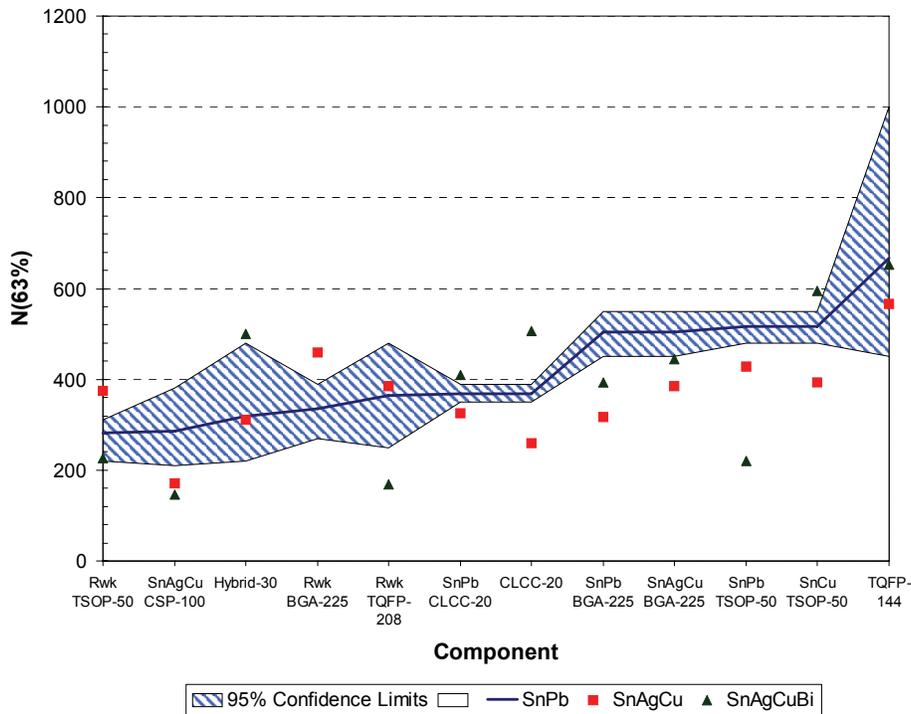
**Figure 49 - Lead free Solders Compared to Tin-Lead Baseline Based on N(63%)**

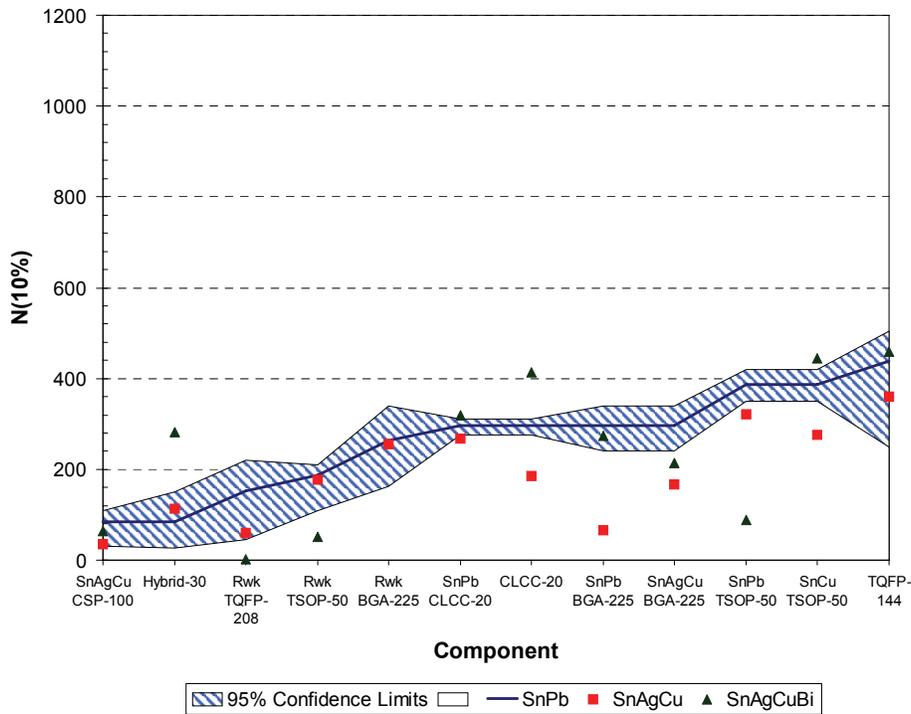
**Figure 50 - Lead free Solders Compared to Tin-Lead Controls Based on N(10%)**

Only seven lead free soldered samples met the JTP acceptance criteria of lead free solder joint reliability better than or equal to eutectic tin-lead controls at ten percent Weibull cumulative failures. The seven samples are tabulated in Table 13. Those samples include tin-silver-copper-bismuth soldered CLCC-20 components, TQFP-144 components and tin-copper TSOP-50
