Reliability Testing and Failure Analysis of Lead-Free Solder Joints under Thermo-Mechanical Stress

Hirokazu Tanaka, Yuuichi Aoki, Makoto Kitagawa and Yoshiki Saito
ESPEC CORP.
Osaka, JAPAN

IPC Printed Circuit Expo/APEX

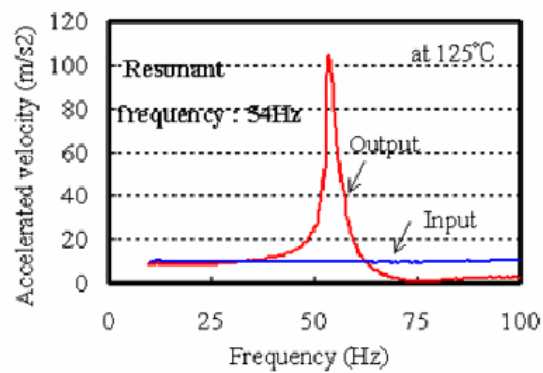
Figure 3 - Method of Resonant Frequency Detection for Combined Thermal-Vibration Test

Figure 3 shows the method of resonance frequency detection for the combined thermal-vibration tests. Because of the possibility of creating severe distortion to the solder joint when fastening the evaluation PCB to the vibration stand, the PCBs were fastened at 2 points on each side (Figure 3-a). The force of vibration was set at 9.8 m/s² (=1 G) as the acceleration during transportation by truck. The direction of vibration was up and down (on the z axis) for the PCB. The upper temperature limit was set at 125 °C for the tests. Figure 3-b shows the output during the sweep of the vibration frequency (10 to 100 Hz) for the input acceleration (9.8 m/s²). The evaluation PCBs showed a maximum acceleration of approximately 54 Hz. Based on this, the tests were performed at 54 Hz +/- 5 Hz.

(a) PCB fixed point and sensor

(b) Resonant Frequency under test

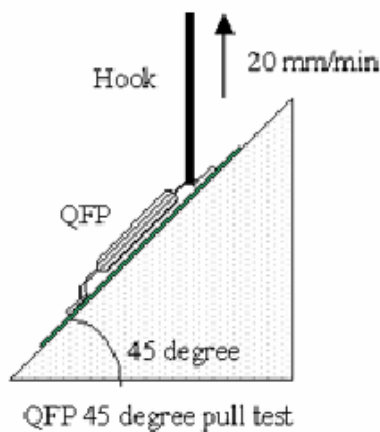
Figure 4 – Method of Measuring Solder Joint Strength

Figure 4 shows the method of measuring solder joint strength. As the diagram shows, the pull test for the QFP leads was performed at 20 mm/min and at a 45-degree angle. The pull test was performed during and after each reliability test, measuring the strength of at least one lead for each vicinity and calculating the averages. Figure 5 shows the method of measuring the electrical conductivity of the solder joints during thermal cycle tests. The daisy-chained QFPs were measured by the four terminal measurement methods using a scanner and a milli-ohmmeter. This method is capable of measuring the degradation time of the solder joints.

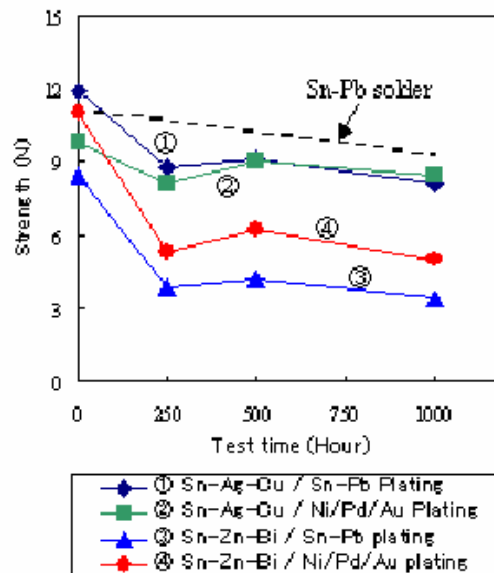
Figure 6 - Results of 45-degree Pull Test for QFP Lead-free Solder Joints after High Temperature Test

Figure 6 shows the variation over time of the joint strength during high temperature test. The Sn-Zn-Bi solder exhibits a loss of joint strength at 250 hours after the beginning of the test. However, we were able to confirm that Sn-Ag-Cu solder did not exhibit this significant loss of joint strength that was seen in Sn-Zn-Bi.

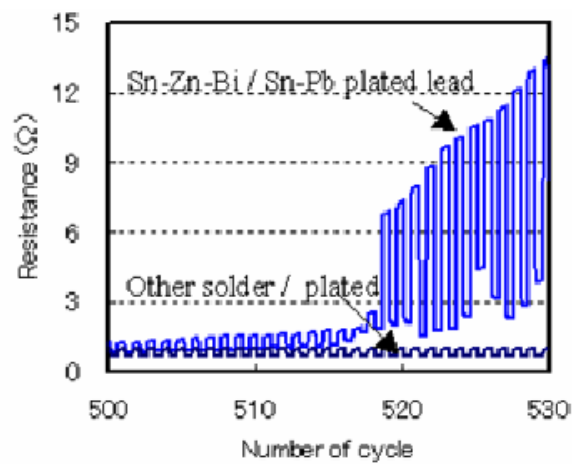
Figure 8 - Change in Resistance of QFP Solder Joints during Thermal Cycle Test

Figure 8 shows changes in resistance during the thermal cycle test. The combination of Sn-Zn-Bi solder with Sn-10Pb-plated leads exhibited a gradual rise in resistance at approximately 500 cycles. However, with other combinations of solder materials and lead finishes, this type of change was not seen before 1,000 cycles. A cross-sectional analysis was performed to determine the factors causing the temperature rise for the combination of Sn-Zn-Bi solder with Sn-10Pb-plated leads.

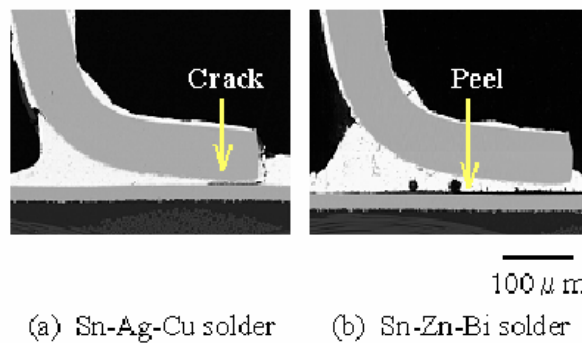
Figure 9 Cross-sectional BE Image of QFP Solder Joints with Sn-10Pb-plated Lead after Thermal Cycle Test

Figure 9 shows the results of cross-sectional observation following the thermal cycle tests. The Sn-Ag-Cu solder exhibited small cracking in top solder fillet. The Sn-Zn-Bi solder exhibited peeling between the solder joint and the PCB, similar to the peeling seen after the pull tests done during the high temperature test. This indicates that the rise in resistance in Sn-Zn-Bi solder results from incomplete conductor contact due to solder joint cracking caused by thermal stress during the thermal cycle test.

In these experiments, the evaluations were performed on specimens mounted in open air, but it has been reported that in thermal cycle tests using parts mounted in a nitrogen atmosphere, the combination of Sn-Zn-Bi solder with Sn-10Pb-plated leads was able to maintain reliability for a minimum of 1,000 cycles.⁹ These results suggest that solder joint conditions differ for different assembly conditions, resulting in major differences in time to failure.

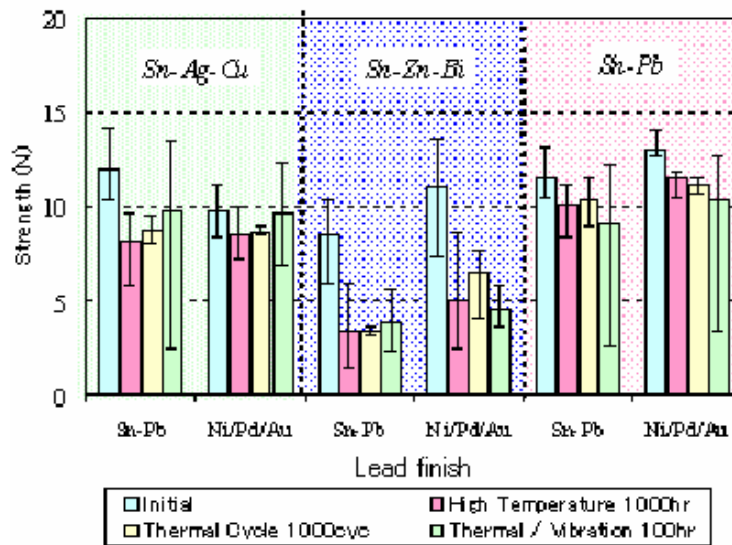
Figure 11 - Comparison of QFP Solder Joints Strength following Each Type Reliability Test

Figure 11 shows a comparison of solder joint strength following each type of reliability test. Overall, Sn-Zn-Bi solder is the material in these experiments most affected by thermo-mechanical stress. On the other hand, Sn-Ag-Cu solder exhibited a slight drop in joint strength caused by thermo-mechanical stress. The amount of joint strength lost is approximately the same as with conventional Sn-Pb eutectic solder.

In considering the effects of lead finish on Sn-Zn-Bi solder, Sn-10Pb-plated leads exhibited a much greater loss of joint strength than Ni/Pd/Au-plated leads. These results indicate that to obtain solder joint reliability, lead finishes containing Pb must not be used with lead-free solder.

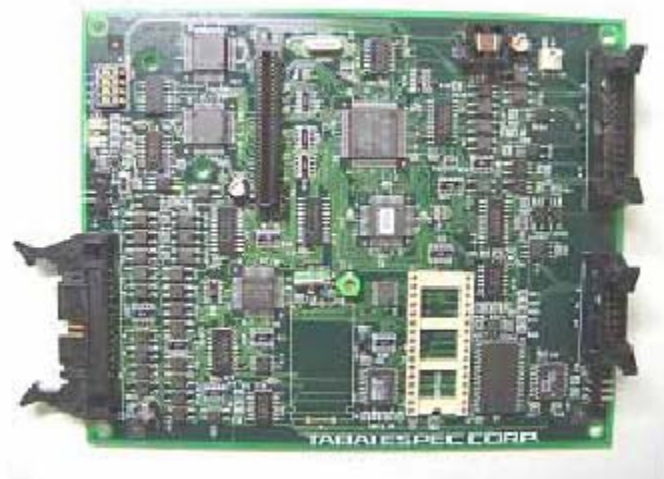
Figure 15 - Mass Production Prototype PCB.

Figure 15 shows one section of a mass production prototype PCB (150 x 120 x 1.6mm). The substrate is glass epoxy with parts mounted on the surface. For purposes of comparison, this evaluation also considered PCBs mounted with conventional Sn-Pb eutectic solder.
