## Conductive Anodic Filament Growth Failure

Tarun Amla  
Isola Laminate Systems Corp.  
La Crosse, WI

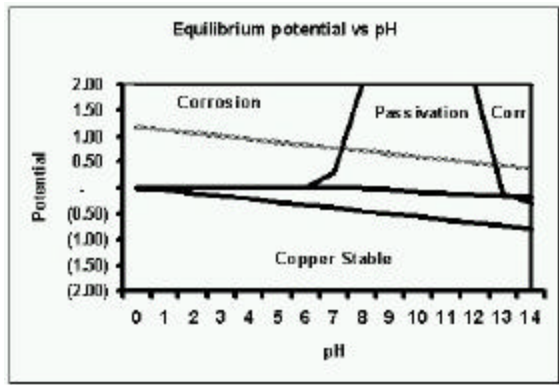
Figure 1 – Pourbaix Diagram

A simplified pourbaix diagram for copper (see Figure 1) shows that at a pH of around and beyond 7 a passivation layer protects the corrosion. The cell potential as seen from equation (1) is a direct function of temperature and the concentration; and directly affects the kinetics.

The thermodynamics of corrosion reactions can be represented by PourBaix diagram. The lines are drawn between the equilibrium potential and the pH.

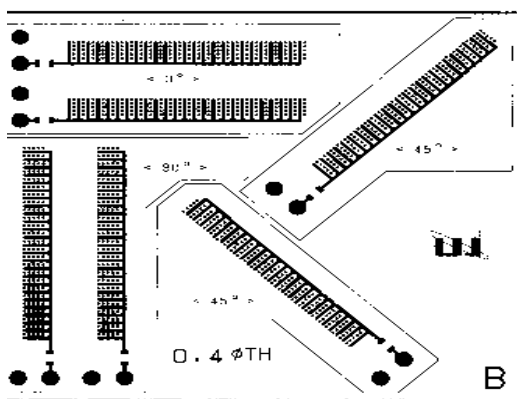
Figure 2 – CAF Test Vehicle

The test vehicle was designed after acquiring input from various OEM's. The vehicle is a four-layer board consisting of several rows of coupons with hole spacing from .006" to .035". These are positioned in both the X and Y direction on the panel. The failure mode is apparent and very easy to see with this design. The dielectric spacing can be changed with the use of different materials to understand its impact on CAF formation. (See Figure 2.)

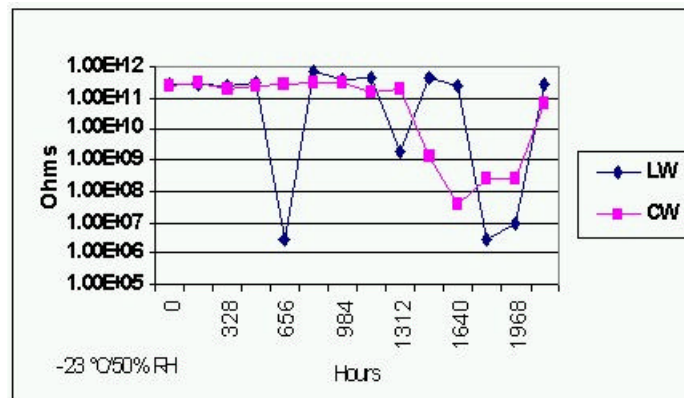
Figure 3 – Insulation Resistance Lengthwise and Crosswise with Solder Mask

Glass finish had only a marginal effect and no special finish or treatment was needed to pass the test. Figures 3, 4, 5 and 6 show the performance of Isola's best performing products with and without mask.

No CAF failure was seen, only a drop in insulation resistance and this was reversible.

The mask seems to play a major role. In the absence of the mask, the system stayed robust, but with the addition of the mask the drop was significant and the results were not very consistent.

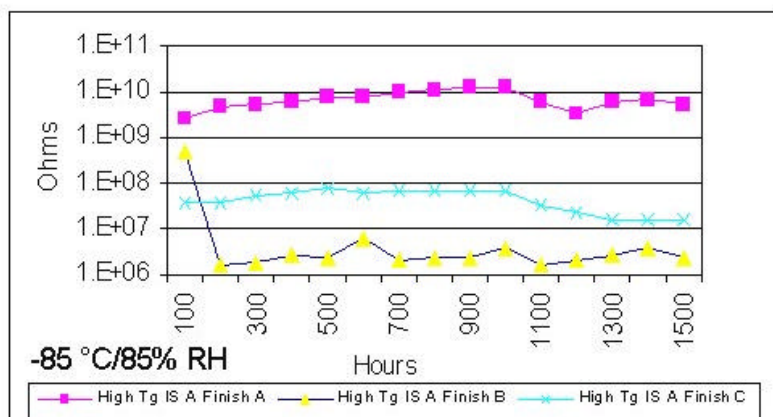
**Figure 7 – Effect of Glass Finish on Resistance Drop**

Figure 7 depicts that the glass finish has a significant impact on the magnitude of the insulation resistance. Isola's best performing grade, as far as insulation resistance is concerned, was also impacted by different finishes.

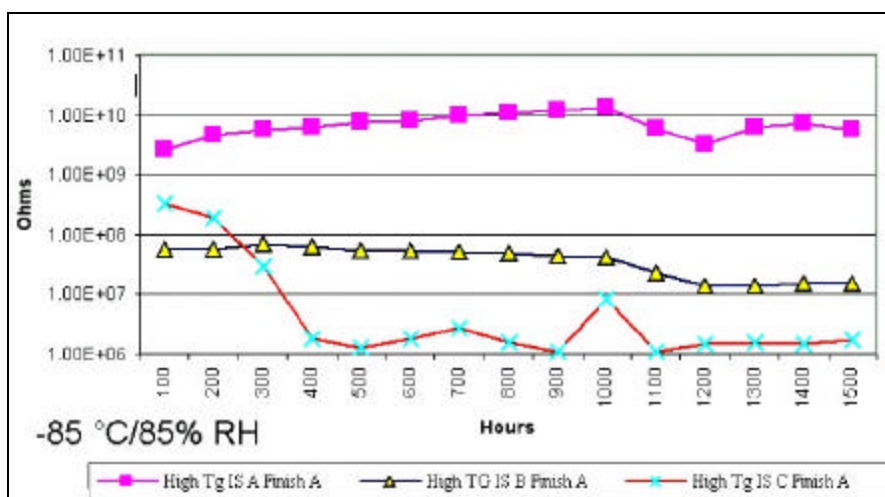
**Figure 8 – Effect of Resin System on Resistance Drop**

Figure 8 shows different resin systems with the best performing finish and one can see a significant difference in the magnitude of the insulation resistance of various resin systems.
