# Counterfeit Electronic Components Identification: A Case Study

Martin Goetz and Ramesh Varma  
Northrop Grumman Corporation  
Linthicum, MD

## Abstract

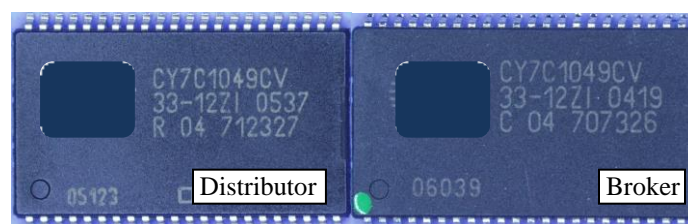
Once the failure occurs on a component or subsystem, typically there is an optical inspection to determine if there was any physical damage to the part either before or during testing. Damage can occur from a variety of sources including handling, testing conditions and setup, foreign object damage or debris (FOD), fixturing, etc. Figure 1 shows a comparison of an SRAM received by an authorized distributor and the broker in question. It was noted that the lot number of the broker part was not in the OCM database.

Figure 1 – Comparison of two SRAM parts. Different lot numbers.

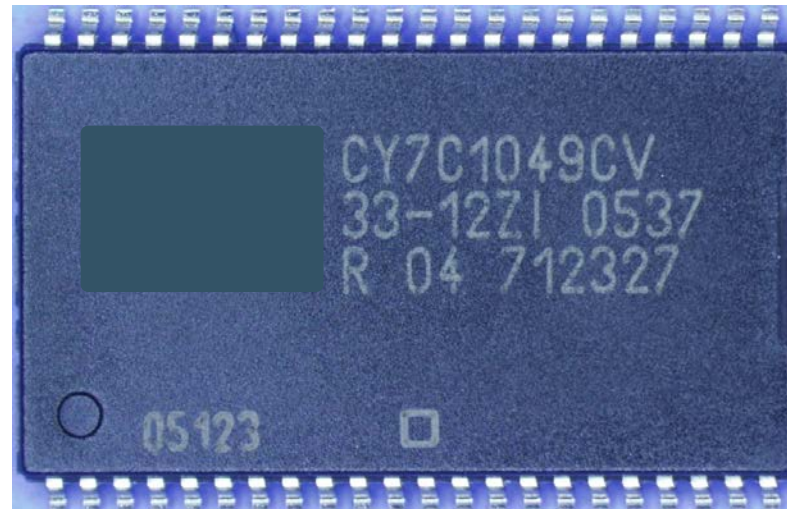
- Top view of OCM SRAM
- Damage can occur in from a variety of sources:
  - *Handling*
  - *Testing conditions and setup*
  - *Foreign object damage or debris (FOD)*
  - *Fixturing, etc.*

Distributor (authorized part)

Broker (suspect part) Part#

This lot # does not match OCM database
