# **The Relationship between Backward Compatible Assembly and Microstructure on the Thermal Fatigue Reliability of an Extremely Large Ball Grid Array**

Richard Coyle, Richard Popowich, Peter Read, and Debra Fleming Alcatel-Lucent, Murray Hill, NJ

Accelerated temperature cycling was used to evaluate the thermal fatigue reliability for the case of backward compatible assembly (mixed alloy, Pb-free BGA/SnPb paste) of a 3162 pin count, extremely large body (51.0 mm x 59.5 mm) ball grid array (BGA). The BGA component was fabricated with Sn-4.0Ag-0.5Cu (SAC 405) Pb-free solder balls and surface mount assembly was done using SnPb eutectic soldering profiles. The profiles were selected to simulate situations involving incomplete mixing in order to study the effect of various levels of Pb mixing and microstructure on solder joint quality and thermal fatigue reliability. Although the most common criteria for acceptable mixed alloy assembly are uniform or 100% Pb mixing throughout the solder joint and complete ball collapse during reflow, these criteria can be difficult to meet with larger BGA packages due to thermal issues. The effect of such imperfect mixing on reliability of large packag

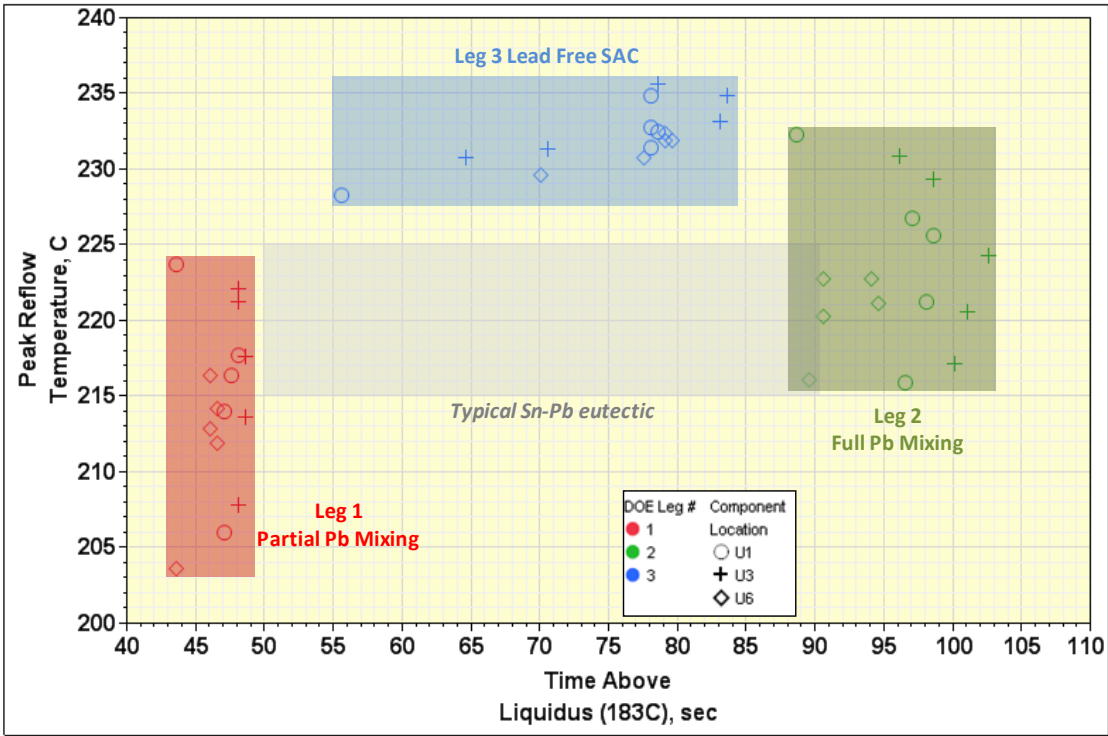
**Figure 3: Reflow profile windows for the three Legs of the DOE using three package test vehicles on the test board**

from Figure 3 that both the Leg 1 and Leg 2 reflow profile windows are outside the typical Sn-Pb eutectic soldering reflow window used in the industry.

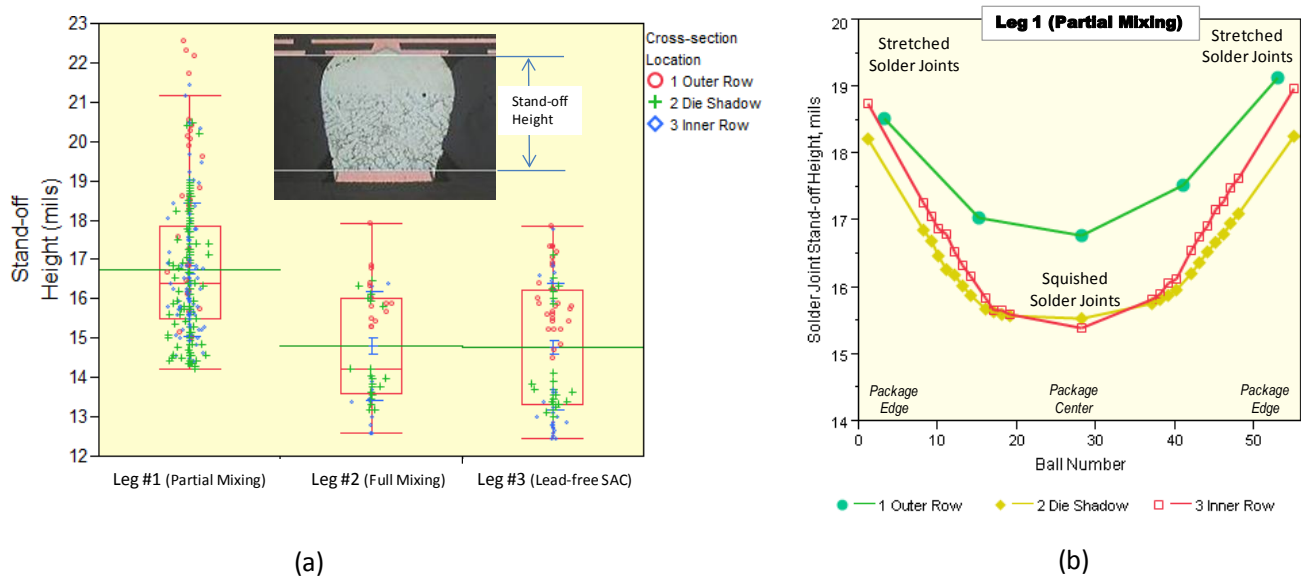
**Figure 8: (a) Stand-off heights of the BGA solder joints for all three Legs of the experiment; the inset micrograph depicts the measurement of the stand-off height. (b) Variation of the stand-off heights of the BGA solder joints for Leg 1 (Partial Pb mixing) assemblies across the outer, die shadow and inner rows.**

Figure 8b shows the variation of the solder joint stand-off heights across the three cross-sectioned rows, an outer row, an inner row and a die shadow row, indicated on the ball map of the package test vehicle in Figure 5. This plot is for Leg 1 (partial mixing) assemblies only. Each data point in this graph is a mean of the stand-off height for the same ball numbers from six packages across two assemblies. The reason for the wide range in the stand-off heights is apparent from this plot. Due to the dynamic warpage characteristics of the package test vehicle the solder joints on the outer rows are stretched with tall stand-off heights, whereas those in the inner rows, particularly within the center of the package are compressed (squashed) with short stand-off heights.

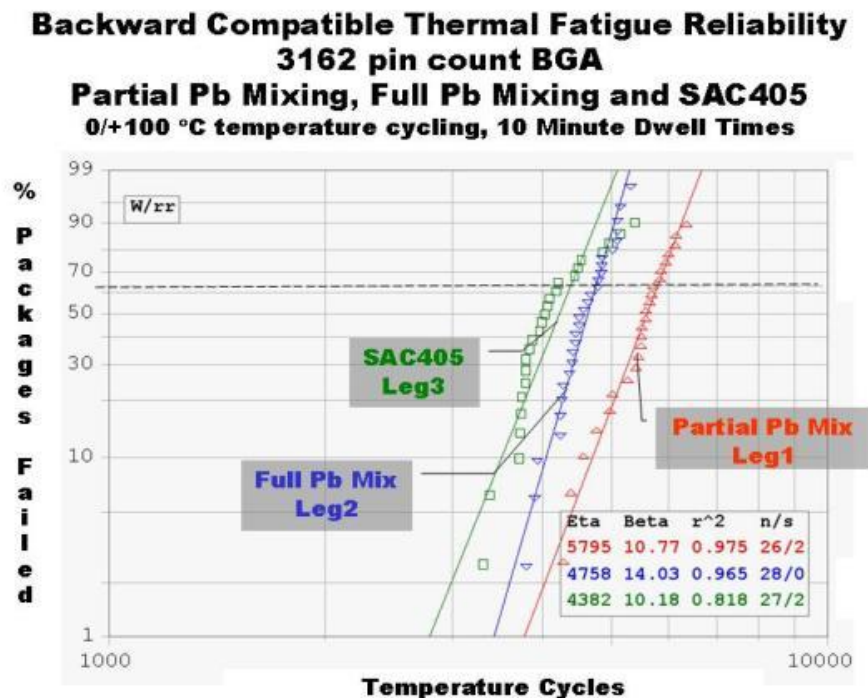
**Figure 12: Weibull plot comparing the temperature cycling performance of mixed alloy Leg 1 (partial Pb mixing) and Leg 2 (full Pb mixing) and the Pb-free Leg 3 (SAC405, no Pb mixing).**

The temperature cycling data for the 3162 ball count BGA test cells are summarized in Table 2 and presented in the Weibull plot in Figure 12. The Weibull plot presents only censored data, with the early, non-fatigue failures removed. The parameter used to assess the reliability or thermal fatigue performance is the Weibull characteristic fatigue lifetime ( $\eta$ ). For these three test cells, the Leg 1 Partial % Pb Mixing cell has better reliability than either the Leg 2 Full Pb Mixing cell or the completely Pb-free SAC405 cell. Additionally, the full Pb mixed cell (Leg 2) has approximately 10% better reliability than the SAC405 Pb-free cell (Leg 3).

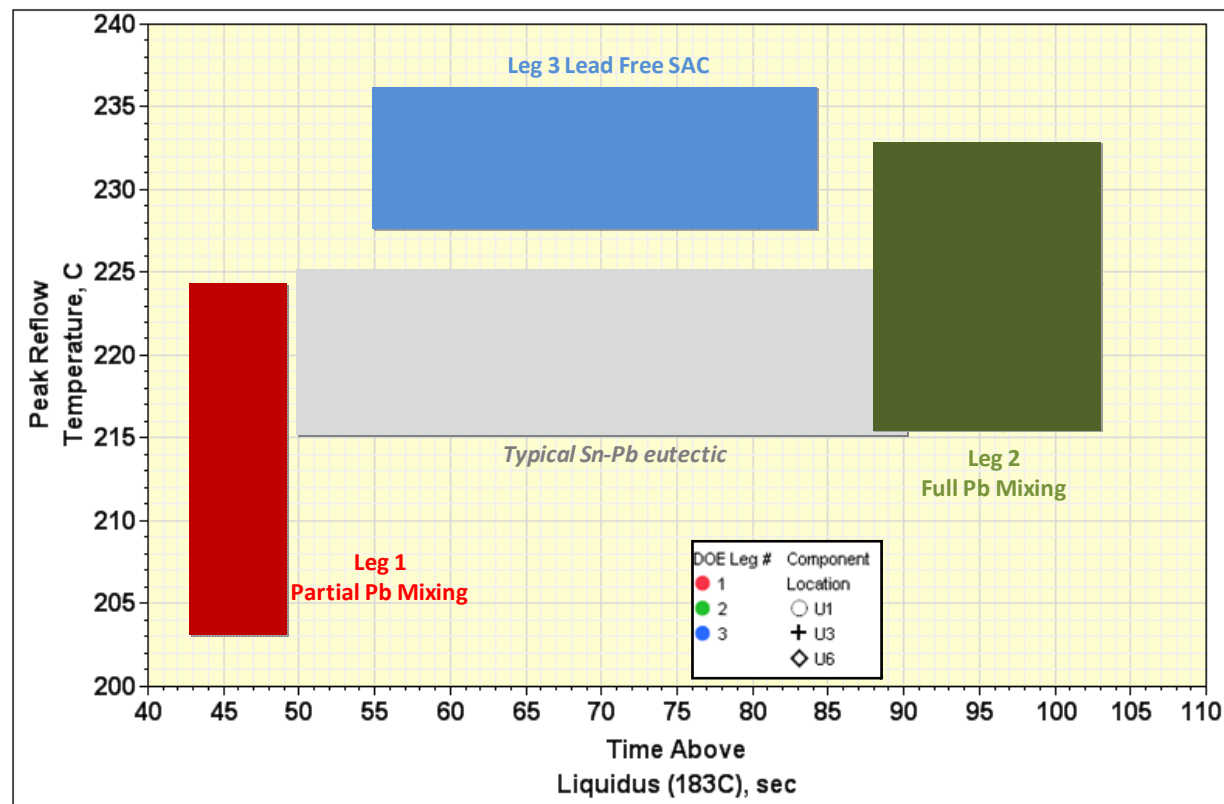
# Reflow Profile Windows

- Reflow Profiles for the 3 Legs compared by plotting the Windows on a Peak Reflow Temperature – Time above Liquidus (183C) Graph

- Wide range for Peak Reflow Temperature for all three legs
- Large body of the BGA and its high thermal mass require assembly profiles outside the typical industry SnPb reflow profile windows

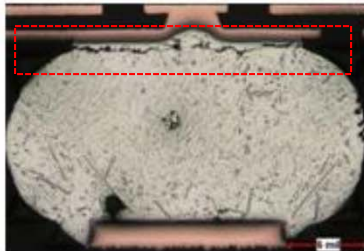
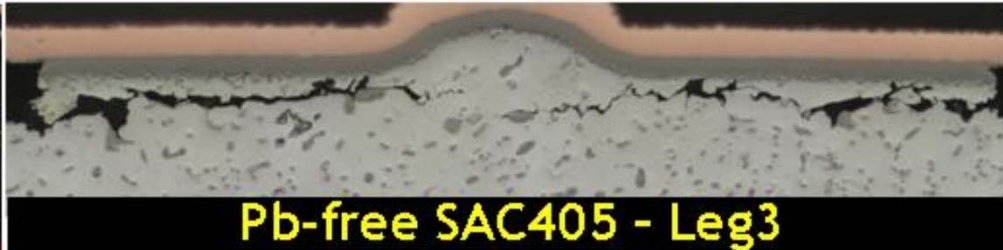
## Optical Photomicrographs of Solder Joint Fatigue Cracking

- Inter-granular fatigue fracture observed within the solder joint near the package land

- The solder fatigue cracking is intergranular along Sn boundaries and appears to occur independent of Pb mixing
