NASA-DoD Lead-Free Electronics Project: Mechanical Shock Test

Thomas A. Woodrow, Ph.D.
Boeing Research and Technology
Seattle, WA

Abstract

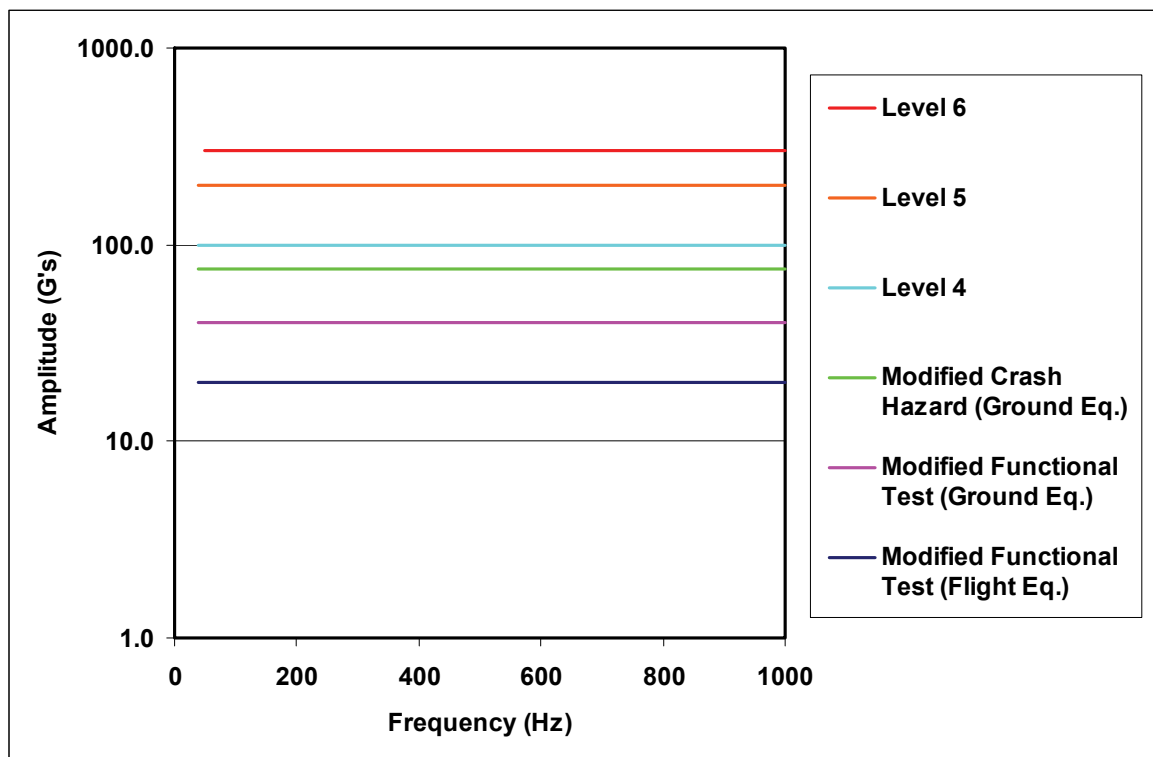
Figure 8. Mechanical Shock SRS Test Levels (5% Damping)

At the third stress level, the test vehicles were subjected to 100 shock pulses using the 75 G Shock Response Spectrum (SRS) shown in Figure 8. This is a standard test (i.e., the Crash Hazard Test for Ground Equipment as defined in MIL-STD-810G Method 516.6) during which the test article is exposed to a minimum of three shock pulses.

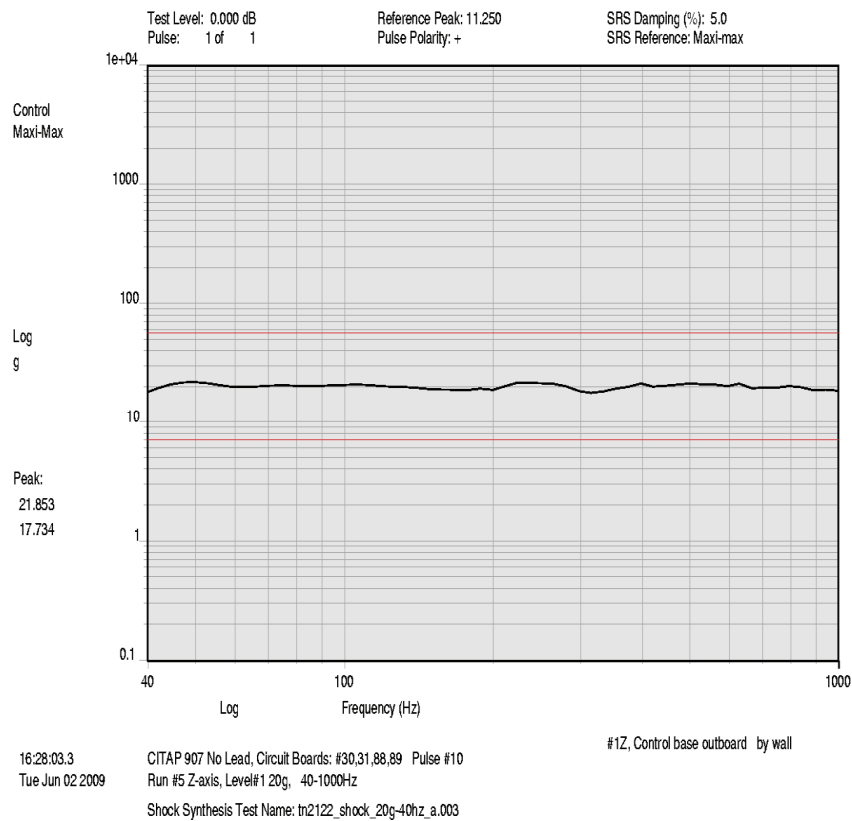
Figure 9. 20 G SRS Input (Accelerometer on Fixture)

The accelerometer data recorded at each test level included: the SRS inputs into the fixture; the pulse shape and amplitudes used for each test level; and the response of each "Manufactured" test vehicle. Representative accelerometer data for the 20 G test level is shown in Figures 9 through 11. At each test level, the same pulse shape was used for each of the shock pulses. The use of an electrodynamic shaker insured that reproducible pulse shapes could be produced for each test level during testing of the four batches of test vehicles. It should be noted that the accelerations experienced by each test vehicle were much higher than the SRS accelerations input into the fixture. For example, during a 20 G shock pulse, the centerline of Test Vehicle 30 was actually accelerating at 168 G (at 70 Hz) (see Figure 11).

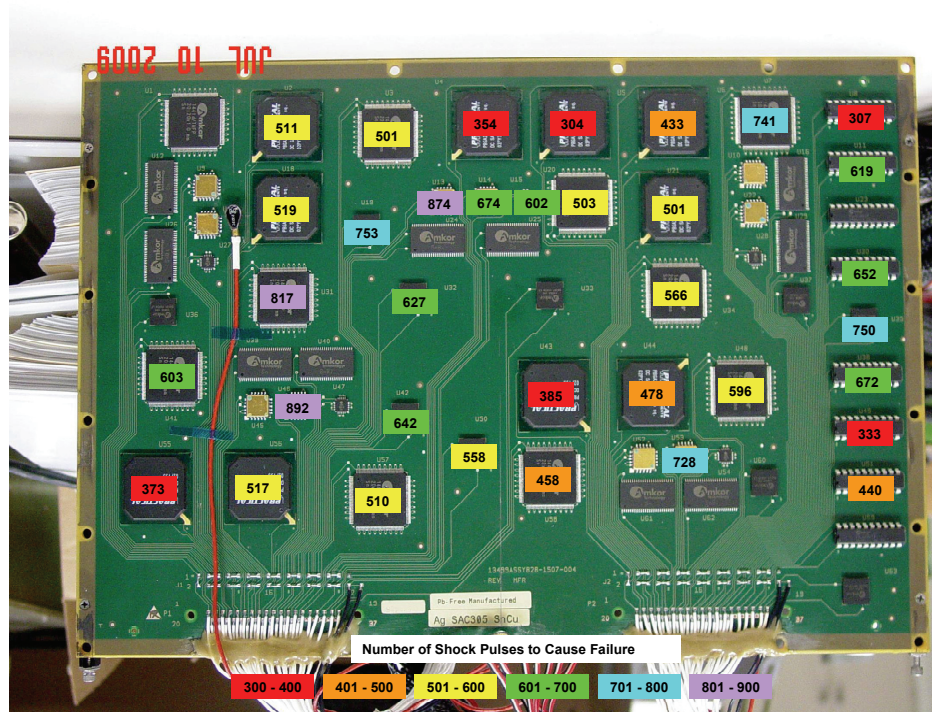
Figure 13. Number of Shocks Required to Fail Components on Test Vehicle 75

Figure 13 shows how many shock pulses were required to fail the components on a test vehicle. The failures are color coded according to how many shock pulses were required to cause the failure (red = 300 to 400 pulses; orange = 401 to 500 pulses;

yellow = 501 to 600 pulses; green = 601 to 700 pulses; blue = 701 to 800 pulses; and purple = 801 to 900 pulses). In general, the components tended to fail first down the centerline and along the edges of the test vehicle (near the wedgelocks). Therefore, the first component failures coincide with the regions of highest strain as shown in Figure 7.

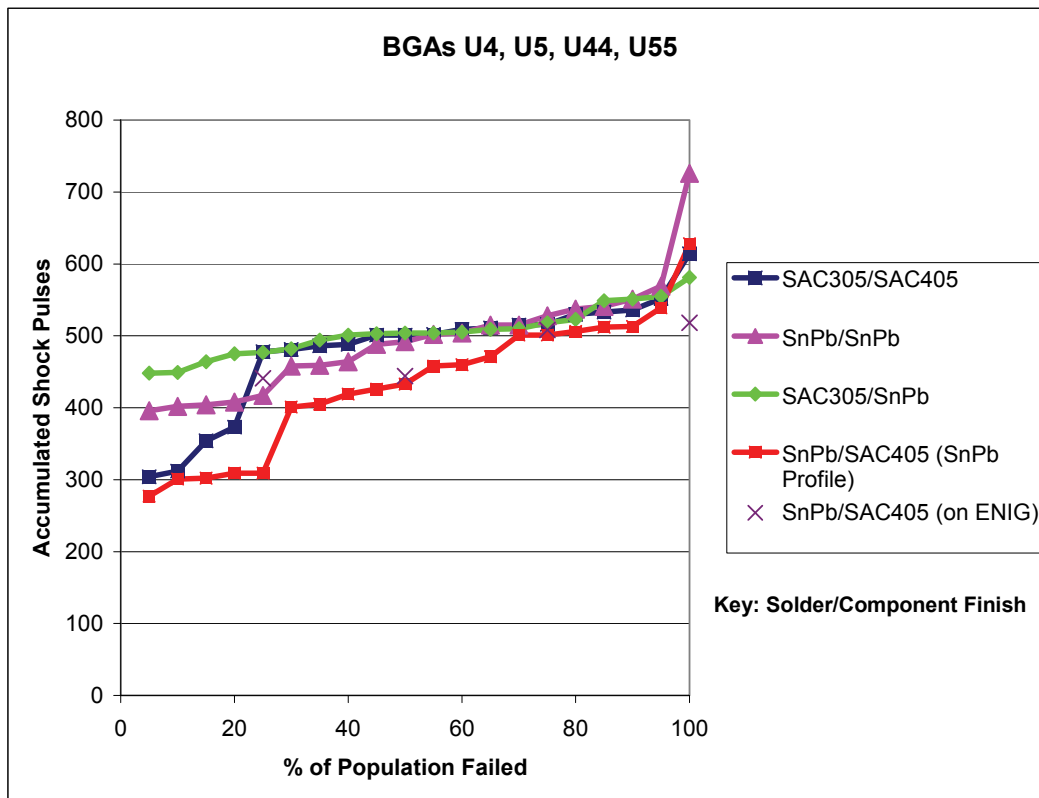
Figure 14. Combined Data from BGA's U4, U5, U44, and U55

The combination of SAC305 solder/SAC405 balls generally performed as well as the SnPb/SnPb controls in mechanical shock (see Figures 14, 15, and 16) although there were some early SAC305/SAC405 failures (see Figure 14). Microsections made at the end of the test showed that the corner solder joints failed first. The SnPb/SnPb microsections showed pad cratering, PWB trace cracking, and solder joint cracking on the component side. The SAC305/SAC405 microsections showed PWB trace cracking and solder joint cracking at the component side intermetallic layer. Which failure mechanism occurred first could not be determined from the microsections.

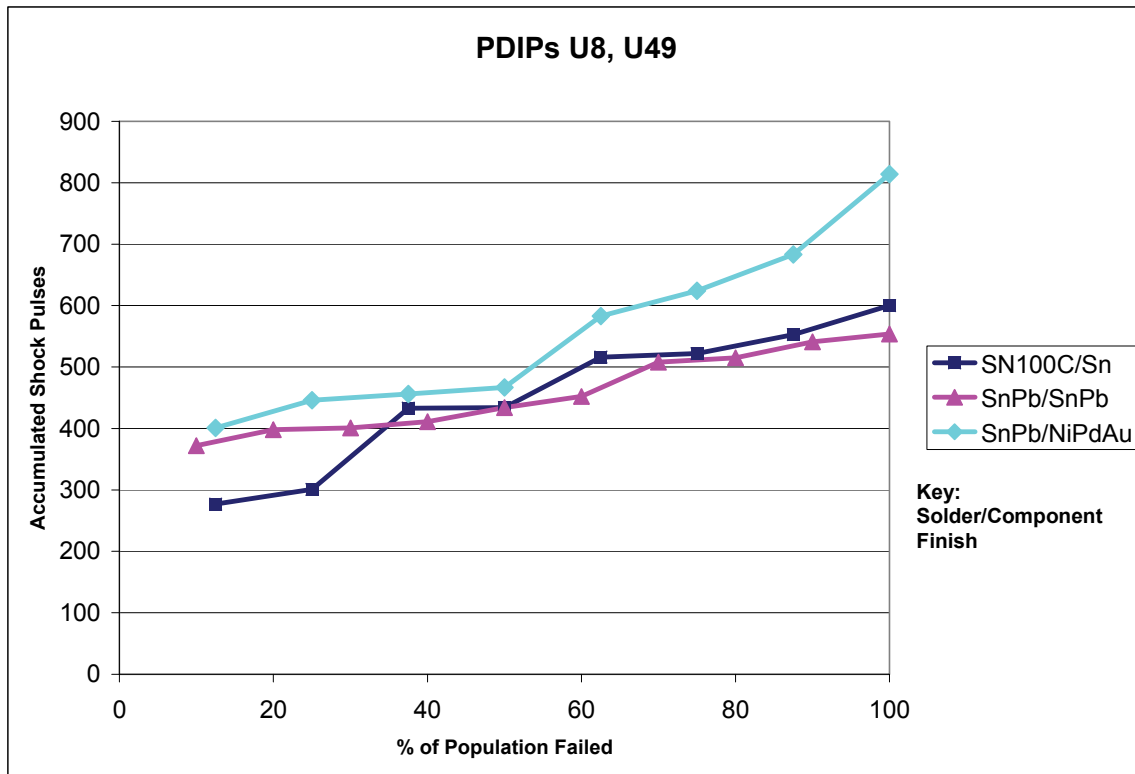
Figure 21. Combined Data from PDIP's U8 and U49

The combination of SN100C solder/Sn component finish generally performed as well as the SnPb/SnPb controls in mechanical shock (see Figure 21) although some of the the SN100C/Sn solder joints failed early. Microsections made at the end of the test showed that the corner solder joints failed first. The topside solder fillet would crack first followed by cracking of the lead where it necks down at the top of the PTH (see Figure 23). Another observation is that many of the PDIP's soldered with SN100C exhibited trace cracking at the corner solder joints (see Figure 24). This failure mode was not observed with the PDIP's assembled with SnPb solder.

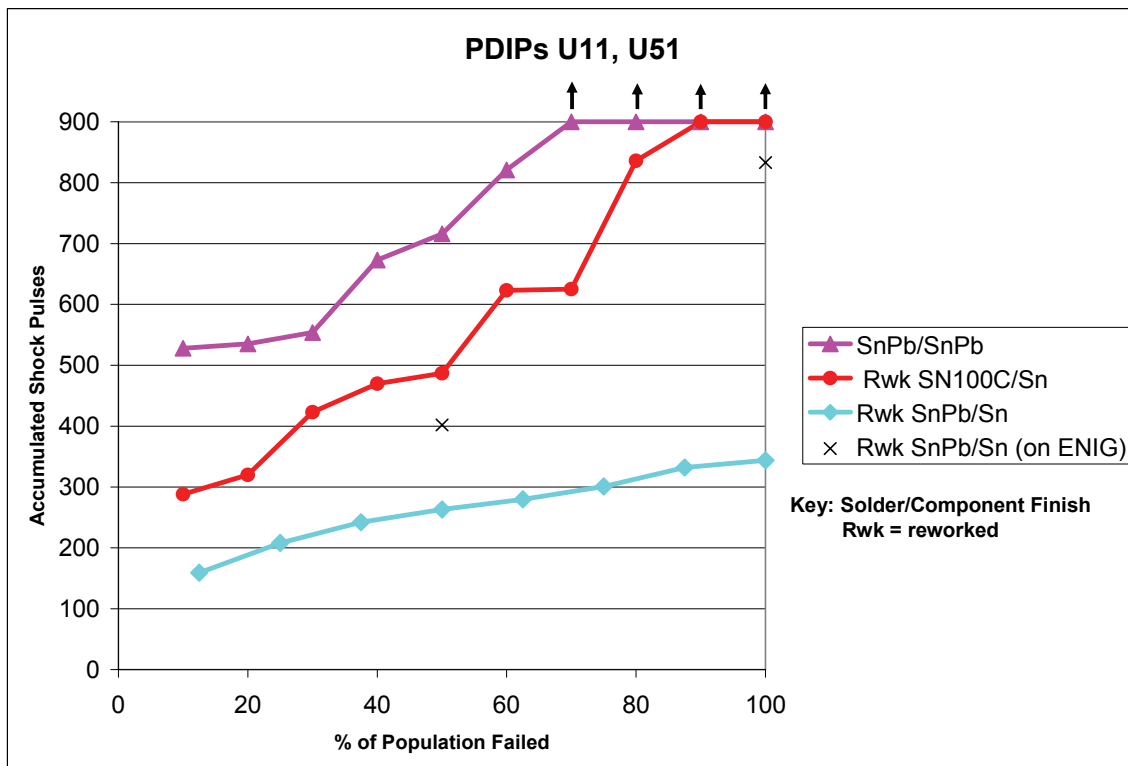
Figure 22. Combined Data from PDIP's U11 and U51

The SnPb/SnPb PDIP's reworked with SnPb/Sn and the SN100C/Sn PDIP's reworked with SN100C/Sn were less reliable than the unreworked SnPb/SnPb control PDIP's (Figure 22).

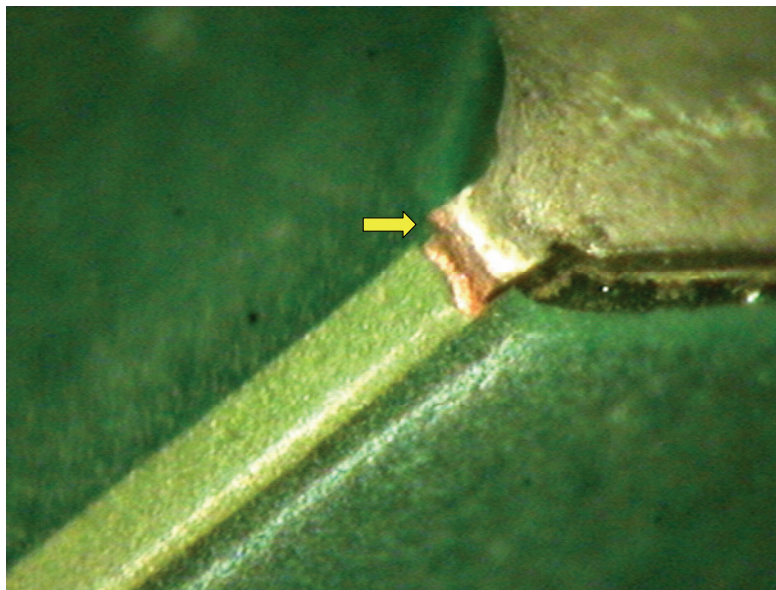
Figure 24. PDIP U38 (SN100C)

Several of the earliest failures on the "Manufactured" test vehicles were SN100C/Sn solder joints. One possible cause is that some of the SN100C joints did not have a substantial topside solder fillet. This could have resulted in a point of high stress concentration where the PDIP lead necked down resulting in premature failure of the lead. The trace cracking mentioned above is another possible cause for the early failures. The PDIP's that failed early exhibited both types of defects so it could not be definitively determined which occurred first.

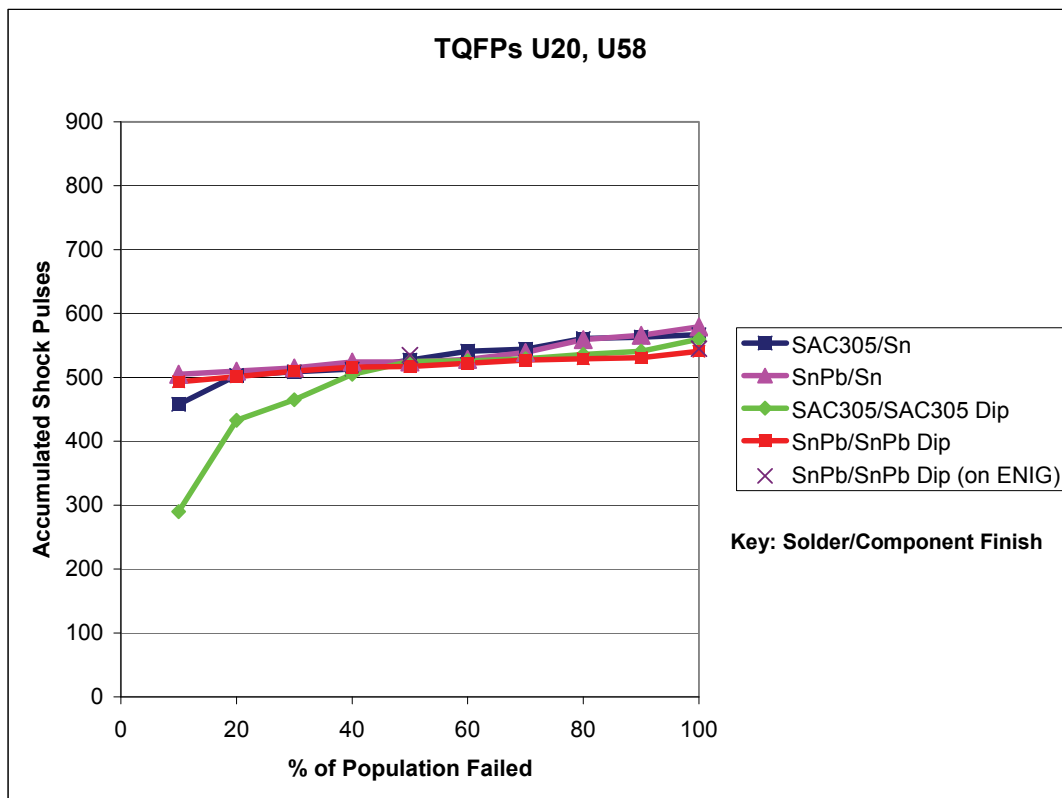
Figure 27. Combined Data from TQFP's U20 and U58

For this test, some Sn-plated TQFP-144 leads were dipped into either molten SnPb or SAC305 to evaluate the effectiveness of the hot solder dipping on tin whisker formation. The combination of SnPb/SnPb Dip was equivalent to the SnPb/Sn control in performance but the SAC305/SAC305 Dip performance was inferior to that of the SnPb/Sn control due to some early failures (Figure 27).
