Effect of Design Variables on the Reliability of Lead Free Area Array Connectors

Abstract

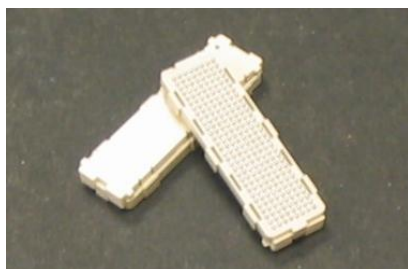
Figure 1 - Area Array Mezzanine Connector

The component discussed in this paper is an area array mezzanine connector, and is shown in Figure 1. It has 240 I/O on a 1.27mm pitch, and has eutectic tin/lead balls when used on the “Metro” test vehicle, and lead free SAC405 balls when used on the “Metro2” test vehicle. It has been referred to in previous publications on the “Metro” and “Metro2” test vehicles as Mezzanine Connector B²⁻⁴.

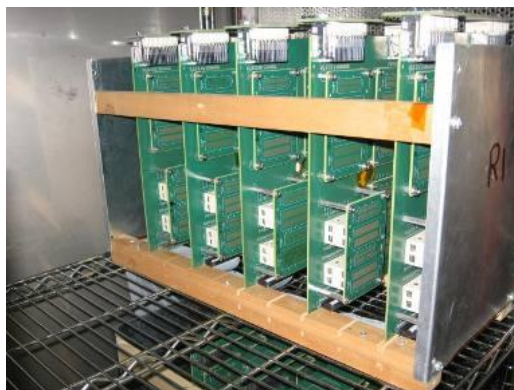
Figure 6 - "Metro2" Cards Mounted in a Rack for ATC Testing

A total of 22 “Metro2” assemblies were placed in a chamber for accelerated thermal cycling. The thermal cycling was conducted in accordance with IPC-9701A, and used the 0°C – 100°C profile, with 10 minute dwells at both temperature extremes. Figure 6 shows the customized fixtures which were created to hold the test vehicles in place, and to allow the airflow to circulate freely around the cards.

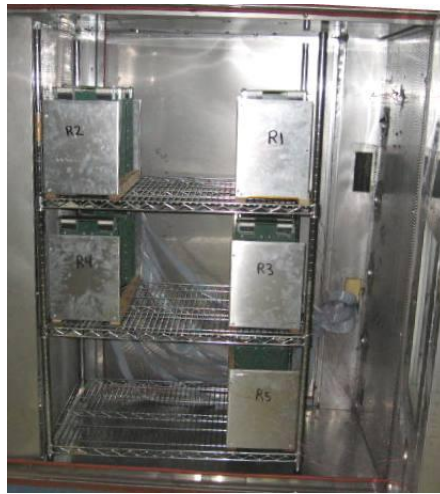
Figure 7 - ATC Chamber Showing Layout of Racks

A total of five similar racks were used to hold the test vehicles in the chamber, as shown in Figure 7. The test setup for the original “Metro” test vehicle was very similar – the profile in that case was also compliant with IPC-9701, and utilized similar racks for holding the test vehicles. The main difference between the two tests was that the ramp rate for the original “Metro” test was slower, as a larger chamber with lower ramping capability had to be used for that test due to the larger number of samples. In both cases, however, the ramp rates complied with IPC-9701.
