Comparison of Copper Erosion at Plated Through-Hole Knees in Motherboards Using SAC305 and an SnCuNiGe Alternative Alloy for Wave Soldering and Mini-pot Rework

Alan Donaldson, Raiyo Aspandiar and Kantesh Doss
Intel Corporation
Hillsboro, Oregon, USA

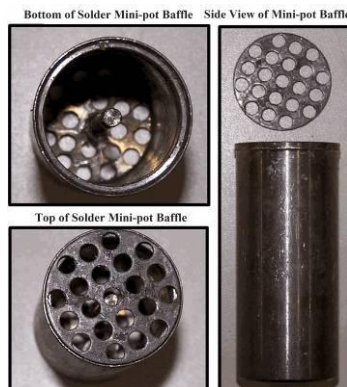
Figure 2 – Modified Solder Mini-pot Baffle

The mini-pot rework was run at Intel Corporation on our machine. A modified baffle was used to reduce the solder flow out of the rework nozzle in the middle of the connector. Figure 2 shows this modified baffle. Equipment and machine settings are shown in Table 3.

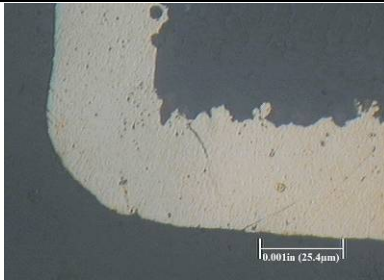
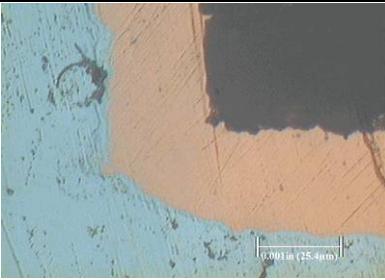
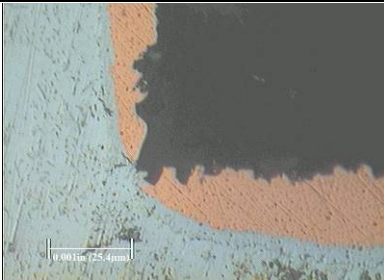
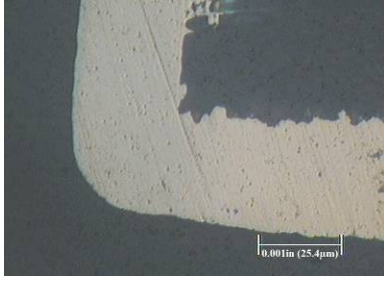
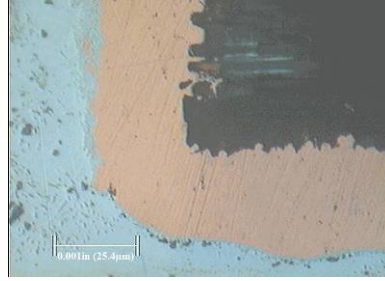
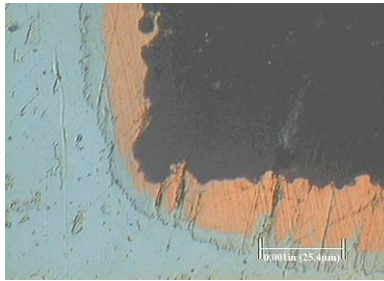
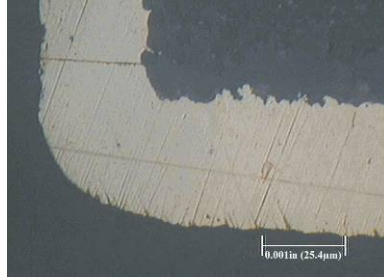
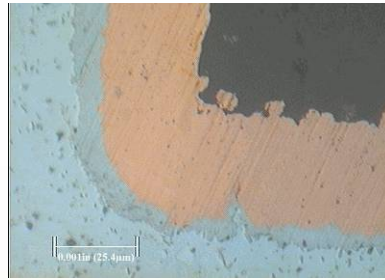
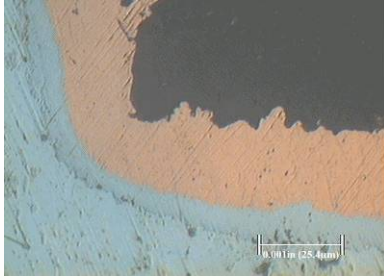
Photos of PTH Knees for the PCI Extended Connector after Various Steps along the Assembly Process

- The increasing trend of copper erosion at the PTH knee with each step is apparent
- A copper break at the PTH knee is shown for board reworked with the SAC305 solder

Table 5 shows photos of PTH knees that exhibited the thinnest copper for the PCI Extended connector after the various process steps for all three experimental legs. The difference in the amount of copper removed at the PTH knee is easily apparent from these photos.
