Printed Circuit Board Reliability and Integrity Characterization Using MAJIC

M. Simard-Normandin
MuAnalysis Inc.
Ottawa, ON, Canada

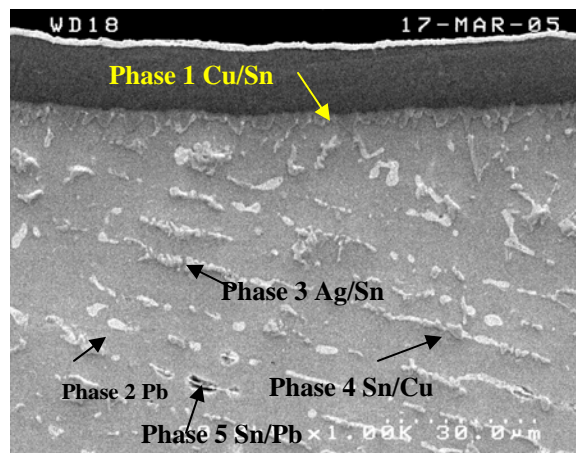
The last part of the MAJIC methodology is to examine the various compound/intermetallic phases created during the soldering process to ensure that proper reflow has occurred. Surprises, such as the unwanted presence of lead, may appear.

Figure 12 – EDX analysis shows the various compound/intermetallic phases present in this BGA ball cross-section.

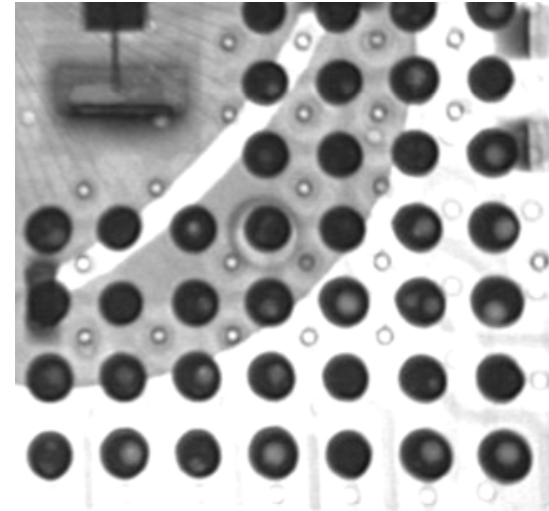
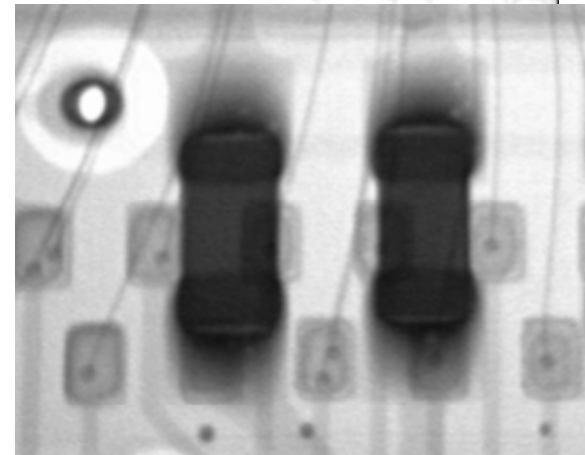
XRAY of BGAs and QFNs

- BGAs and QFNs have hidden solder joints.
- Voiding and wetting are known issues and readily detectable if one spends the time to look carefully.
- Suggests location of some of the cross-sections
