Salt Atmosphere, Temperature Humidity, Mechanical Shock Environmental Stress Testing Results, and FMA of the JG-PP / JCAA Lead Free Soldering Program

Rajan Deshmukh and Lee Whiteman
American Competitiveness Institute
Philadelphia, Pennsylvania

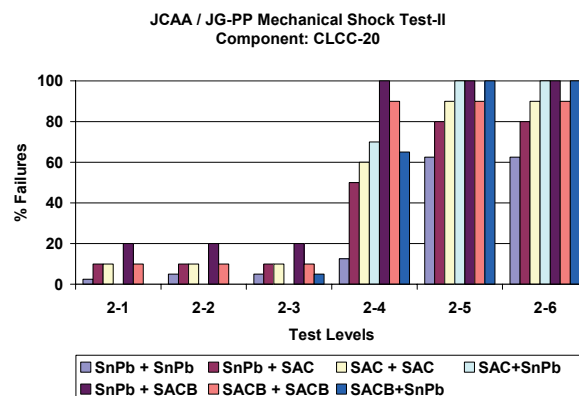
Figure 7 - Mechanical Shock Test 2 Test Results

Tin Lead (SnPb) soldered test vehicles performed better than the SAC and SACB soldered test vehicles. Lead Free Solder failures were most prominent after Level 2.3, as shown in Figure 7. The results are attributed to the higher mechanical shock levels experienced by the components, the quantity of shock pulses per test step level, and the tests being performed in the Z-axis only.

At the higher shock levels, Level 2.4 (> 100 G Peak) and above, failure event data indicated simultaneous failures and intermittent failures of several devices. The intermittent failures confound the test data and do not allow clean interpretation of the test results. An intermittent contact/open may be result of several possibilities such as: shock failed solder/interconnect joints break and remake the contact or the failures are not at the device level but somewhere on the board interconnect chain at the board level or at the mechanical connector. For these reasons, we rigorously applied the IPC 9701 failure criteria. Failure was defined as an electrical interruption lasting greater than 0.2 μ sec and continuity interruption greater than 300 Ω up to 1000 Ω .
