# A Reliability Comparison of Different Lead-Free Alloys and Surface Finishes in SMT Assembly

## Jignesh Rathod and Daryl Santos, Ph.D. Binghamton University Binghamton, NY

Prashant Chouta, Joe Belmonte and Alan Rae, Ph.D. Cookson Electronics Foxborough, MA

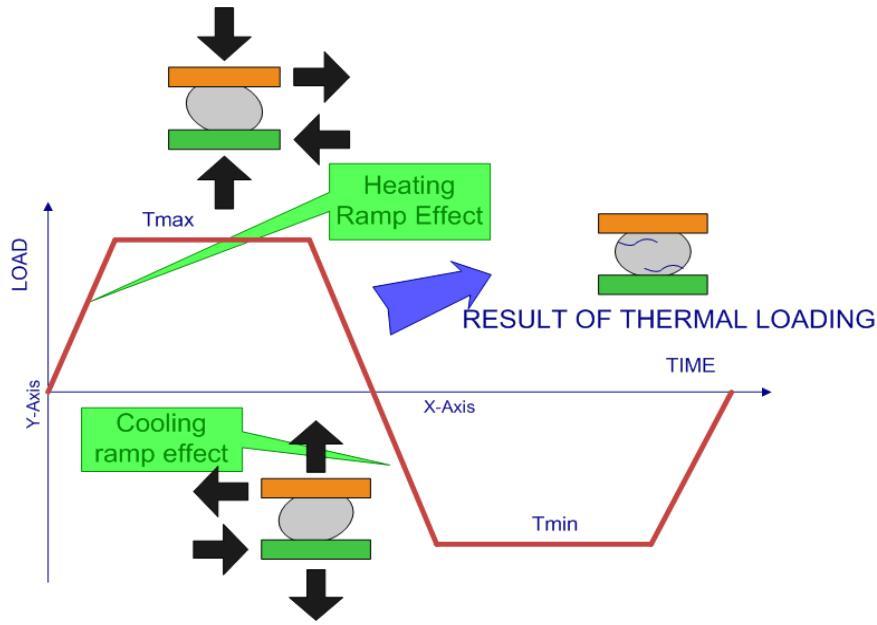
Figure 14 - Thermal Loading Pattern (Source: Ref. 1)

As some material is left at a very high temperature, the microstructure of that material becomes coarsened and the fatigue strength reduces. When the temperature is suddenly changed from a higher temperature to a lower temperature, the thermal stresses are induced in them. A site having higher concentrations of these thermal stresses shows initial signs of cracking and ultimately fails with a fractured joint. A typical thermal cycling loading that occurs during the accelerated environmental testing is as shown in Figure 14.<sup>1</sup> The schematic shows a typical loading pattern that causes fatigue and the solder joint deformation process.
