Rework and Reliability of High I/O Column Grid Array Assemblies

Reza Ghaffarian, Ph.D. Jet Propulsion Laboratory, California Institute of Technology Pasadena, CA <u>Reza.Ghaffrian@JPL.NASA.Gov</u> (818) 354-2059

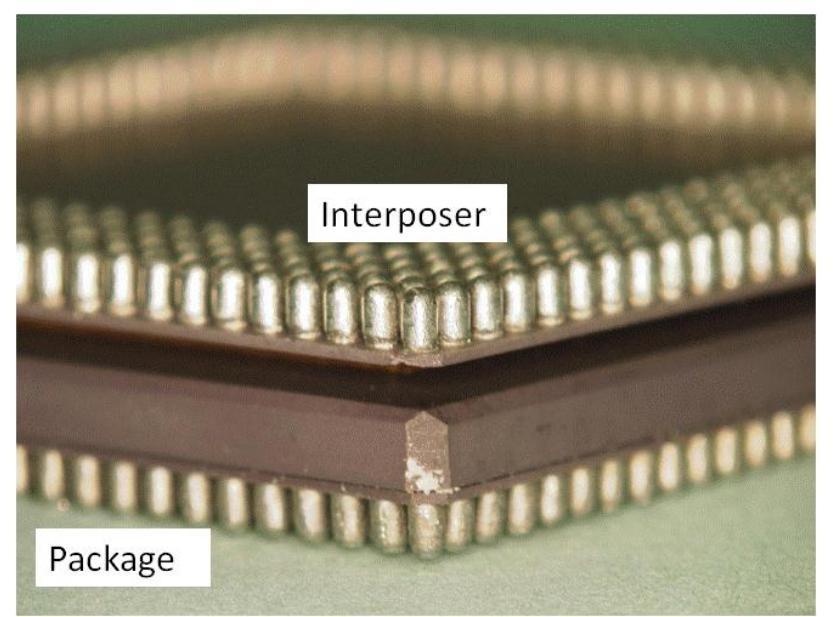
Fig. 1. Optical photomicrograph of a virgin CGA 560 I/O package before re-columning with interposer (bottom) and an interposer layer alone on the top.

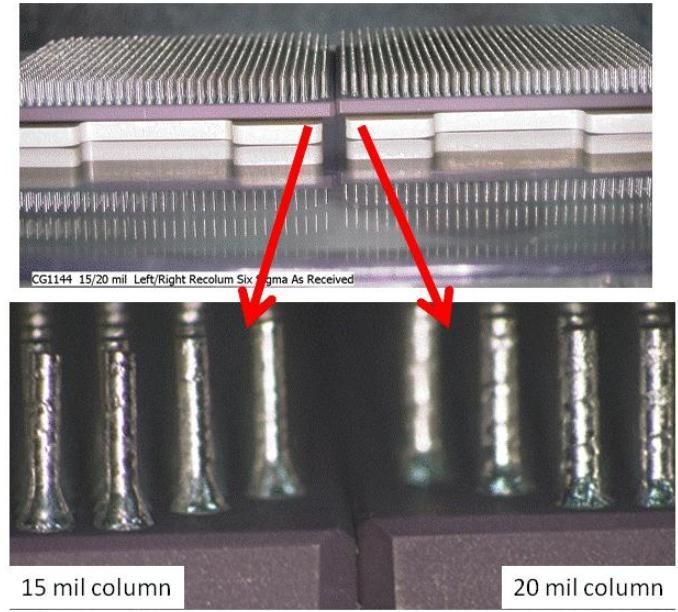
Re-columning was performed using Cu-spiral columns at the same facility that CGA560 packages were re-columned. Two re-column sizes were used, one with 20- and the other with 15-mil diameter. Photomicrographs of the two re-columns at a low and a high magnification are compared in Figure 13; the right side shows the 20-mil diameter columns. Except for the column size differences, solder joints for both conditions have visually acceptable quality with shiny appearance and good fillets. No pull testing was performed; therefore, the tensile strength differences between the two column sizes are unknown.

Fig. 13. Photomicrographs of the two sizes of re-columned packages (20- and 15-mil columns) at low and high magnifications.

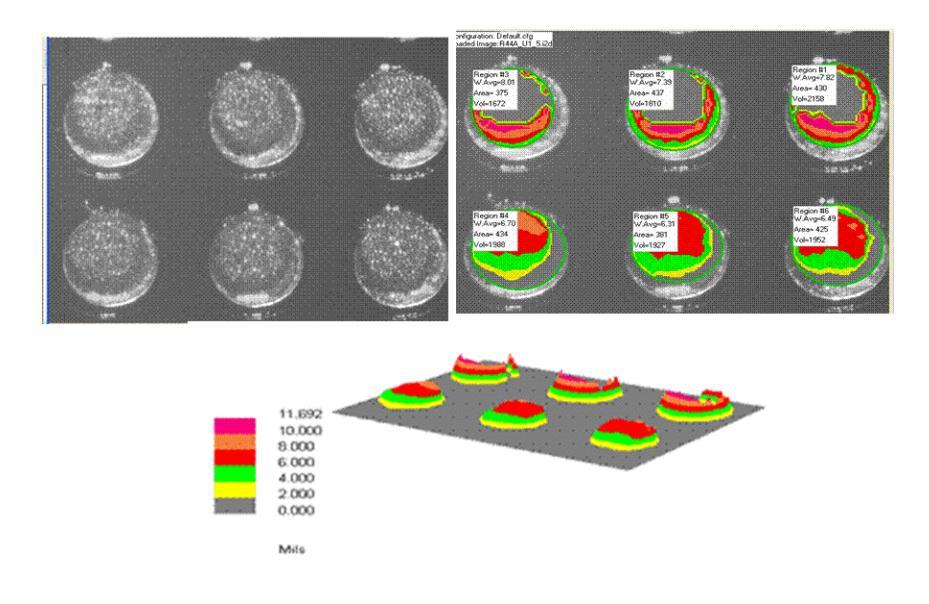
Fig. 16. Optical photomicrograph and measured/calculated solder paste information for paste print with ministencil with 7-mil thickness and 23-mil aperture opening diameter.

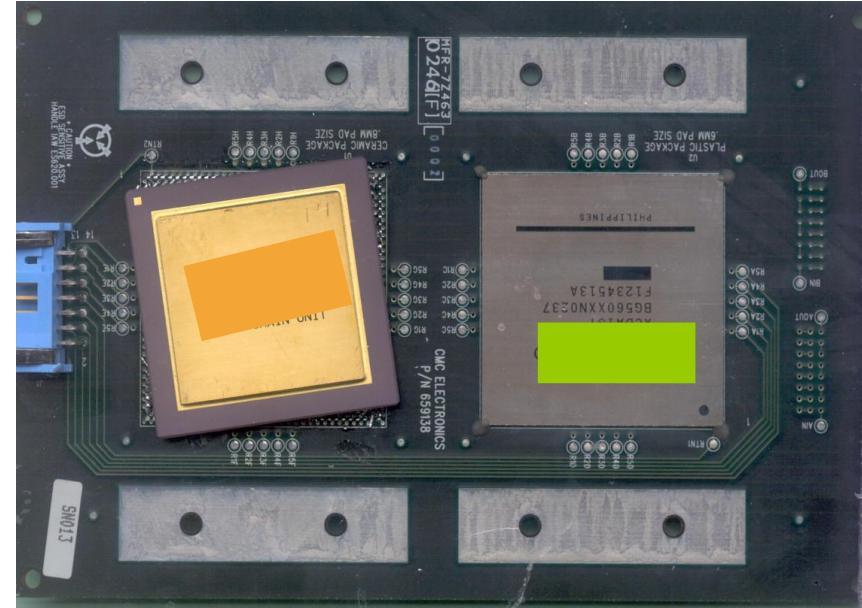
Recolumn/Rework- Reject

The soldered column separation from the package side is a significant failure and is unusual. This might be due to the weakness in re-column attachment, which might have been exacerbated by another reflow during re-assembly causing solder separation at the pads. Note; however, that the new columns have much smaller diameter that are placed on relatively larger package pads allowing more movement of columns during reflow. Follow-on test results for strength reduction on re-columned packages with and without additional reflow and subsequent aging at 125°C all indicated lack of significant interfacial degradation. Consequently, the tensile test results reject the possibility of failure due to weakness of solder joints at interfaces. Another possibility is that the smaller re-column size relative to the large package size and weight causes elimination of self-alignment, which is a key advantage of the area array package. Daisy chain connections between the pads at the package side also are not representative of a working part and may contribute to such interfacial failure. Solder on daisy chain traces can possibly further facilitate column shifting to the neighboring pads during solder reflow.

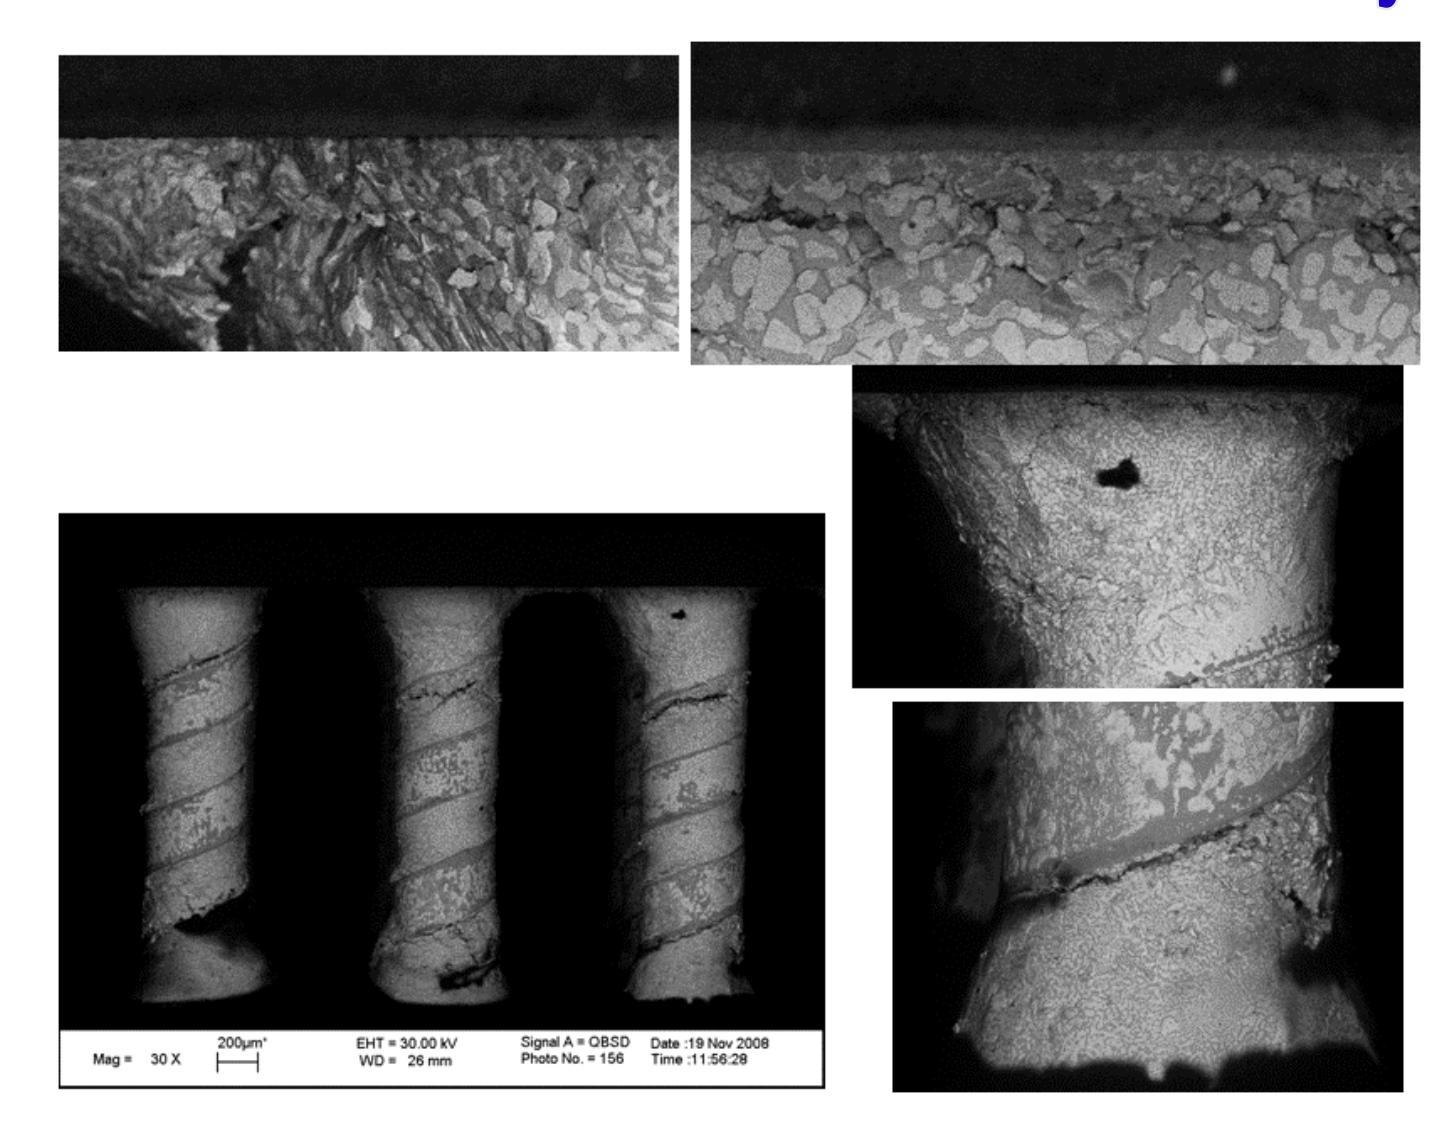
SEM of TC CGA560 Re-column Assembly

Figure 12 depicts SEM photomicrographs at higher magnifications, showing interfacial damage conditions both at the package and at the PCB sides. Separation at the package pad interface with minimum solder remnant at the pad is possibly an indication of weaker metallurgical bond due to re-columning and second reflow due re-work/re-assembly. More damage and cracking at the package side may also be due to a larger local CTE mismatch between the ceramic and solder at the package side in comparison to polymeric PCB and solder at the board level.

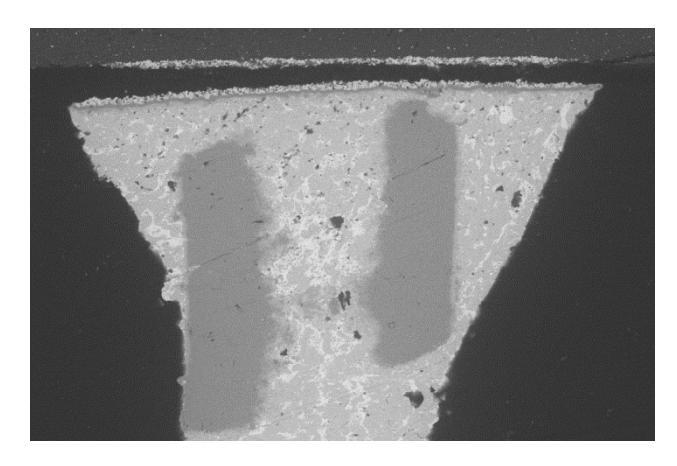
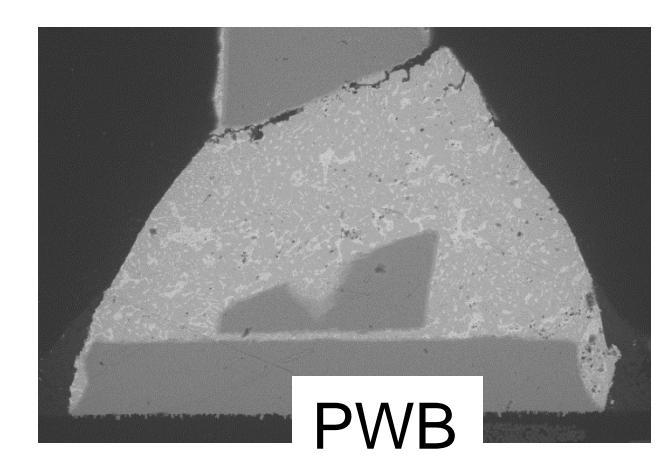
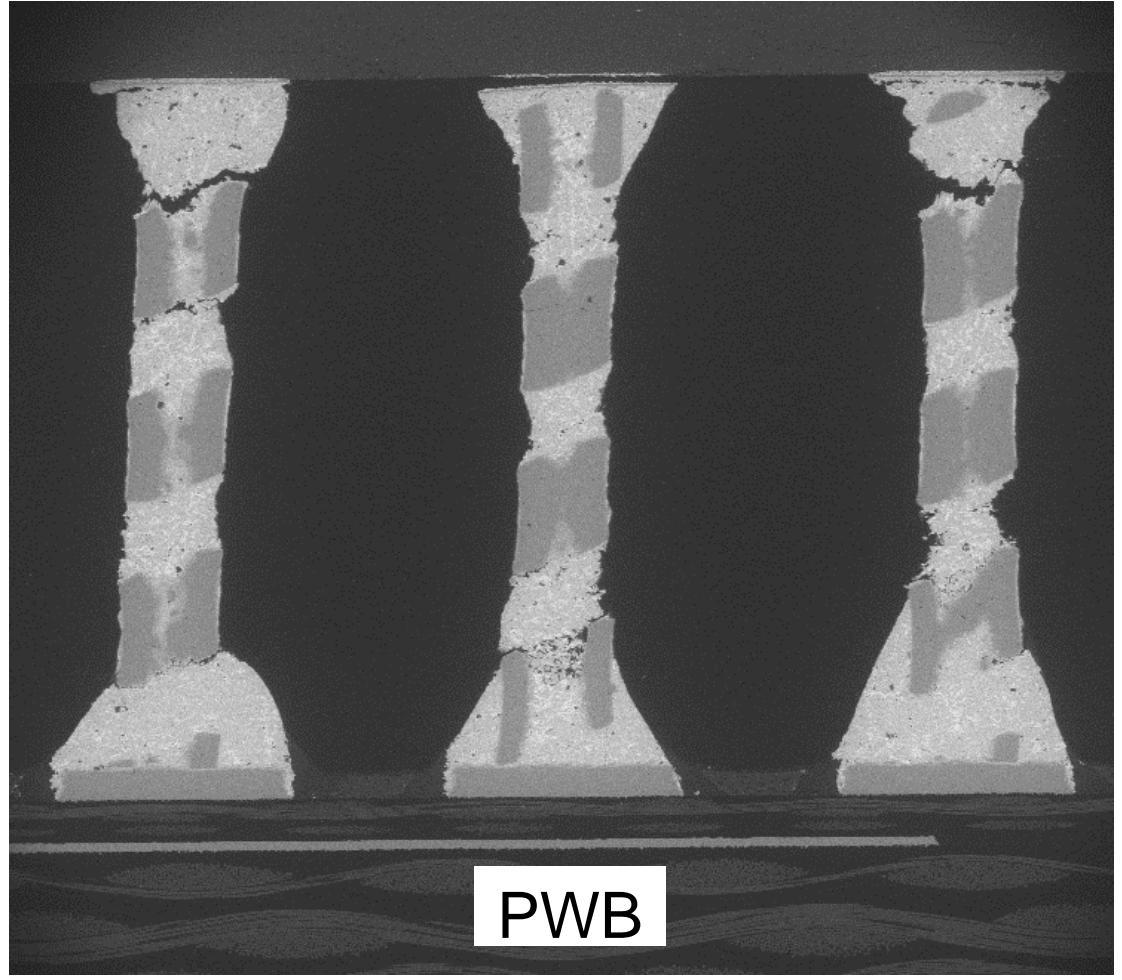
X-sections of TC CGA560 Re-column Assembly

X-section photomicrographs for the three corner columns are shown in Figure 11. It clearly shows significant damage and minor-to-full cracking, more often at the package sides.
