QFN Flux Entrapment Case Study

By Terry Munson

Foresite Inc.

QFN Flux Entrapment Case Study #1

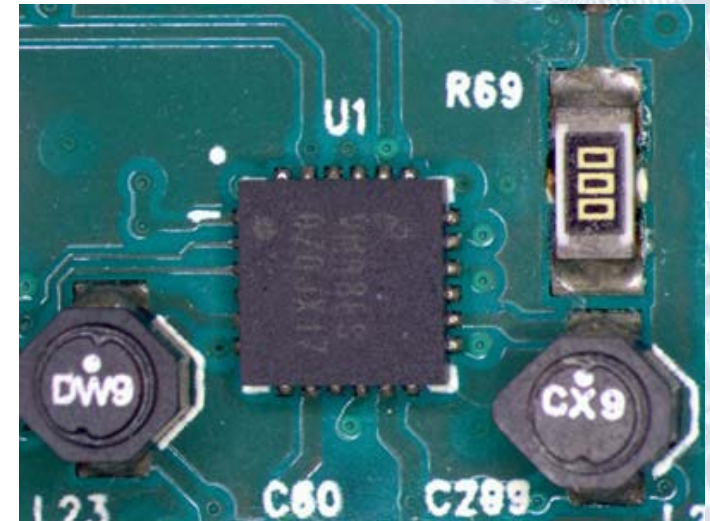
- In this case study on Quad Flat No-lead components we will compare no clean with and without soldermask standoff. The units without soldermask standoff (SS) showed poor leakage and units with SS showed good performance.

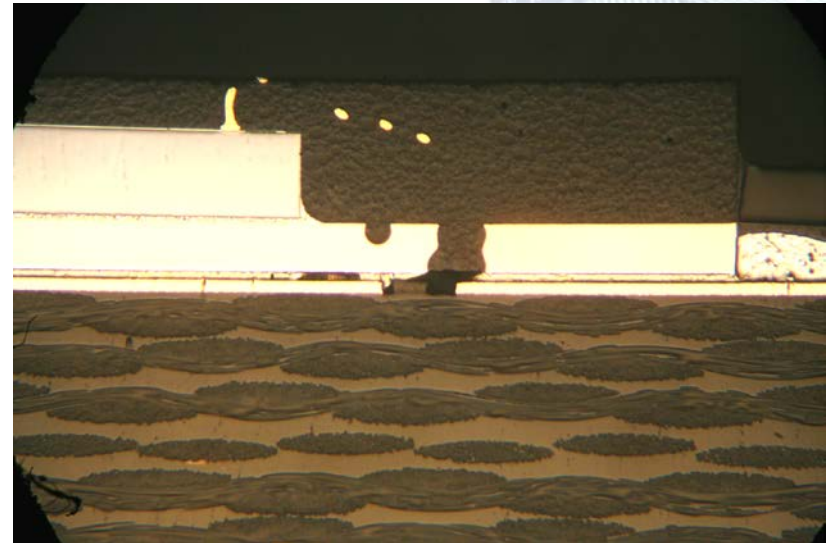
- Many of components have a large heat sink on the base that covers more than $\frac{3}{4}$ of the component surface. This large thermal mass for conducting heat while the component is in operation.
- The cross section shows that the QFN has four key areas
 - Solder at the edge of the pad
 - Gap
 - Perimeter pad
 - Thermal / Ground pad
