Telecommunications Case Studies Address Head-In-Pillow (HnP) Defects and Mitigation through Assembly Process Modifications and Control

Russell Nowland
Alcatel-Lucent
14000 Quail Springs Parkway, Suite 300
Oklahoma City, OK 73134-2620, USA
E-mail: russell.nowland@alcatel-lucent.com
Phone: 405-302-1660

ABSTRACT

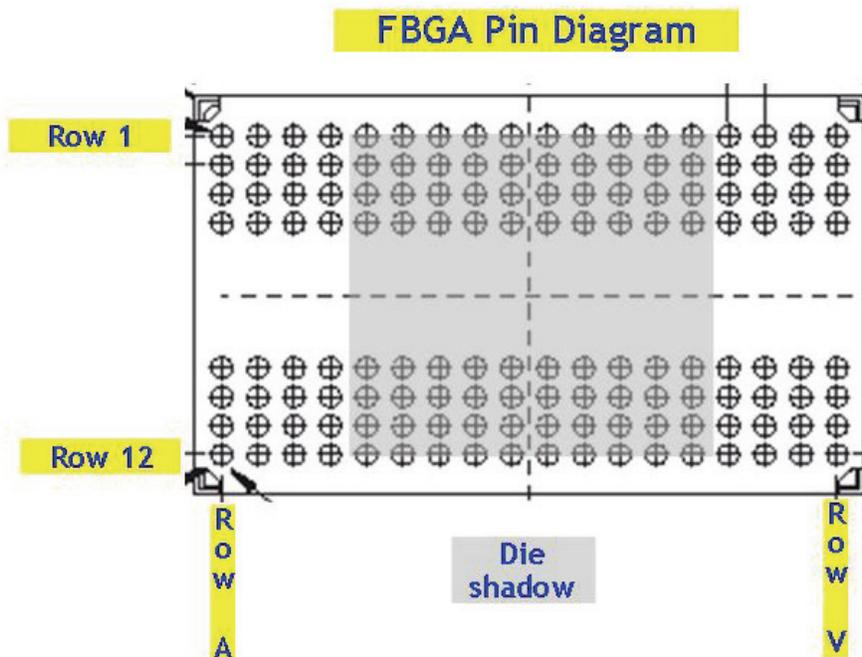
Figure 3. The package pin diagram for the 144 I/O FBGA.

In this application, the FBGA component exhibited extremely low yields (as low as 10%) when used in a complex telecommunication printed circuit board assembly (PCBA). There were multiple SnPb 144 I/O FBGA components soldered onto this PCBA and each had a unique pattern of HnP defects. Data provided by the device supplier indicated that this component was not sensitive to HnP defects when used in high temperature, Pb-free solder assembly process. The basic package pin diagram for the component is shown in Figure 3. Figures 4 and 5 show the defect maps and metallographic cross sections for two devices that exhibited severe HnP open joint failures.

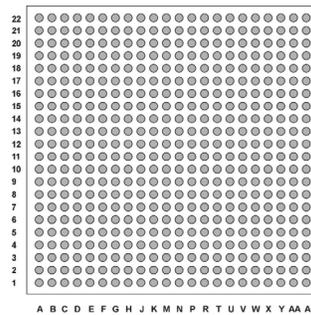
Figure 8. The 484 I/O PBGA pin diagram.

In this application, a 19mm x 19mm, 0.8 mm pitch, 484 I/O PBGA component exhibited variable or erratic production yields when used in a complex telecommunication printed circuit board assembly (PCBA). The PCBA contained an array of multiple SnPb 484 I/O PBGA (Figure 8) components. Only some of the sites had HnP defects, the frequency of defects varied dramatically from one PCBA to another, and the overall yield was approximately 80%. Defects were mostly localized at the corners and in the outer rows of the BGA but each component location and PCBA had a unique pattern or number of HnP defects. Optical inspection images of HnP defects are shown in Figure 9. Data provided by the device supplier indicated that this component was susceptible to warpage but was less sensitive to HnP defects when used in high temperature, Pb-free solder assembly process.

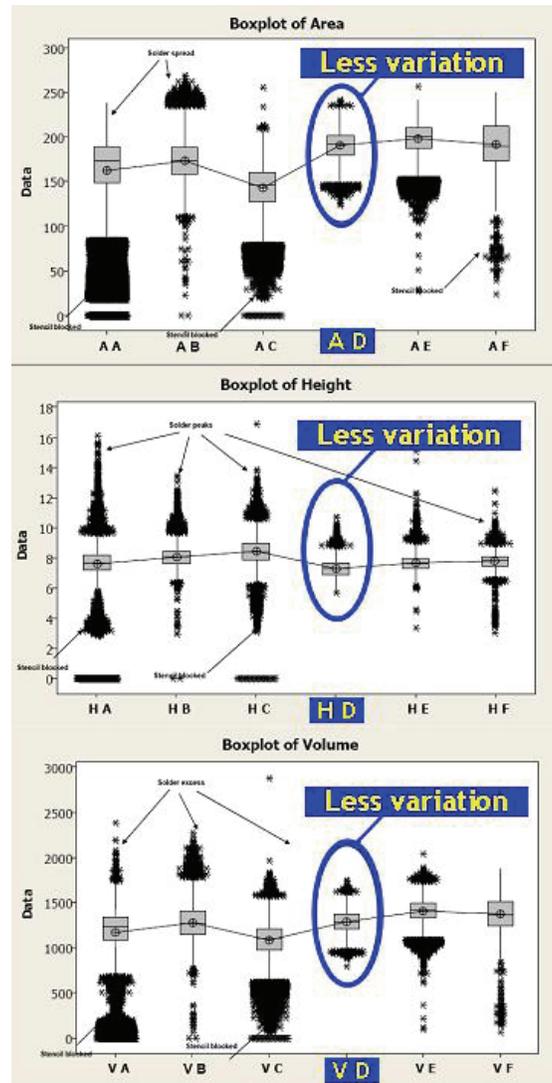
Figure 15. DOE scatter plots for solder paste area (top), b) height (middle), and c) volume (bottom). Solder paste “D” in blue was the best performer with the lowest variations in area, height, and volume.

The paste printing DOE consisted of 30 printed boards of each paste and generated scatter plots for area, height, and volume. Following the printing DOE an assembly DOE was run to assess the ultimate performance of the paste printing. Figure 15 shows the scatter plots for the paste printing DOE.

The scatter plots show that paste D clearly had the tightest, most consistent variations in area, height, and volume. Pastes A, C, and F had some aperture clogging and required additional cleaning. These data were used to select the pastes for the assembly phase of the study. Paste C was eliminated based on poor performance and paste E was eliminated due to availability. Despite poor print performance, pastes A and F remained in the assembly phase matrix because both pastes have advertised effectiveness for eliminating HnP defects. The effectiveness of these pastes is based on their prolonged flux activity, which promotes wetting and soldering better during the ramp down [4]. Thus, solder pastes A, B, D, and F were chosen for the final assembly evaluation phase.

The data from the two-phase DOE showed that a carefully chosen combination of paste selection and print control could provide significant mitigation of HnP defects. When solder paste D was implemented into the production process, it was done in conjunction with incorporation of 100% solder paste inspection (SPI) to enable improved manufacturing process control. The SPI was viewed as a critical step because it was needed to maintain control of a soldering process with a relatively narrow window for success. By all accounts, it seems that deviation from the optimum process window results in unacceptable levels of HnP defects in the 484 I/O devices. The corrective action plan required process changes and quality monitoring that deviated from conventional manufacturing practices. Those process changes required substantial resource commitments in manufacturer but this eliminated nearly all HnP defect, and resulted in acceptable production yields.

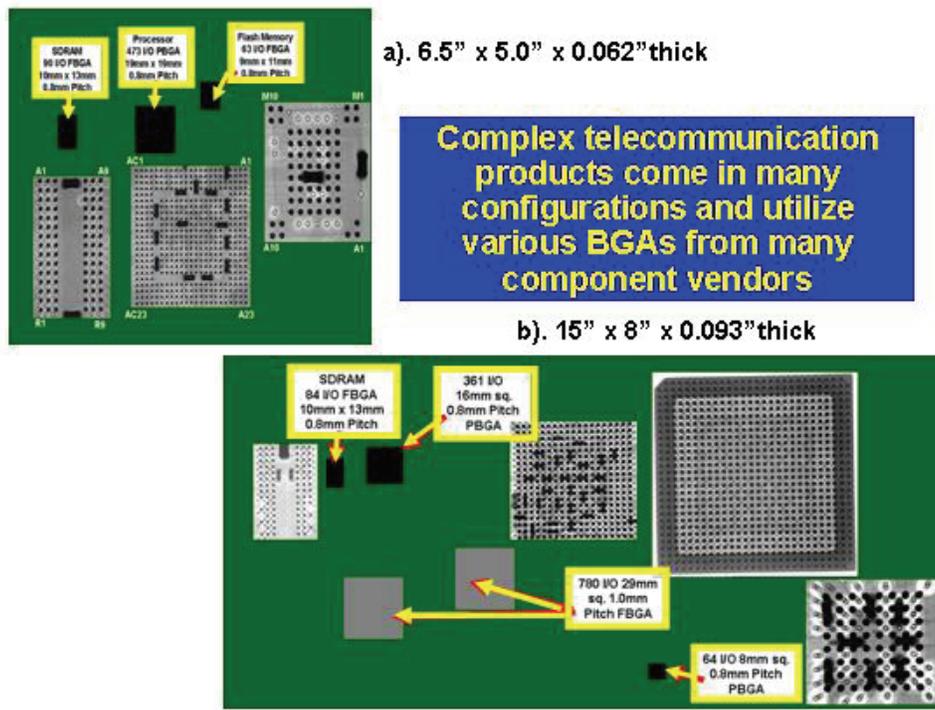
Figure 16. Examples of variation and range of components seen in telecommunication NPI.

In this application various complex telecommunication Pb-free development products exhibit intermittent or open FBGA and PBGA component solder joints. The rapid expansion of 3G and 4G telecommunication has dramatically changed New Product Introduction (NPI). Design cycles have been reduced from years to months, and multiple designs are being developed simultaneously to meet customer demands for features and performance. The combination of high-mix, low-volume, product diversity, and aggressive schedules is causing an increased occurrence of HnP and intermittent BGA solder joint defects in NPI. Figure 16 shows two examples of new telecommunication products. The PCBA geometries are considerably different and there is a wide range of BGA component sizes and pin counts being used as evidenced by the x-ray images included in Figure 16.

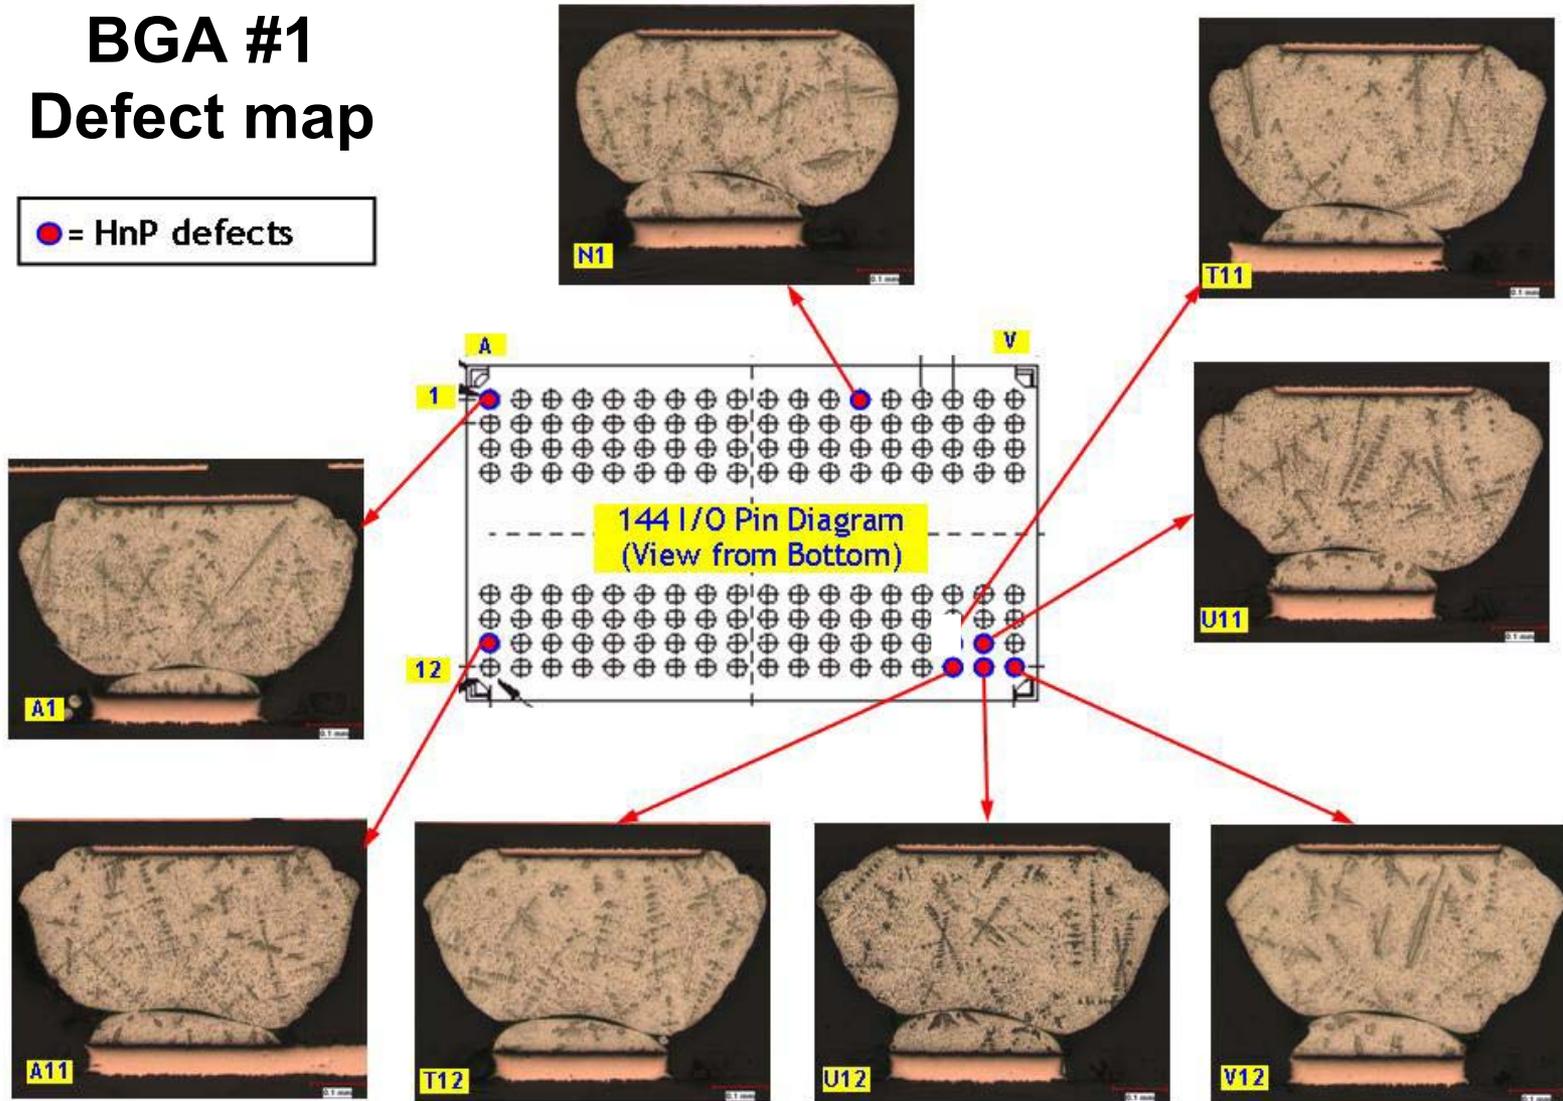
Defect map

- Multiple **SnPb** 144 I/O 0.8 mm pitch FBGA components are soldered onto a large telecom PCBA
- Each BGA location on the PCBA has a unique occurrence frequency and pattern of HnP defects.
- Device supplier data indicated that component was not sensitive to HnP defects when used in a **Pb-free solder** assembly process.

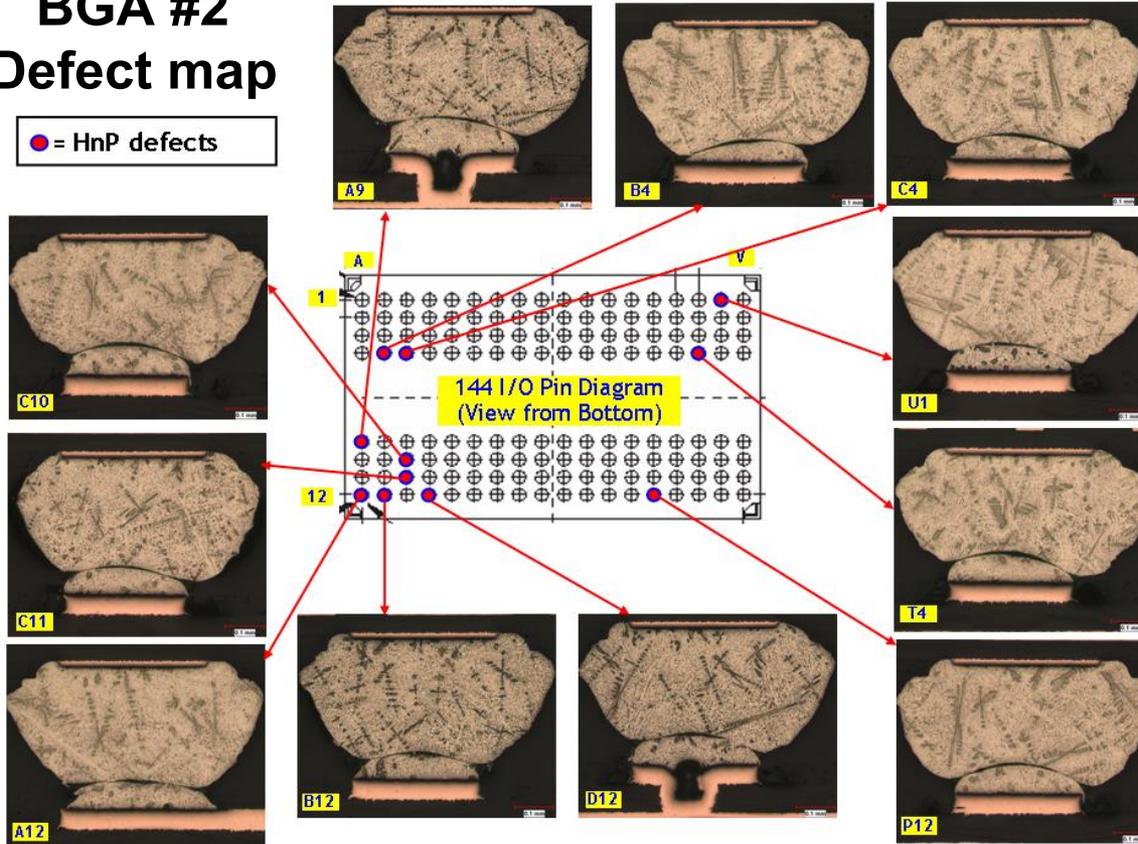
BGA #2 Defect map

- Variations in HnP appearance.
- Defects not limited to the corners or edges of the package.

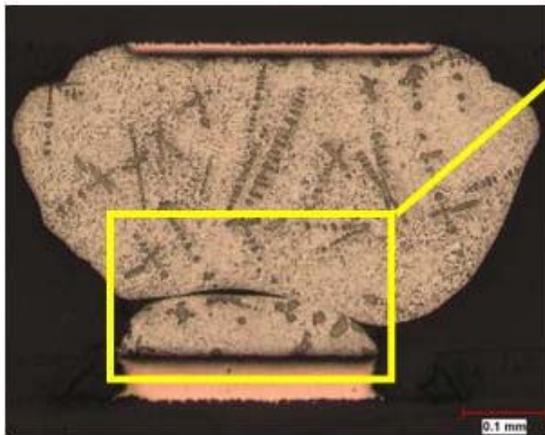
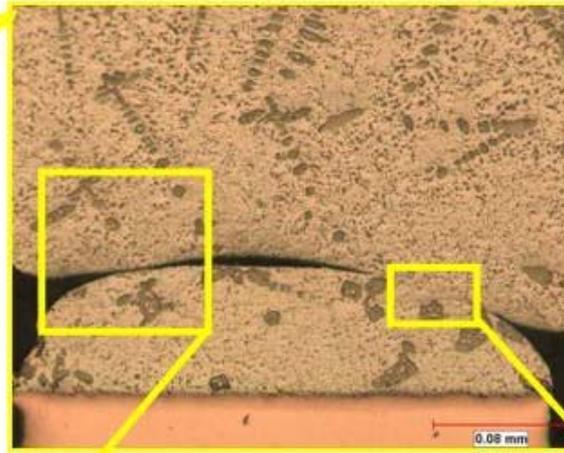
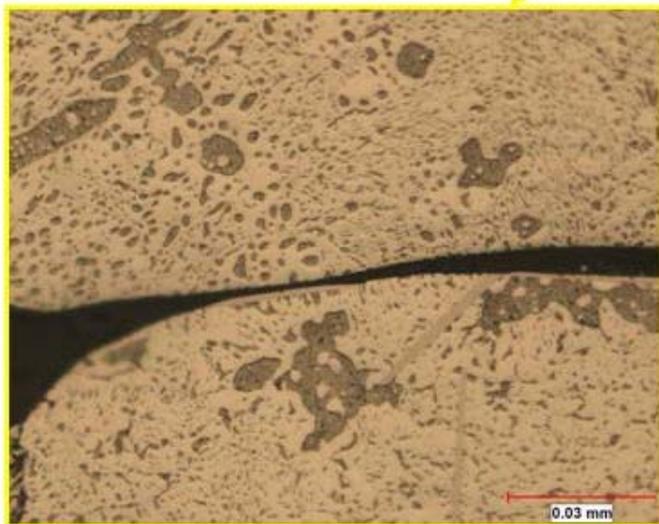
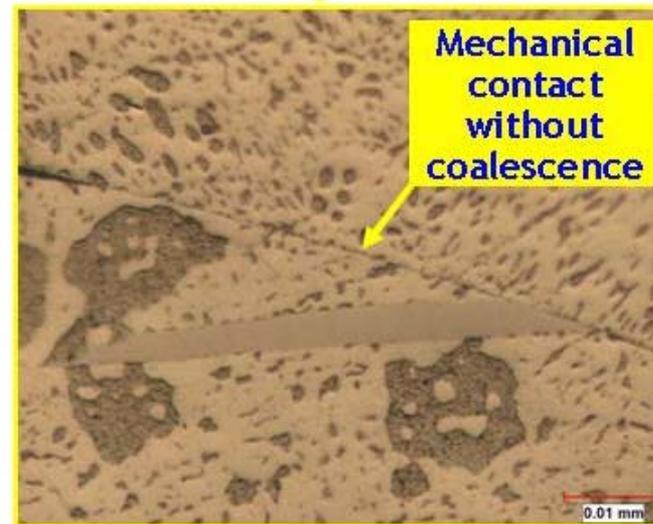
BGA #1 U11

This is an insidious type of HnP defect because it can escape manufacturing and result in an early failure.

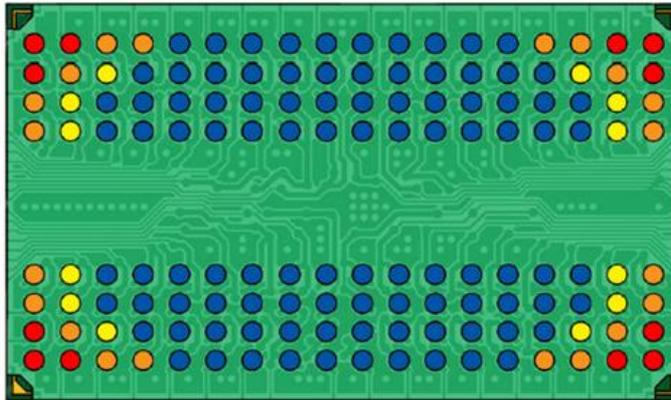
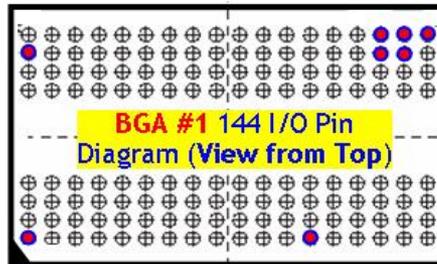
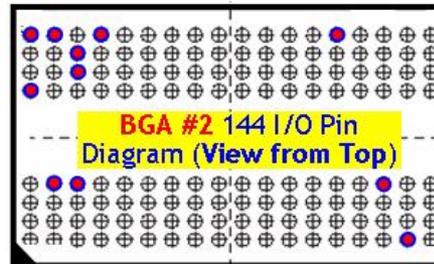
Proposed Stencil Modification for Mitigation of FBGA HnP Defects

Based strictly on the actual location of defects, the proposed modified stencil would provide additional solder paste volume on ~75% of the affected PCB pads.

- There are limitations to mitigating HnP though paste printing.
- Note: This modification proved successful in some applications of the 144 I/O FBGA.

- - Typical Circular Opening of 1:1
- - Circular Opening + 25um to Radius
- - Circular Opening + 38um to Radius
- - Circular Opening + 50um to Radius

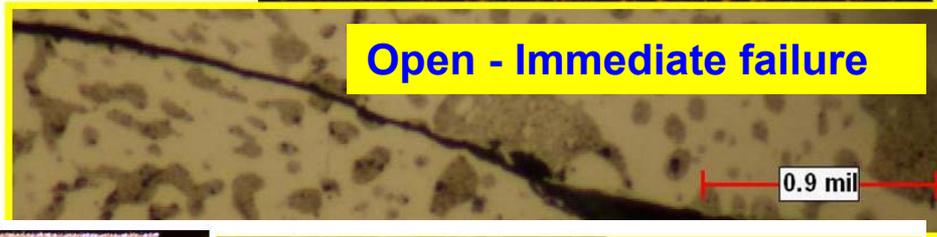
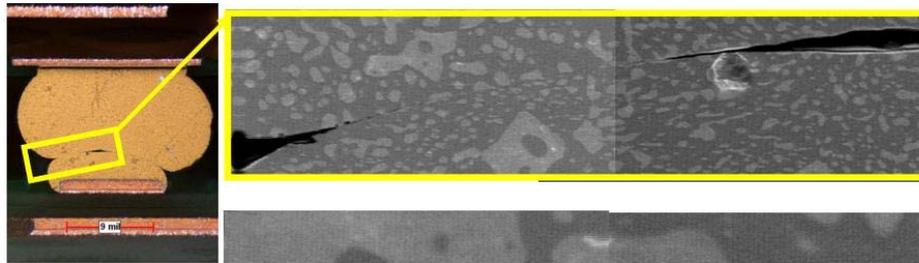
Open - Immediate failure

**Solder
coalescence
across interface**

**No solder
coalescence
across interface**

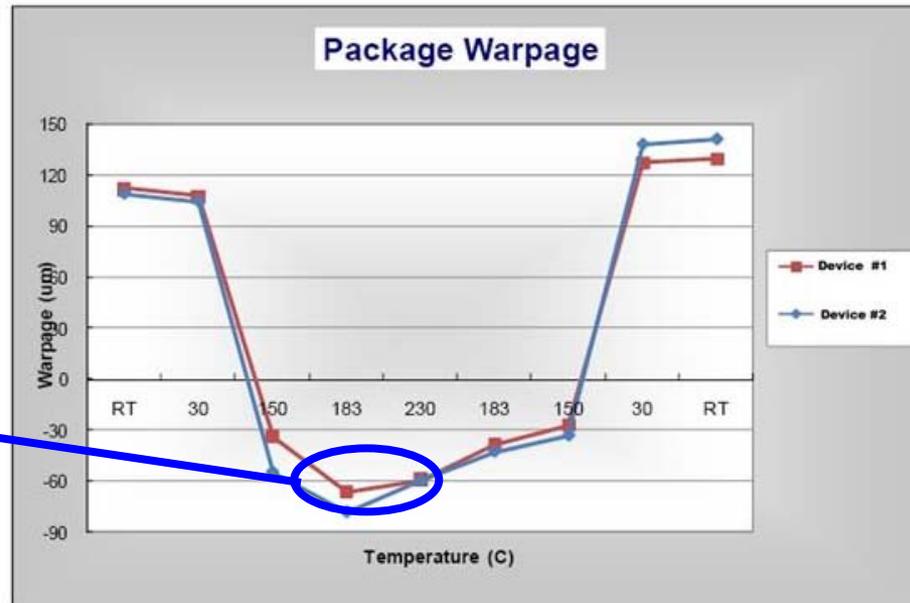
Root Cause Analysis – Warpage-Induced HnP Defects

HnP defects form in this temperature range

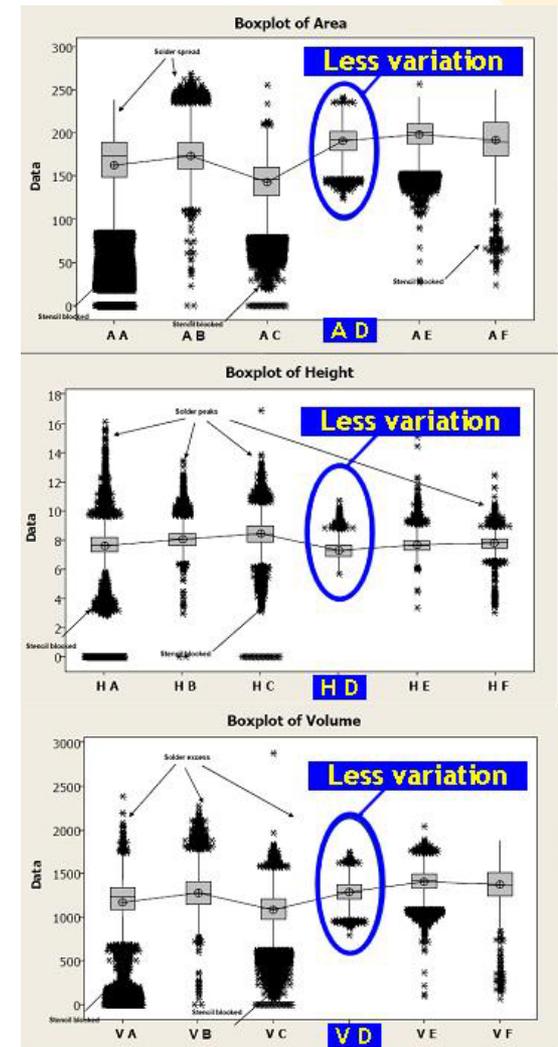
- Phase 1 – Conduct a DOE to evaluate solder paste printing of 6 commercial solder pastes.
- Phase 2 – Evaluate the relationship between solder printing, assembly, and propensity for HnP.
- Solder paste “D” was the best performer with the lowest variations in area, height, and volume in Phase 1.

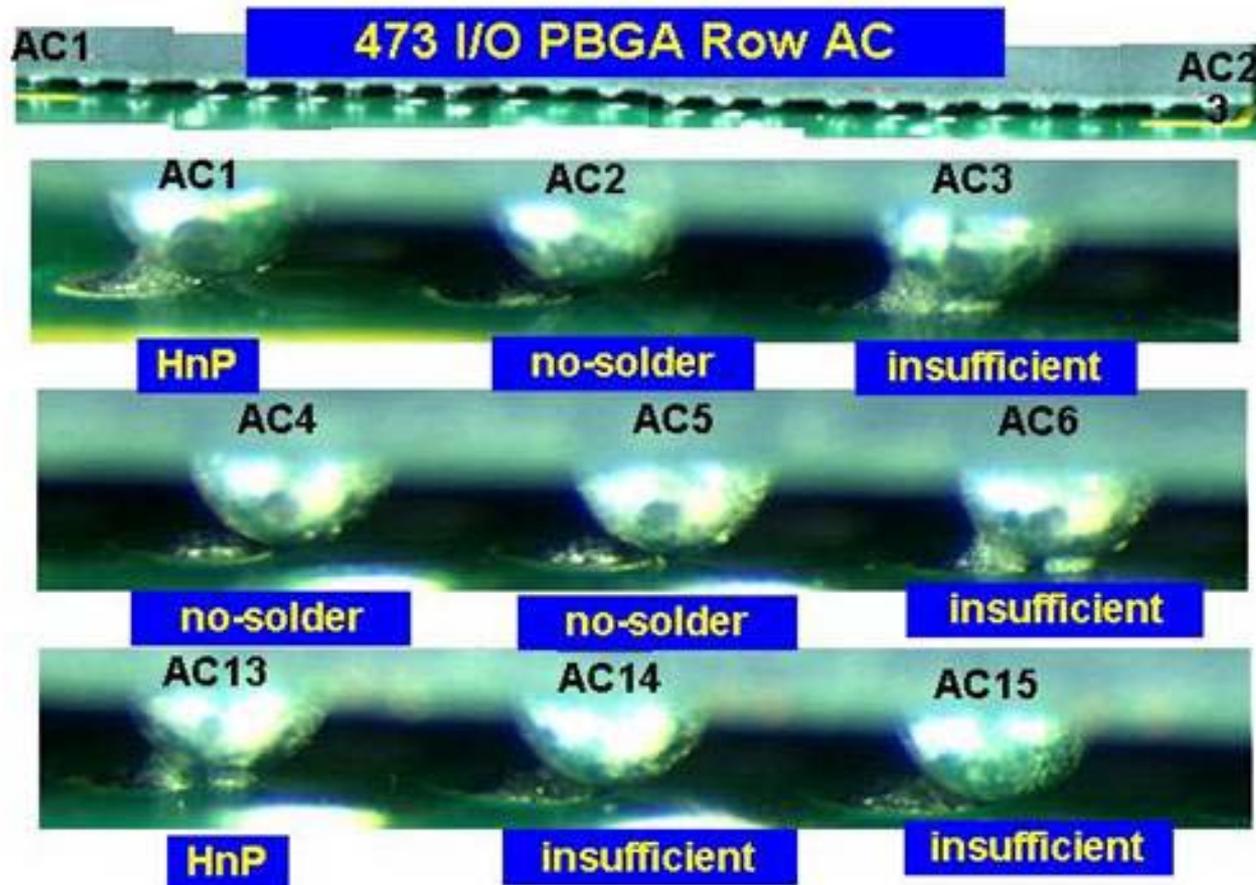
- Various solder defects including insufficient and no-solder defects, *in addition* to HnP suggest that there are quality and process problems besides package warpage.
