Failure Analysis of Eutectic and Pb-Free Solder Alloys after High Stress Exposure

Christian Navarro and Harvey Abramowitz
Purdue University Calumet
Hammond, IN

Dennis Fritz
SAIC, Inc
Merrillville, IN

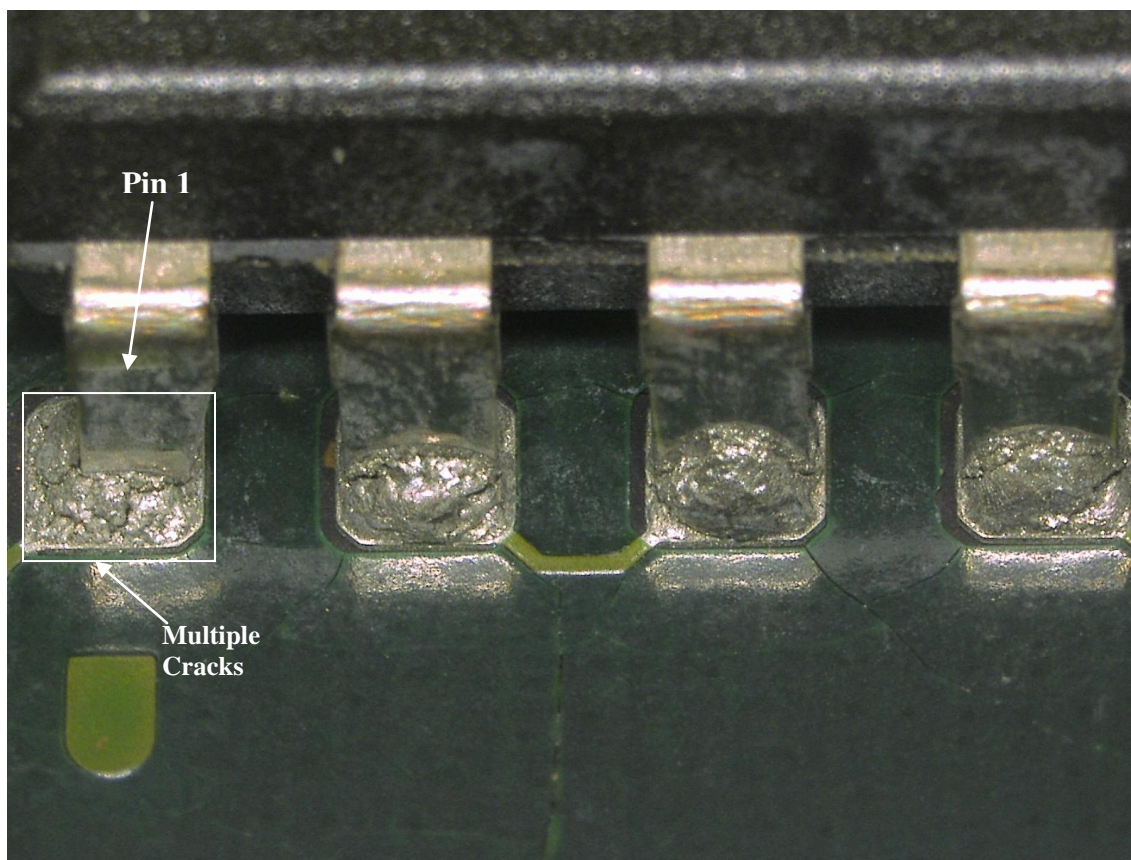
Figure 4 – PWB 58 - U59, Pins 1 – 4 (Au/Pd/Ni Finish)

The individual solder joints of components listed in Table 1 that did not fail during testing had measured resistances between 0.2 and 0.7 Ω . Figures 4 – 17 show pictures of pins from the components that did not fail. From the components that did not fail, almost all those that had a Sn finish showed more visual evidence of damage (surface cracking and pad lifting) than those with an Au/Pd/Ni Finish.

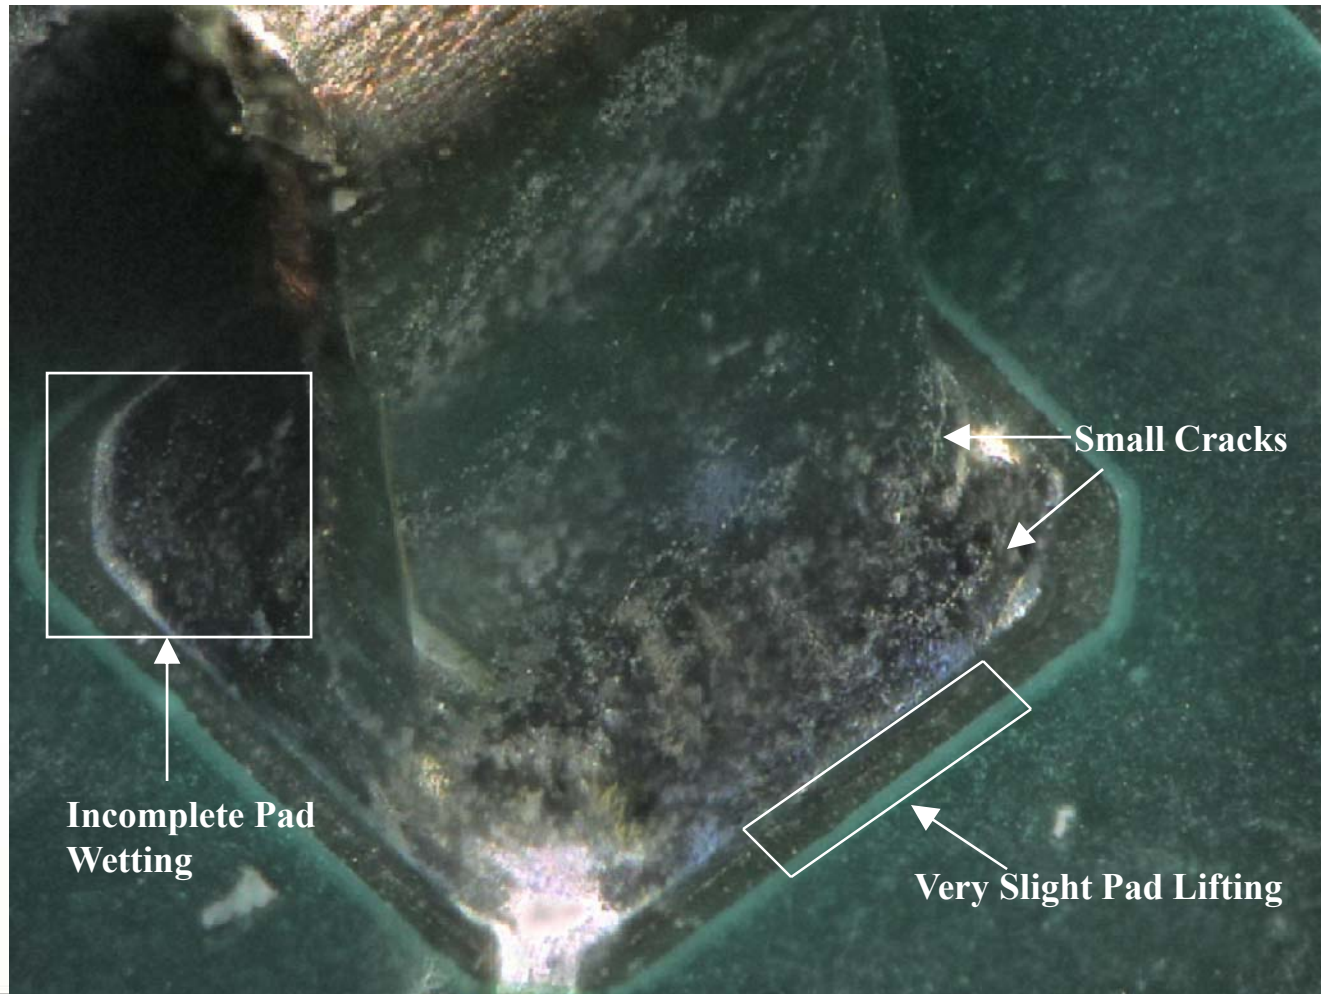
PWB 50 - U59, Pin 3

From the digital microscope pictures, it was determined that pin 3 (Figure 19) showed evidence of small cracks developing as well as incomplete pad wetting and lifting. Pin 18 (Figure 20) showed some evidence of cracking in the surface of the solder and some evidence of incomplete pad wetting. The pins, which are parallel to each other, have different appearances.

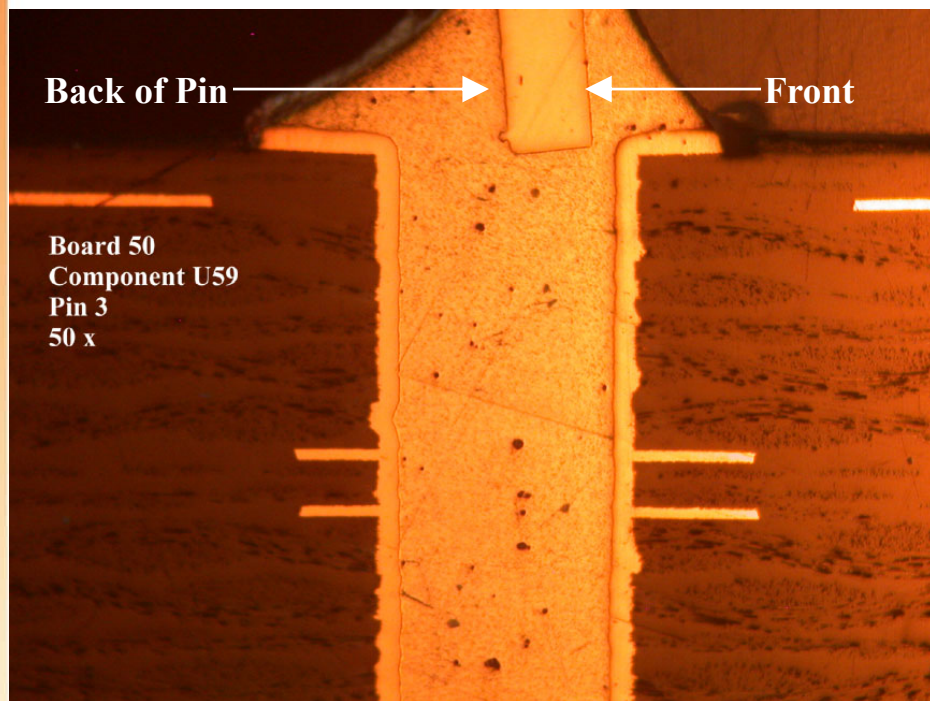
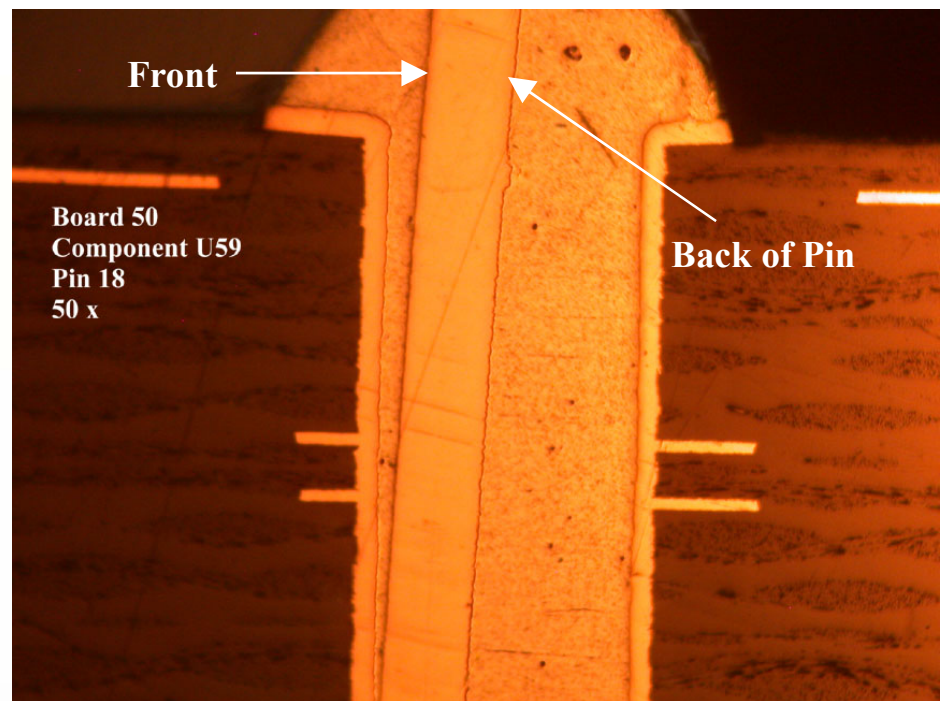
PWB 50 - U59, Cross Sections - Pins 3 & 18

The cross-section pictures (Figures 21 and 22) for the pins from component U59 showed no evidence of cracks or pad lifting in the solder joint. Pin 3 was cross sectioned and analyzed from the right side while pin 18 was cross sectioned and analyzed from the left side. This cross-section was used as the baseline for comparison with component U63. The pictures showed that pin 3 was ground too deep, which caused the pin to appear as if it did not go through the board hole. From the pictures, it appears that both pins would still be capable of functioning.

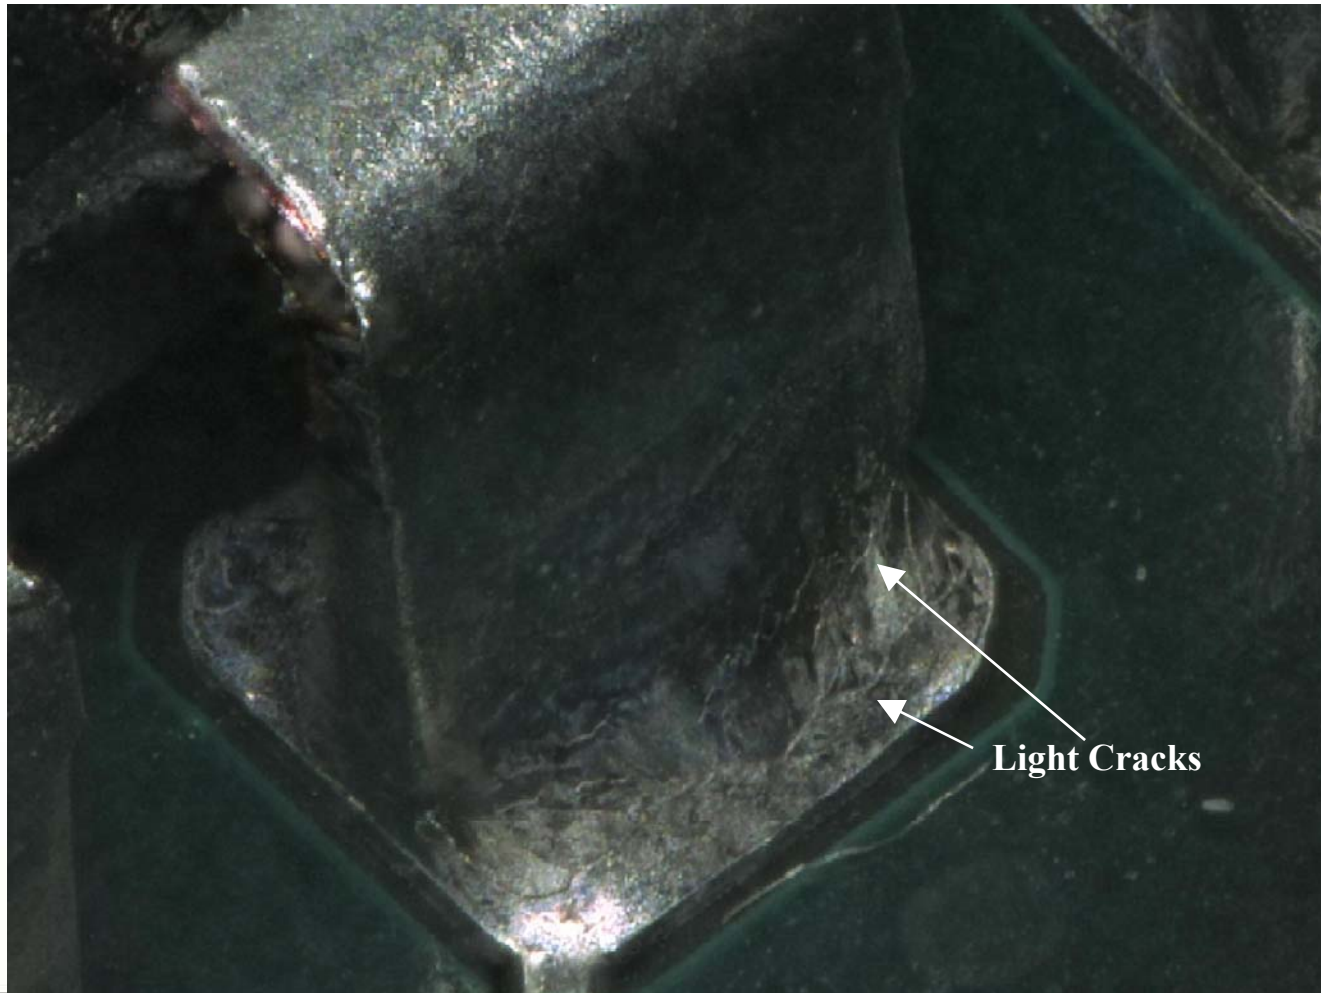
PWB 50 - U63, Pin 3

From Figures 23 and 25, it was determined there was some visual evidence of surface cracks in pins 3 and 18. There was also visual evidence of some pad lifting on the outer edge of pin 18. The pictures of pins 10 and 11, Figures 27 and 29, show visual evidence of cracks that may have gone deep into the solder joint. Figure 27 shows a small crater forming in one of the lower corners of its pad, while Figure 29 shows an upside down T-formation in the same location on its pad.

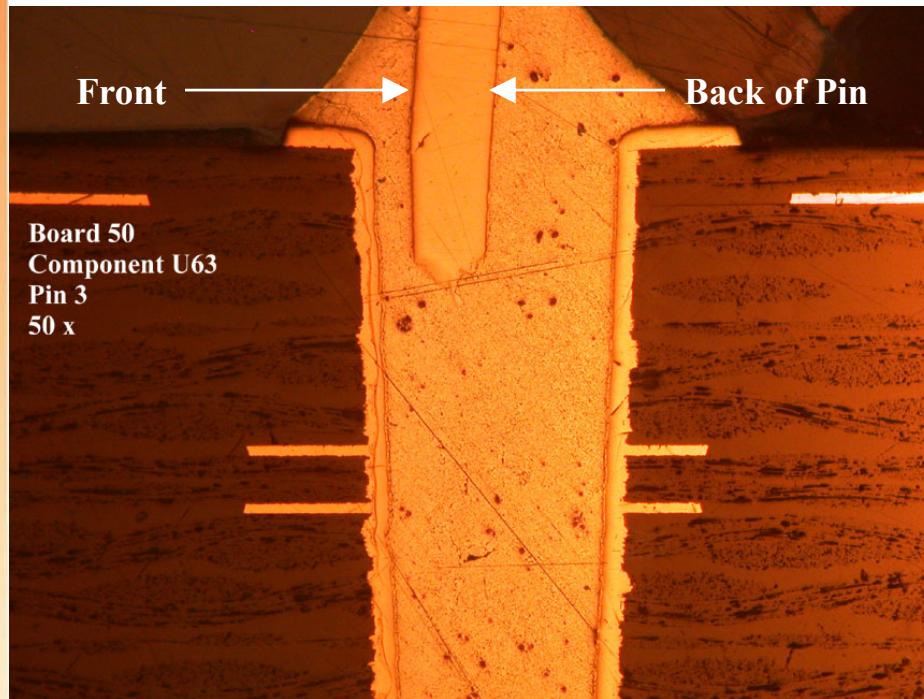
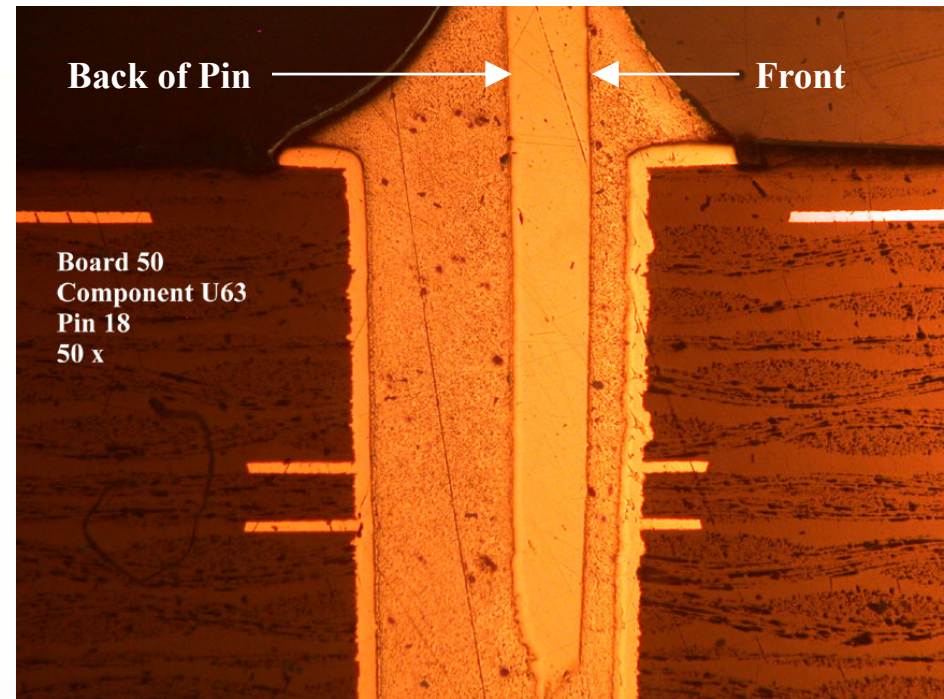
PWB 50 - U63, Cross Sections - Pins 3 & 18

Pins 3 and 10 (Figures 24 and 28) were cross-sectioned and analyzed from the left side of the solder joint while pins 18 and 11 (Figures 26 and 30) were cross-sectioned from the right side. The pictures for pins 3 and 18 showed no evidence of cracking in the solder. Figures 27 and 29 show the pictures of pins 10 and 11 that were taken with the digital microscope before they were cross-sectioned while Figures 28 and 30 show pins 10 and 11 after they were cross-sectioned, ground, and polished. Pins 10 and 11 clearly show through cracks which are located above the barrel. The picture for pin 11 revealed that the sample was ground too deep, with part of the sample being completely removed. The cross-section pictures revealed only component U63 on PWB 50 had cracks through the solder joints and pins. As a result, the component would fail if it were in use. In general, visual evidence of other anomalies such as pad and fillet lifting, cracking in the knees, and awkward solder formation was noticeable in the pictures of the cross-sections.

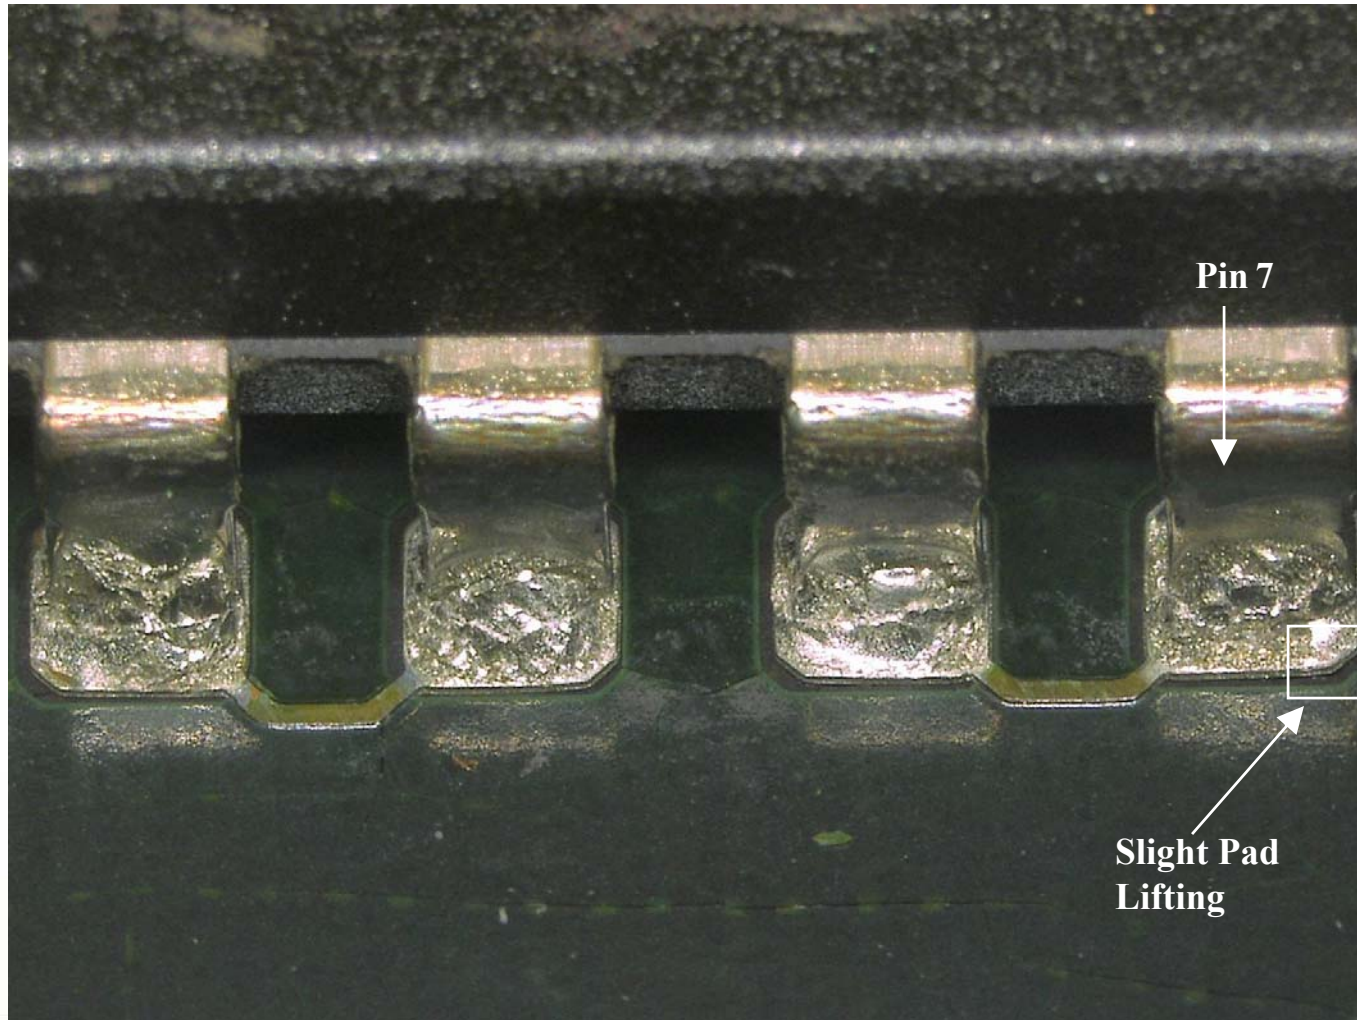
PWB 191 – U59, Pin 7

The 3D digital microscope images (Figures 31 and 32) showed evidence of small cracks and pad lifting that could have been capable of causing serious damage to the component. Pin 7 was cross-sectioned and analyzed from the left side of the solder joint while pin 14 was cross-sectioned and analyzed from the right side. The cross-section for pin 7 (Figure 33) showed visual evidence of severe pad lifting and incomplete pad wetting, but the cracks didn't appear to have caused much damage in the solder joint. For pin 14, the cross-section (Figure 34) revealed that the pin was ground too deep and there was no evidence of cracking in the solder. The cross-sections for both pins revealed some cracking in the knees, lifting in the pad, and barrel distortion.

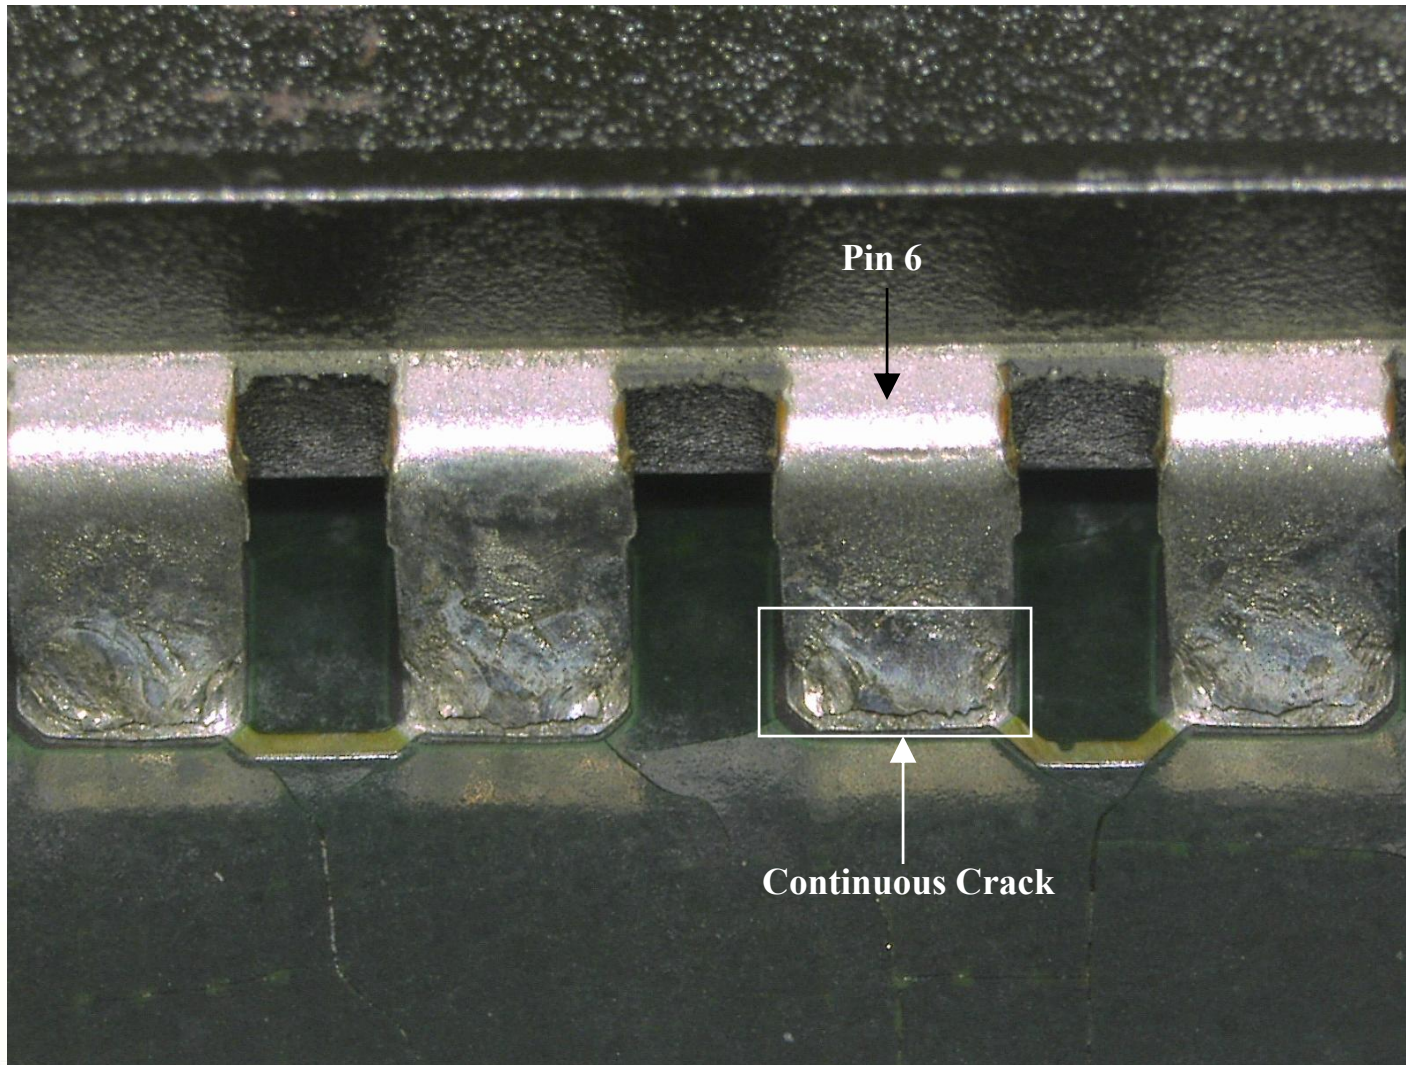
PWB 191 – U63, Pin 6

From the digital microscope pictures (Figures 35 - 38) pins 6 and 15 showed visual evidence of surface cracking and some pad lifting. The pins next to 6 and 15 on both the wave solder and the component side of the board showed similarities in crack patterns.

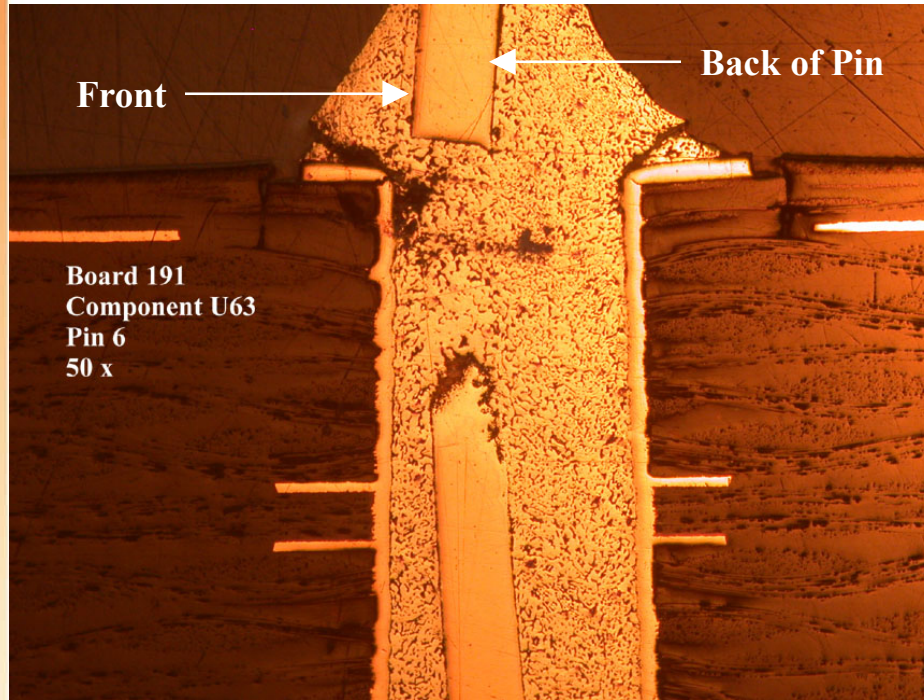
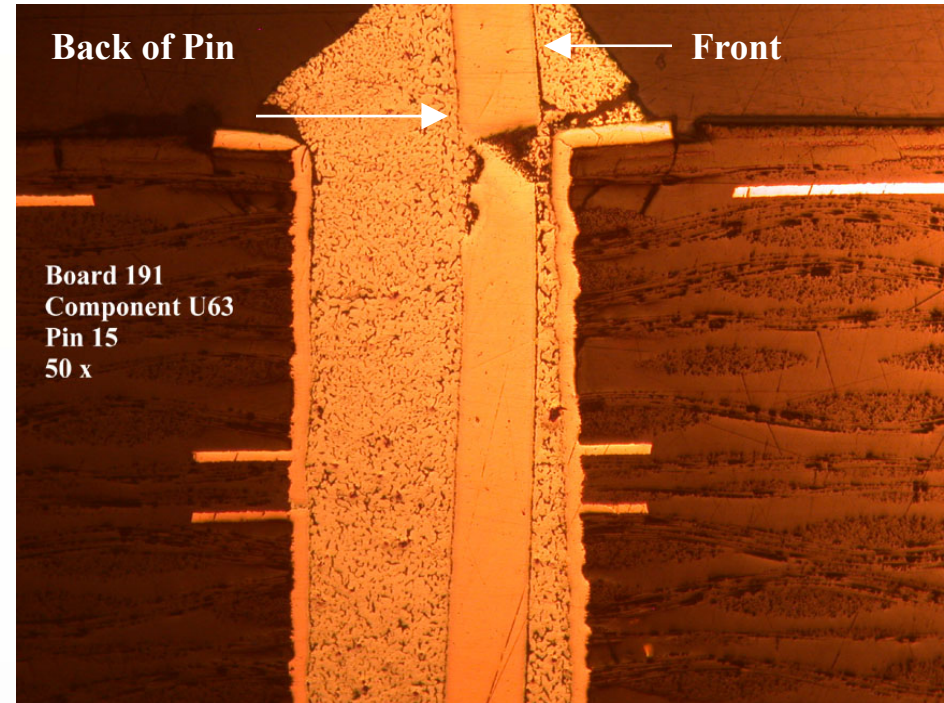
PWB 191 – U63, Cross Sections - Pins 6 & 15

Pin 6 (Figure 39) was cross-sectioned and analyzed from the left side of the solder joint while pin 15 (Figure 40) was cross-sectioned and analyzed from the right side. It is apparent that some cracking did occur in these solder joints. However, these pins would still be capable of functioning since the cracks did not penetrate the entire solder joint or the component's pins. Both pictures also showed visual evidence of cracking in the knees and pad lifting. For the cross-sections from this board, there was some cracking and pad lifting apparent, but components U63 and U59, were both declared electrically sound.

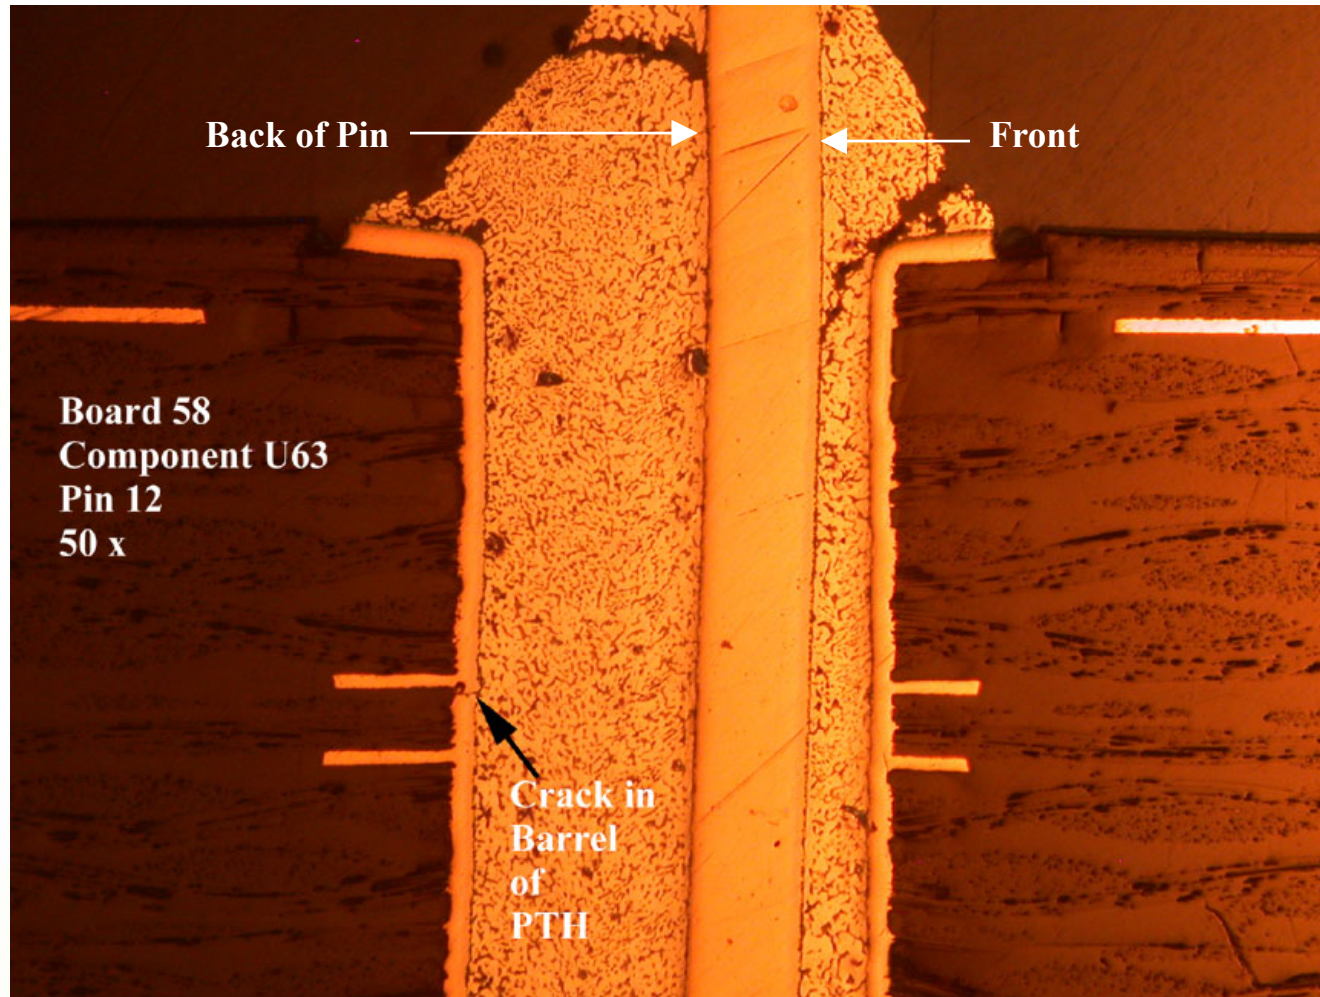
PWB 58 – U63, Pin 12 Cross Section

Cross-sections of non-critical components revealed a few areas where the components that did not fail had cracks in their solder joints. Some pictures revealed a coarse solder structure or the development of damage such as cracking in the barrel (Figure 41), or bad fillet lift (Figure 42). Even though the components began to crack during testing and started to develop other forms of damage in their solder joints, they were still capable of functioning. To gain a better understanding of what happened in the solder, the cross-sectioned samples will need to be further examined on the wave solder side. This will help to make a better comparison with the digital microscope images regarding how cracks, lifting, and other anomalies occurred during testing. It will also provide information on the depth of cracks, lifting, and other damage in the solder joints or their pads.
