# Contamination of Hydrocarbon Ceramic Dielectric

Michael Vernoy, Patrick Case, Mahendra Gandhi, Eric Hong  
Northrop Grumman  
Redondo Beach, CA

## Abstract

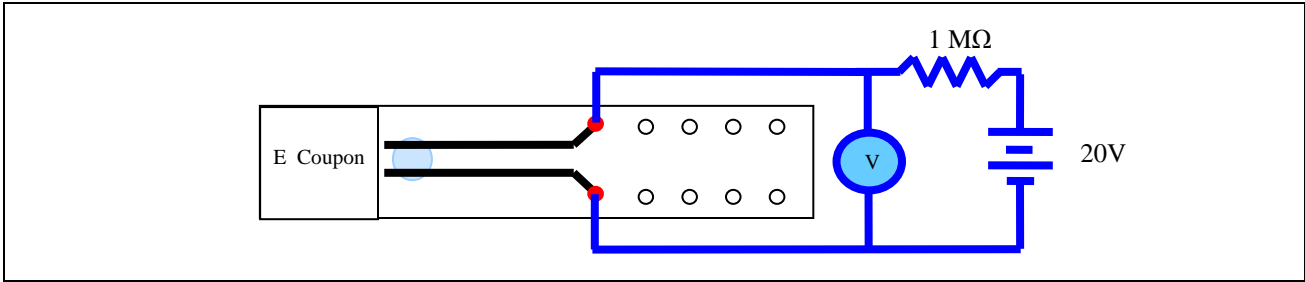
Now that it was clear that the stained samples had slightly higher ionic contamination levels, it was necessary to assess the risk posed by dendrite formation. To do this water droplet tests were performed on IPC E coupons from lots of parts similar in construction to the affected assemblies. The test setup is schematically illustrated in Figure 4. An electrical bias was established across two electrodes that were bridged by a deionized water droplet. In the tests performed, the electrode spacing on all E coupons was 20 mils and a voltage bias of 20 V was applied across the electrodes with a 1 M $\Omega$  current limiting resistor in series with the power supply. Each test was run for a maximum of 30 seconds per coupon.

**Figure 4 – Water droplet test schematic. Water drop is shown bridging left end of “Y” pattern electrodes.**

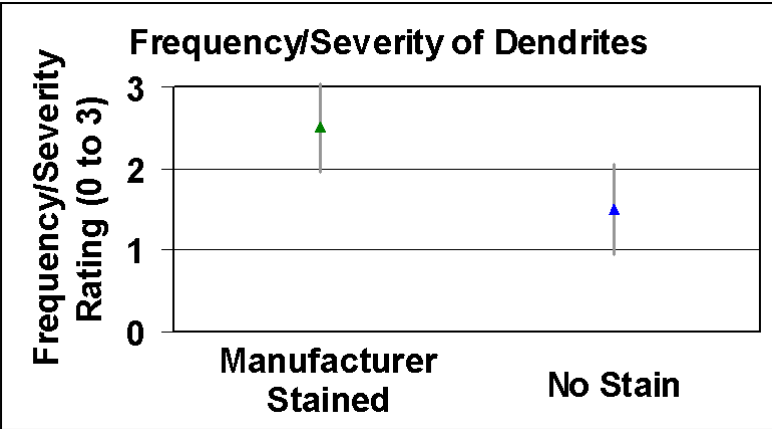
Although often subjective, stained coupons seemed to grow more dendrites, a longer distance, in a shorter period of time than the unstained control group. However, no differences between the two groups were significant. A typical dendrite formation is shown in Figure 5. Results are plotted in Figures 6 through 8.

**Figure 6 – Subjective average rating of the frequency and severity of dendrite formation in the stained and unstained test coupons. Standard deviations are shown by grey bars.**

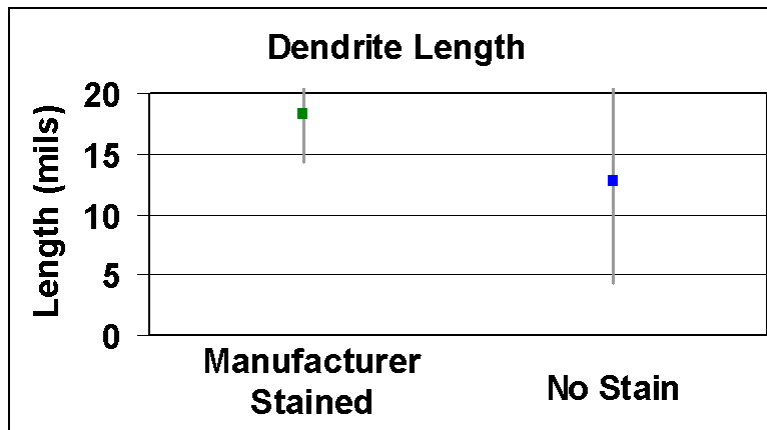
Figure 7 – Average length of dendrites for the stained and unstained test coupons. Standard deviations are shown by grey bars.

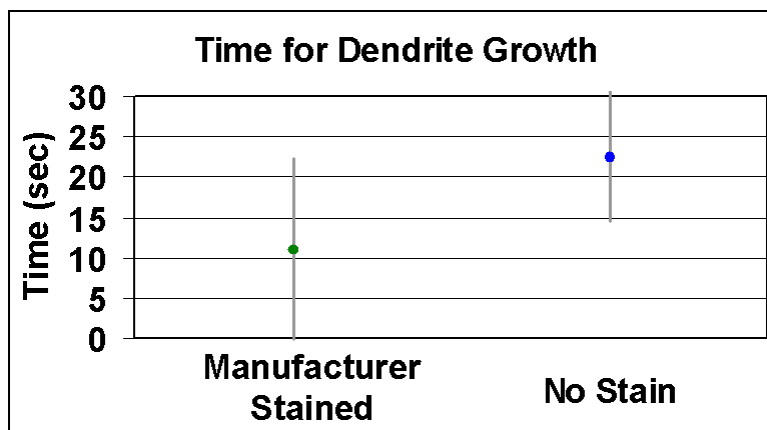
Figure 8 – Average time for dendrites to bridge the 20 mil electrode separation for the stained and unstained test coupons. Standard deviations are shown by grey bars.

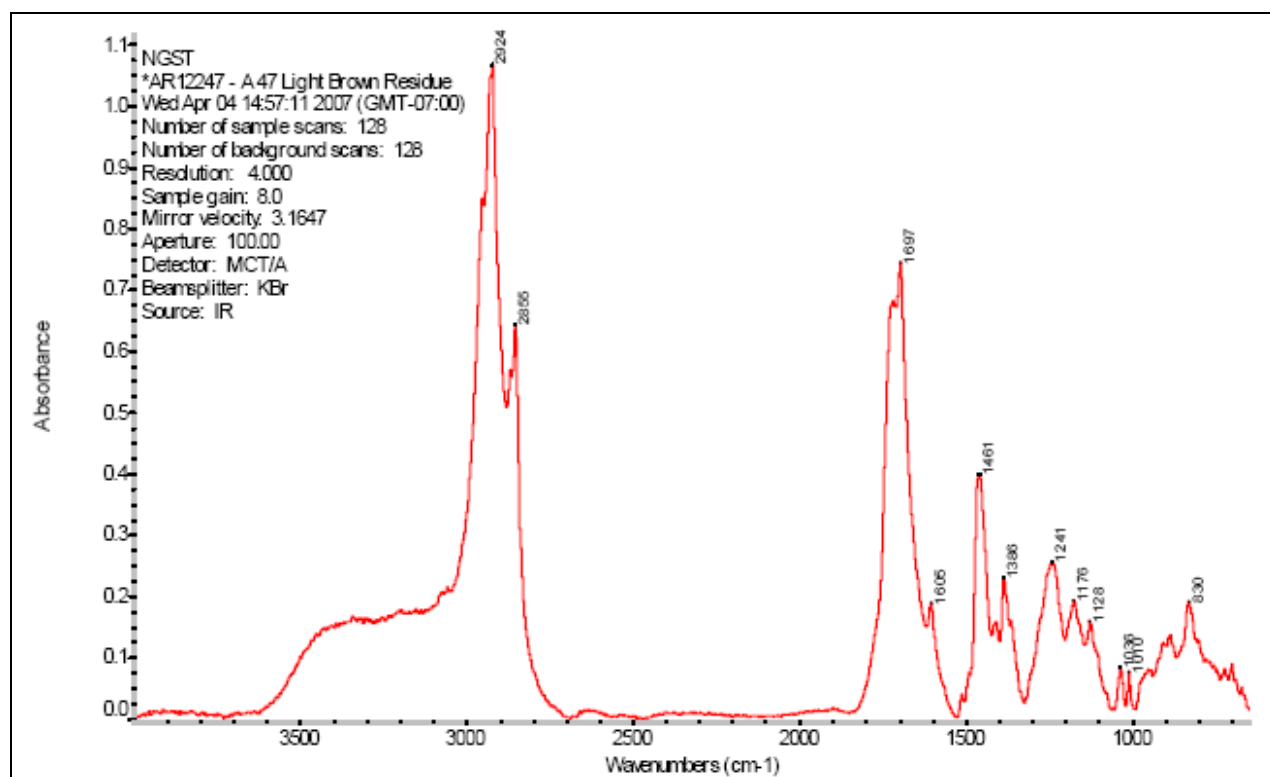
To obtain the FTIR spectrum, the stained board was placed in a clean glass tray and submersed in a solution of 75% methylene chloride and 25% methanol until the PWB was completely covered. Then, the tray was placed into an ultrasonic bath for 20 minutes. The solvent was removed and the procedure was repeated until most of the stain was removed. A non-volatile residue (NVR) analysis was preformed on the combined extracts and found that 16 $\mu\text{g}/\text{cm}^2$  of residue was removed. A beaker blank was carried through all analyses as a control. Following NVR determination, the residue was characterized by FTIR by resuspending the residue in isopropyl alcohol and transferring the result to an aluminum-coated glass slide for analysis. The sample's spectrum was collected using 128 scans of the slide in reflectance mode using a clean portion of the slide as a background. Through FTIR characterization, the residue was determined to be consistent with rosin oil, see Figures 12 and 13.

Figure 12 – FTIR spectrum of brown stain extracted from PWB.

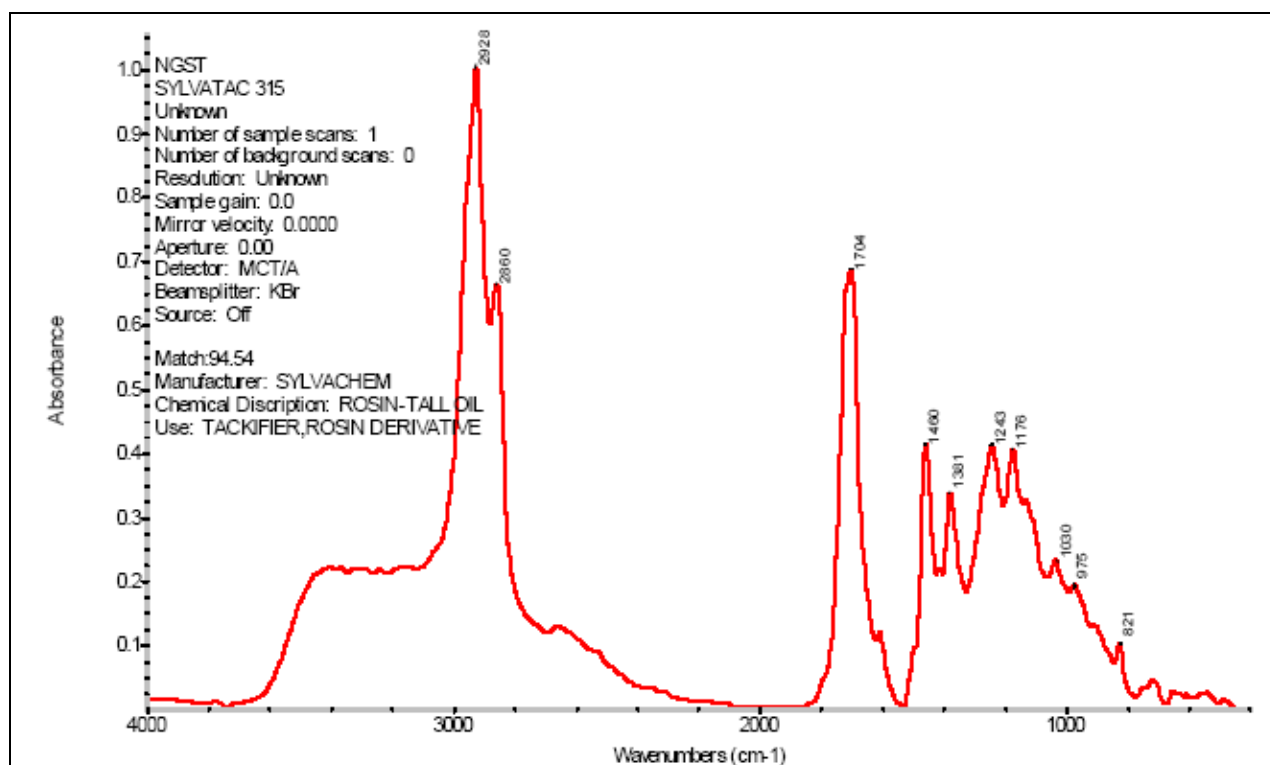
Figure 13 – FTIR reference spectrum of rosin oil.

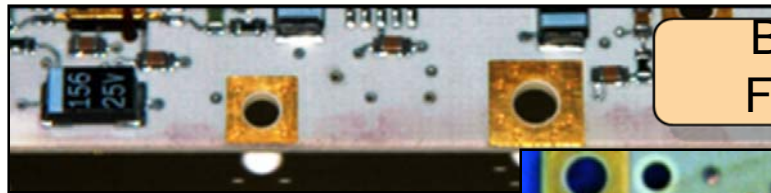
Purple Stains:  
Gold Plating Touchup

- Stains were discovered on populated multilayer PWBs with Sn-Pb surface finishes and Au mounting locations.
- All PWBs were inspected prior to assembly.
- Conjectured to be Au plating solution residue from touchup.

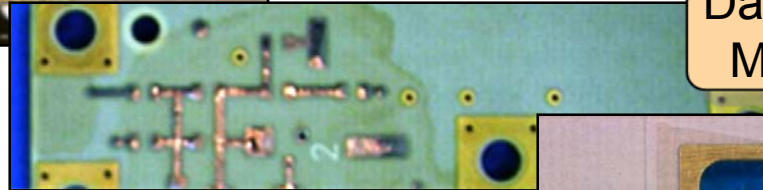
Brown Stains:  
Flux Exposure

- Visual inspection revealed brown-colored staining on the white dielectric surface of RF PWBs.
- Again, the discoloration was of concern due to the possibility of ionic contamination.
- Due to the color of the stains and their proximity to solder pads, rosin mildly active (RMA) solder flux was suspected.

Acetone is recommended when cleaning populated boards.

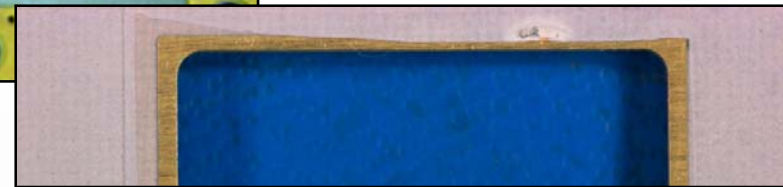
Darkening/Bleaching:  
Multiple Processes

- The unprotected dielectric was bleached.
- Although no reliability risk exists, concerns regarding the contamination and material homogeneity arise during inspection.

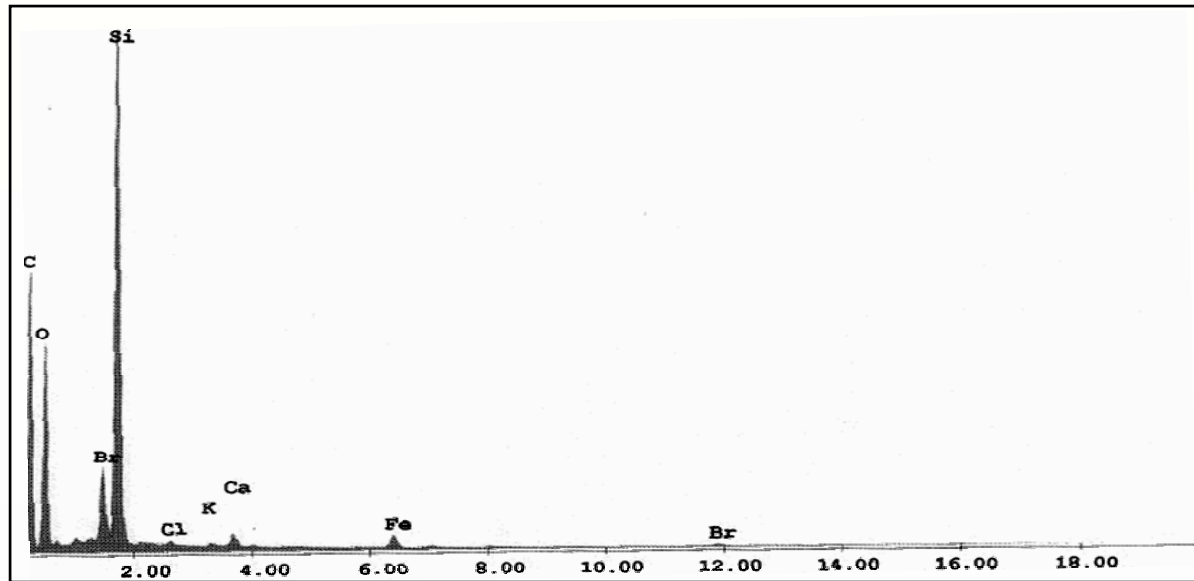
- Energy dispersive x-ray (EDX) spectroscopy was performed to determine if stained laminate was conductive.
  - No metals were found in any significant concentration.

Purple stains were not conductive.

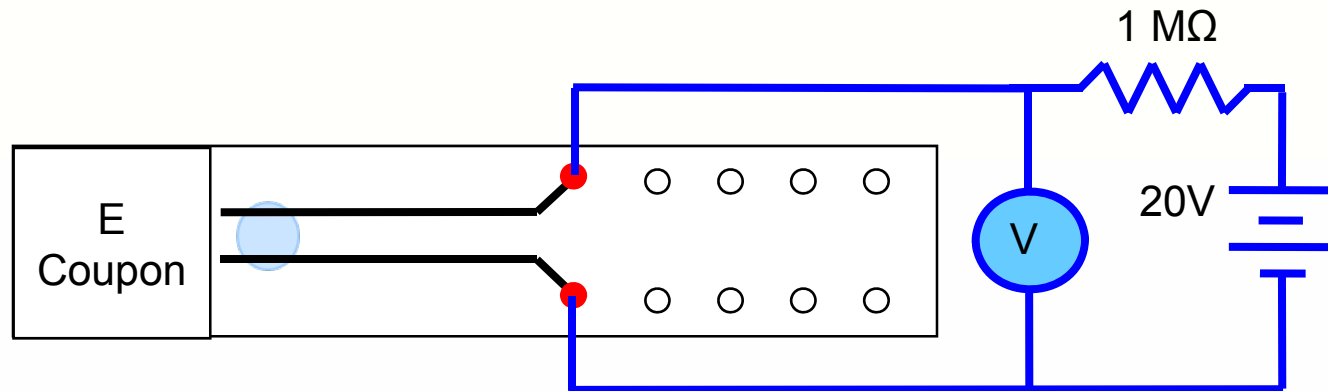
- Electrically biased water droplet test was performed to assess any increased dendrite formation risk.

Biased water droplet test was performed to assess dendrite risk.

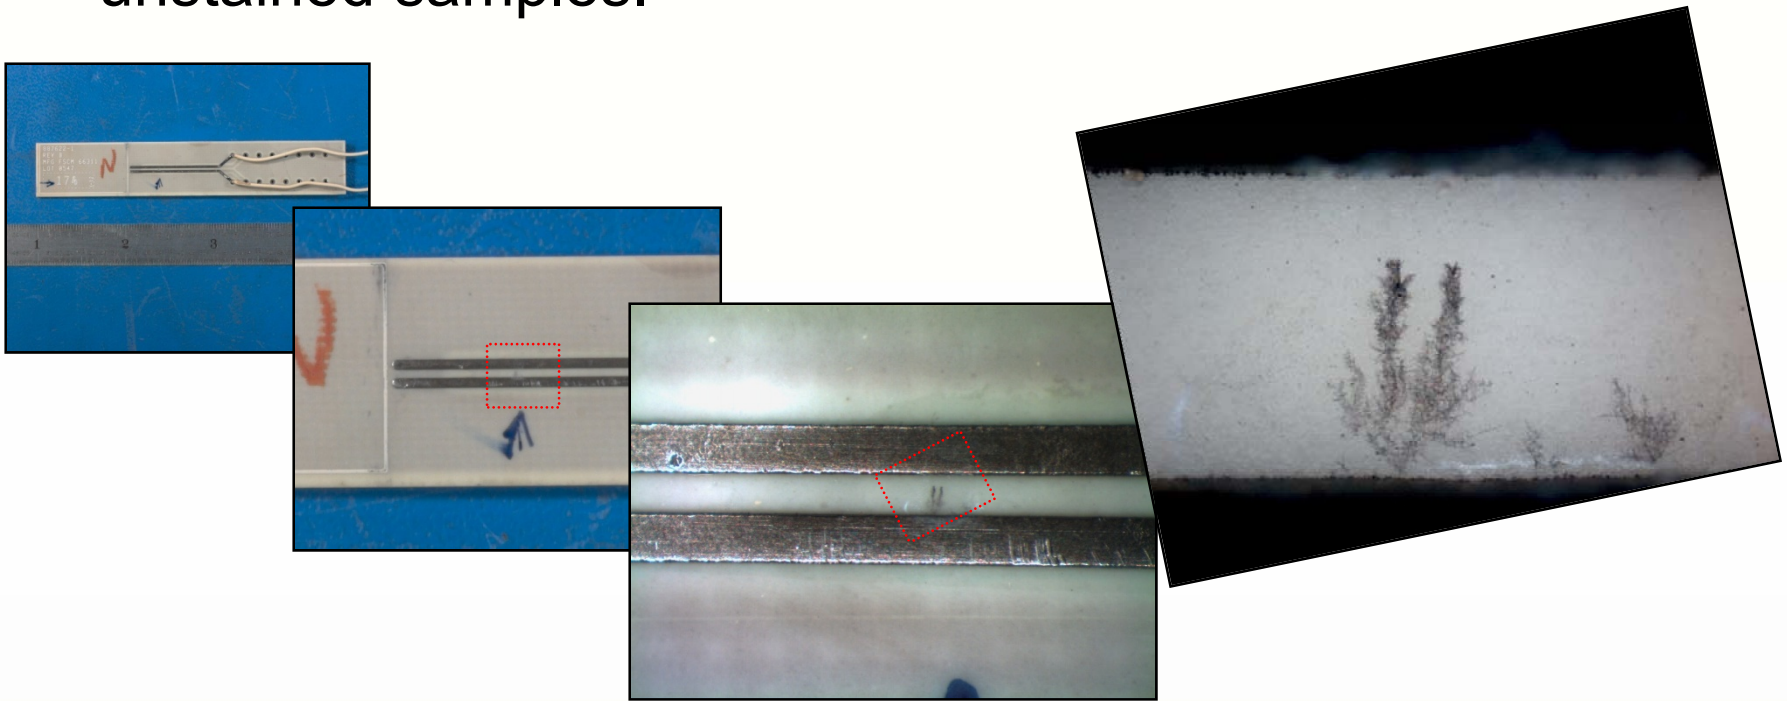
- Dendrite formation occurred on both stained and unstained samples.

Dendrites formed on both stained and unstained samples.

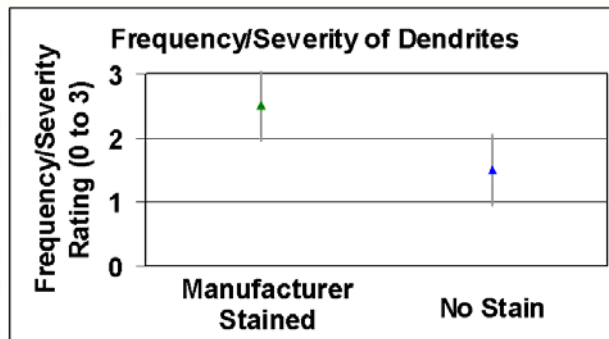
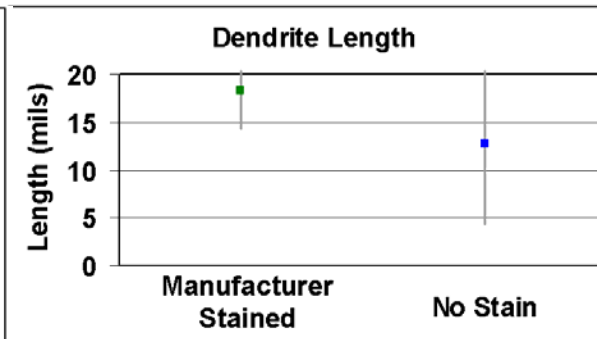
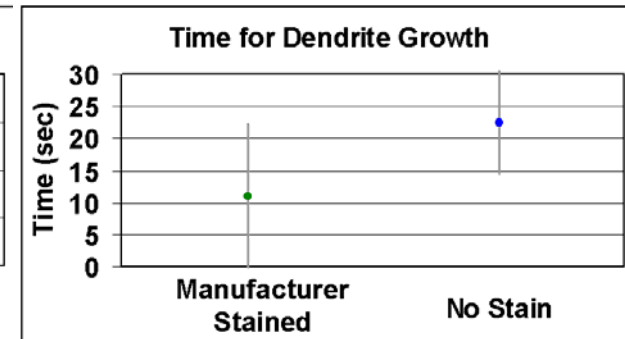
- Although often subjective, stained coupons seemed to grow more dendrites, a longer distance, in a shorter period of time than the unstained control group.
- However, no differences between the two groups were significant.

Purple stains due to gold plating touchup do not pose a reliability risk.

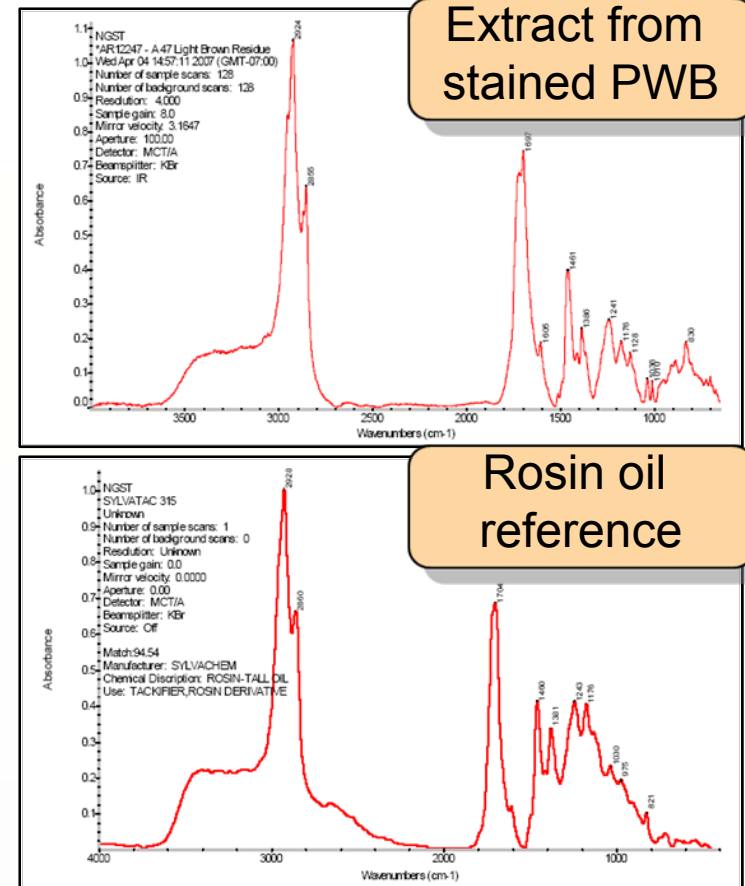
- In an attempt at reproducing the brown-colored stain, rosin mildly active (RMA) flux was applied to a solder sample board, sent through a convection reflow oven two times, and then cleaned with IPA.
- The brown-residue that remained after cleaning was then analyzed by Fourier Transform Infrared (FTIR) Spectroscopy.

FTIR confirmed flux as the cause of the brown stains.

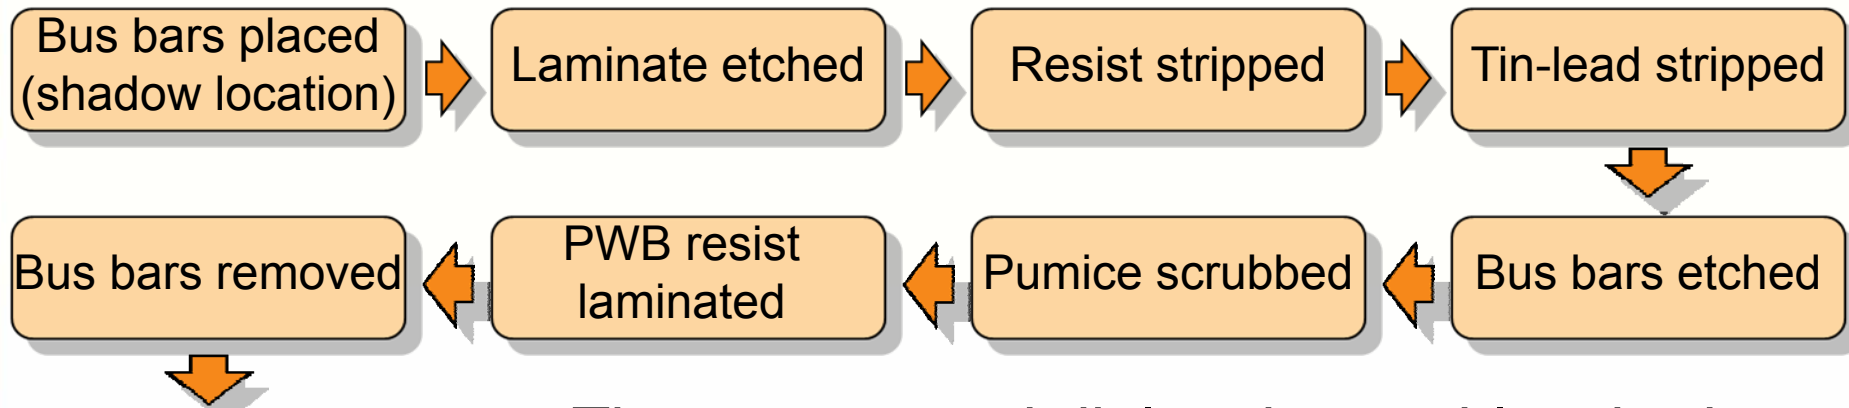
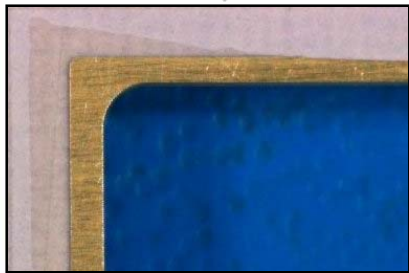
- Bus bar etching involves multiple process steps.

“Shadowing” resulted from processing that bleached the dielectric.
