IPC-9121A

# Troubleshooting for Printed Board Fabrication Processes

Developed by the Printed Board Process Effects Handbook  
Task Group (7-24a) of the Process Control Management  
Committee (7-20) of IPC

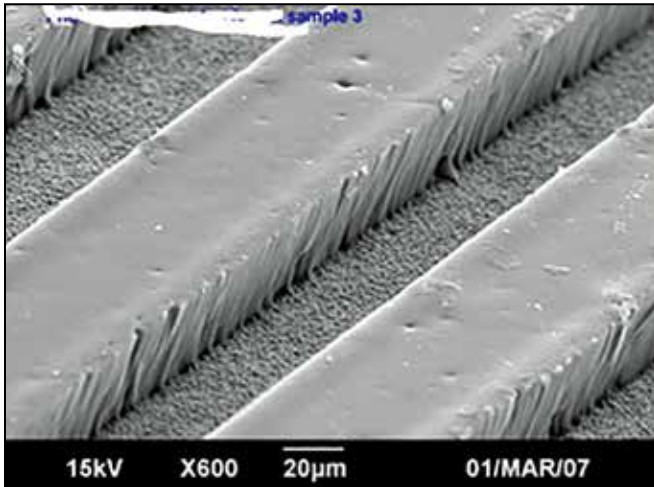
Figure 1-1 Photo Resist Under-Exposure

CAUSE	ACTION
UV source inadequate	Check exposure intensity/wavelength/duration
Expose intensity inadequate	Review, reinstated exposure control procedures
Expose time inadequate	Review, reinstated exposure control procedures
Oxygen exposure of photoresist prior to exposure	Review photoresist shelf life
Potential test methods (discover)	Potential test method (verification)
AOI (line/space reproduction)	AOI
Etch-outs	Periodic UV photometer and step tablet exposure checks

**1.6 IPC-9121 Format Example** This document follows the general format seen below. In instances where there is no photo, a photo is not necessary or one could not be found. Potential test methods for discovery and verification are included in tables where applicable.
