Lead Free First Article Inspection: The Key to Success

Mark Cannon ERSA GmbH Wertheim Germany

IPC APEXPO 2004 Technical Conference February 24th, 2004

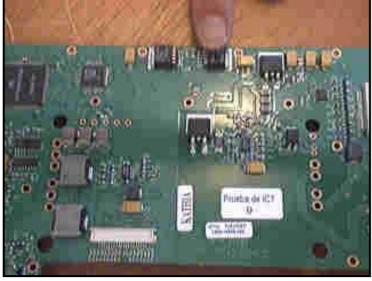
Lead Free solder has Wetting problems!!!

Initial Lead Free Reflow Solder Test: LF Solder paste: SnAg3.8Cu0.7

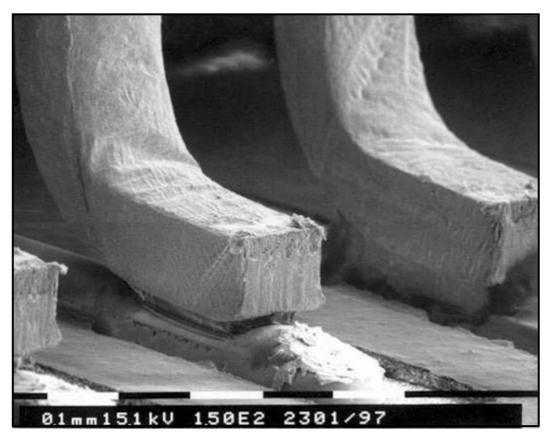
Result of board warpage and component bulging due to high temperature

High magnification and optimal viewing angle required!

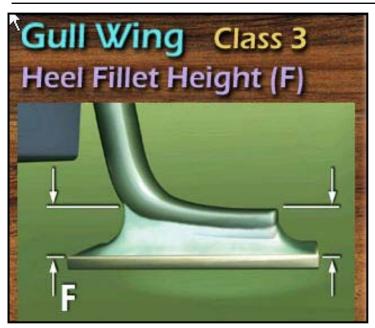
IPC Electronic Workmanship Standard A-610: Sec. 12.2.5.6; J-STD-001

Inspect and measure heal fillet

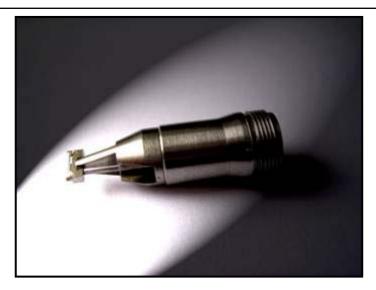
New Optical Micro Flip Chip Inspection
