## Mechanical Bending Technique for Determining CSP Design and Assembly Weaknesses

Mark R. Larsen, Ian R. Harvey Ph.D.,  
University of Utah  
Salt Lake City, Utah

### Abstract

A cyclic board-bending technique has been developed to ensure a reproducible multiaxial stress state at the Chip Size Package (CSP) solder fillet. Mechanically stressing the package serves as a valuable tool to quickly determine and provide feedback on design and assembly weaknesses, 20-30 times faster than less comprehensive data can be obtained using temperature cycling.

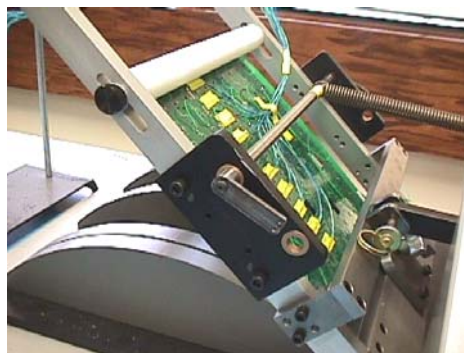
The fixture for bend testing as designed and built at Bourns uses a 200mm radius of curvature and operates at 1 Hz (Figure 2). One edge of the board is clamped and the opposite edge is then forced downward over the radius creating a reproducible family of stress states with every cycle. The stress-state depends upon the position of the DUT relative to the clamp.

**Figure 2 - Board-Bending Apparatus with 200mm Radius of Curvature Operates at 1 Hz. 100 Daisy Chain Parts are Tested Simultaneously - 10 Parts per Row Constitute a Population with a Given Imposed Strain Energy State - Wires seen coming off the Board are attached to Strain Gages associated with each Row Position**

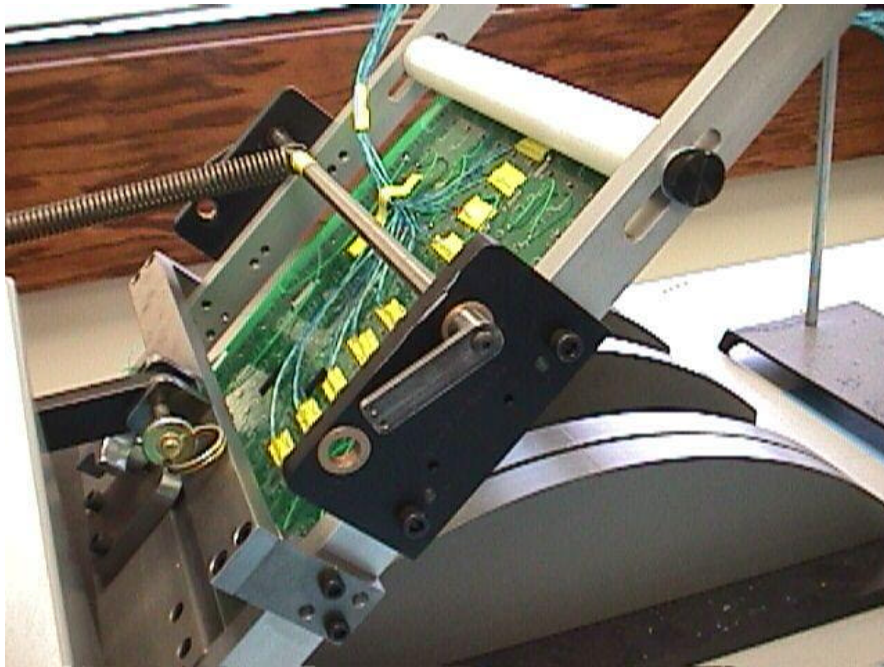
# Characterization of Board Strain

## Rows 1 – 10 Each Evaluated Individually
