Image Rotation to Mitigate the Fiberweave Effect its Impact on PCB Manufacturing

Jon Kuchy, Intel® Corp.
Jonathan.Kuchy@Intel.com

Jeff Loyer, Intel® Corp.
Jeff.Loyer@intel.com

PCB Image Rotation to Mitigate the Fiberweave Effect – Impact to PCB Assembly

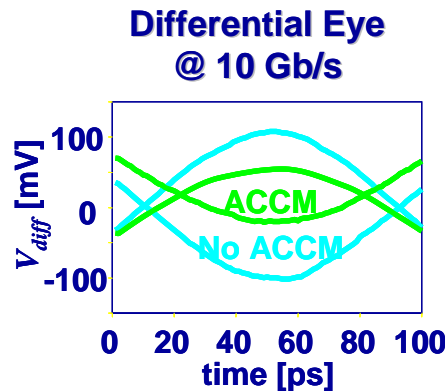
Figure 4: Effect of skew on differential eye

At high data rates the difference in propagation velocities leads to skew between the 2 traces which can amount to a substantial fraction of the transmission unit interval, resulting in an increased common mode voltage (Figure 3) and a correspondingly degraded differential signal (Figure 4) [1]. In addition, the resulting common mode signal can become a source of increased crosstalk and EMI in the system.

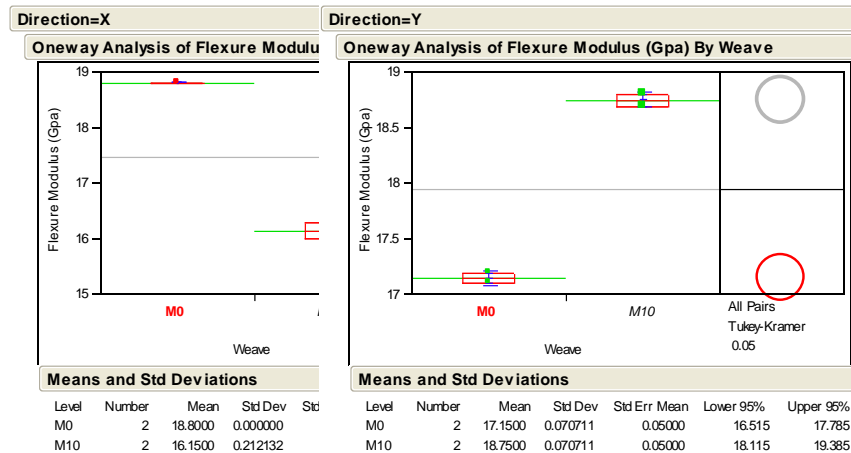
Figure 20: 0 and 90° Test Results

A difference was noted between the X and Y measured responses as shown in Figure 20. While the measured response showed no significant difference, there was an inversion of the responses between the 2 PCB's.

The most popular explanation for this inversion was that it is an artifact of the PCB manufacturing process where the glass weave may have been placed down at different rotations. No further investigation of this was performed due to this being a typical manufacturing process and has not driven any influence of failure modes prior to this investigation.

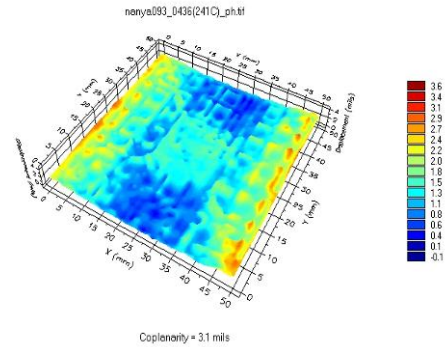
30 C Room

240 C

Figure 21: Shadow Moiré Measurement Results of a Normal Test Coupon

No significant influence of the rotation of the fiber weave to warpage was noted. The differences that were noted i.e. relaxation or “potato chipping” were deemed as typical noise within the PCB manufacturing process.

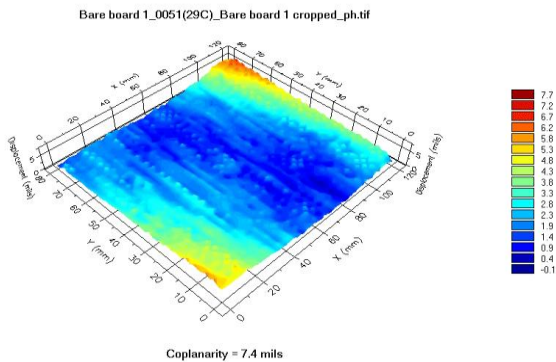
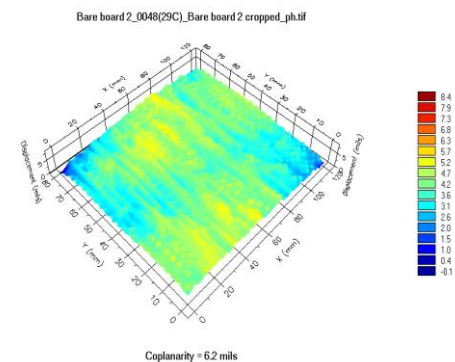
30 C Room

240 C

Figure 22: Shadow Moiré Measurement Results of a Test Coupon with 10° Fiber Rotation

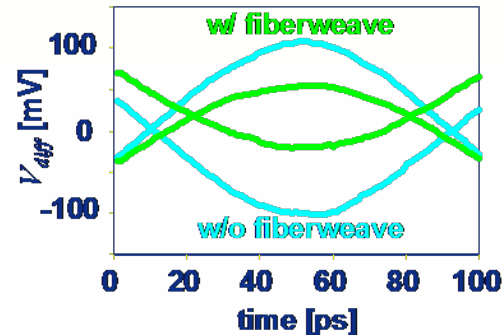
Differential Eye @ 10 Gb/s

Can cause significant degradation of differential "eye"
