#### HALT Testing of Backward Soldered BGAs on a Military Product

#### B. Gumpert, B. Fox, L. Woody

Lockheed Martin Ocala, FL

The move to lead free (Pb-free) electronics by the commercial industry has resulted in an increasing number of ball grid array components (BGAs) which are only available with Pb-free solder balls. The reliability of these devices is not well established when assembled using a standard tin-lead (SnPb) solder paste and reflow profile, known as a backward compatible process. Previous studies in processing mixed alloy solder joints have demonstrated the importance of using a reflow temperature high enough to achieve complete mixing of the SnPb solder paste with the Pb-free solder ball. Research has indicated that complete mixing can occur below the melting point of the Pb-free alloy and is dependent on a number of factors including solder ball composition, solder ball to solder paste ratio, and peak reflow times and temperatures. Increasing the lead content in the system enables full mixing of the solder joint with a reduced peak reflow temperature, however, previous research is conflicting regarding the effect that lead percentage has on solder joint reliabi

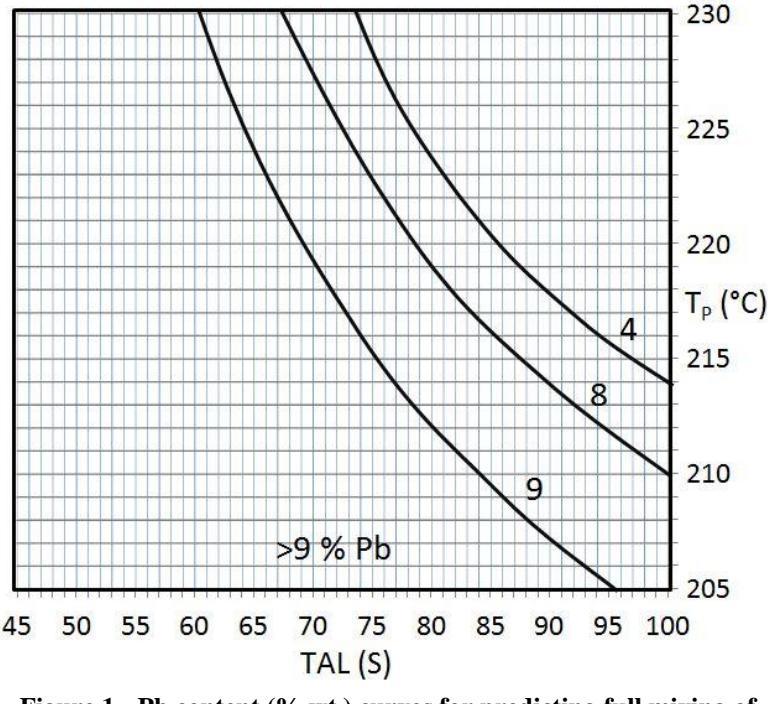
Figure 1 - Pb content (% wt.) curves for predicting full mixing of backward compatible solder joints based on  $T_P$  and TAL (183°C)

The degree of mixing in backward compatibility assembly is expected to be a function of the reflow peak temperature, time above liquidus (183°C), the alloys used (ball and paste), and the mix ratio of those alloys[3][7][11-18]. In previous studies, the authors developed processing guidelines for lead-free BGAs and CSPs with SnPb solder paste based on lead content, reflow peak temperature, and time above liquidus (TAL)[19]. The result was the chart shown in Figure 1, which is used by the assembler to ensure that full alloy mixing in the BGA solder joint is achieved, thus providing a reliable joint, while allowing the assembler to adjust the desired parameters of their process to optimize for design-specific restrictions.

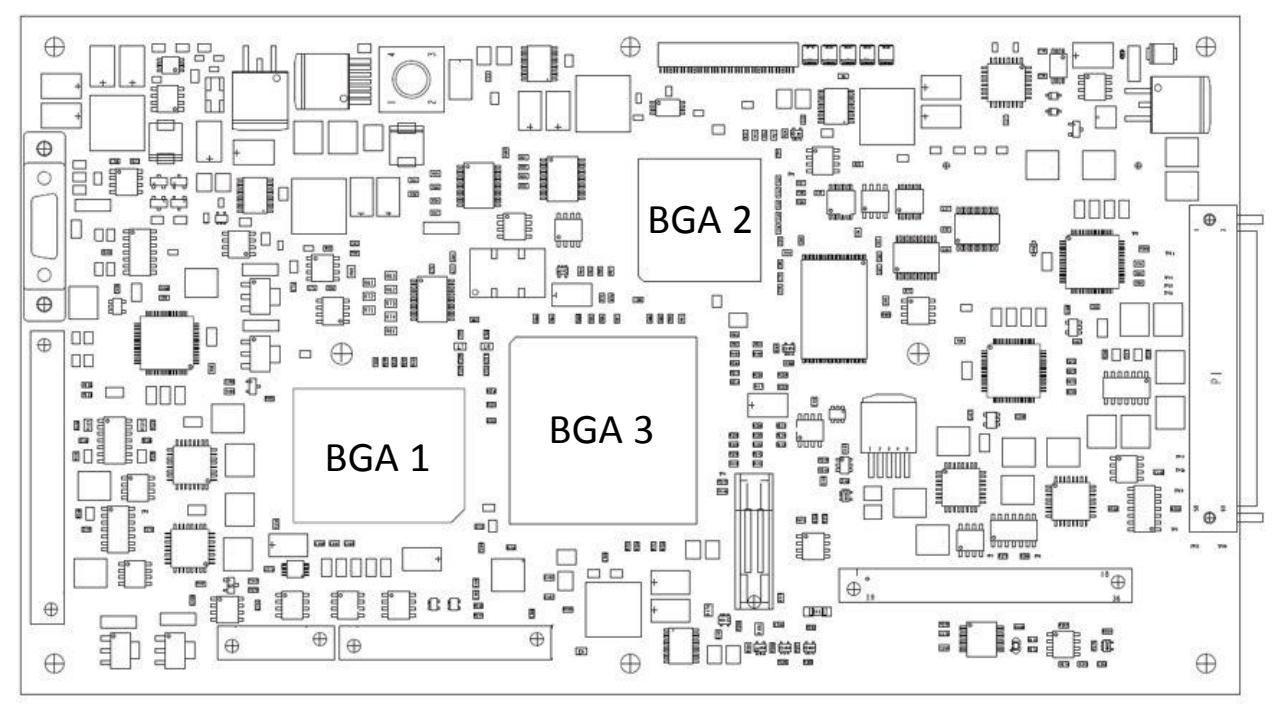
Figure 2 – Circuit card test vehicle top side layout

The test vehicle chosen for this study was a 9" x 5", two-sided, multi-layer surface mount (predominantly) circuit card with a variety of component package types (see Figure 2). Three of these components are BGA packages with the properties shown in Table 1.

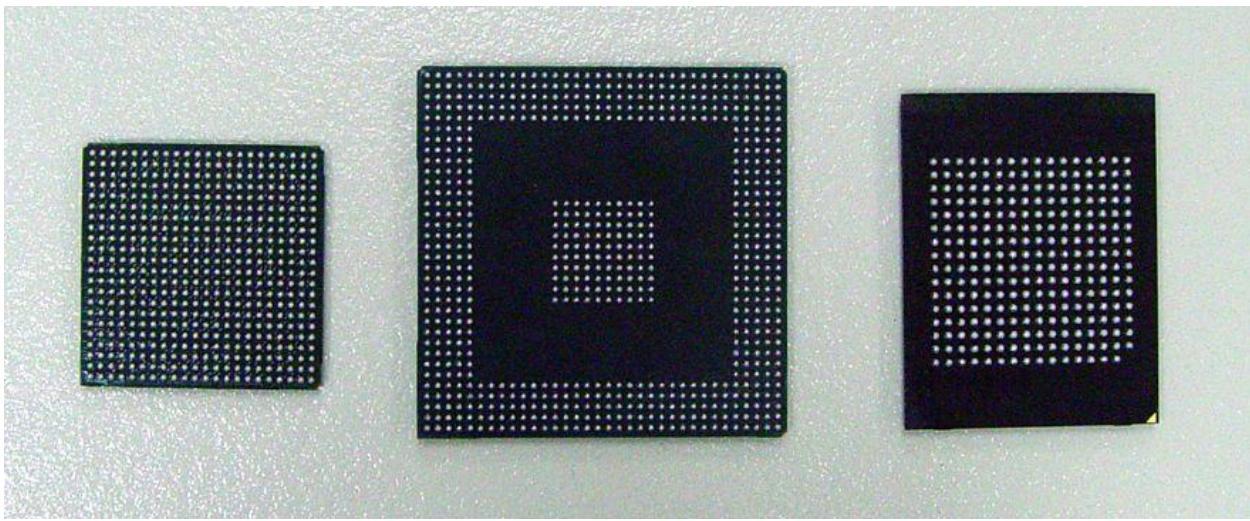
Figure 3 – BGAs used on test vehicle

BGA #	Length (mm)	Width (mm)	Ball Count	Ball Ø (mm)	Array Type	Pitch
1	32	25	255	0.762	Full	1.27
2	23	23	484	0.6	Full	1
3	35	35	680	0.6	Island	1

Table 1 – BGA component properties

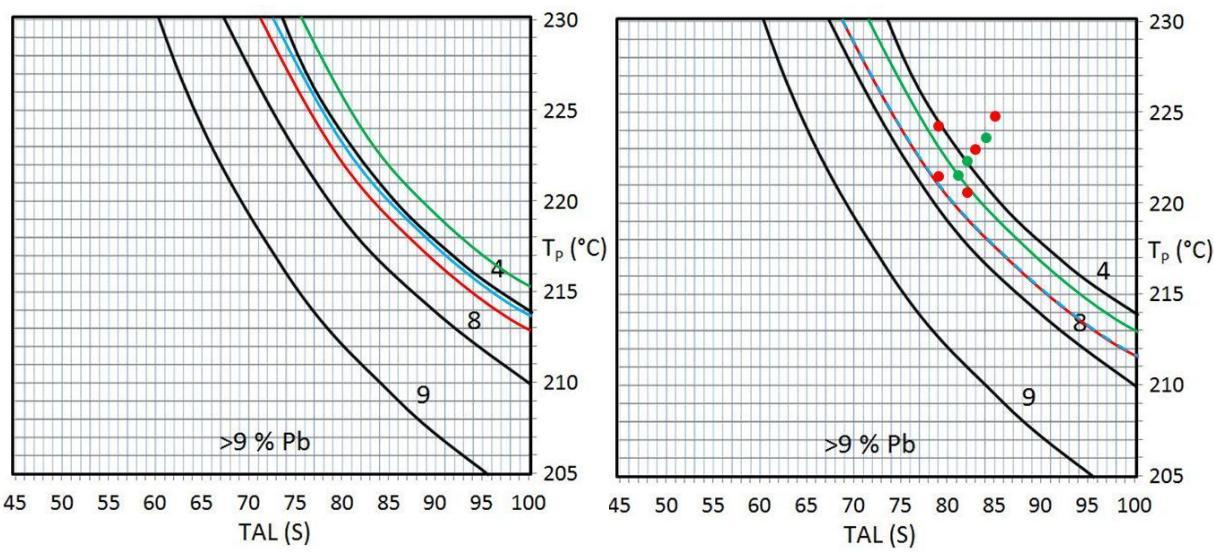
Figure 4 – Initial expected Pb curve levels applied to process chart (left) and updated Pb curve levels applied to process chart (right). Actual thermocouple values are plotted on the updated chart.

For each BGA, the size of the ball and the existing stencil design was evaluated to determine the expected Pb content that would be present in the final joint, assuming full mixing in the joint (see Table 2). Using the current stencil design, the Pb content in the joints was expected to be quite low. Because there are some component types used in SMT assembly which have temperature sensitivities beginning around 230-235°C, it was desirable to keep the reflow profile below 230°C. To stay above the appropriate curves for these Pb levels in Figure 1, a long reflow profile or a tight process window would be required. In order to enlarge this process window, the stencil apertures were enlarged to increase the volume of solder paste applied and therefore increase the expected Pb content in the final joint.

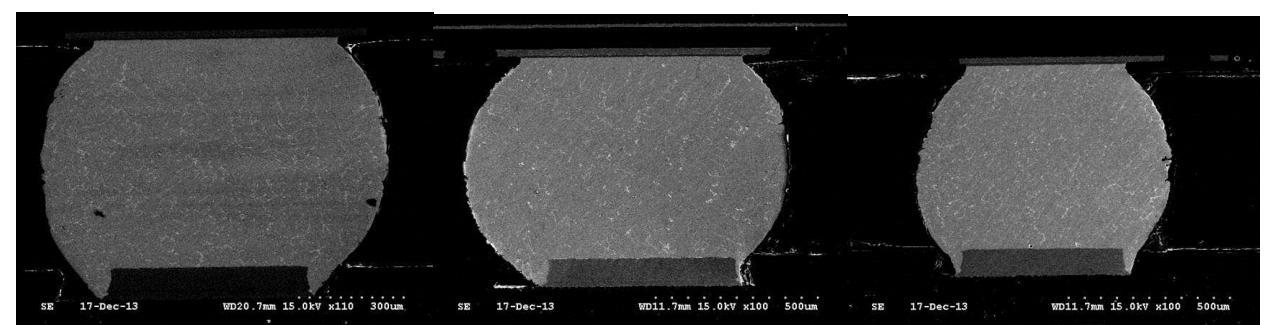
Figure 5 – Micrographs of cross-sections for BGAs 1, 2, and 3 in as-built condition.

All units built were built using standard production processes with in-process checks; inspection, x-ray evaluation and functional test. No issues were identified through these processes. Cross-sections were made of one unit for an evaluation of the as-built condition and verification of full solder joint mixing in the BGA solder joints. These cross-sections are shown in Figure 5. The Pb content of the joints was measured through SEM/EDX and found to be 6.4%, 7.4%, and 7.4% by weight for BGAs 1, 2, and 3, respectively. As seen in the images, mixing of the alloys in the solder joint is good, with Pb-rich areas uniformly distributed through the ball. As expected, the Pb-rich areas are not as dense as they would be in a standard Sn63Pb37 solder joint, and they have a stringy appearance.

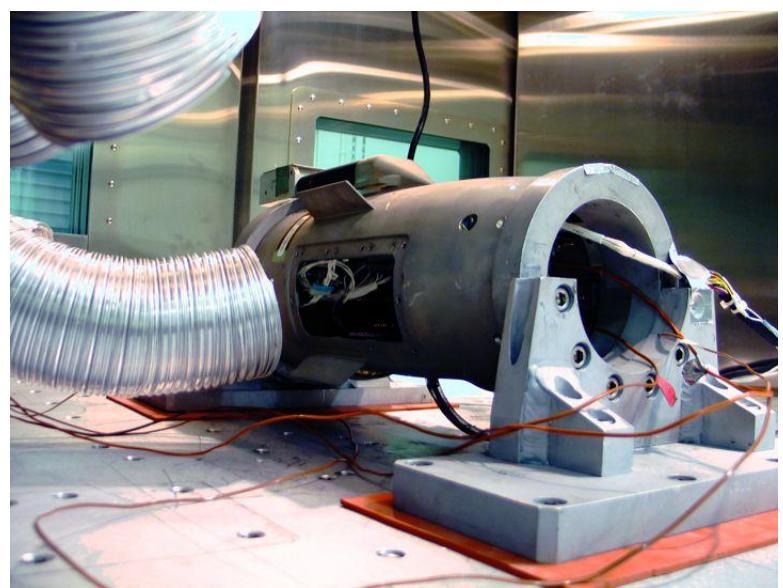
Figure 6 – Unit assembled into test fixture and mounted in the HALT chamber.

The three assemblies subjected to HALT were built into a representation of a higher level assembly and mounted in the HALT chamber as shown in Figure 6. A vibration survey was performed on each unit to determine the vibration response at the BGA sites. At the lowest vibration input, the BGAs experience about 5 Grms, and they saw progressive increases in response as the input was increased, with maximum values of 20, 22, and 27 Grms experienced at the three BGA sites.

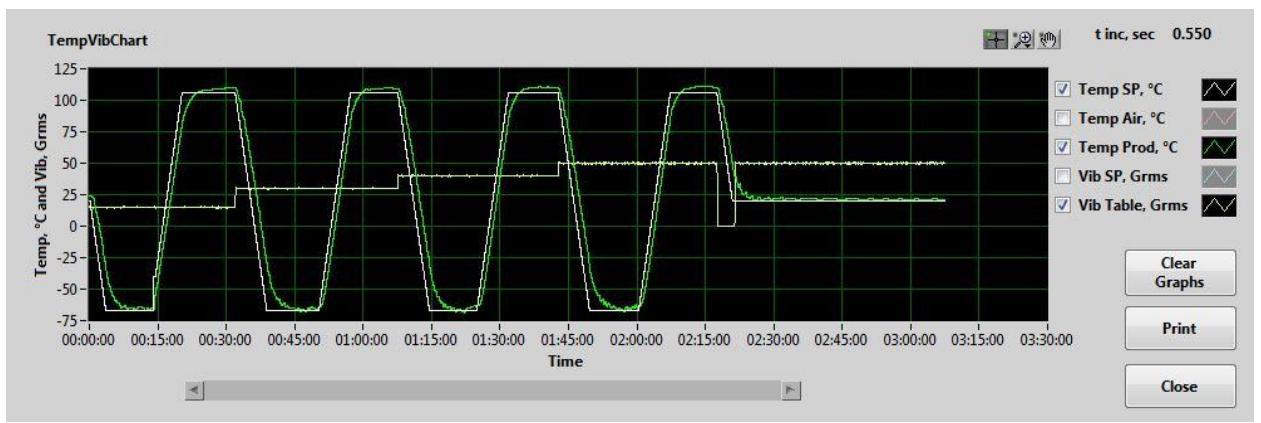
Figure 7 – Combined thermal and vibratory profile for units in HALT, with extended vibe. The yellow line shows vibration input levels at the table, the grey line is the thermal program, and the green line is the thermal reading on one of the BGAs.

The assembly was exposed to the combined thermal and vibration profile as shown in Figure 7. A thermocouple located on top of one of the BGAs (the green line in Figure 7) demonstrated good temperature tracking and was used to ensure that the desired dwell period was reached. At the completion of the fourth thermal cycle, two of the three units were subjected to the addition period of vibration shown, at the maximum level for 60 minutes. The entire test lasted for a little over three hours. Units were tested functionally at the end of each dwell period, and during each transition. Units were also tested approximately every ten minutes during extended vibration. All tests were passed successfully.

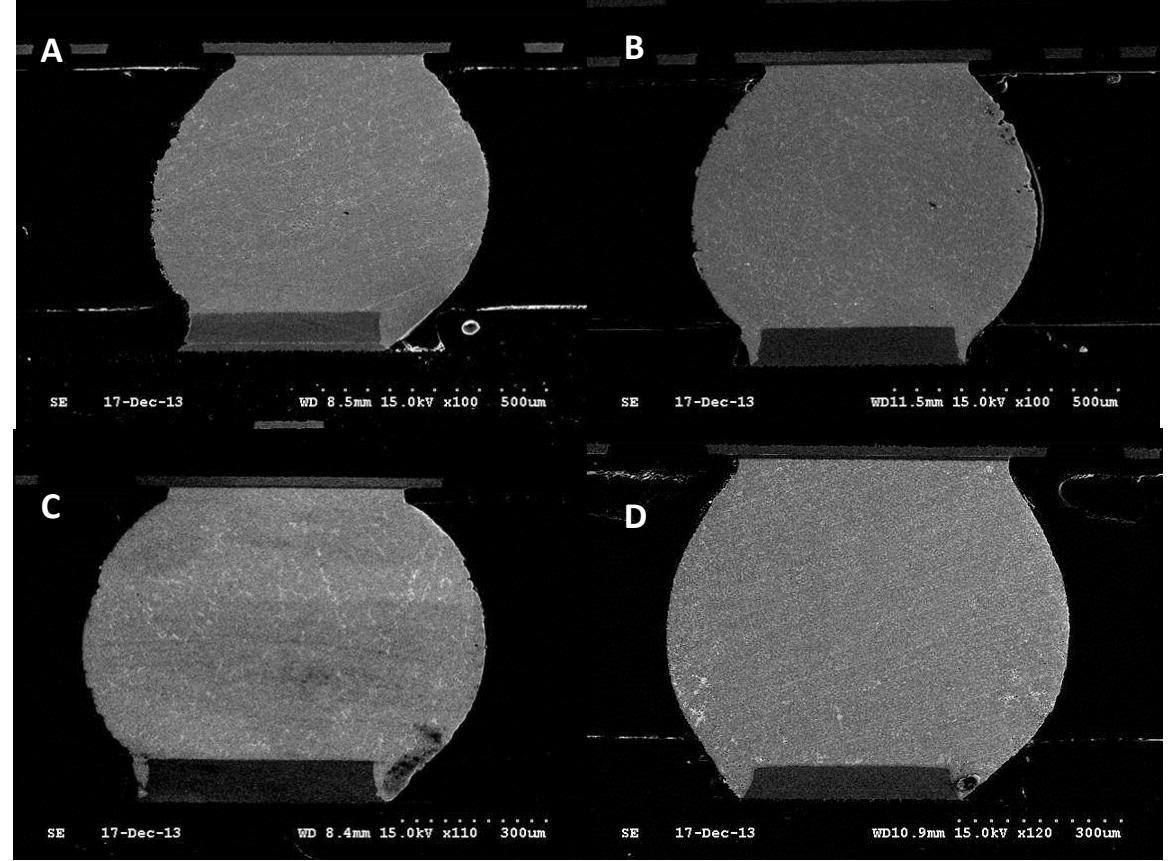
Figure 8 - Micrographs of cross-sections for BGAs 1 (A), 2 (B), 3 (C), and Sn63Pb37 (D) after HALT.

One of the test units was cross-sectioned after HALT to examine the condition of the BGA solder joints. Although a standard Sn63Pb37 test unit was not exposed to HALT, there was another circuit card in the HALT setup which included such a BGA. This unit was also exposed to the thermal and vibratory conditions, and was cross-sectioned as a comparison. The cross-sections of these post-HALT units are shown in Figure 8. There is no significant change to the solder joints from the as-built conditions. Although the surfaces of these low-Pb solder joints are rough compared to the Sn63Pb37 joint, this roughness has not increased from the as-built condition. Similarly, the Sn63Pb37 solder joint has not changed significantly from the condition typically seen in an as-built joint; the grain structure is fine and there is no evidence of damage to the joint.

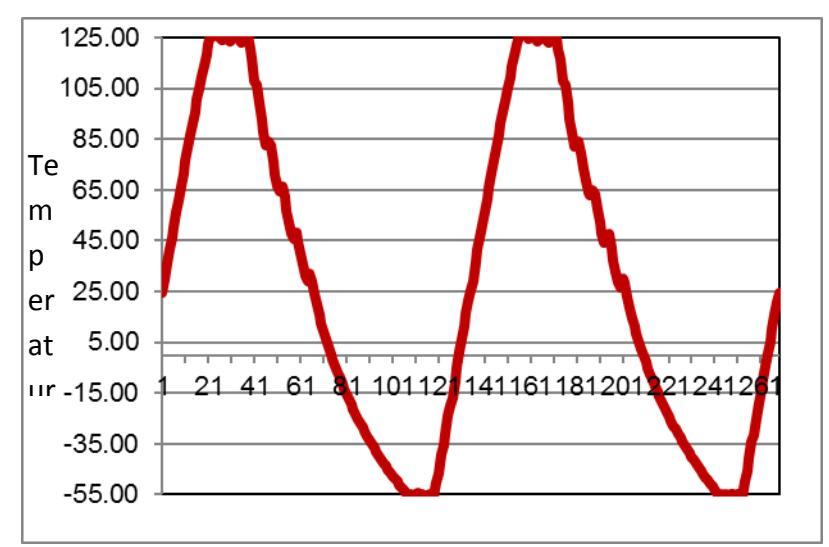
Figure 9 – Thermal cycling profile for accelerated aging test units.

The second environment used in the aging sequence was periodic instances of 50 temperature cycles. The profile consisted of temperature swings from -43°C to 85°C, with a ramp rate of approximately 2.7°C per minute, and with 15 minute dwells at each extreme, for a time of approximately 1 hour per cycle.

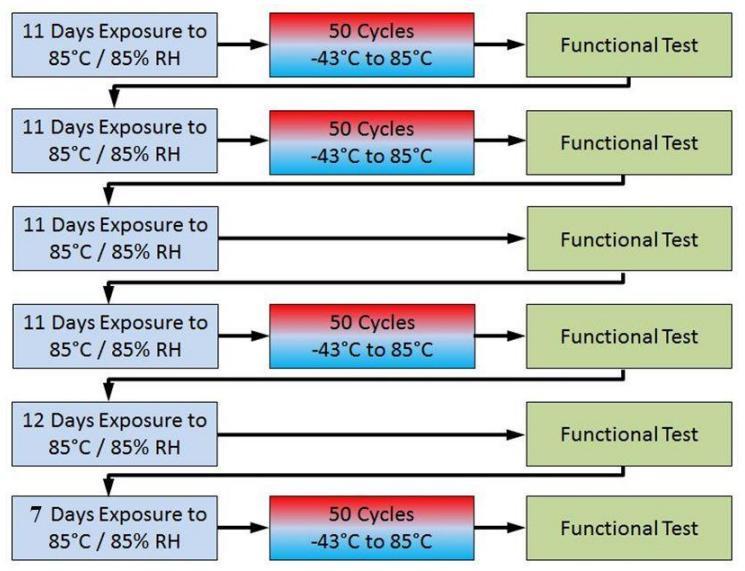
Figure 10 – Accelerated aging process flow

Six test units and four control units (standard SnPb) were subjected to multiple sessions of accelerated aging and thermal cycling. Electrical acceptance testing was performed between these sessions to verify functionality. In all, the test units were exposed to 63 days temperature / humidity (85°C / 85% RH) and 200 thermal cycles (See Figure 9) for simulation of approximately 30 years relative to a 60%RH/30°C application environment. The overall flow for this process is shown in Figure 10.

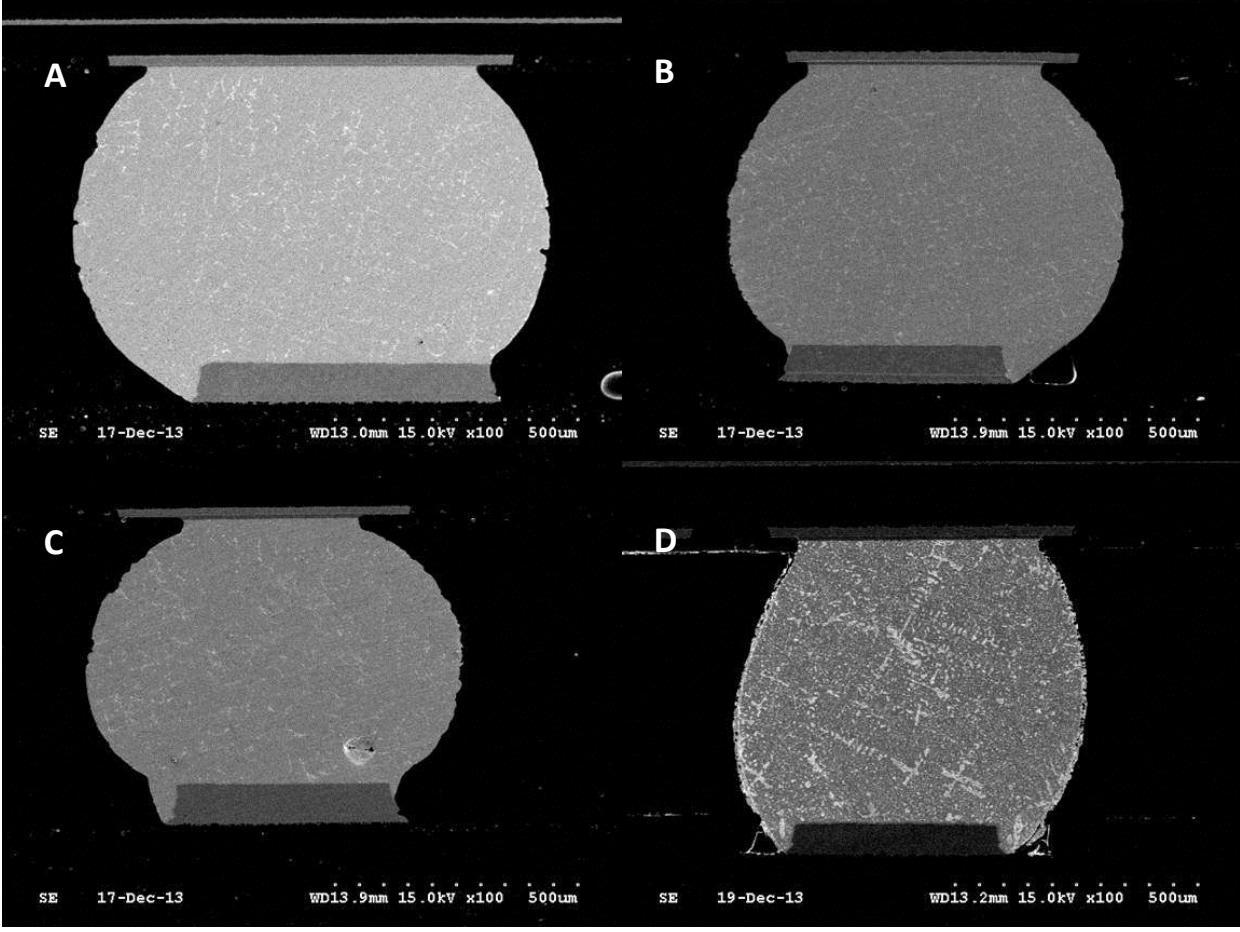
Figure 11 - Micrographs of cross-sections for BGAs 1 (A), 2 (B), 3 (C), and Sn63Pb37 (D) after accelerated aging.

All ten test units successfully passed testing until the final round of aging. In the final test, two of the six mixedalloy units failed a test, indicating a problem with BGA 1. One of the mixed-alloy units subjected to accelerated aging was cross-sectioned, as well as one of the Sn63Pb37 units, to evaluate the resulting condition of the solder joints (see Figure 11). The cross sectional images of the post-aging units do not show any significant anomalies in the solder joints; there were no fractured solder joints, no crack initiation sites, and generally no apparent deterioration of the solder joints. The mixed-alloy joints still display a uniform distribution of Pb-rich areas of relatively fine grain structure. In the post-aging image for the standard SnPb joint, however, there is a significant amount of grain growth. The grain structure of the joint is not as fine as in the as-built condition. Dye-and-pry was used to evaluate the failed units, and there was no indication of solder joint failure from this inspection; the printed circuit board pad was partially or fully lifted at all joints as a result of the component removal.

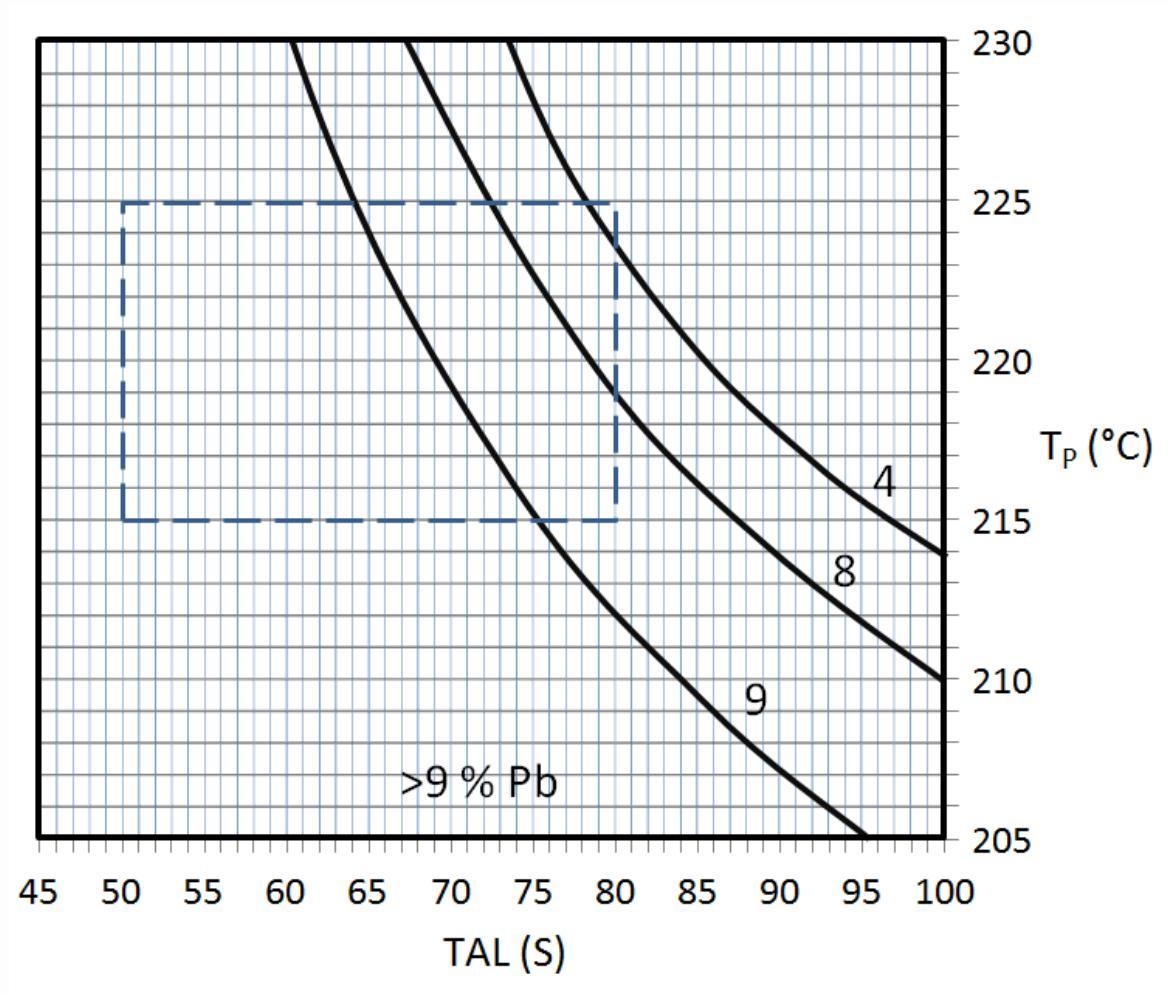
## **Acceptable Solder Joint Prediction**

- Dashed box represents range of data from prior testing
- Reflow needs to be above the appropriate curve for fully mixed joint

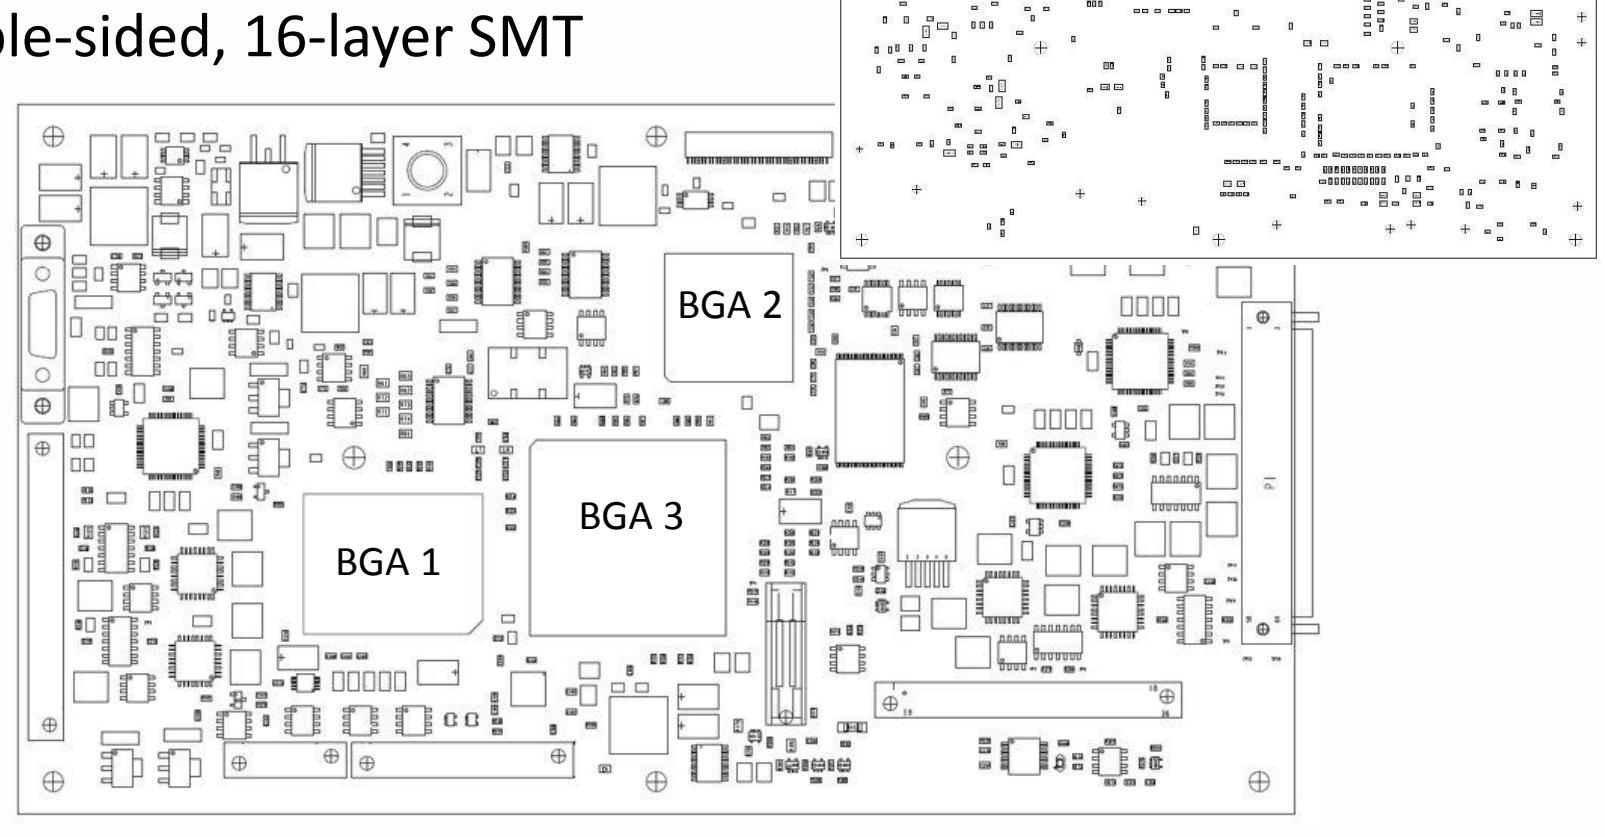
### **Test Vehicle**

- Variety of package types
- Three different BGA types
- Double-sided, 16-layer SMT

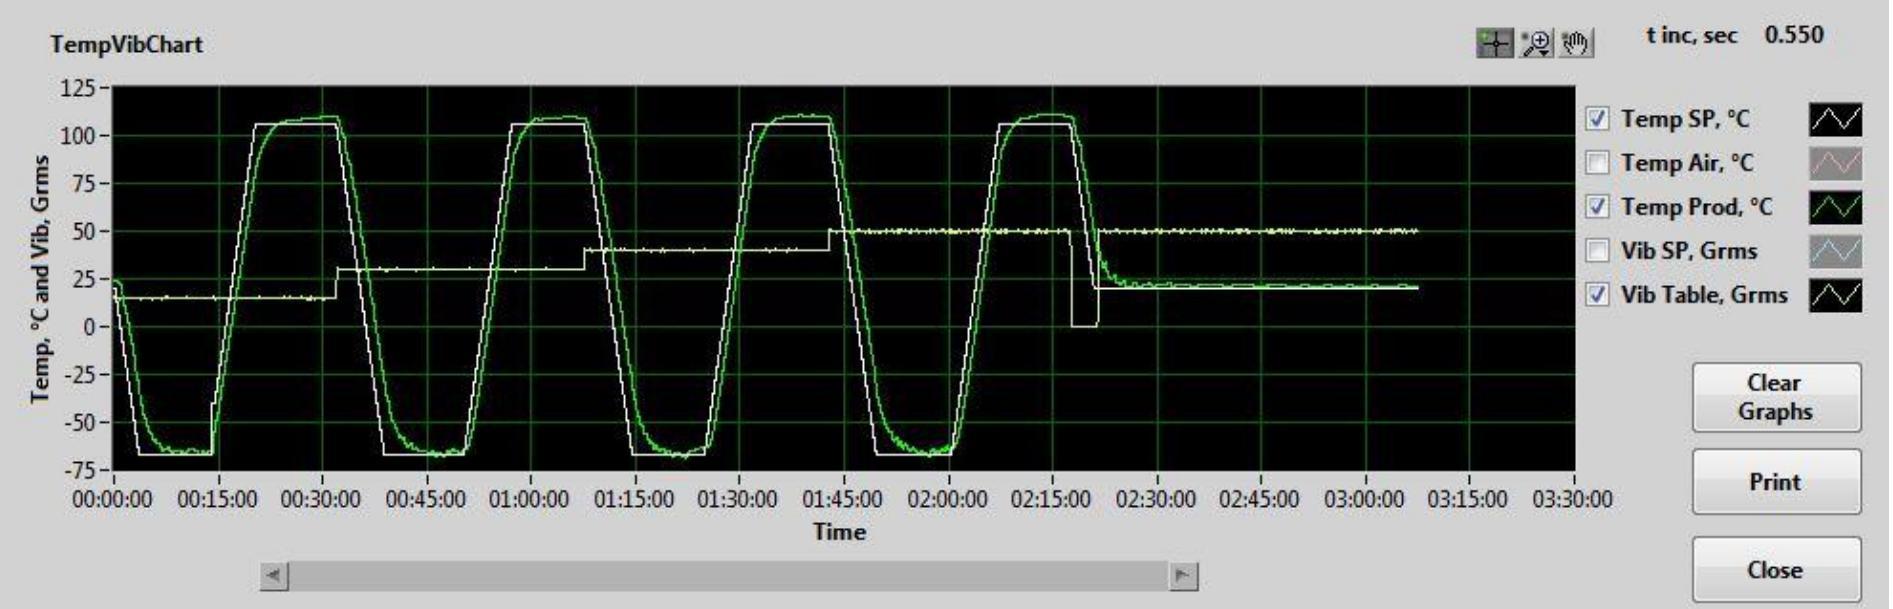
## **HALT Profile**

- Thermal cycles
  - -67°C to 106°C, 25°C / minute ramp
- Vibration
  - Increasing input, from 5 up to 20+ Grms response
  - Extended vibration duration at high level

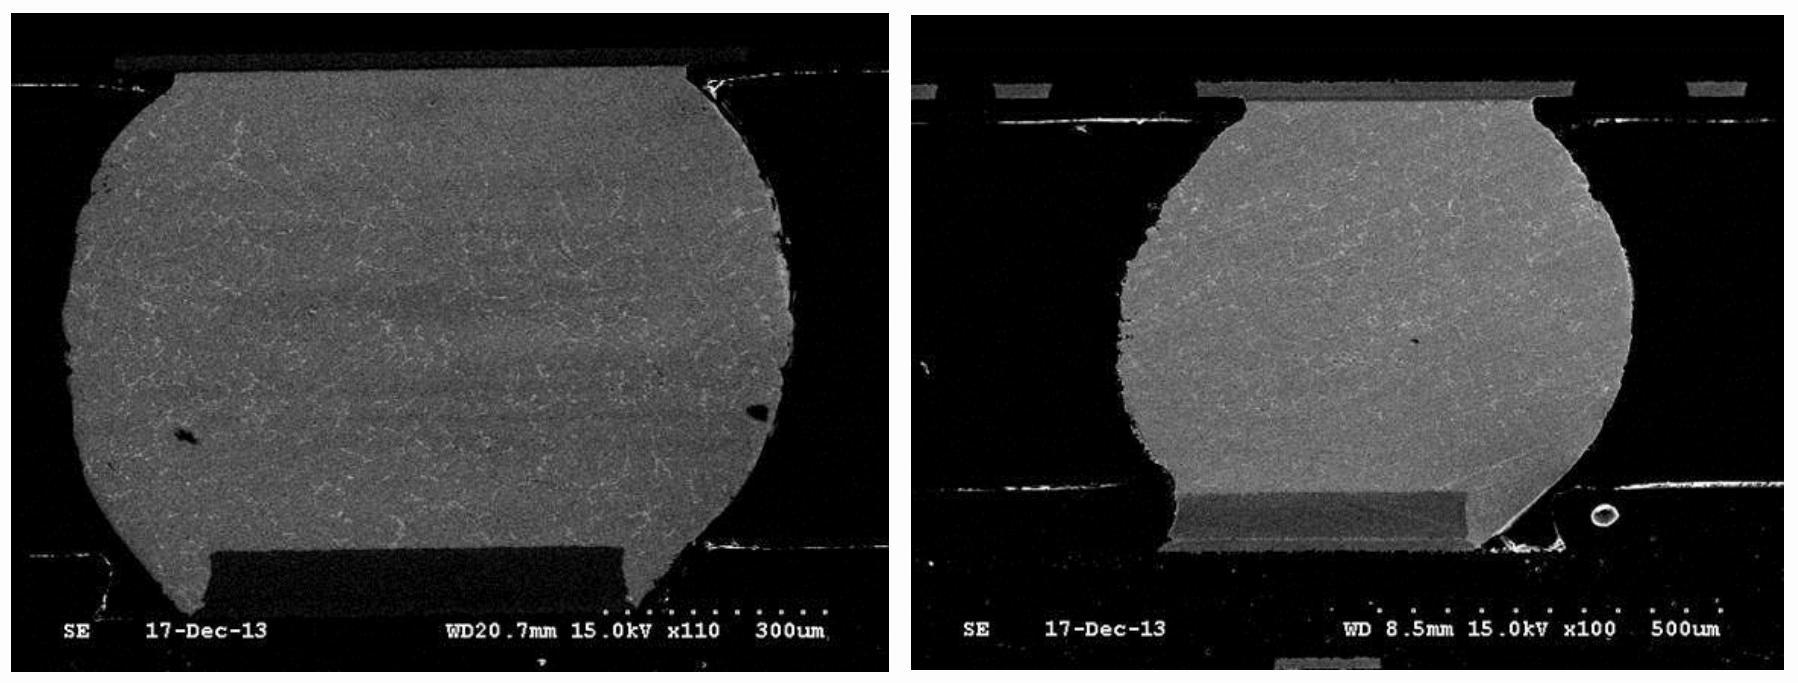
### **HALT Results**

- No failures throughout testing
- No significant impact to solder joint

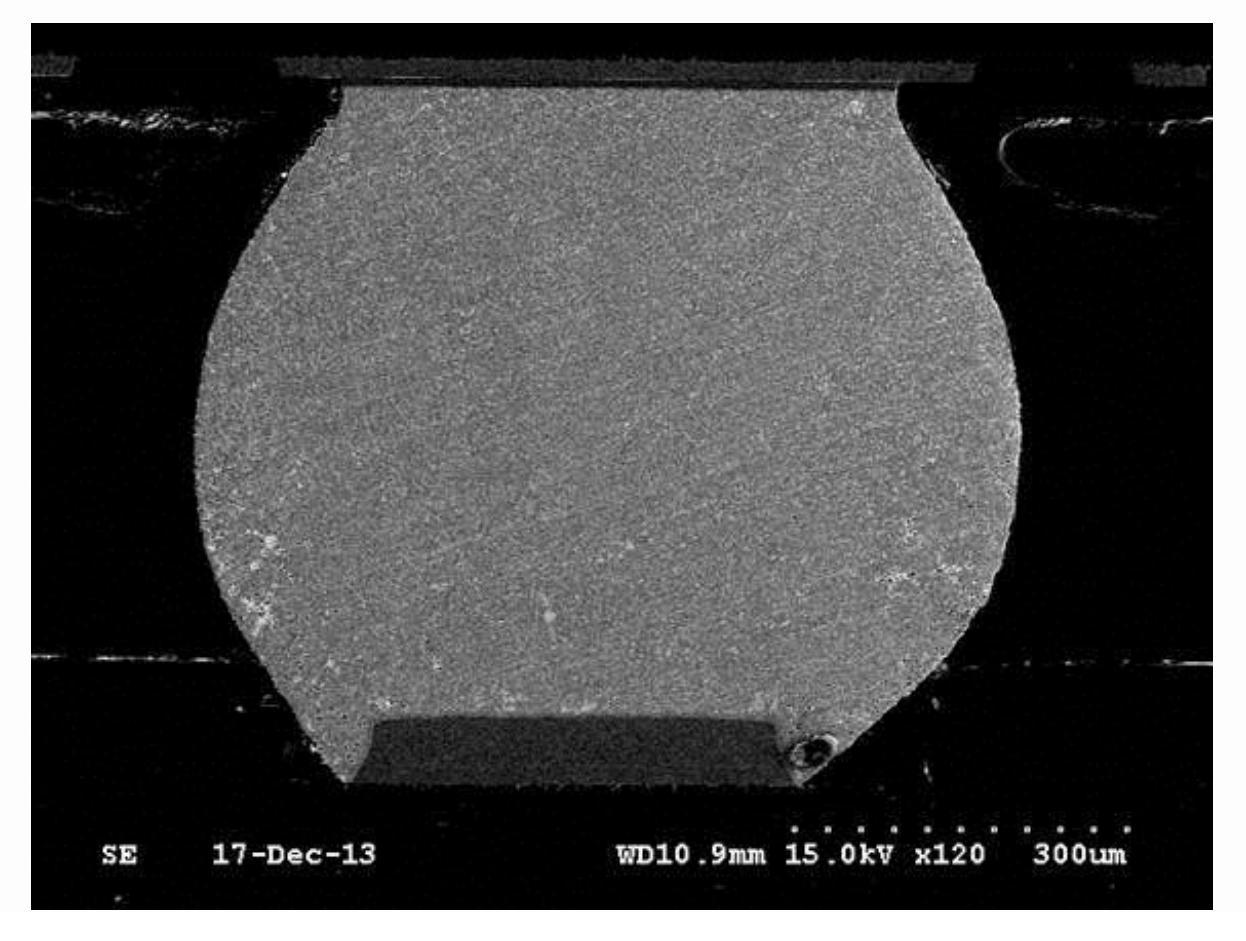
### **HALT Results**

• Sn63Pb37 control (Post-HALT)

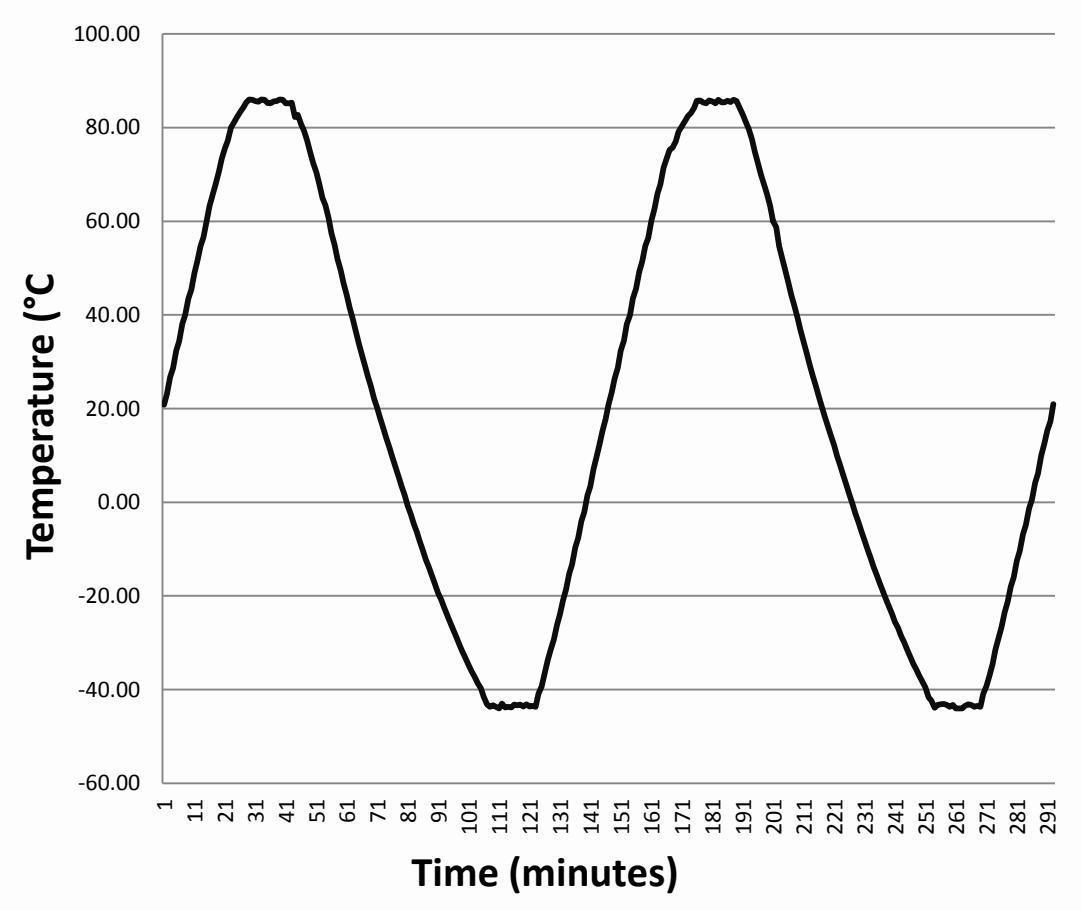
## **Accelerated Aging – Thermal Cycling**

- -43°C to 85°C
- 15 minute dwells
- 50 cycle sessions
- 4 sessions total through testing

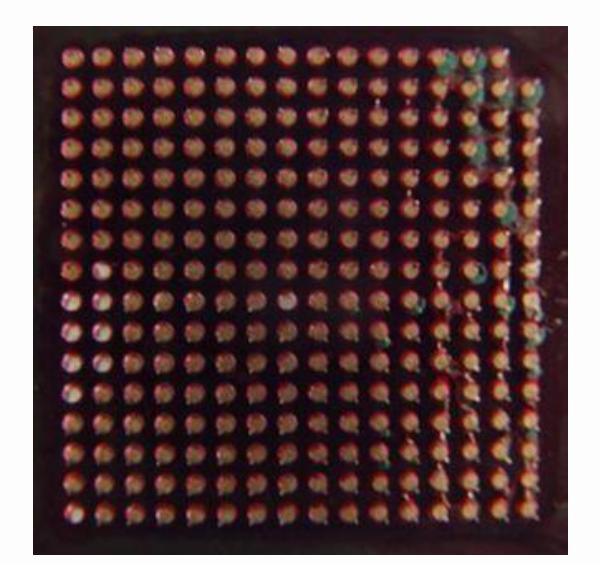
## **Accelerated Aging Results**

- No test failures through the first 56 days aging and 150 thermal cycles
- Two failures at final round of functional test
  - Both failures were at BGA 1 on mixed-alloy units
  - Attributed to component failure
    - Representative solder joints look good in cross-section
    - Dye and pry does not indicate joint fracture, all pads lifted at board

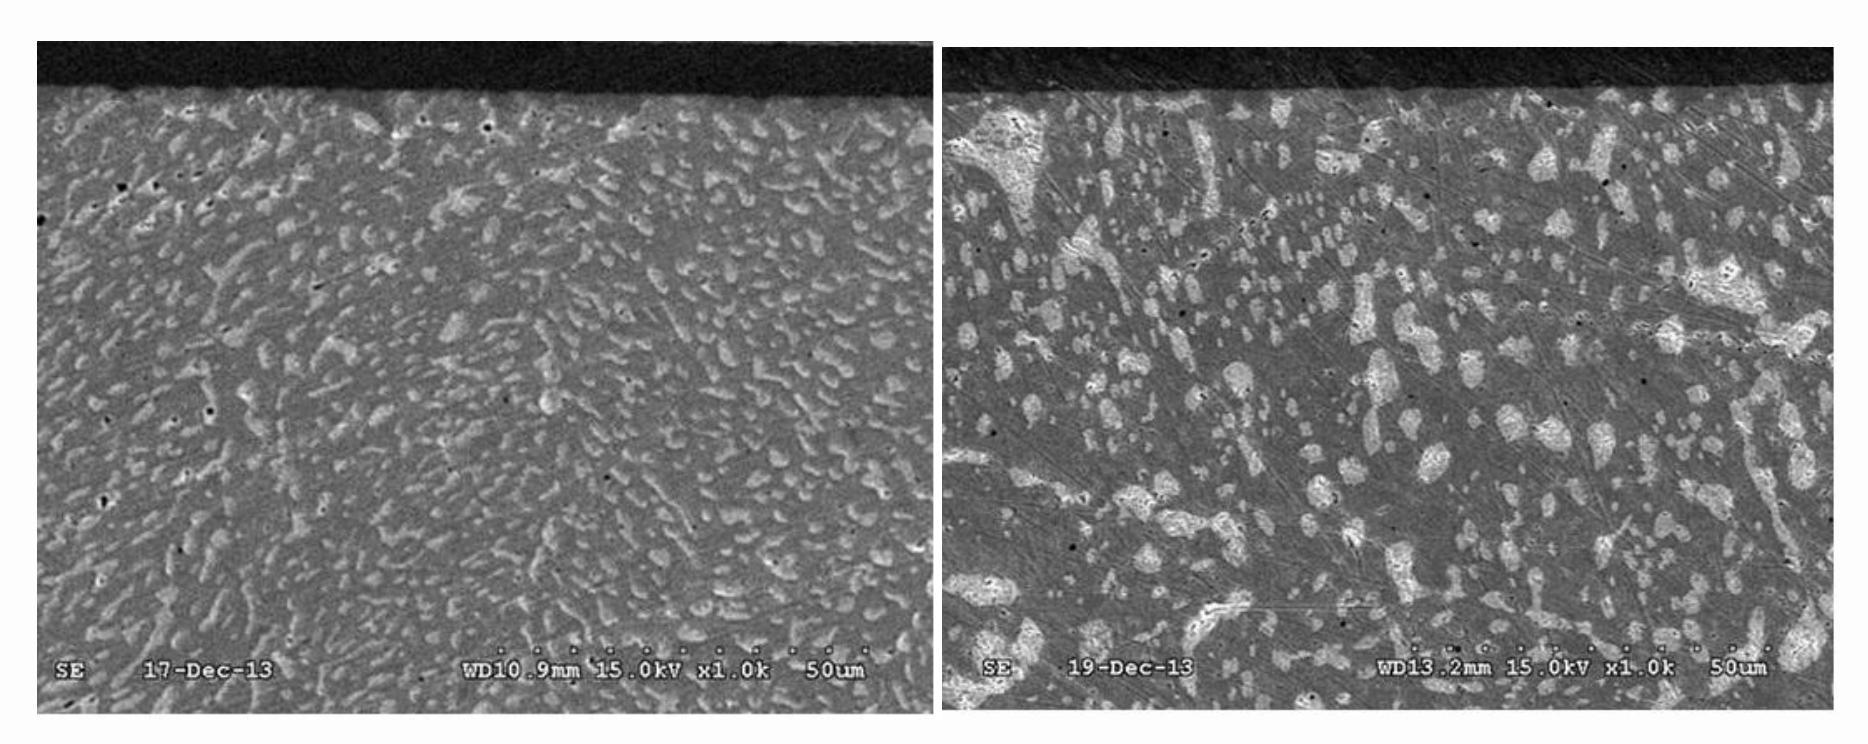
## **Accelerated Aging Results**

Grain growth apparent in solder joints of Sn63Pb37 units
 Pre-Aging Post-Aging

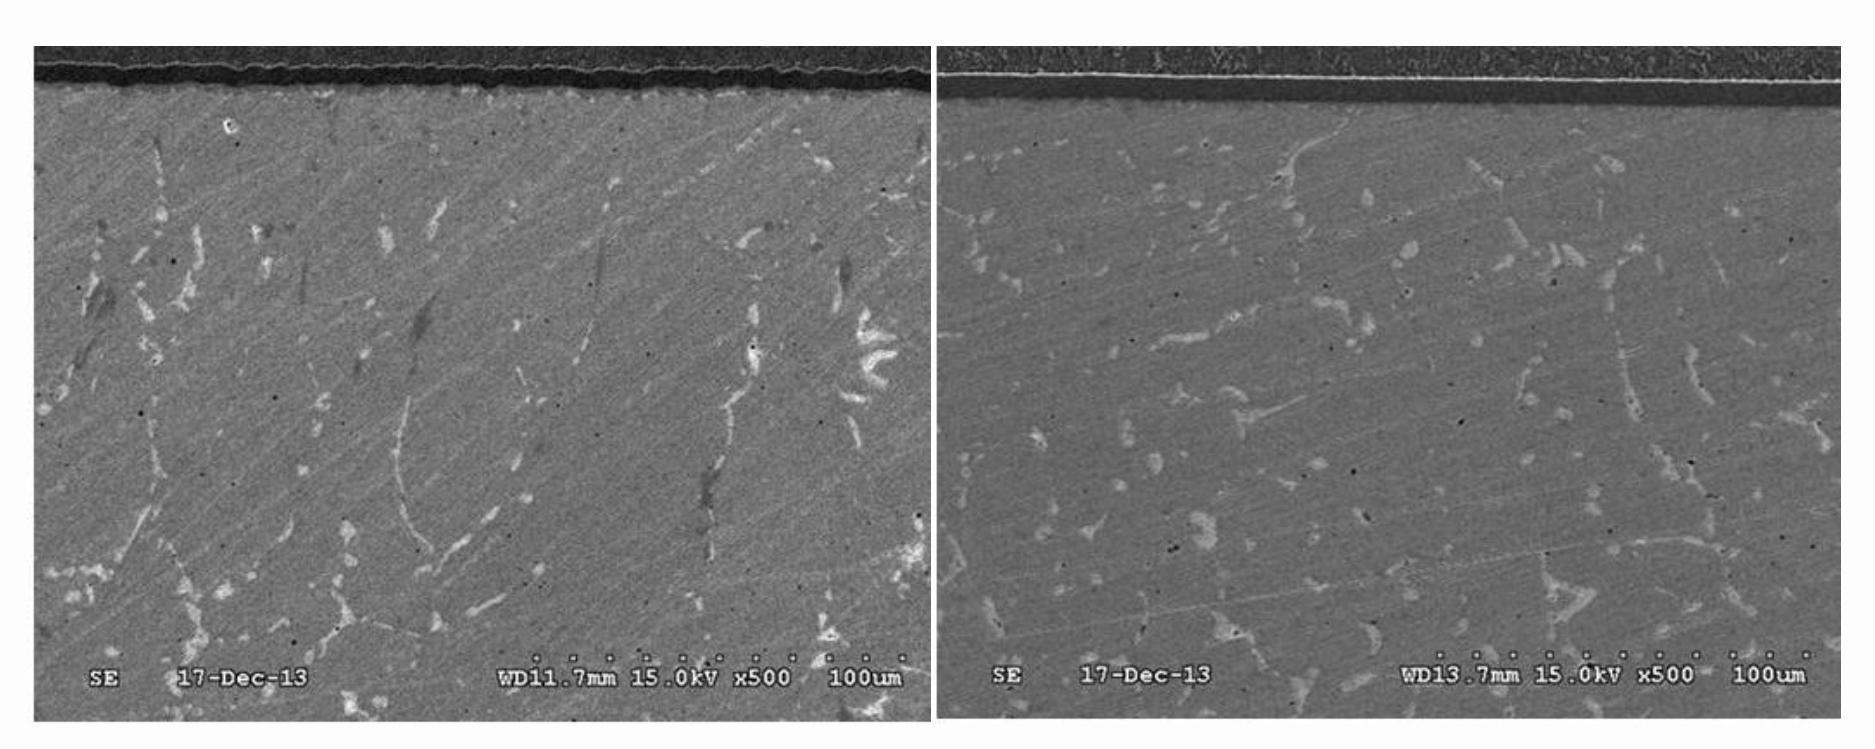
## **Accelerated Aging Results**

No significant change to solder joint in mixed-alloy units
 Pre-Aging Post-Aging
