Challenges of Manufacturing with Printed Circuit Board Cavities

Intel Corporation

Benefits and Challenges of Manufacturing with Printed Circuit Board Cavities

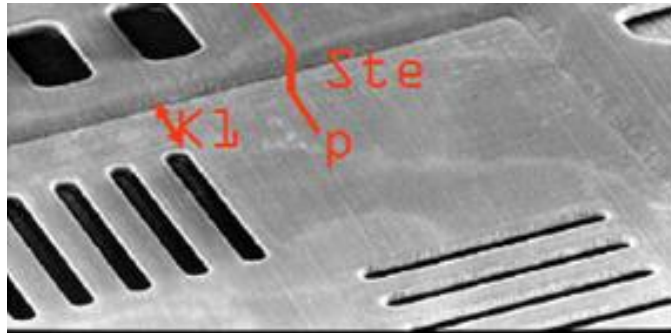
Figure 8. K1 Air gap per IPC 7525 Guideline.

$$K1(Gap) = \frac{StepDist(um)}{25um} (900um)$$

The IPC 7525A “Stencil Design Guidelines” states that there is a relationship between the cavity or “step” depth relative to the width of the air gap measured from the wall of the cavity to the nearest feature to be printed. To summarize the guideline: the minimum air gap (cavity wall to the nearest printed feature) increases at a fixed rate of 900um for every 25um of step depth. Therefore the calculated gap “K1” (shown in Figure 8) for a 250um deep cavity would be 900um.

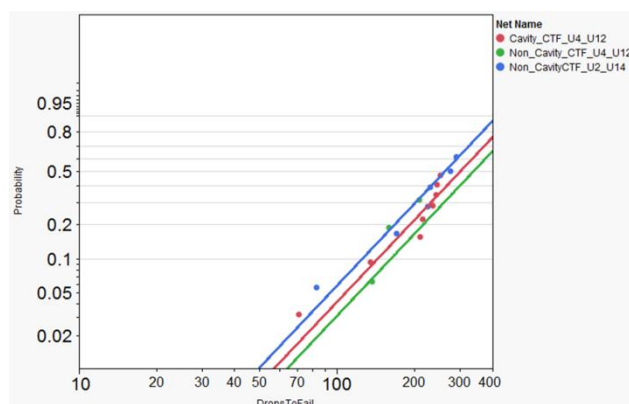
Figure 15. Cavity and Non-cavity CTF solder reliability

Note: No CTF failures observed at the U2 and U14 cavity locations.

The cavity reliability drop test results for the critical to function (CTF) and the non-critical to function (NCTF) solder joints (see Figures 14 and 15) were statistically equivalent to the historical data of the non-cavity BGA packages at the same locations.

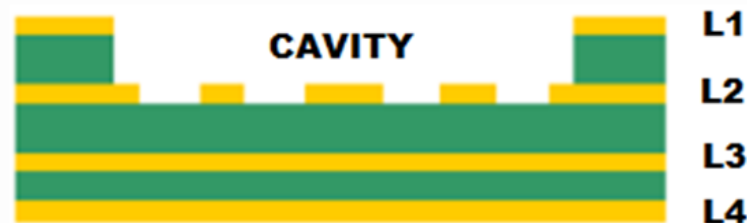
A cavity is be defined as a hole in the PCB going from the outer copper layer to an inner copper layer, but not completely through the PCB.

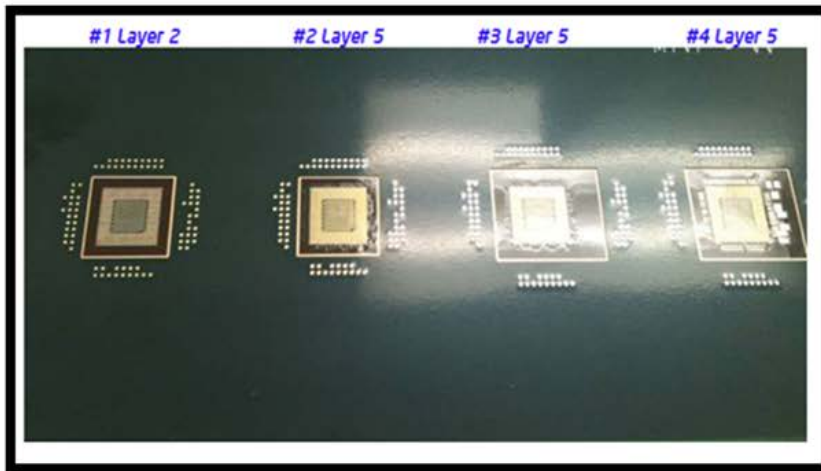
TB1

TB1: 0.7mm thick, 203mm X 127mm, 10 layer Any Layer uVia high density interconnect (HDI) PCB with an Electroless Nickel Gold (ENIG) surface finish.

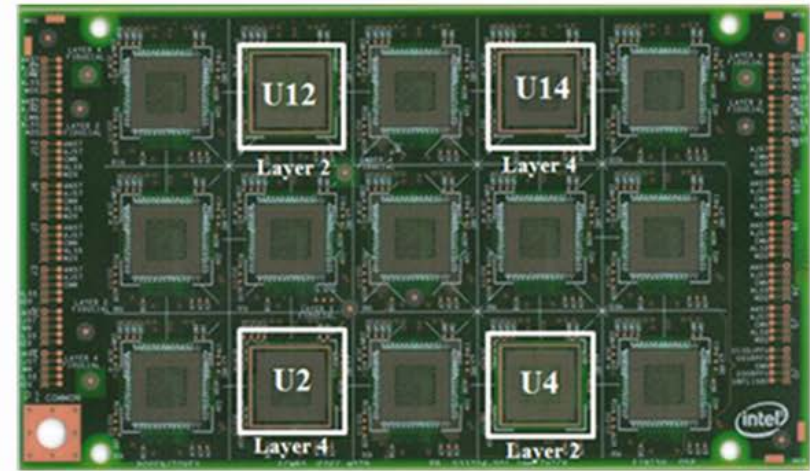
TB2

TB2: 1.0mm thick, 140mm x 132mm (with assembly rails), 4-2-4 high density interconnect (HDI) PCB with an Organic Surface Preservative (OSP) surface finish

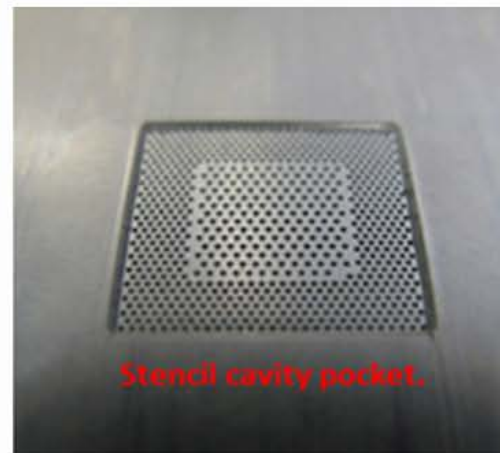
One squeegee supplier used an actual board to verify the alignment of the stencil pockets to the cavities.

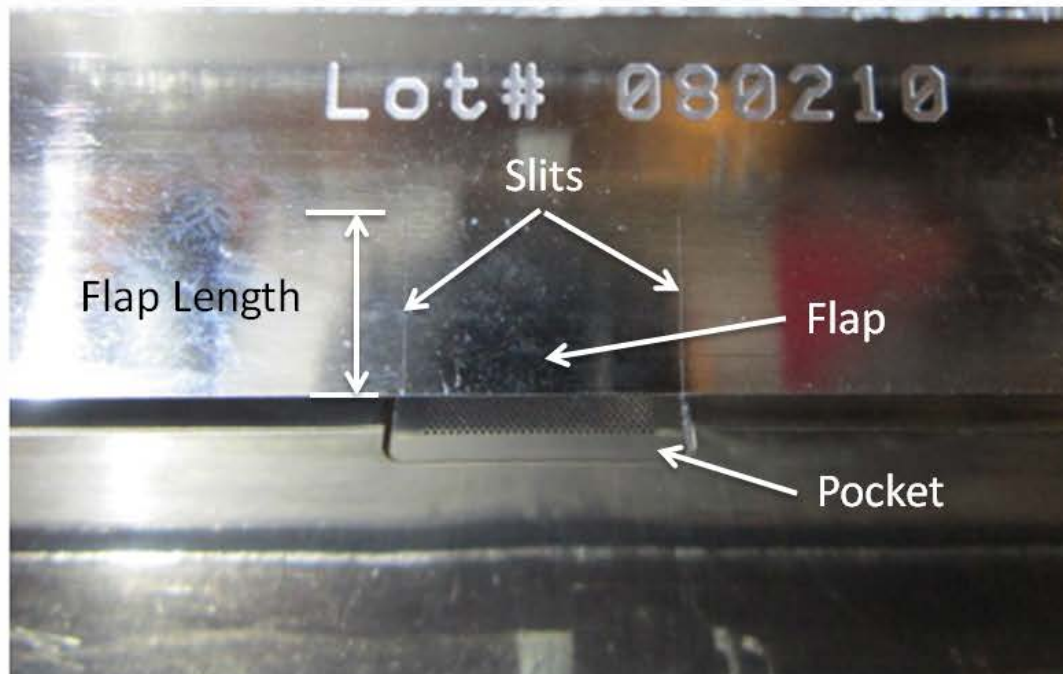
Solder Paste Squeegee

The metal squeegee is cut to form the flaps which align with the pockets in the stencil.

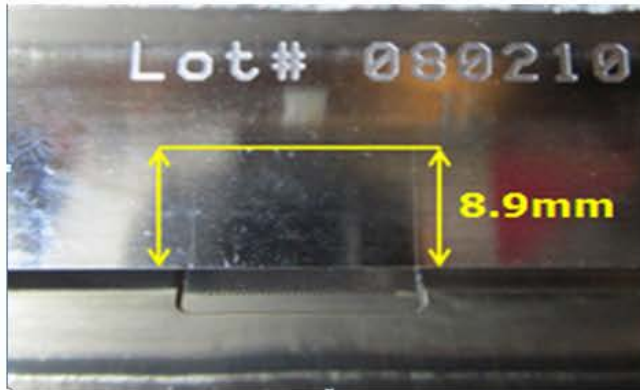
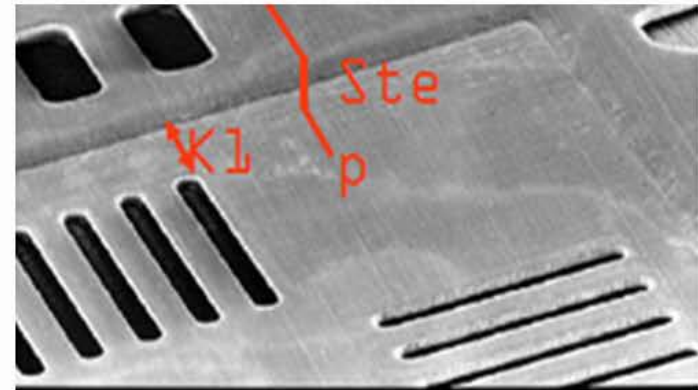
Flap Length

- Squeegees with flap lengths of 5mm, 8.9mm, 12.7mm on TB1, and 16mm on TB2 were tested.
- The 8.9mm and the 16mm flaps provided uniform paste print on the corresponding cavity depths and air gaps.
- Exception: Cavity # 2 on TB1 with a 300um depth and a 2mm air gap bridged due to over printing with all 3 squeegees.

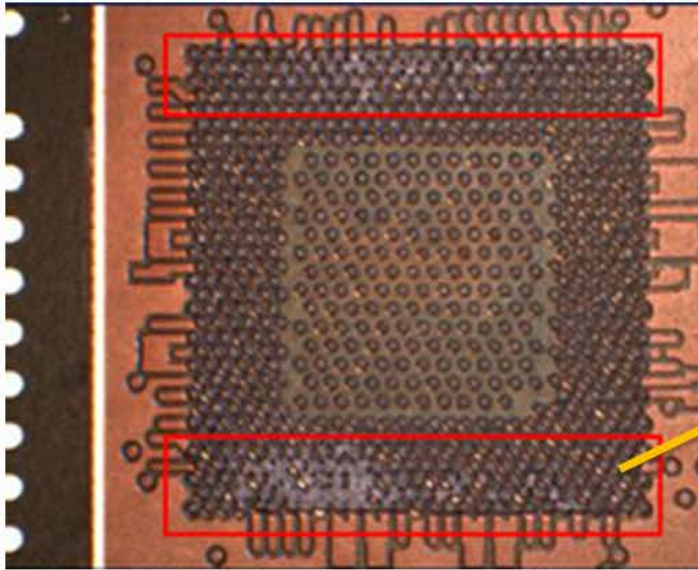
Before Redesign

- A review of the print process and fixture showed Cavity #2 was not supported as well as the other 3 cavities.
- A redesign of the fixture improved the support and reduced the amount of over print but bridging persisted.

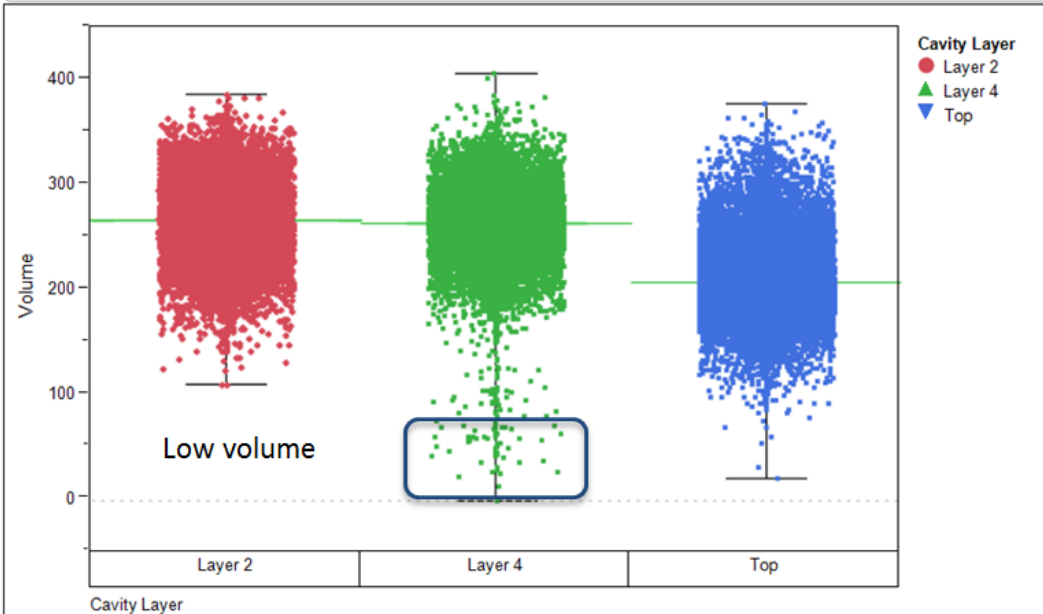
Variability Chart for Volume

- Paste volume optimization on TB2 resulted in lower solder paste volumes at the leading edges layer 4 cavities.
- The surface print had a lower average paste volume but the volume was still at an acceptable level.

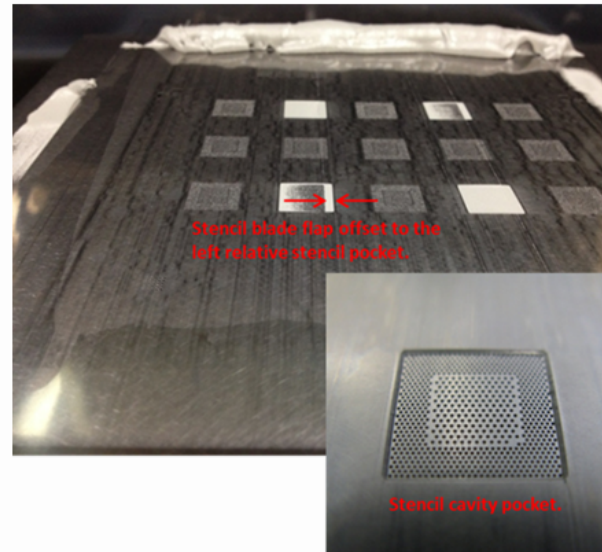
Squeegee Alignment

- Squeegee alignment was achieved by preforming a test print and measuring the paste offset to the stencil pocket which proved to be time consuming.
- This offset was used to adjust the squeegee blade position in the squeegee assembly. The procedure was repeated until the optimal squeegee blade alignment was achieved.

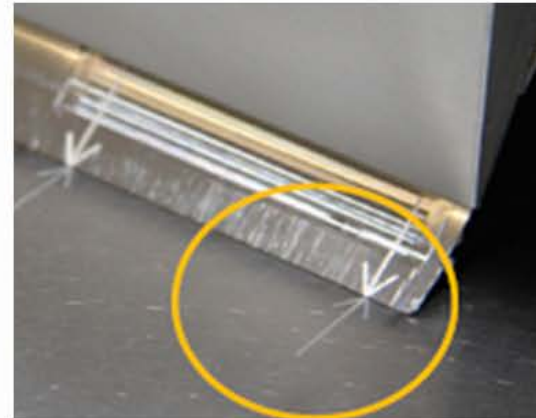
With Alignment Marks

Alignment marks on the squeegee, with corresponding stencil marks would facilitate the alignment process
