Testing Printed Circuit Boards for Creep Corrosion in Flowers of Sulfur Chamber

Haley Fu
iNEMI, Shanghai, China

March 2014

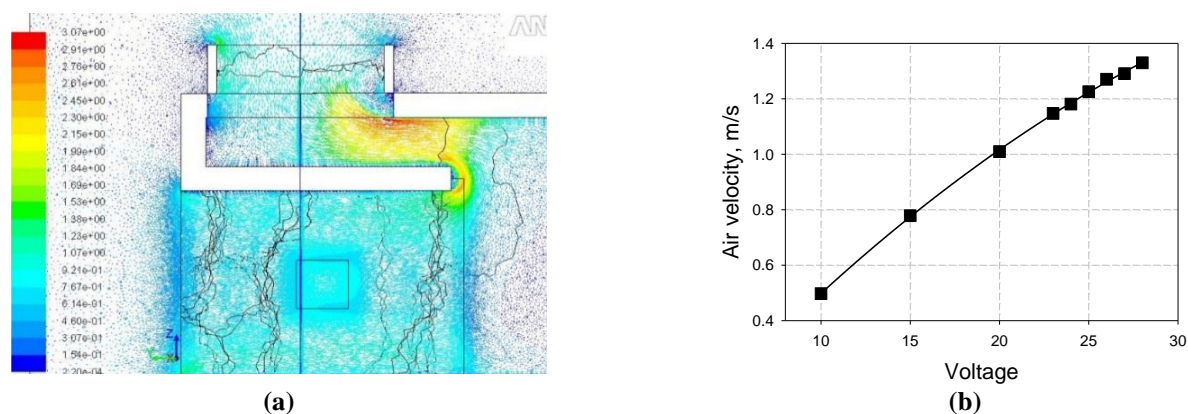
Figure 3: (a) Forced air setup airflow pattern and (b) airflow velocity versus voltage applied to the blower. The air velocity versus voltage relationship was obtained for each forced air setup.

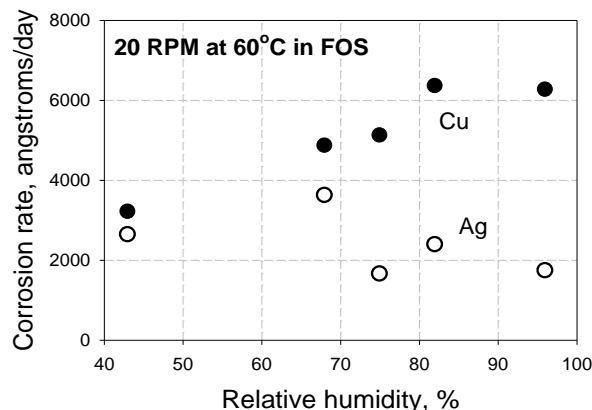
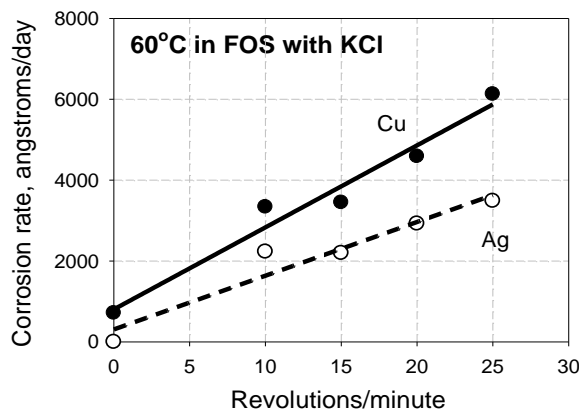
Figure 5: Copper and silver corrosion rates in FOS chamber at 60°C with paddle-wheel setup (a) as a function of relative humidity at 20 RPM and (b) as a function of revolutions/minute at 80% relative humidity. The solid data points are for copper and the open data points are for silver corrosion rates. The corrosion rates were obtained using the weight gain method.

The rates of corrosion of copper and silver foils mounted on paddle wheels rotating at 20 RPM in the flowers of sulfur chamber at 60°C were measured as a function of relative humidity using the weight gain method. Appendices I and II explain how one can calculate the corrosion product thickness from the gain in weight. The relative humidities were obtained using various saturated salt solutions. The air velocity over the metal foils was less than 0.1m/s. The duration of the test was 24 hours. The results plotted in Figure 5a show that the copper and the silver corrosion rates have a somewhat step-wise increase above about 80% relative humidity. Further work is needed to verify this behavior.

The paddle-wheel setup was also used to determine the effect of paddle wheel RPM on the rates of corrosion of copper and silver foils mounted on the paddles. The relative humidity was controlled at 80% in the 60°C chamber using KCl saturated salt solution. The corrosion rates were measured using the weight gain method and are plotted in Figure 5b as a function of the paddle wheel RPM. The corrosion rates increased quite linearly with the paddle wheel RPM. It is expected that the curve would reach a plateau at some point as the RPM is raised. However, as the RPM was limited to about 25, the plateau was not reached.

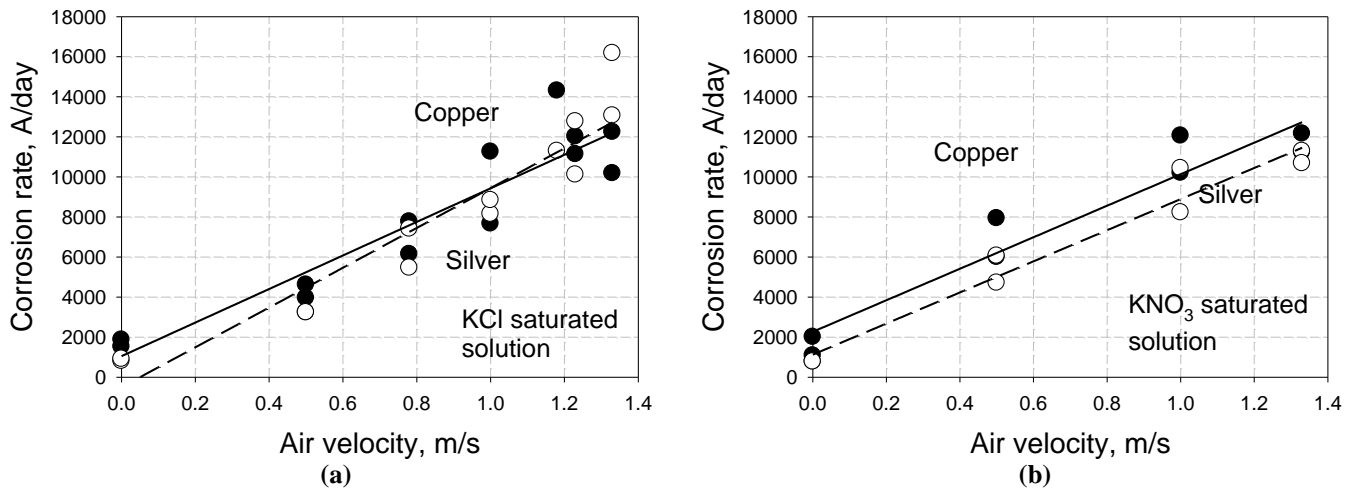
Figure 7: Copper (solid circle) and silver (open circle) corrosion rates in angstroms/day as a function of air velocity in FOS chamber with the forced air setup at 60°C at (a) 80% relative humidity using KCl saturated solution and at (b) 82% relative humidity using KNO₃ saturated salt solution. The corrosion rates were obtained using the weight gain method.

The effect of air velocity on copper and silver corrosion rates, at 80% relative humidity using KCl saturated salt solution and at 82% relative humidity using KNO₃ saturated salt solution, was studied in a forced air flow of sulfur chamber at 60°C. The relationship was quite linear for both the metals, as shown in Figure 7, with no sign of the corrosion rates plateauing off even at velocities as high as 1.3 m/s. In future work, we will extend the study to air velocities as high as 2 m/s.

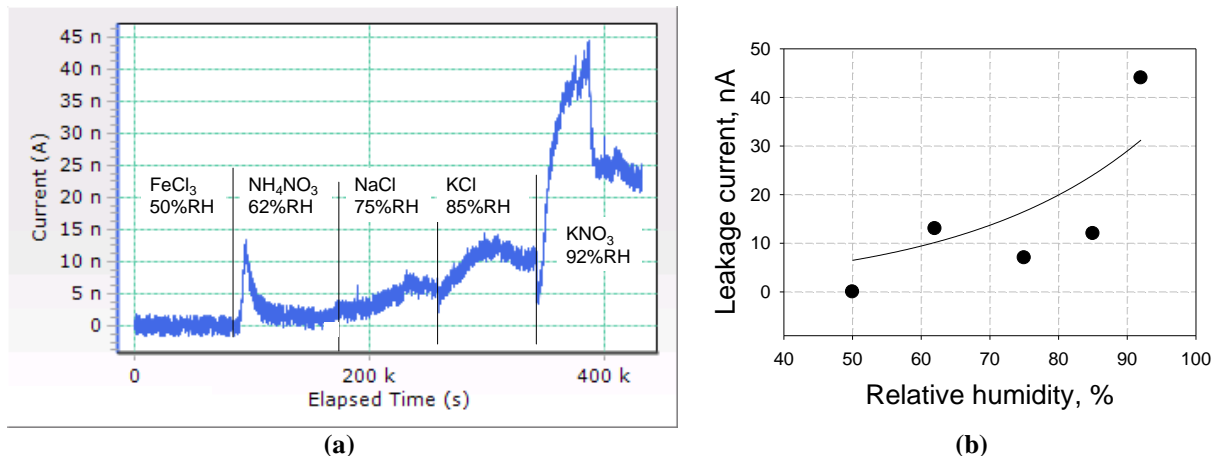
Figure 8: (a) Leakage current across inter-digitated comb coupons with 0.5-mm spacing with the salt covering the combs consisting of equal parts of (NH₄)₂SO₄, NH₄HSO₄, NH₄NO₃ and NaCl. (b) The data of figure (a) are plotted as the peak leakage current versus relative humidity.

The amount of salt on a surface can be determined by extracting the salt in de-ionized water and measuring the increase in the electrical conductivity of the water. The deliquescent relative humidity of a dust can be determined by covering inter-digitated comb coupons (SIR test board, IPC-B24 Rev A) with the dust and applying 10 V across the combs, separated by 0.5 mm spacing, and measuring the leakage current while raising the relative humidity in a step wise or linear manner. Figure 8a shows the current leakage as a function of time at various humidity levels for the ammonium salt and NaCl solution described earlier. The same data are plotted in Figure 8b as leakage current versus relative humidity. Note that the leakage current was in the pico-Ampere range when the humidity was 50% and spiked up when the relative humidity was raised to 62%. The deliquescent relative humidity of this dust is somewhere between 50 and 62%. The reason for the rise in current at 62% relative humidity is the absorption of moisture by the dust; and the reason for the fall is probably the depletion of the mobile

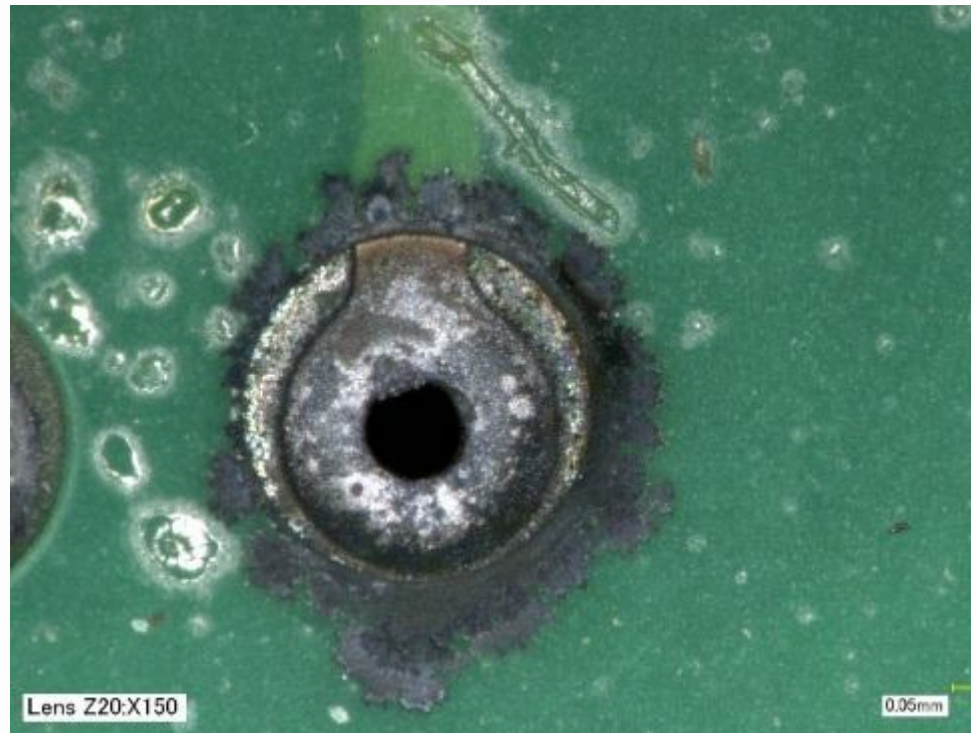
FOS testing of a PCB from a lot that suffered creep corrosion in the field and covered with $35 \mu\text{g ZnCl}_2/\text{cm}^2$. 8 days in FOS chamber with paddle wheel setup at 60°C , 82%RH and 20 RPM.

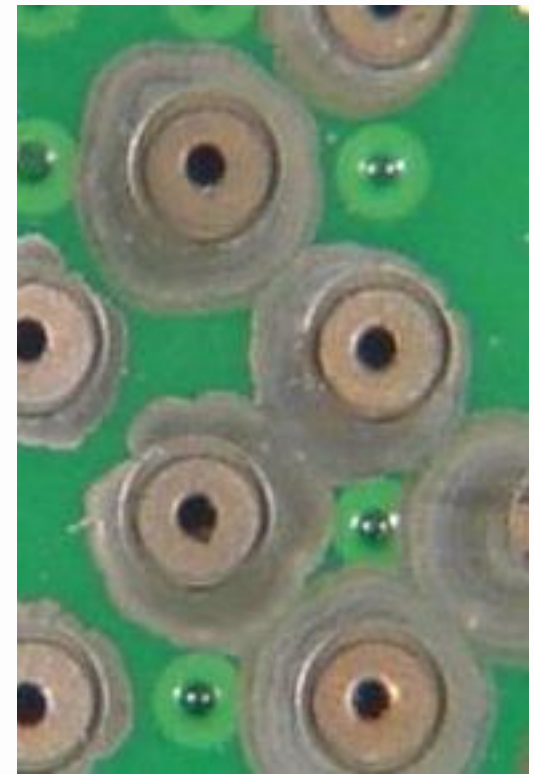
As failed in the field
