# Reliability of ENEPIG by Sequential Thermal Cycling and Aging

Reza Ghaffarian, Ph.D.  
Jet Propulsion Laboratory, California Institute of Technology  
Pasadena, CA  
[Reza.Ghaffarian@JPL.NASA.Gov](mailto:Reza.Ghaffarian@JPL.NASA.Gov)

# **Reliability of ENEPIG by Sequential Thermal Cycling and Aging**

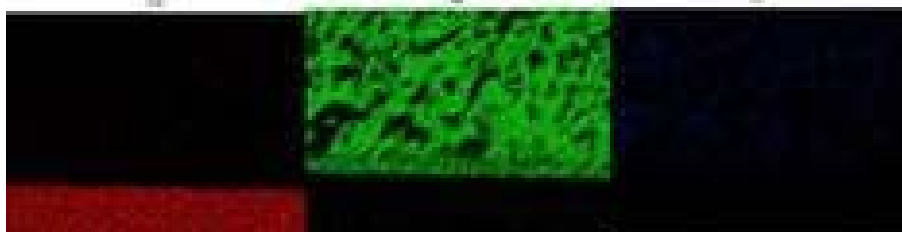
After
