Cold Ball Pull Test Efficiency for the PCB Pad Cratering Validation with the Ultra Low Loss Dielectric Material

Jeffrey ChangBing Lee*, Cheng-Chih Chen, Alice Lin, Dem Lee
iST- Integrated Service Technology, Inc., TAIWAN

Abstract

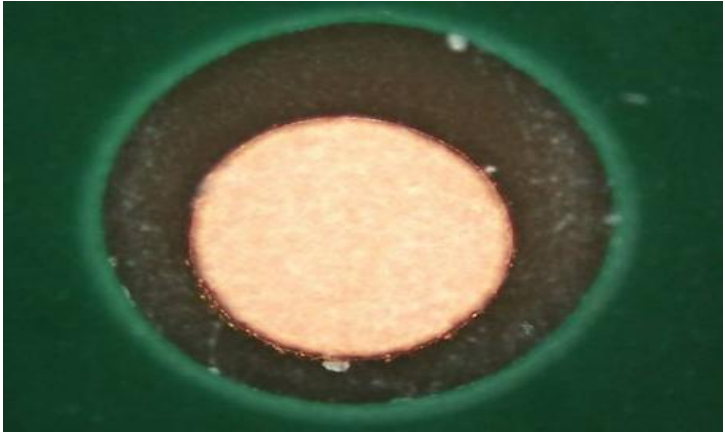
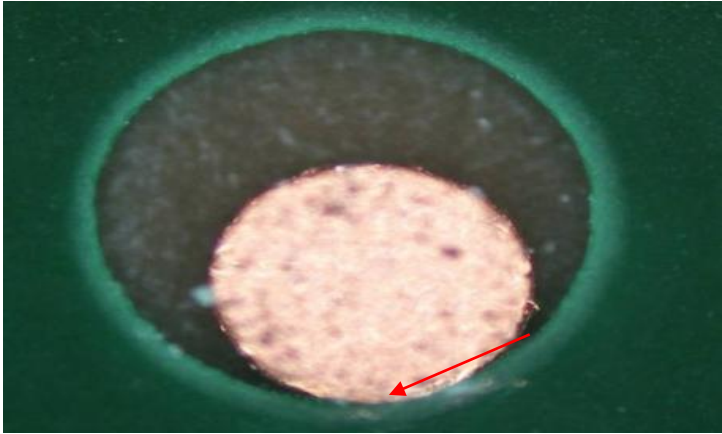
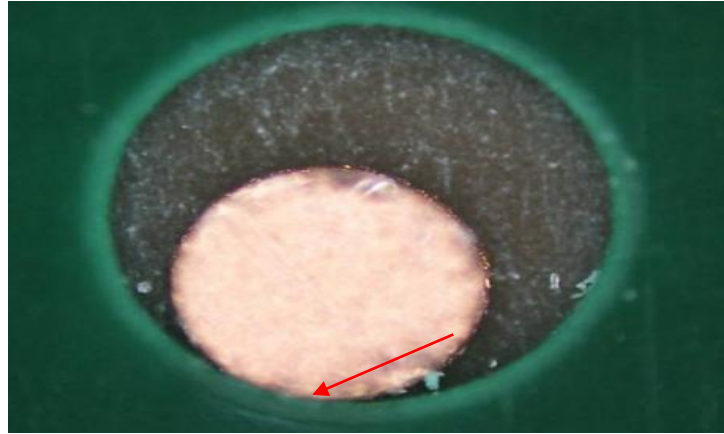
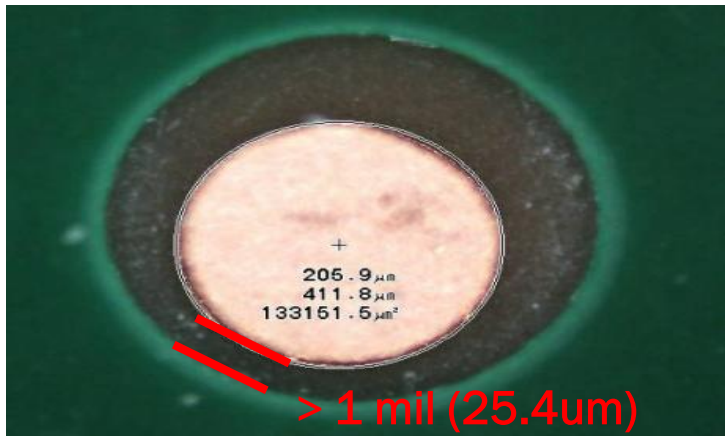
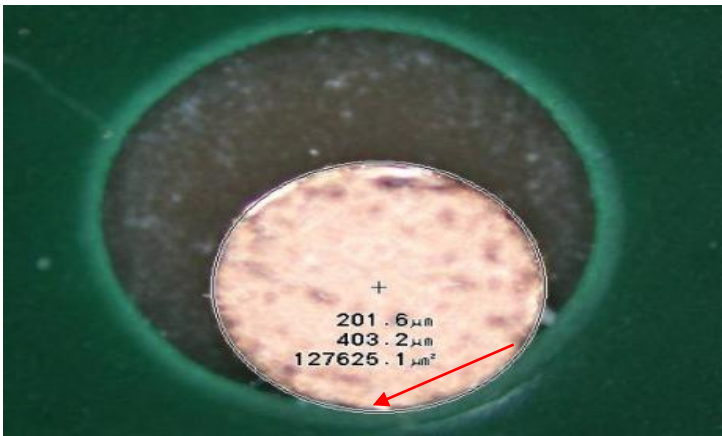
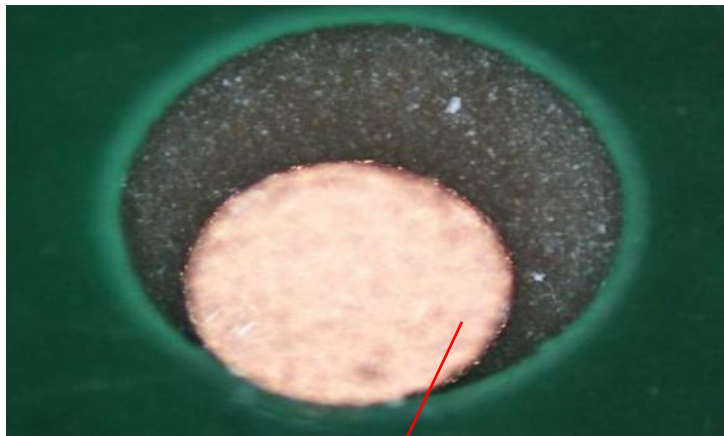
B3 (9-2)	B4 (9-4)	B5 (9-1)
16 mil

- EX : Mis-alignment issue in PCB

Criteria : B3 is OK, B4 and B5 should not be used. Only use samples where there is **at least 1 mil clearance** between the solder mask edge and the pad

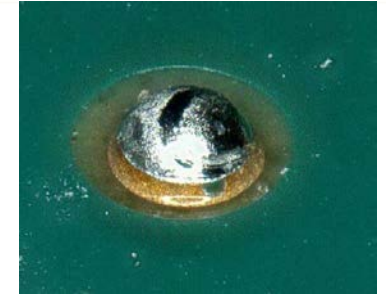
The visual inspection of ball attachment

EX : Physical view of **NO** good samples

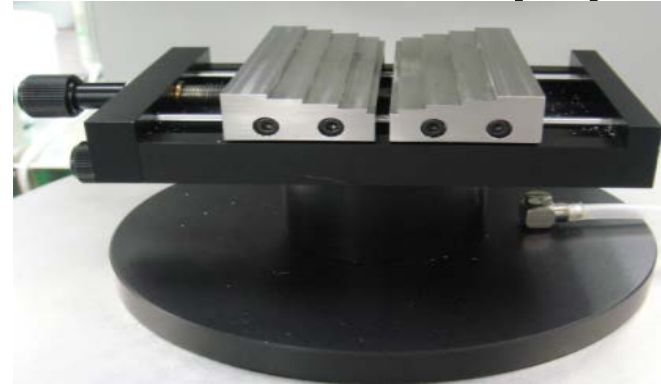
Test Equipment of CBP

Actual pull condition:
1. Clamping Pressure: 21 psi
2. Test speed: 5mm/sec
3. Jaw type : 750um Jaw
