Thermal Cycle Testing of PWBs – Methodology

Mike Freda, Sun Microsystems
Paul Reid, PWB Interconnect Solutions

Reliability testing of printed wire boards (PWBs) by thermal cycling offers the ability to compare relative survivability through assembly and reliability in the end use environment. This article delineates an eleven step method to establish a test protocol that will maximize accuracy, applicability and reduced costs and reduce the propensity for confounded data in thermal cycle testing of bare PWBs exposed to lead-free assembly and rework simulation. The method presented in this paper is targeted to the unique challenges afforded by lead-free testing applications and testing of the integrity of conductive interconnections and dielectric materials.

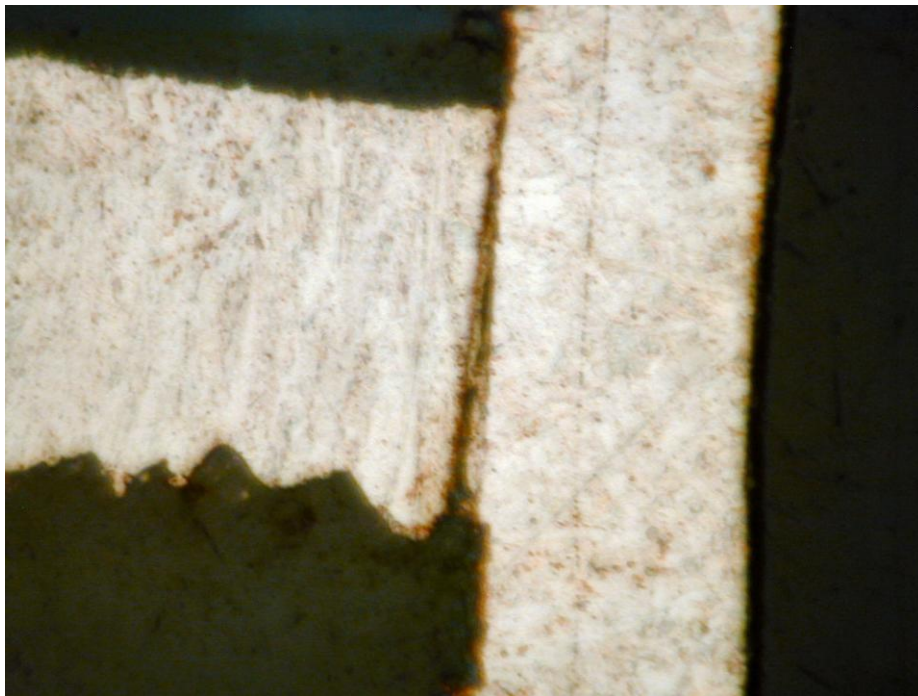
Interconnect Separation: Interconnect separation (figure 11) is defined as a small crack at the internal interconnection. This failure mode is exemplified with small cracks between the copper of the PTH and the internal foil. The connection is frequently not displaced out of plane of the original interconnection site. There is a small gap between the foil and copper of the PTH barrel at ambient. This type of failure produces a constant increase in resistance over the life of the test.

Figure 11 - Interconnect Separation

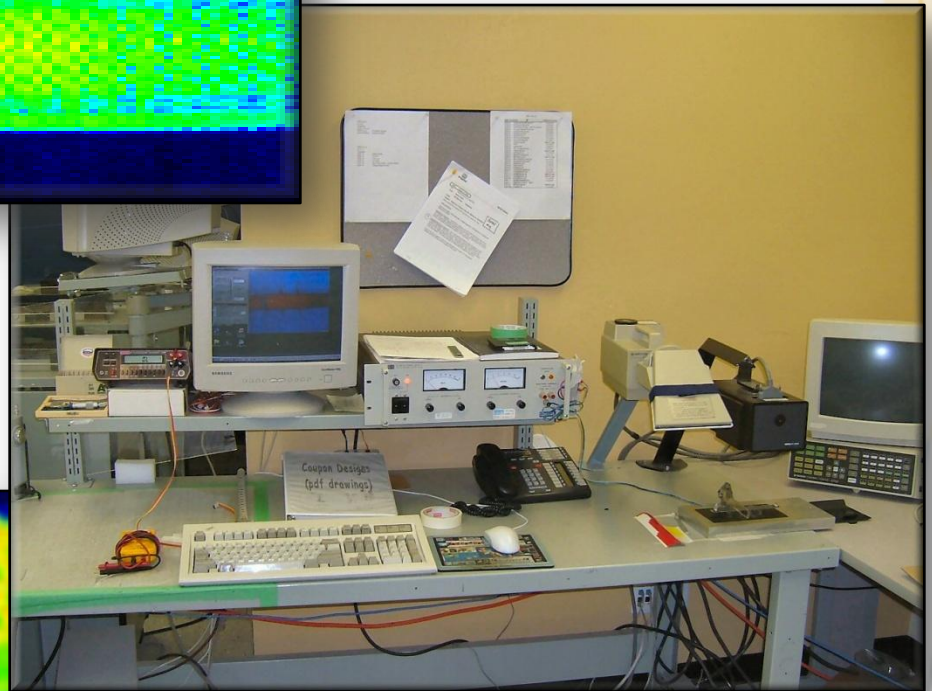
Thermal Imaging (thermo-graphic camera)

Failing Microvia

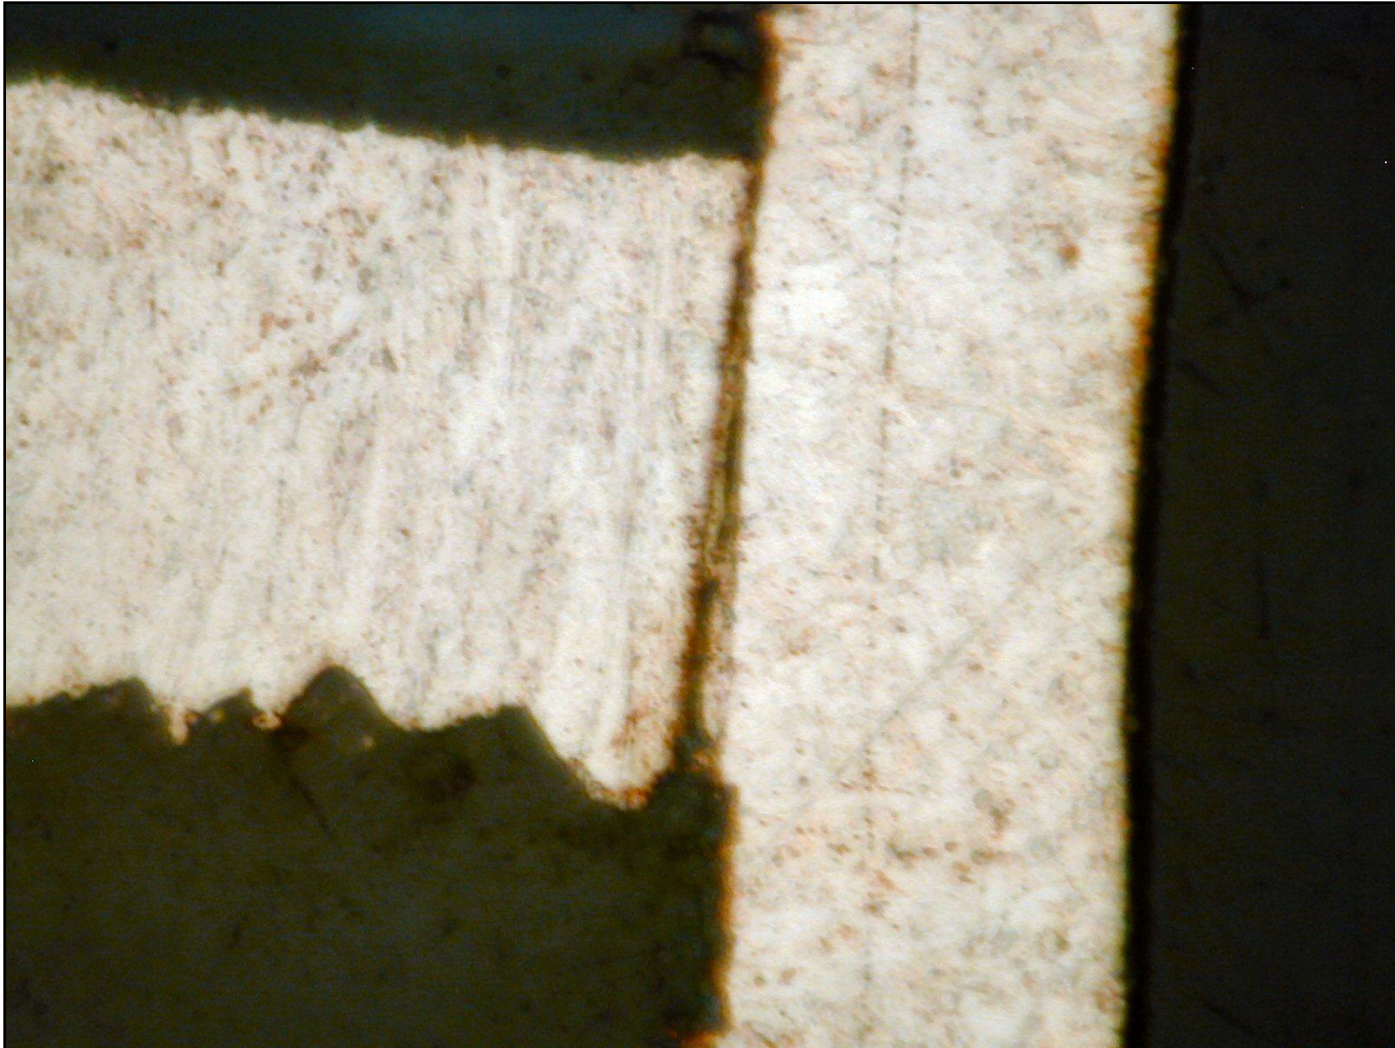
Interconnect Separation
